STREAM INVENTORY REPORT

Bear Haven Creek

A stream inventory was conducted from September 10 to October 2, 2012 on Bear Haven Creek. The survey began at the confluence with Middle Fork Ten Mile River and extended upstream 5.5 miles. A stream inventory and report was also completed for one tributary to Bear Haven Creek.

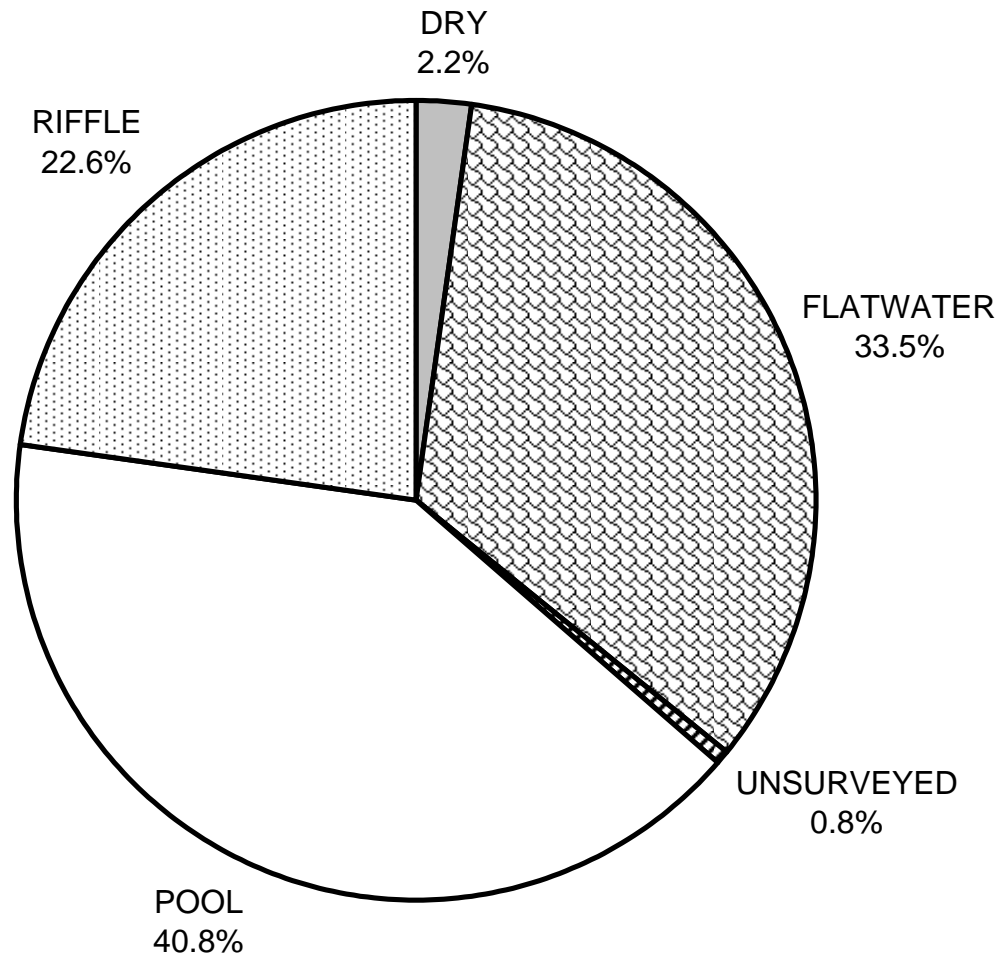
GRAPH 1

Table 1 summarizes the Level II riffle, flatwater, and pool habitat types. Based on frequency of occurrence there were 41% pool units, 34% flatwater units, 23% riffle units, 2% dry units, and 1% unsurveyed units (Graph 1). Based on total length of Level II habitat types there were 45%

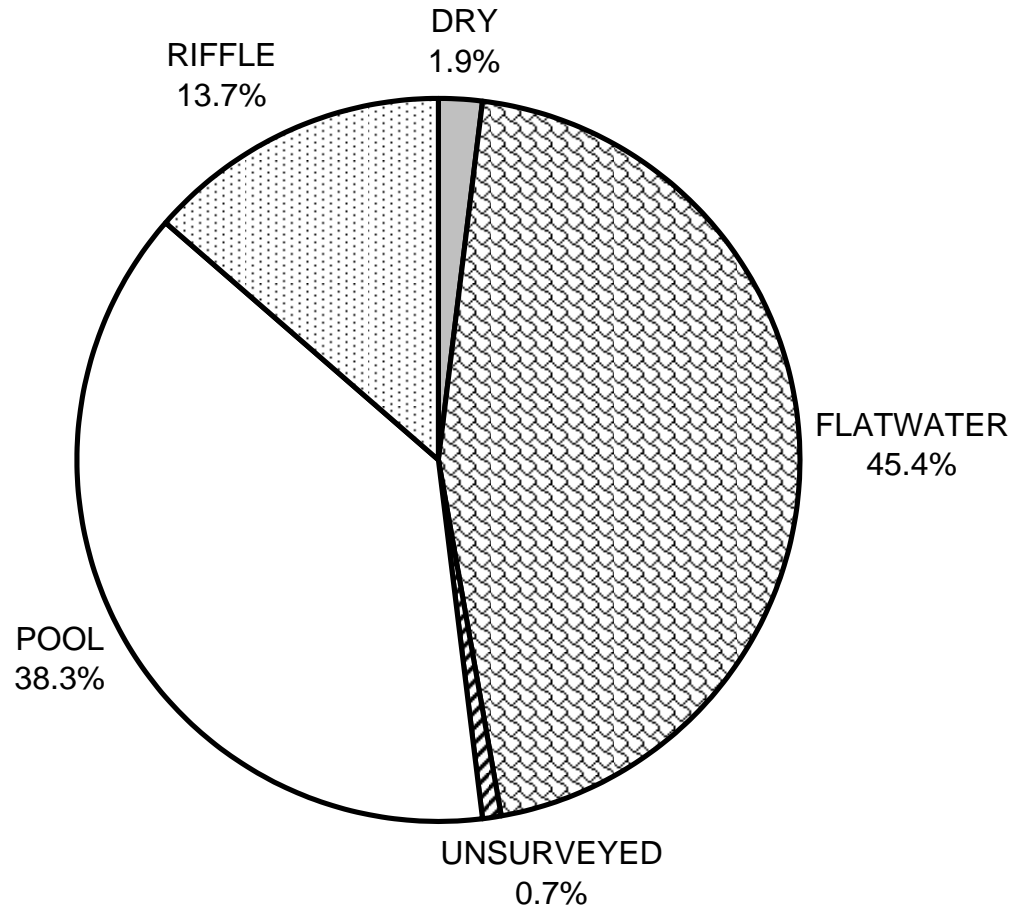
GRAPH 2

flatwater units, 38% pool units, 14% riffle units, 2% dry units, and 1% unsurveyed units (Graph 2).

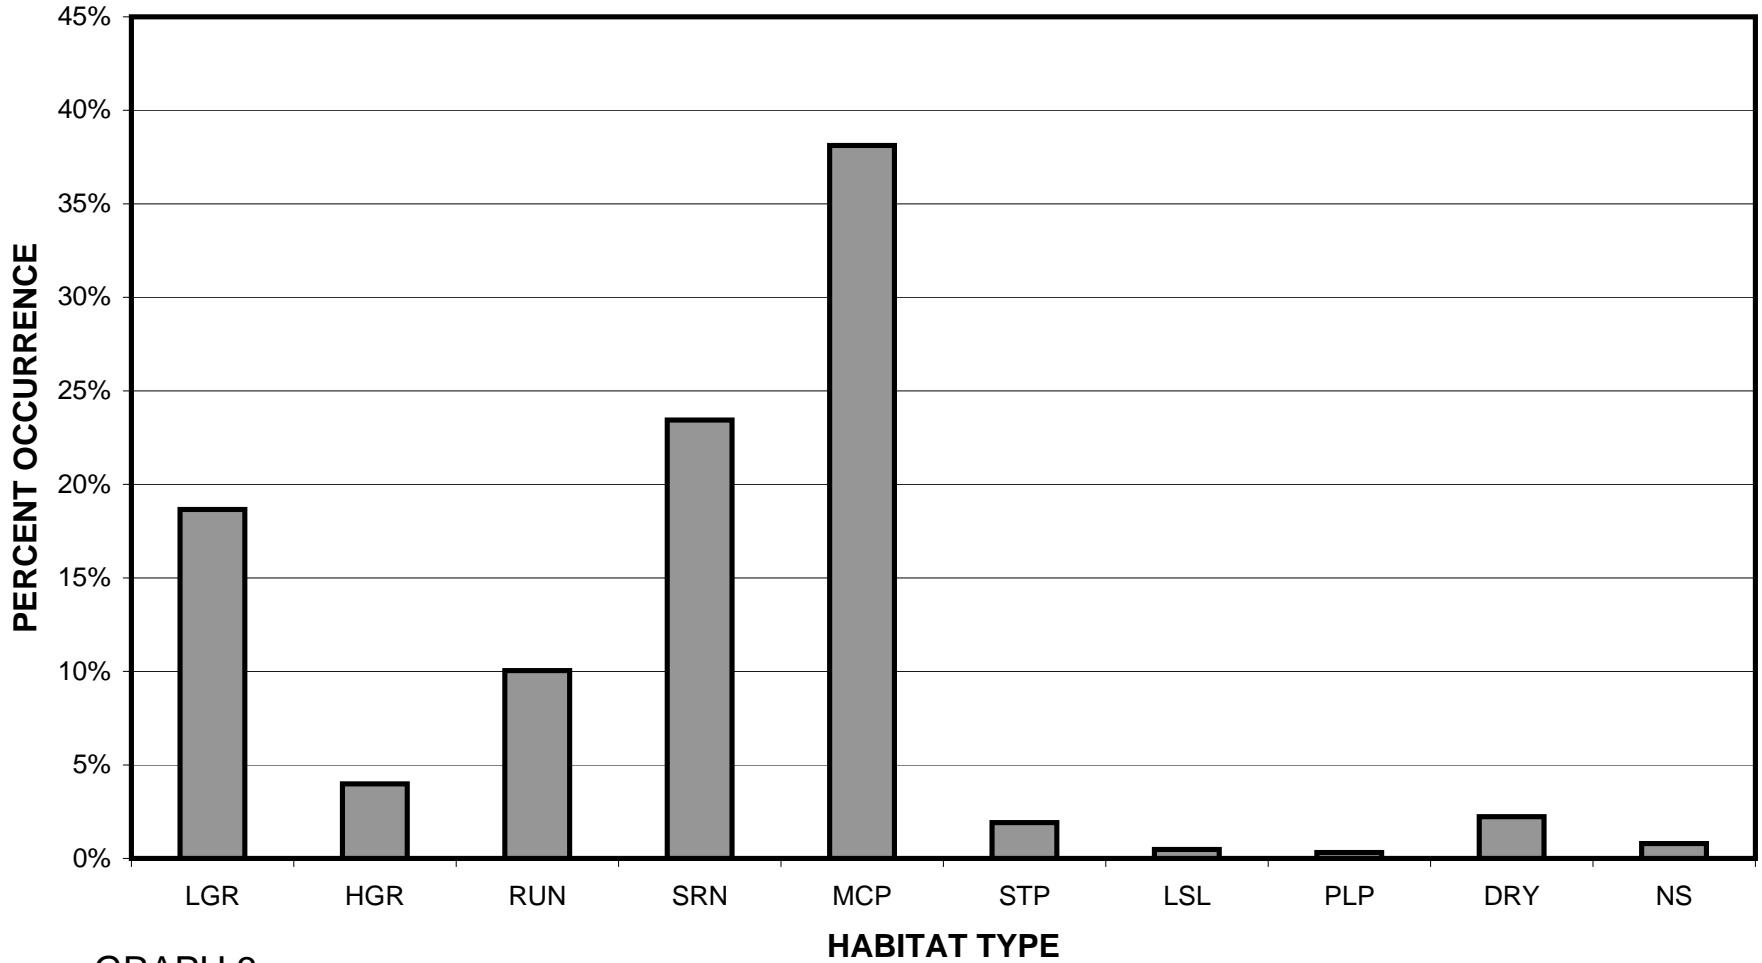
GRAPH 3

Nine Level IV habitat types were identified (Table 2). The most frequent habitat types by percent occurrence were mid-channel pool units, 38%; step run units, 23%; and low gradient riffle units, 19% (Graph 3). Based on percent total length, step run units made up 38%, mid-channel pool units 36%, and low gradient riffle units 11%.

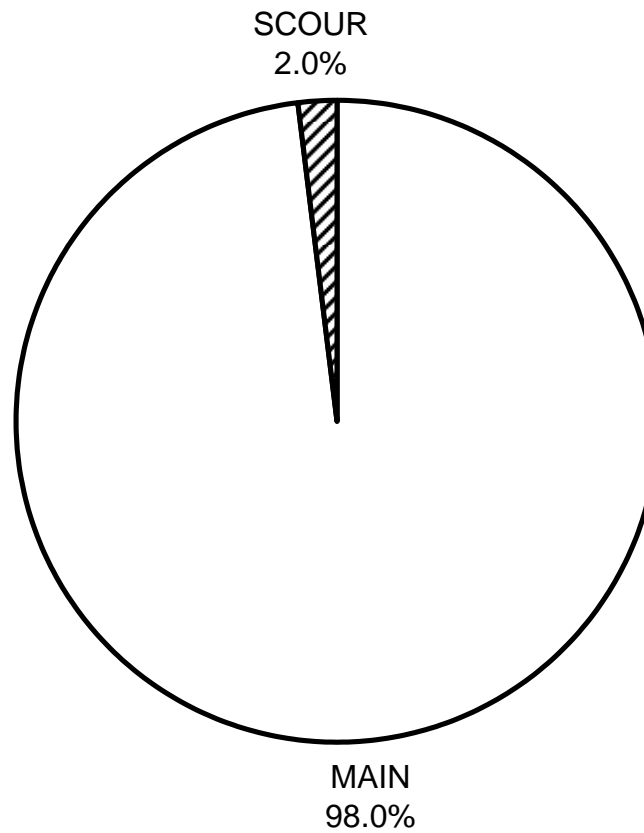
GRAPH 4

A total of 256 pools were identified (Table 3). Main channel pools were the most frequently encountered at 98% (Graph 4), and comprised 99% of the total length of all pools (Table 3).

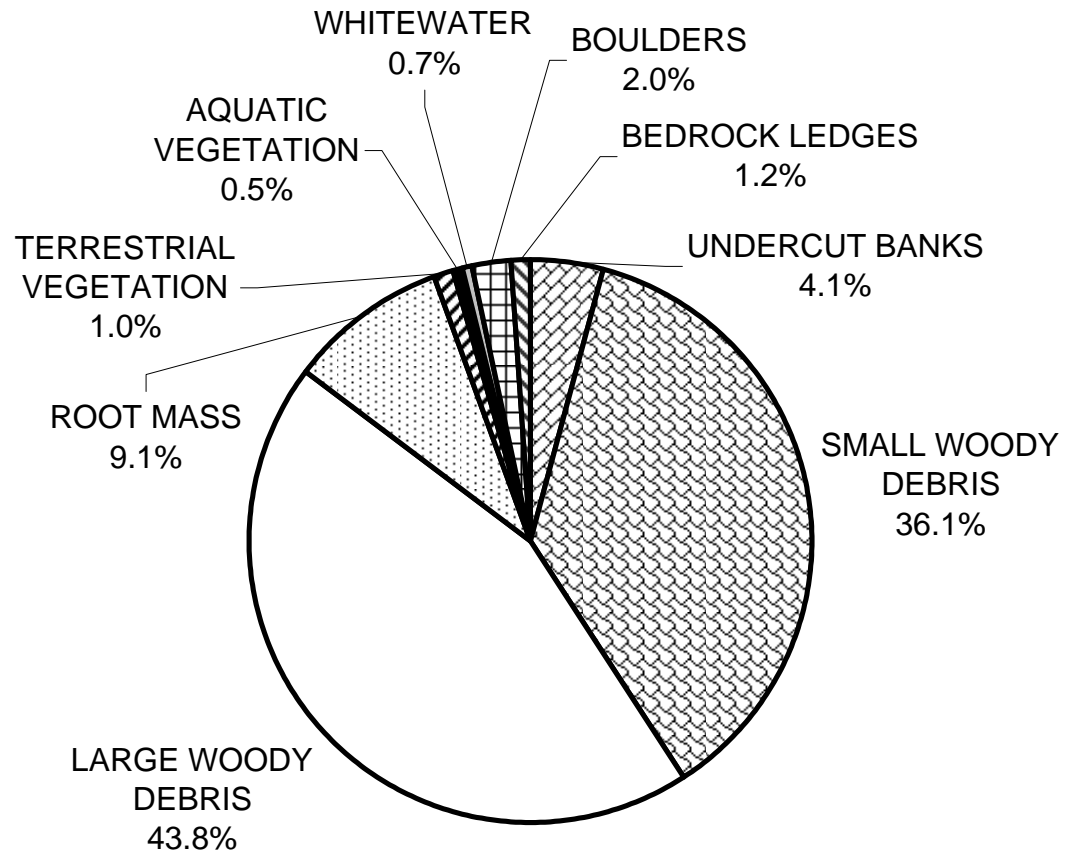
GRAPH 7

Table 5 summarizes mean percent cover by habitat type. Large woody debris is the dominant cover type in Bear Haven Creek. Graph 7 describes the pool cover in Bear Haven Creek. Large woody debris is the dominant pool cover type followed by small woody debris.

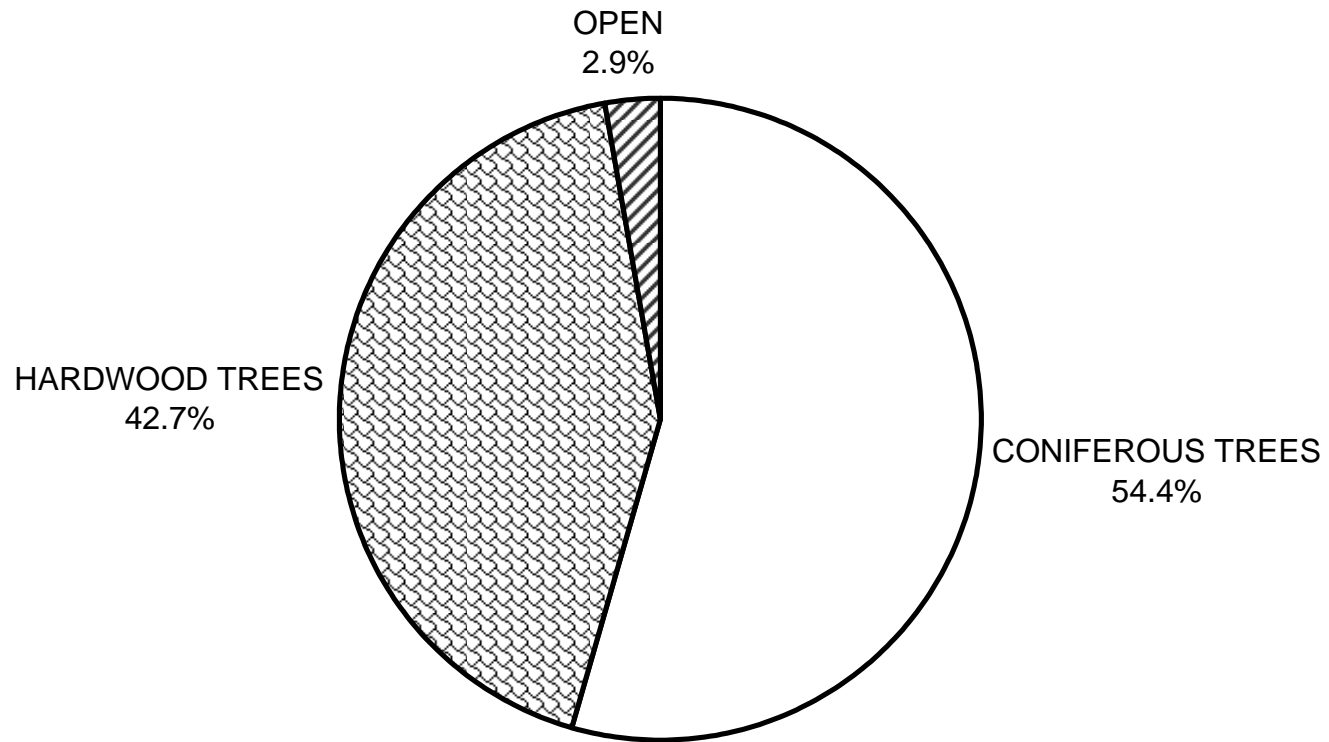
GRAPH 9

The mean percent canopy density for the surveyed length of Bear Haven Creek was 97%. Three percent of the canopy was open. Of the canopy present, the mean percentages of hardwood and coniferous trees were 44% and 56%, respectively. Graph 9 describes the mean percent canopy in Bear Haven Creek.

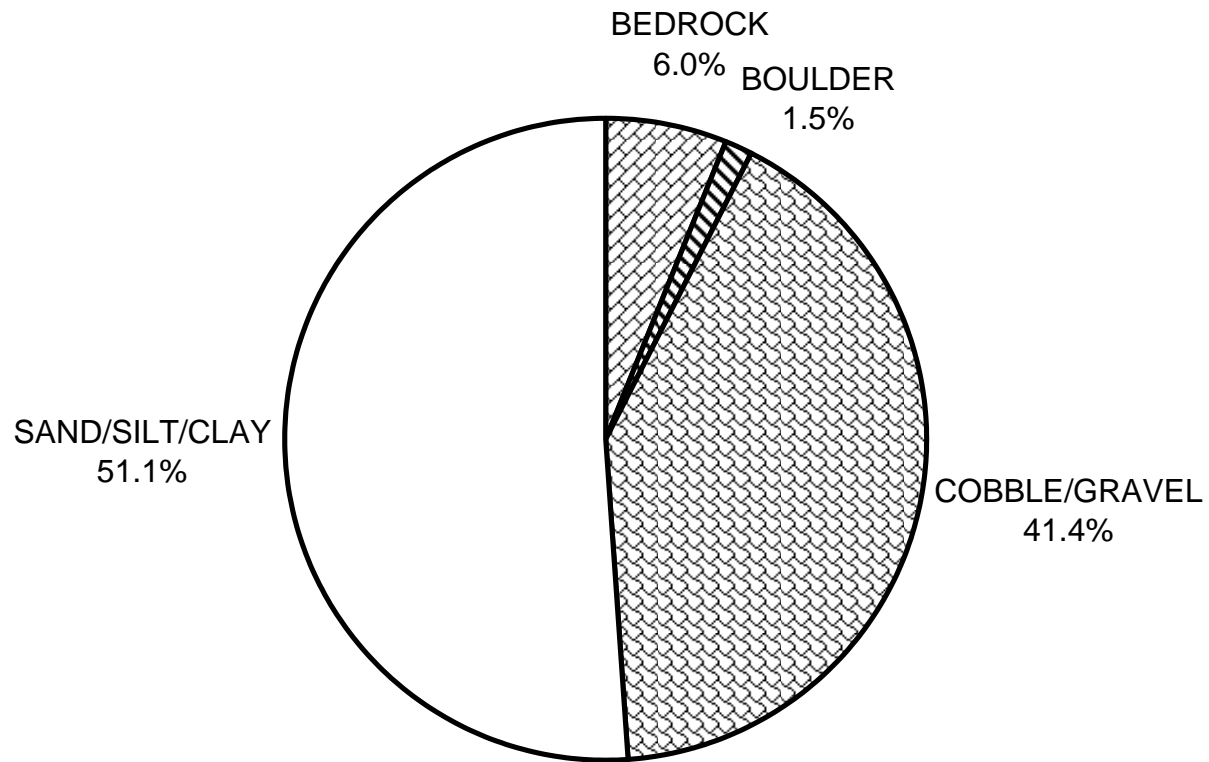
GRAPH 10

For the stream reach surveyed, the mean percent right bank vegetated was 99%. The mean percent left bank vegetated was 99%. The dominant elements composing the structure of the stream banks consisted of 51% sand/silt/clay, 41% cobble/gravel, 6% bedrock, and 2% boulders (Graph 10). Coniferous trees were the dominant vegetation type observed in 82% of the units

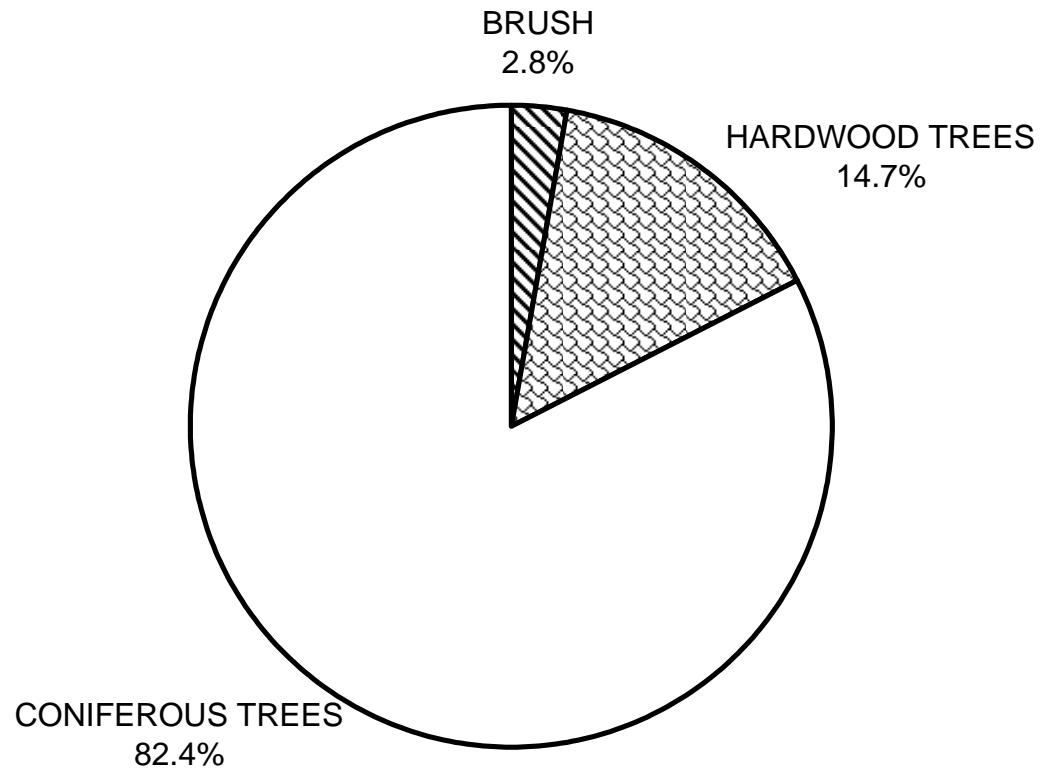
GRAPH 11

surveyed. Additionally, 15% of the units surveyed had deciduous trees as the dominant vegetation type, and 3% had brush as the dominant vegetation type (Graph 11).
