# STREAM INVENTORY REPORT

## Buckhorn Creek

A stream inventory was conducted from October 23 to October 30, 2012 on Buckhorn Creek. The survey began at the confluence with Little North Fork Ten Mile River and extended upstream 1.8 miles.

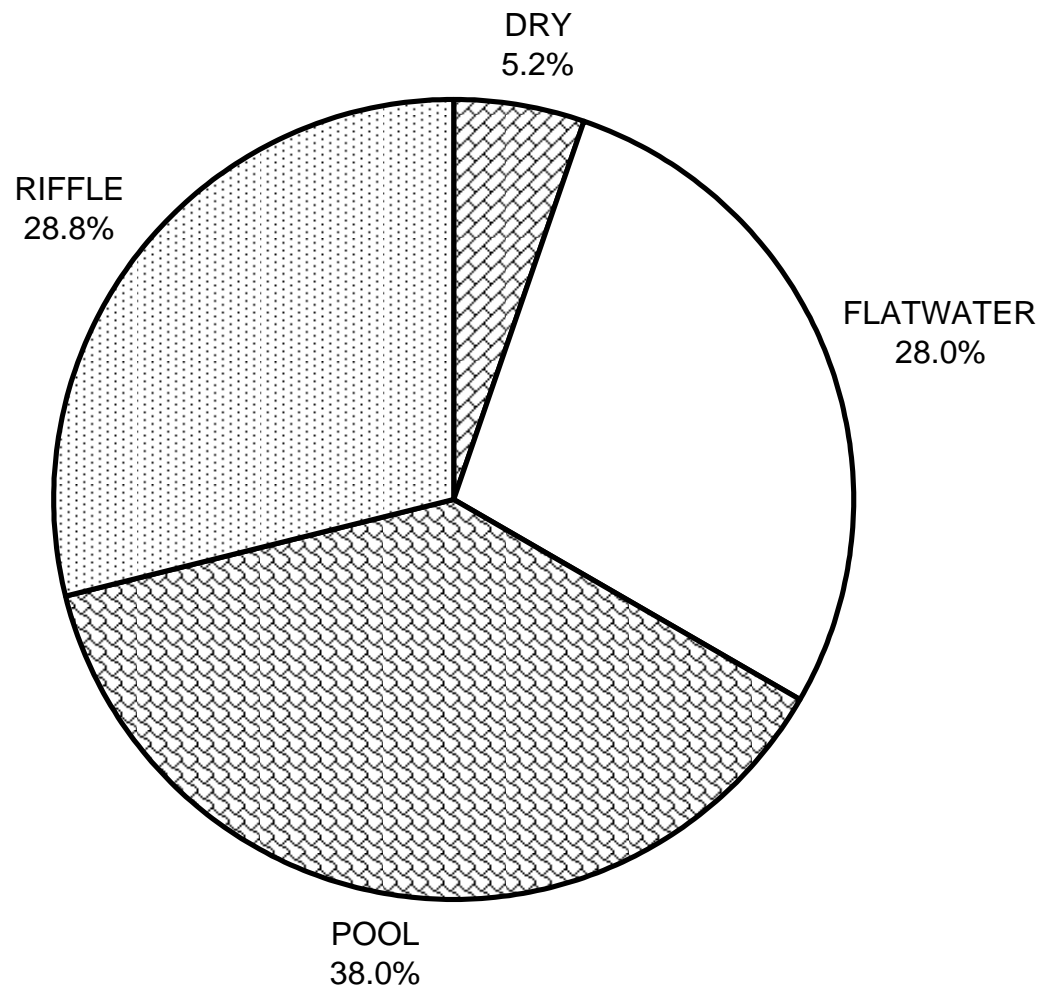
GRAPH 1

Table 1 summarizes the Level II riffle, flatwater, and pool habitat types. Based on frequency of occurrence there were 38% pool units, 29% riffle units, 28% flatwater units, and 5% dry units (Graph 1). Based on total length of Level II habitat types there were 44% flatwater units, 28% riffle units, 21% pool units, and 7% dry units (Graph 2).

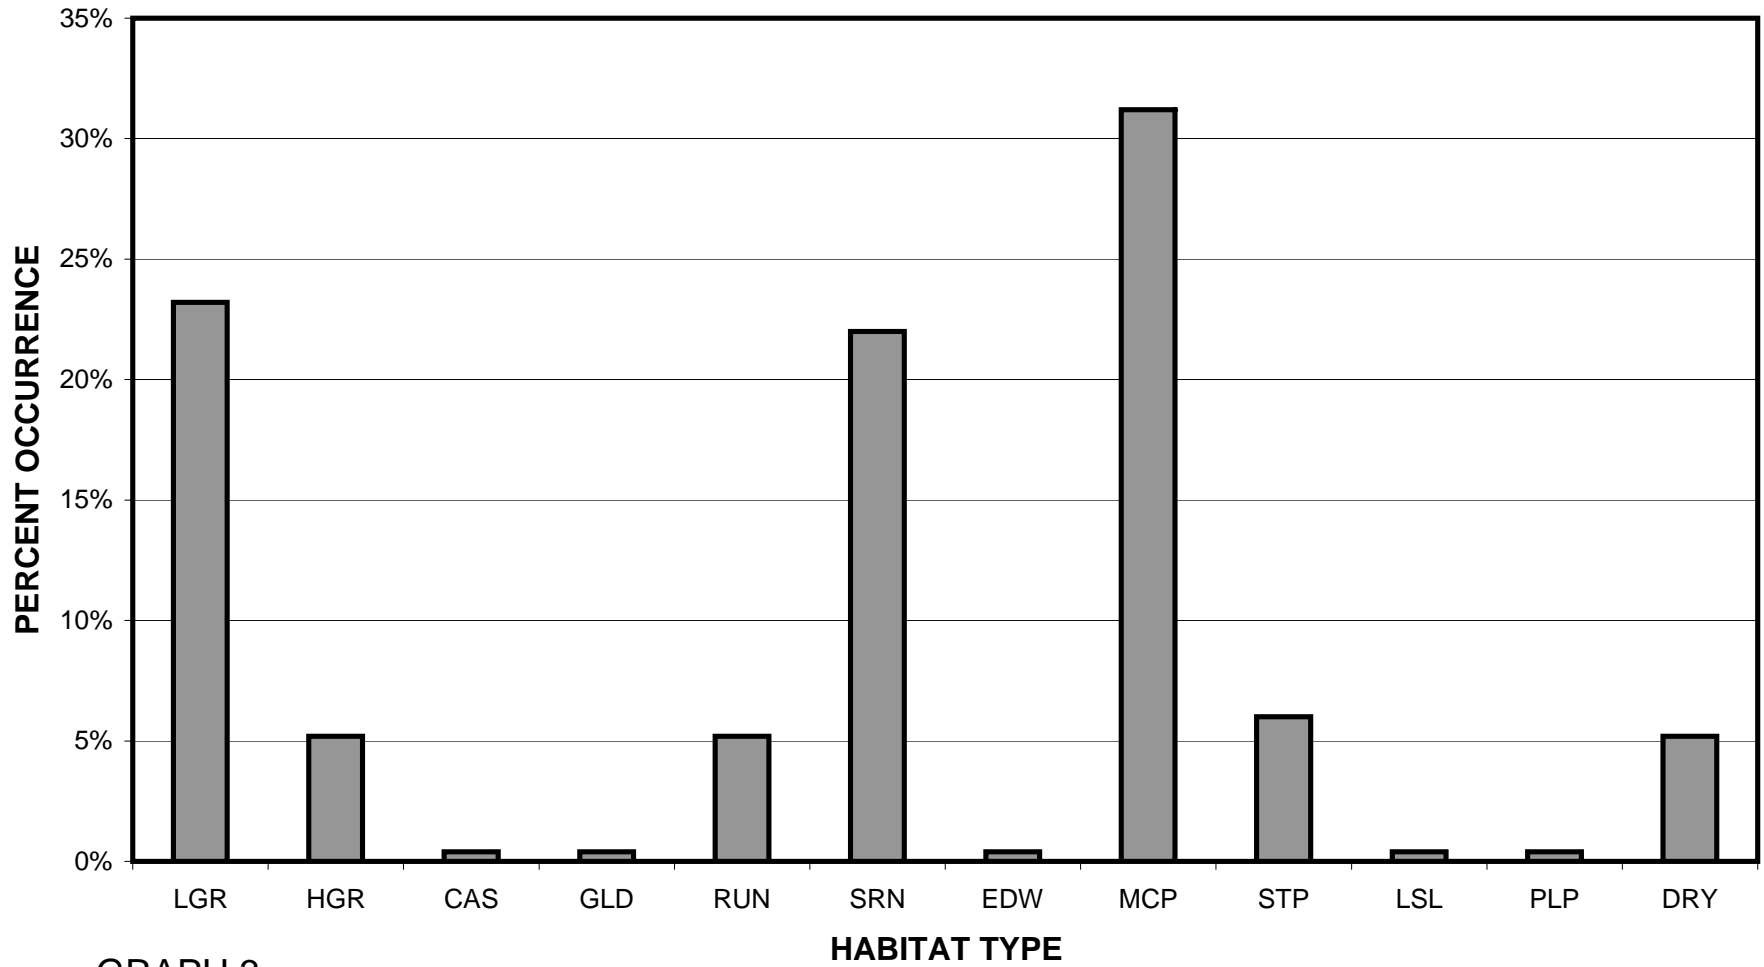
GRAPH 3

Twelve Level IV habitat types were identified (Table 2). The most frequent habitat types by percent occurrence were mid-channel pool units, 31%; low gradient riffle units, 23%; and step run units, 22% (Graph 3). Based on percent total length, step run units made up 38%, low gradient riffle units 22%, and mid-channel pool units 16%.

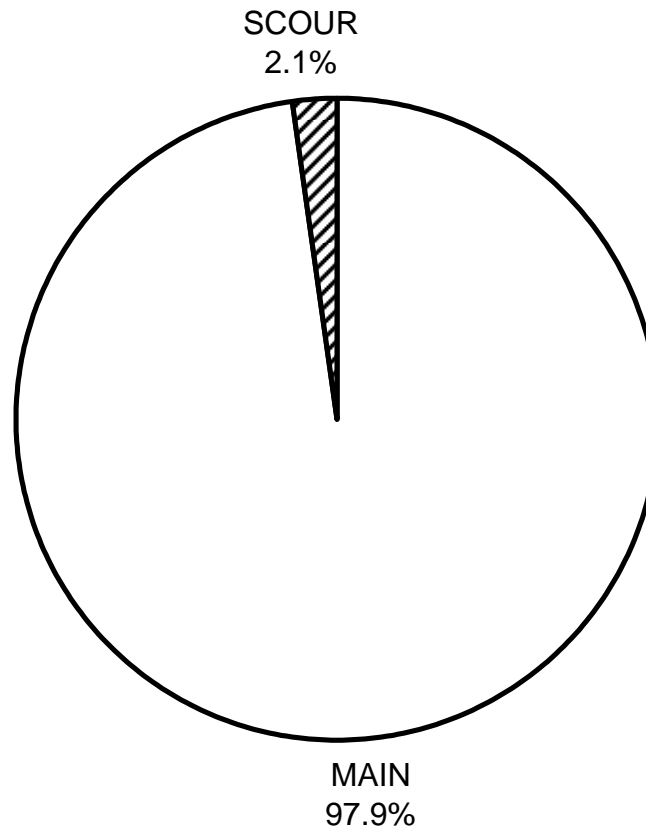
GRAPH 4

A total of 95 pools were identified (Table 3). Main channel pools were the most frequently encountered at 98% (Graph 4), and comprised 98% of the total length of all pools (Table 3).

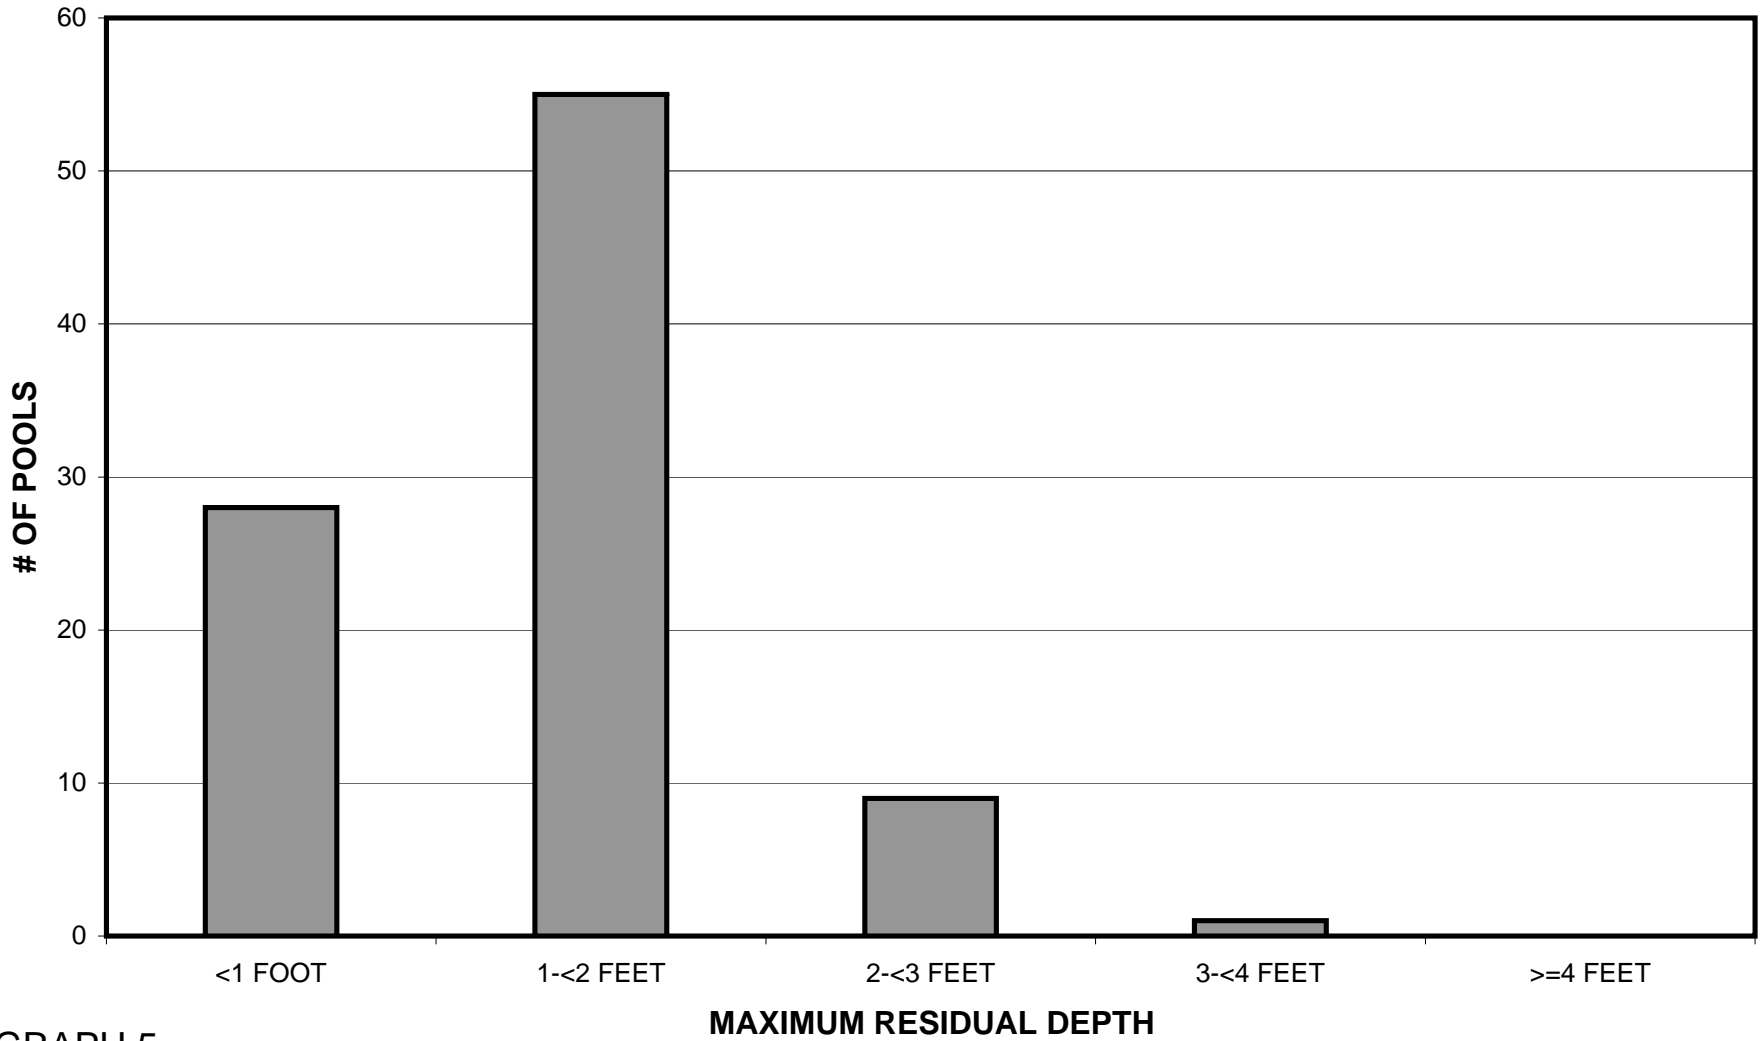
GRAPH 5

Table 4 is a summary of maximum residual pool depths by pool habitat types. Pool quality for salmonids increases with depth. Ten of the 93 pools measured (11%) had a residual depth of two feet or greater (Graph 5).

Flatwater habitat types comprised 44% of the total length of this survey, riffles 28%, and pools 21%. Ten of the 93 (11%) pools had a maximum residual depth greater than 2 feet. In general, pool enhancement projects are considered when primary pools comprise less than 40% of the length of total stream habitat. In first and second order streams, a primary pool is defined to have a maximum residual depth of at least two feet, occupy at least half the width of the low flow channel, and be as long as the low flow channel width. Installing large wood structures that will increase or deepen pool habitat is recommended.

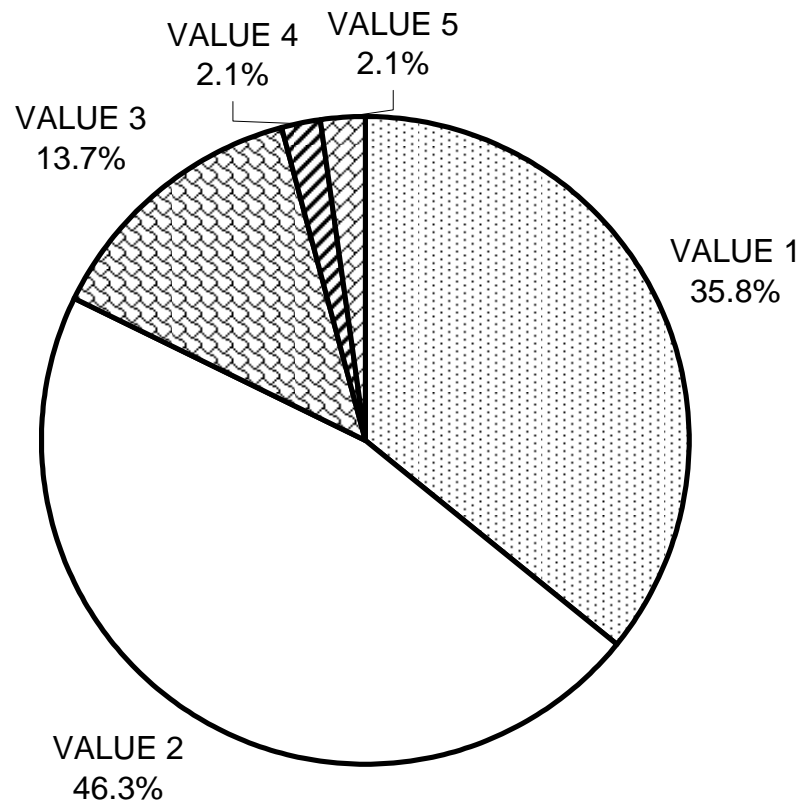
GRAPH 6

The depth of cobble embeddedness was estimated at pool tail-outs. Of the 95 pool tail-outs measured, 34 had a value of 1 (35.8%); 44 had a value of 2 (46.3%); 13 had a value of 3 (13.7%); two had a value of 4 (2.1%); two had a value of 5 (2.1%) (Graph 6). On this scale, a value of 1 indicates the best spawning conditions and a value of 4 the worst. Additionally, a value of 5 was assigned to tail-outs deemed not suitable for spawning due to inappropriate substrate such as bedrock, log sills, boulders, or other considerations.

Seventy-eight of the 95 pool tail-outs measured had embeddedness ratings of 1 or 2. Fifteen of the pool tail-outs had embeddedness ratings of 3 or 4. Two of the pool tail-outs had a rating of 5, which is considered unsuitable for spawning. Cobble embeddedness measured to be 25% or less, a rating of 1, is considered to indicate good quality spawning substrate for salmon and steelhead.

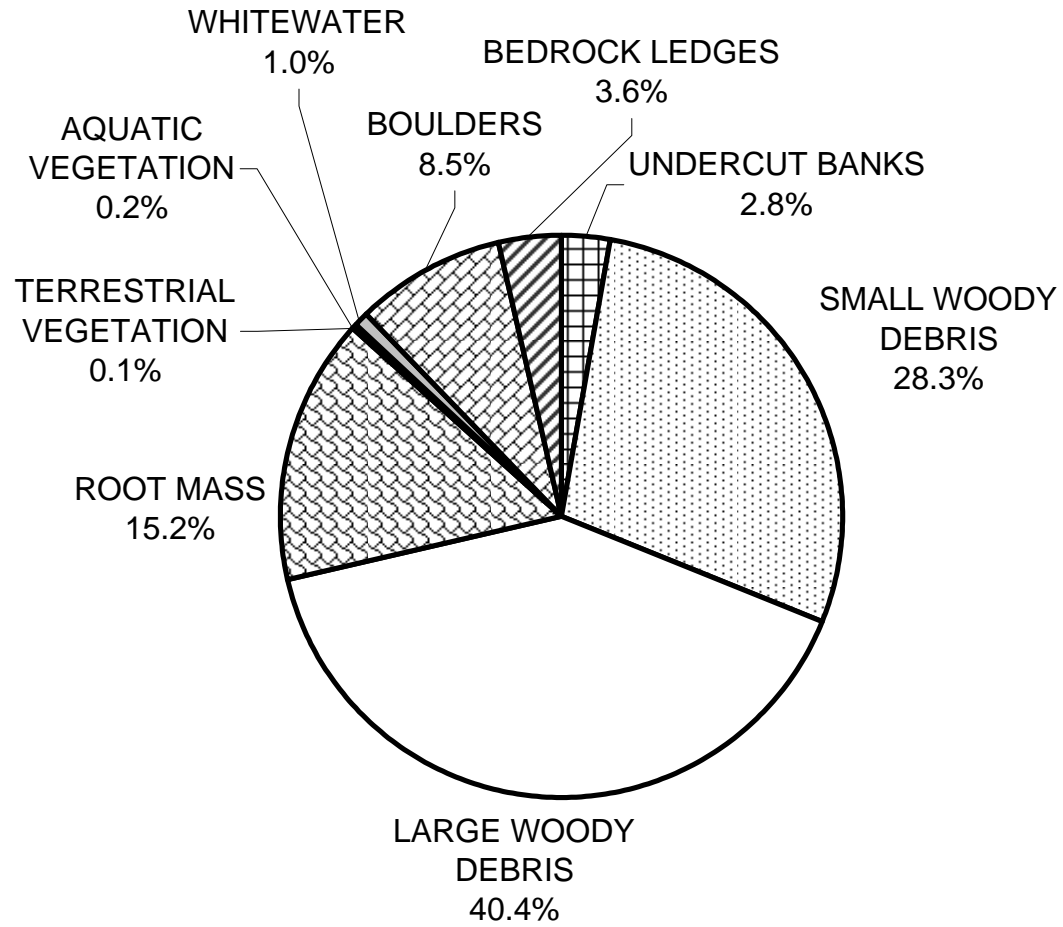
GRAPH 7

Table 5 summarizes mean percent cover by habitat type. Large woody debris is the dominant cover type in Buckhorn Creek. Graph 7 describes the pool cover in Buckhorn Creek. Large woody debris is the dominant pool cover type followed by small woody debris.

The mean shelter rating for pools is 44. The shelter rating in the flatwater habitats is 8. A pool shelter rating of approximately 100 is desirable. The amount of cover that now exists is being provided primarily by large woody debris in Buckhorn Creek. Large woody debris is the dominant cover type in pools followed by small woody debris. Log and root wad cover structures in the pool and flatwater habitats would enhance both summer and winter salmonid habitat. Log cover structures provide rearing fry with protection from predation, rest from water velocity, and also divide territorial units to reduce density related competition.

- 3) Increase woody cover in the pools and flatwater habitat units. Most of the existing cover in the pools is from large woody debris. Adding high quality complexity with woody cover in the pools is desirable.

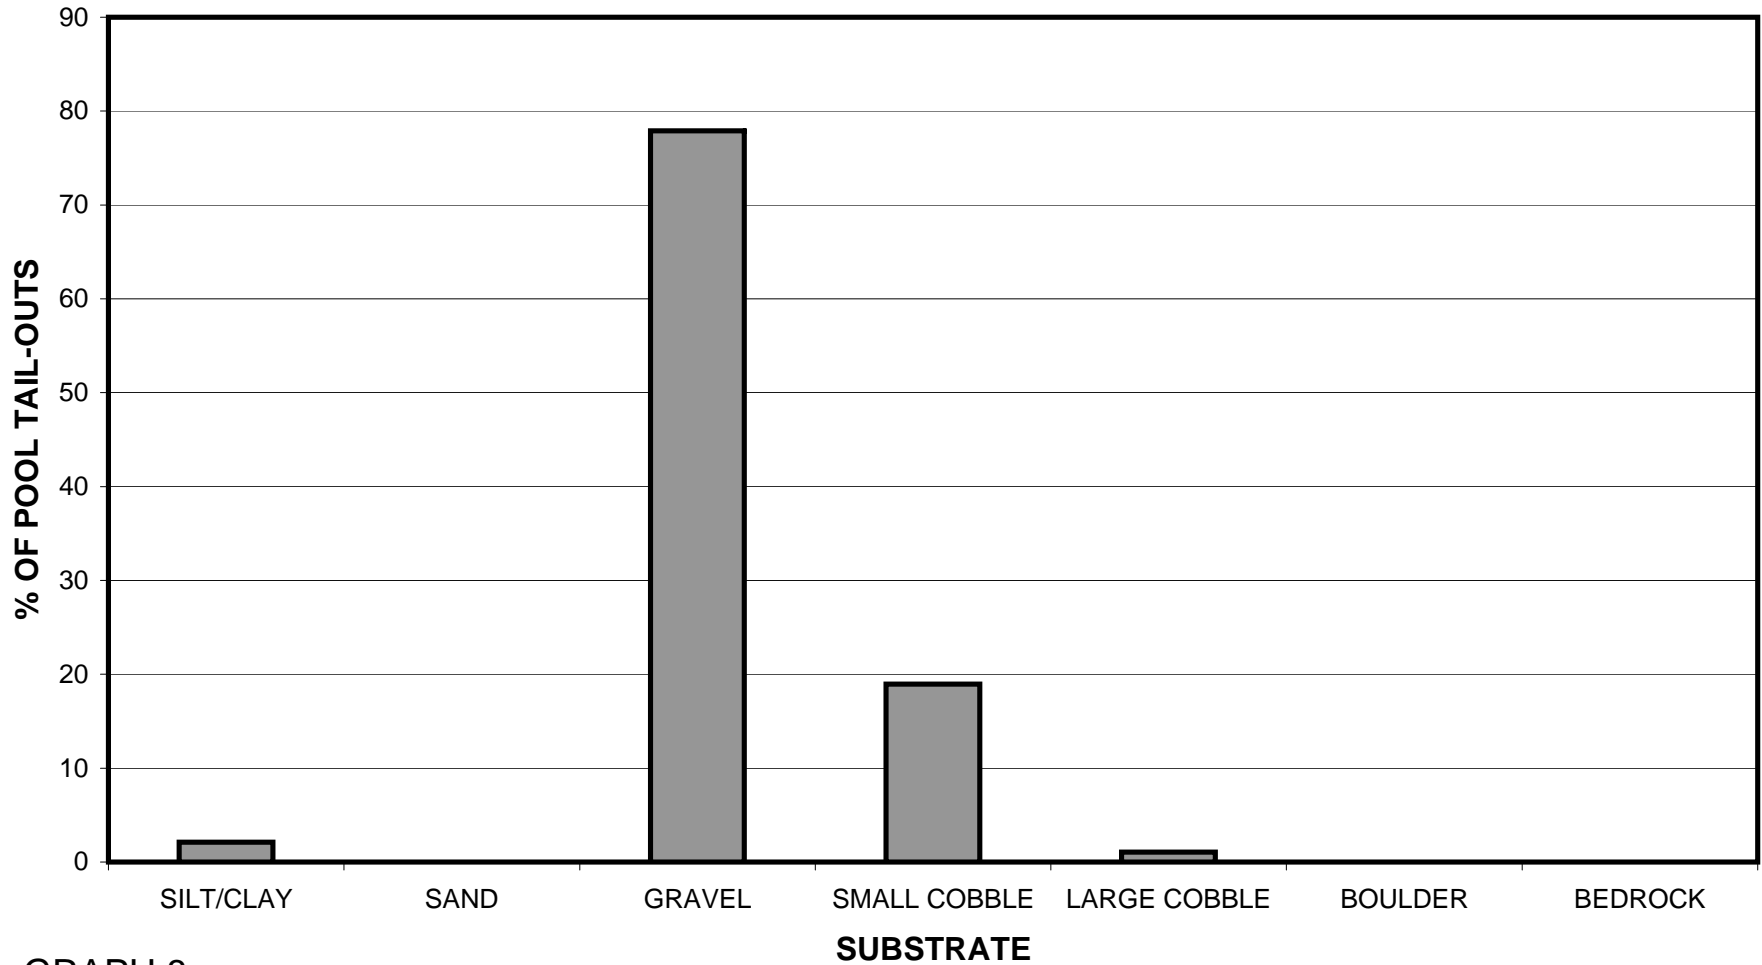
GRAPH 8

Table 6 summarizes the dominant substrate by habitat type. Graph 8 depicts the dominant substrate observed in pool tail-outs. Gravel was the dominant substrate observed in 78% of the pool tail-outs. Small cobble was the next most frequently observed dominant substrate type and occurred in 19% of the pool tail-outs

Ninety-two of the 95 pool tail-outs measured had gravel or small cobble as the dominant substrate. This is generally considered good for spawning salmonids.

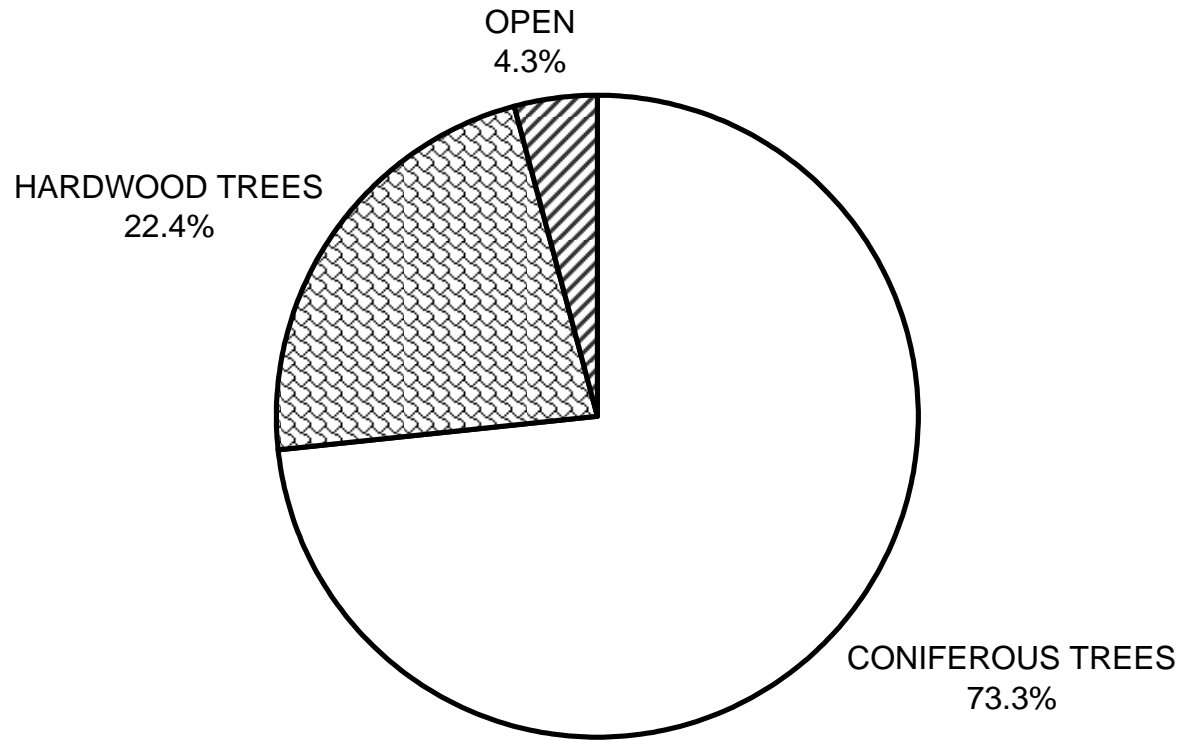
GRAPH 9

The mean percent canopy density for the surveyed length of Buckhorn Creek was 96%. Four percent of the canopy was open. Of the canopy present, the mean percentages of hardwood and coniferous trees were 23% and 77%, respectively. Graph 9 describes the mean percent canopy in Buckhorn Creek.

The mean percent canopy density for the stream was 96%. The percentage of right and left bank covered with vegetation was 97% and 97%, respectively.

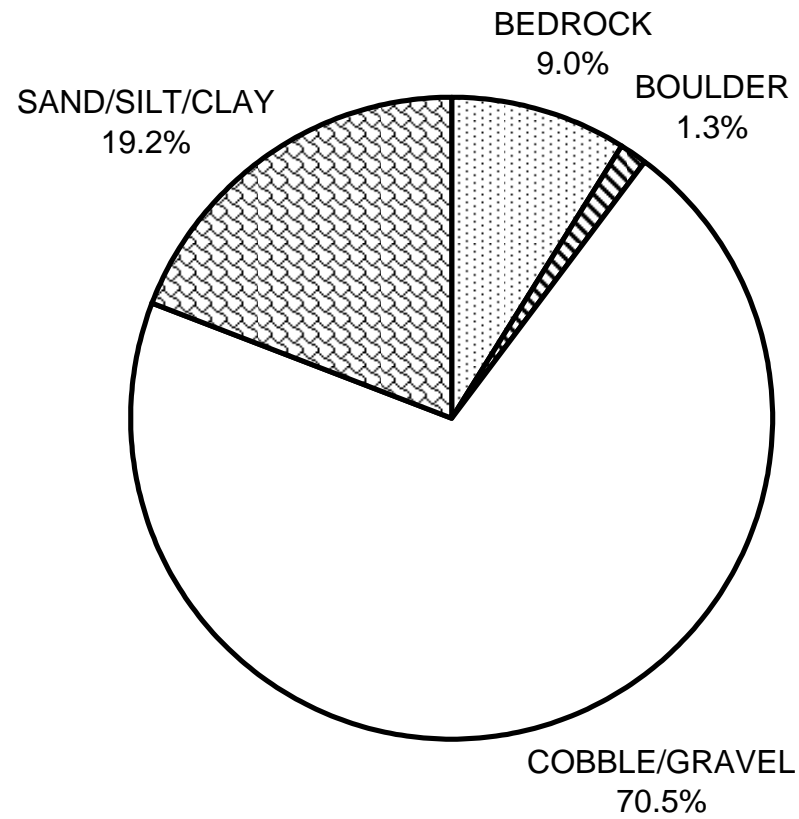
GRAPH 10

For the stream reach surveyed, the mean percent right bank vegetated was 97%. The mean percent left bank vegetated was 97%. The dominant elements composing the structure of the stream banks consisted of 71% cobble/gravel, 19% sand/silt/clay, 9% bedrock, and 1% boulders (Graph 10). Coniferous trees were the dominant vegetation type observed in 91% of the units surveyed. Additionally, 8% of the units surveyed had deciduous trees as the dominant vegetation type, and 2% had brush as the dominant vegetation type (Graph 11).
