STREAM INVENTORY REPORT

Buckhorn Creek

A stream inventory was conducted from October 23 to October 30, 2012 on Buckhorn Creek. The survey began at the confluence with Little North Fork Ten Mile River and extended upstream 1.8 miles.

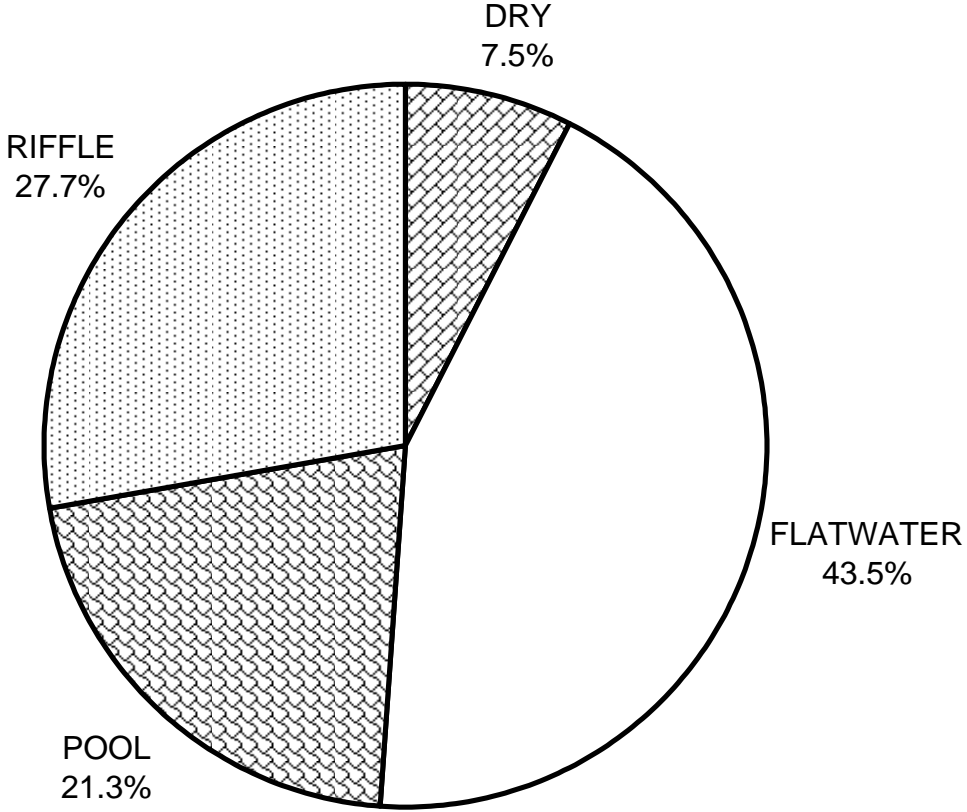
GRAPH 2

Table 1 summarizes the Level II riffle, flatwater, and pool habitat types. Based on frequency of occurrence there were 38% pool units, 29% riffle units, 28% flatwater units, and 5% dry units (Graph 1). Based on total length of Level II habitat types there were 44% flatwater units, 28% riffle units, 21% pool units, and 7% dry units (Graph 2).

Flatwater habitat types comprised 44% of the total length of this survey, riffles 28%, and pools 21%. Ten of the 93 (11%) pools had a maximum residual depth greater than 2 feet. In general, pool enhancement projects are considered when primary pools comprise less than 40% of the length of total stream habitat. In first and second order streams, a primary pool is defined to have a maximum residual depth of at least two feet, occupy at least half the width of the low flow channel, and be as long as the low flow channel width. Installing large wood structures that will increase or deepen pool habitat is recommended.

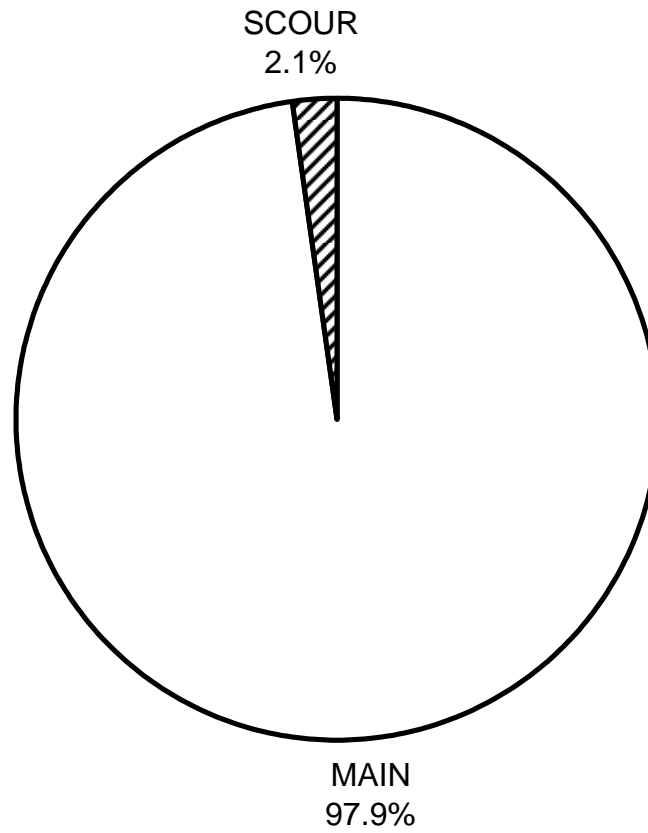
GRAPH 4

A total of 95 pools were identified (Table 3). Main channel pools were the most frequently encountered at 98% (Graph 4), and comprised 98% of the total length of all pools (Table 3).

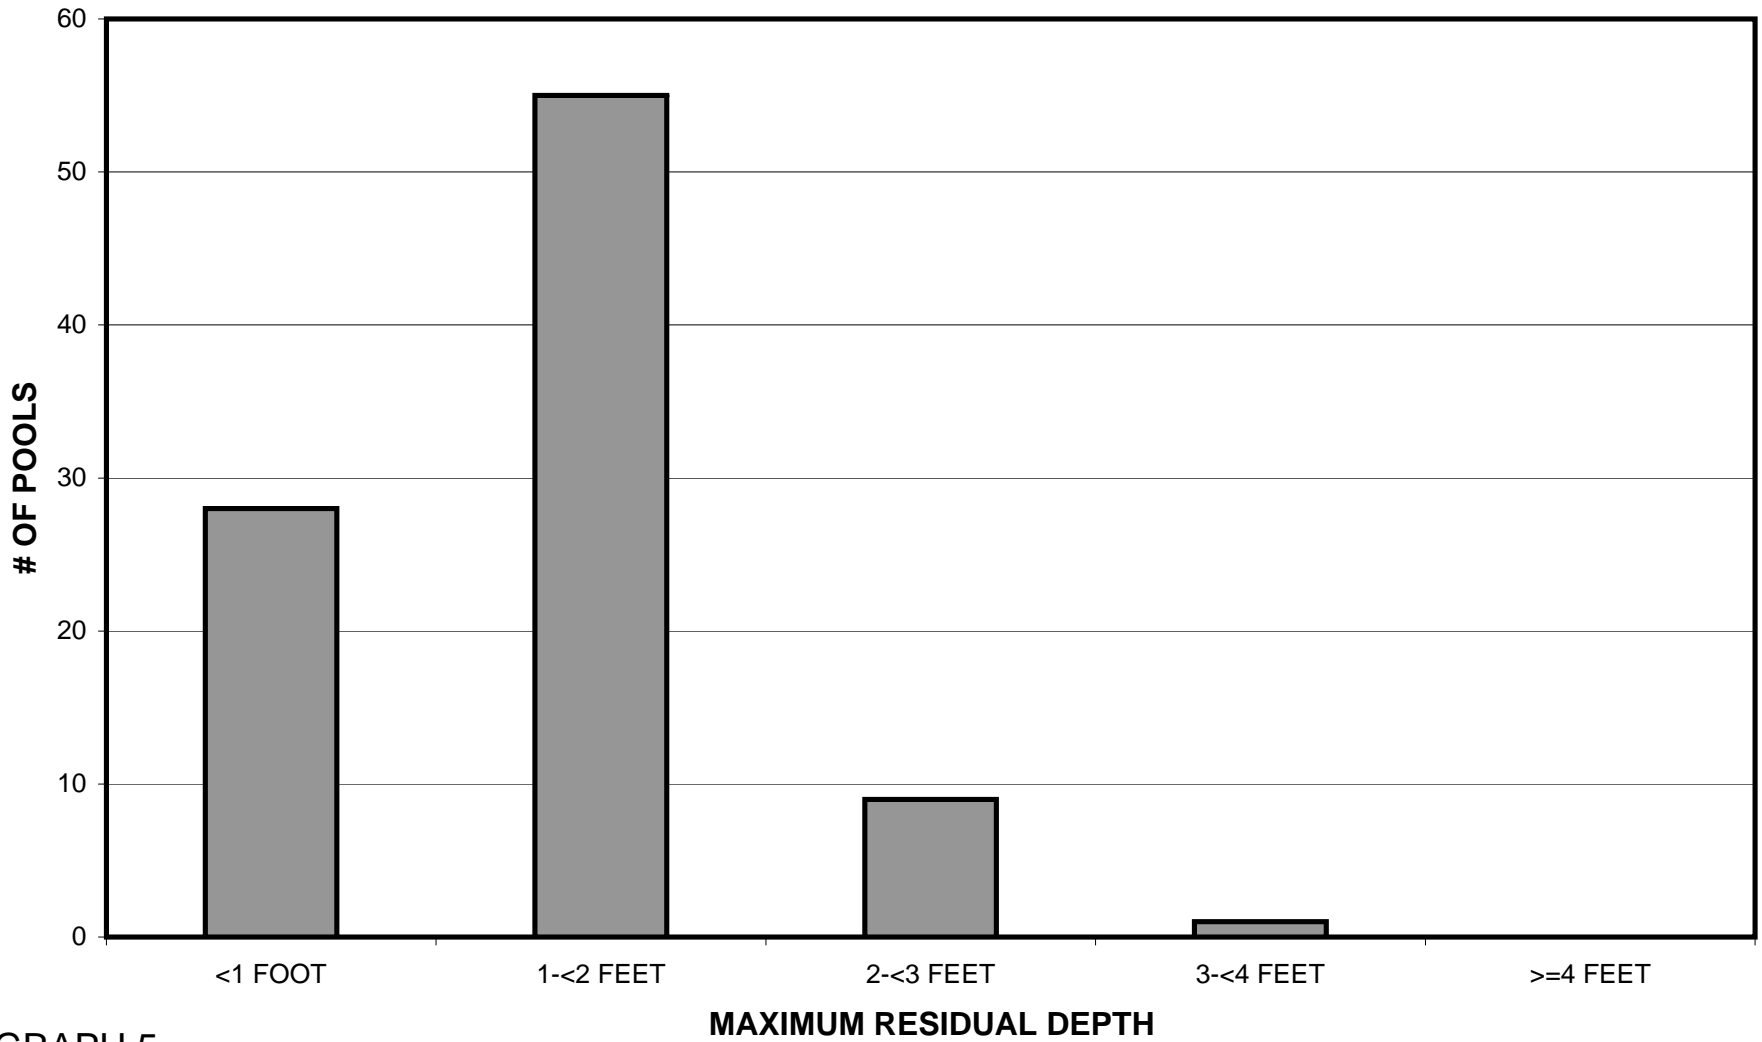
GRAPH 5

Table 4 is a summary of maximum residual pool depths by pool habitat types. Pool quality for salmonids increases with depth. Ten of the 93 pools measured (11%) had a residual depth of two feet or greater (Graph 5).
