# STREAM INVENTORY REPORT

## “Gulch 23”

A stream inventory was conducted from October 15 to October 16, 2012 on an unnamed tributary to Middle Fork Ten Mile River locally known as, and herein after referred to as, Gulch 23. The survey began at the confluence with Middle Fork Ten Mile River and extended upstream 0.3 miles.

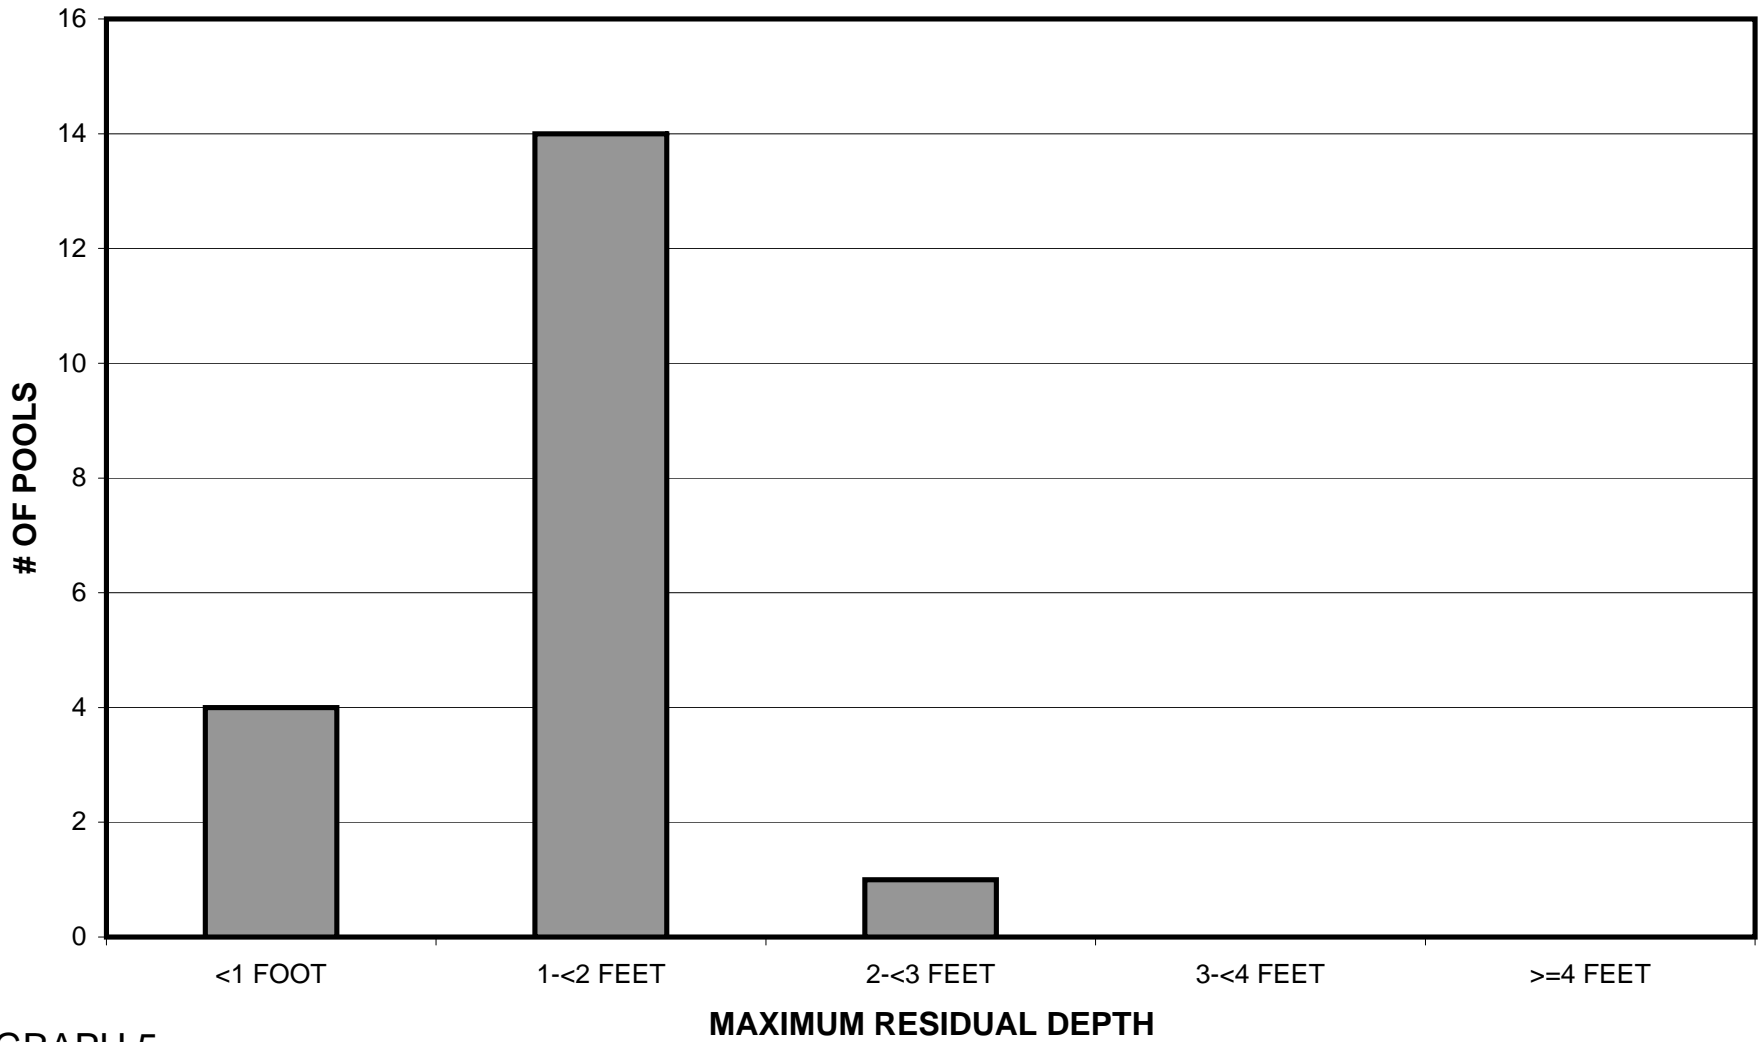
GRAPH 5

Table 4 is a summary of maximum residual pool depths by pool habitat types. Pool quality for salmonids increases with depth. One of the 19 pools (5%) had a residual depth of two feet or greater (Graph 5).

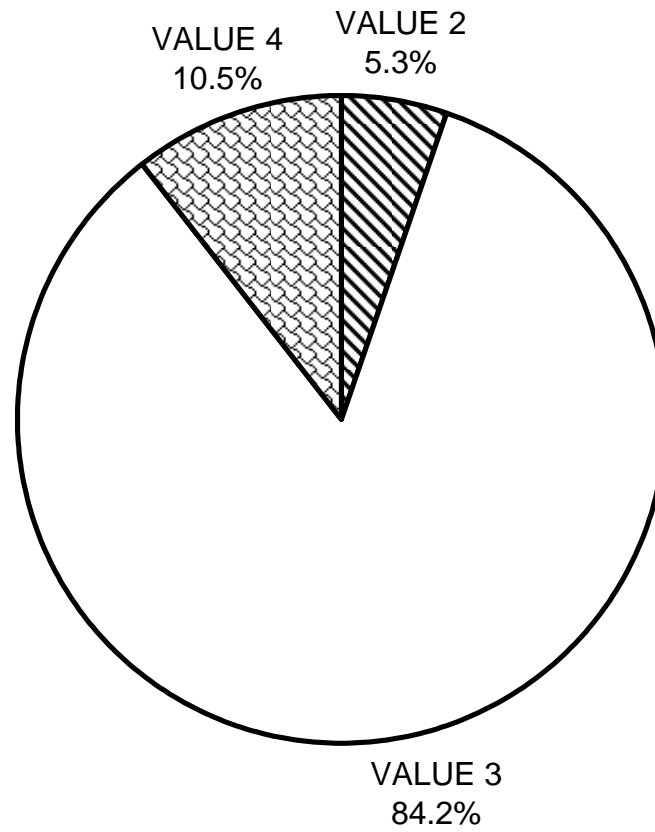
GRAPH 6

The depth of cobble embeddedness was estimated at pool tail-outs. Of the 19 pool tail-outs measured, one had a value of 2 (5.3%); 16 had a value of 3 (84.2%); two had a value of 4 (10.5%) (Graph 6). On this scale, a value of 1 indicates the best spawning conditions and a value of 4 the worst. Additionally, a value of 5 was assigned to tail-outs deemed not suitable for

One of the 19 pool tail-outs measured had embeddedness ratings of 1 or 2. Eighteen of the pool tail-outs had embeddedness ratings of 3 or 4. None of the pool tail-outs had a rating of 5, which is considered unsuitable for spawning. Cobble embeddedness measured to be 25% or less, a rating of 1, is considered to indicate good quality spawning substrate for salmon and steelhead. Sediment sources in Gulch 23 should be mapped and rated according to their potential sediment yields, and control measures should be taken.

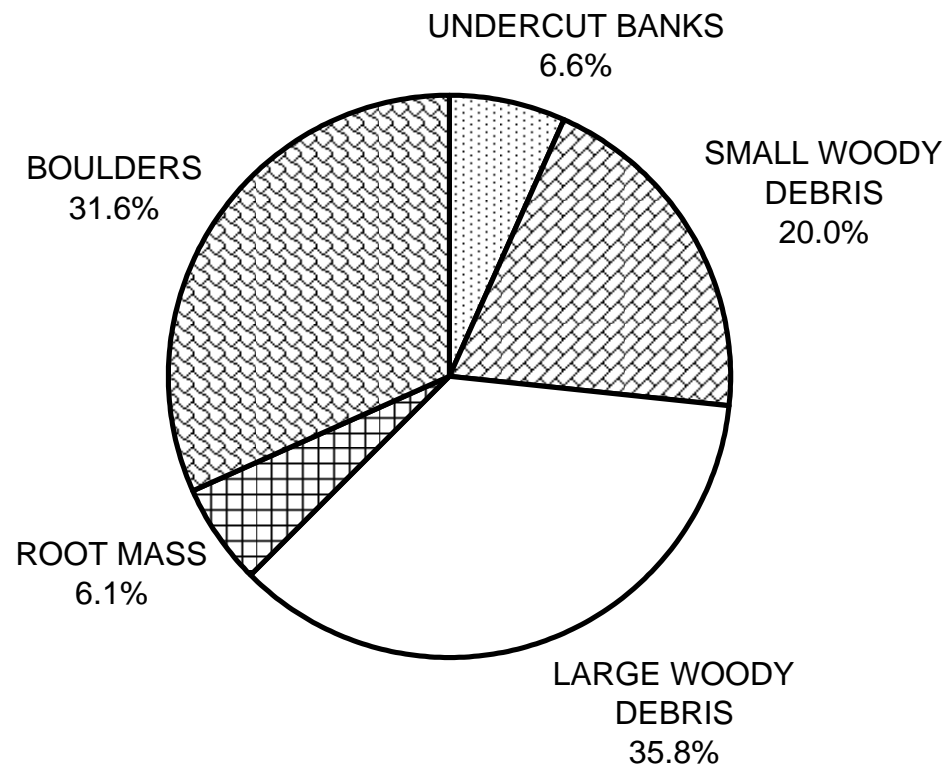
GRAPH 7

Table 5 summarizes mean percent cover by habitat type. Boulders are the dominant cover type in Gulch 23. Graph 7 describes the pool cover in Gulch 23. Large woody debris is the dominant pool cover type followed by boulders.

The mean shelter rating for pools is 23. The shelter rating in the flatwater habitats is 18. A pool shelter rating of approximately 100 is desirable. The amount of cover that now exists is being provided primarily by boulders in Gulch 23. Large woody debris is the dominant cover type in pools followed by boulders. Log and root wad cover structures in the pool and flatwater habitats would enhance both summer and winter salmonid habitat. Log cover structures provide rearing fry with protection from predation, rest from water velocity, and also divide territorial units to reduce density related competition.

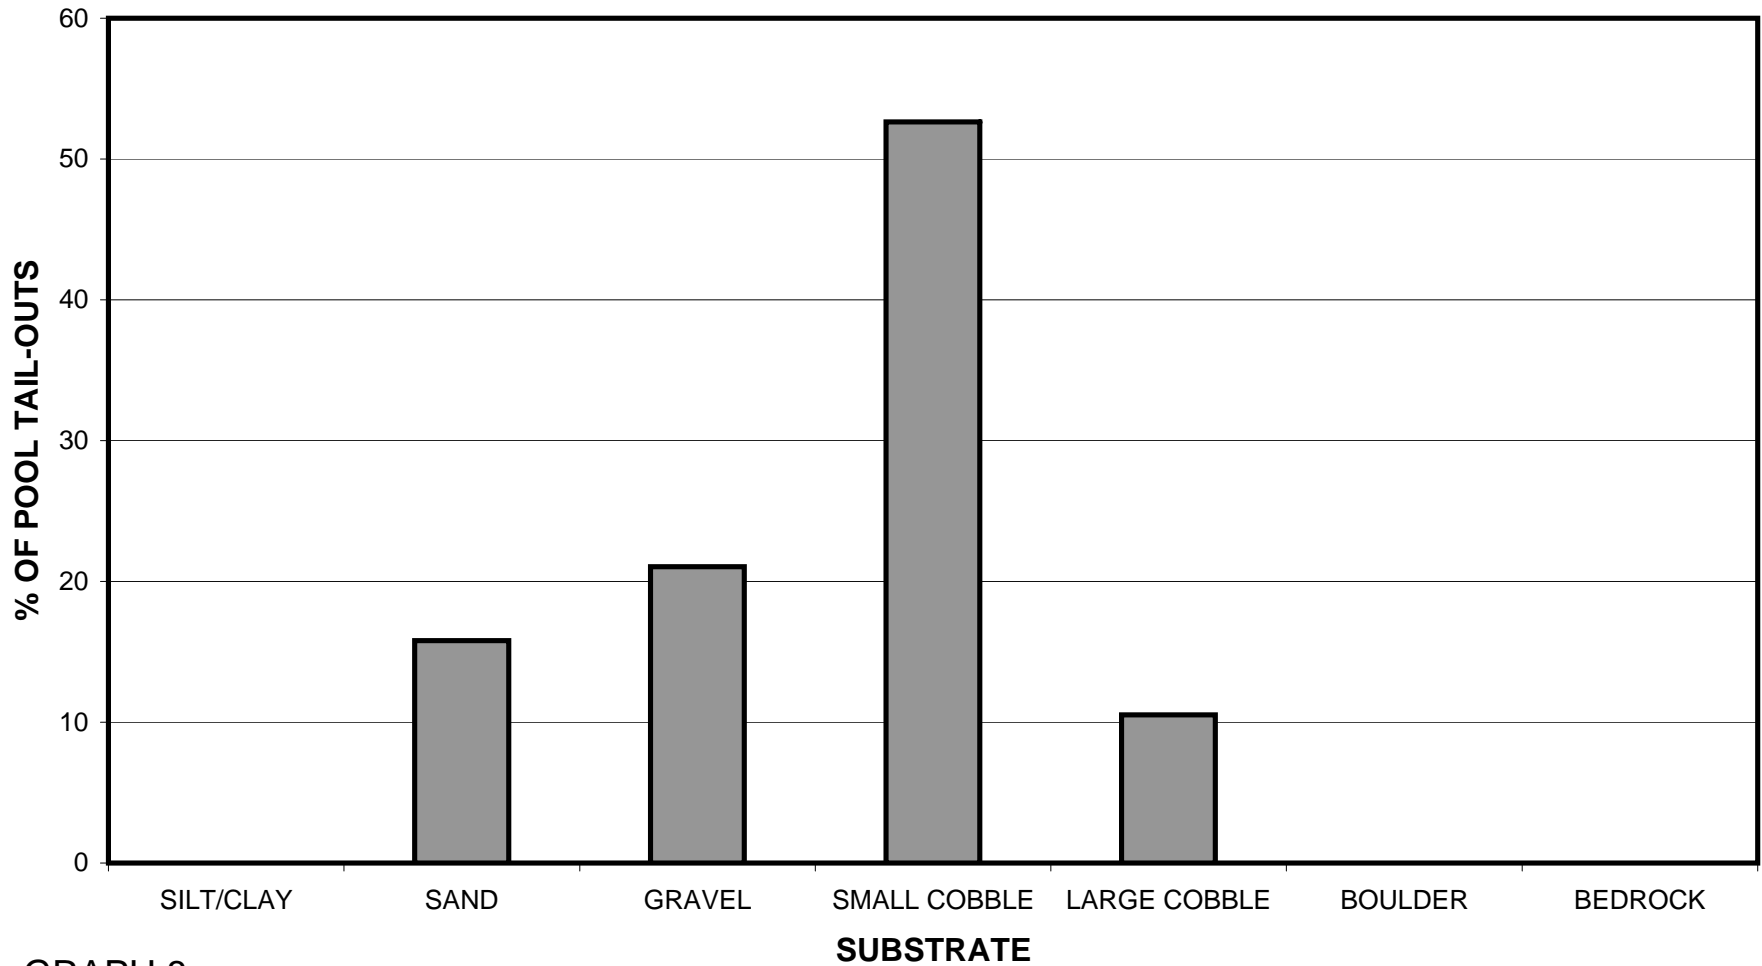
GRAPH 8

Table 6 summarizes the dominant substrate by habitat type. Graph 8 depicts the dominant substrate observed in pool tail-outs. Small cobble was the dominant substrate observed in 53% of the pool tail-outs. Gravel was the next most frequently observed dominant substrate type and occurred in 21% of the pool tail-outs

Fourteen of the 19 pool tail-outs measured had gravel or small cobble as the dominant substrate. This is generally considered good for spawning salmonids.
