# STREAM INVENTORY REPORT

## Gulch Eleven

A stream inventory was conducted from July 17 to July 18, 2012 on Gulch Eleven. The survey began at the confluence with South Fork Ten Mile River and extended upstream one mile. A stream inventory and report were also completed for one tributary to Gulch Eleven.

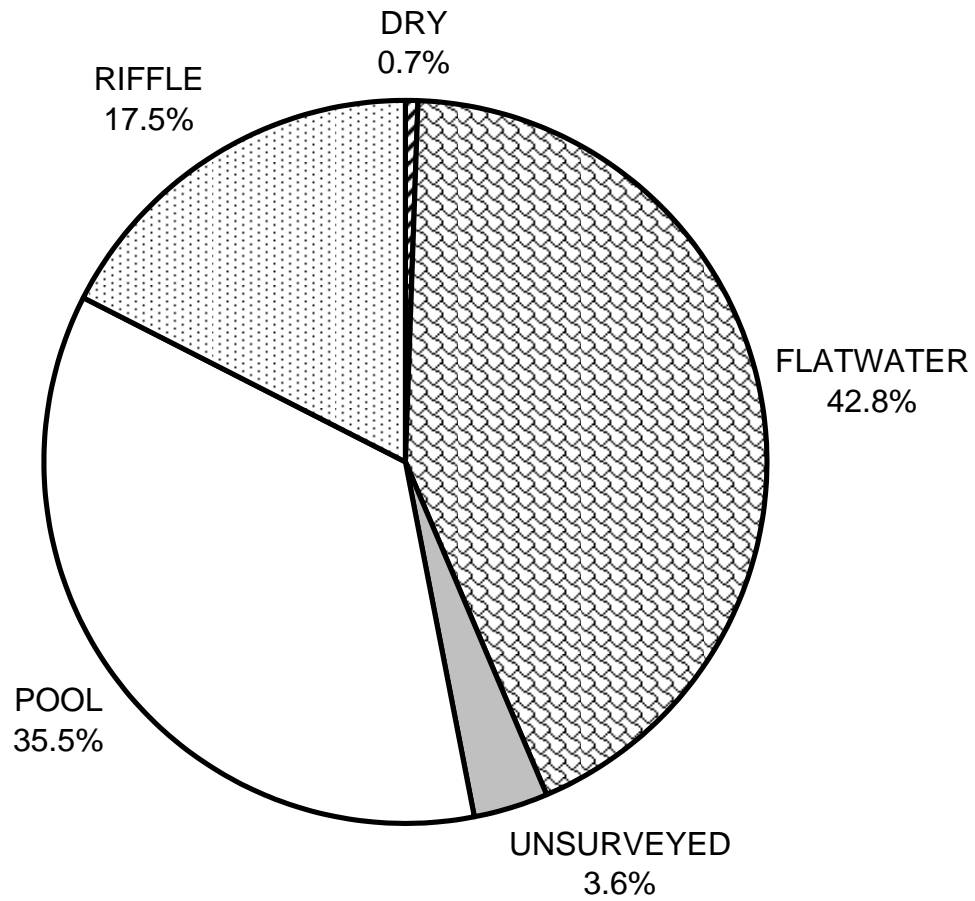
GRAPH 2

Table 1 summarizes the Level II riffle, flatwater, and pool habitat types. Based on frequency of occurrence there were 42% pool units, 28% flatwater units, 25% riffle units, 4% unsurveyed units, and 1% dry units (Graph 1). Based on total length of Level II habitat types there were 43% flatwater units, 36% pool units, 18% riffle units, 4% unsurveyed units, and 1% dry units (Graph 2).

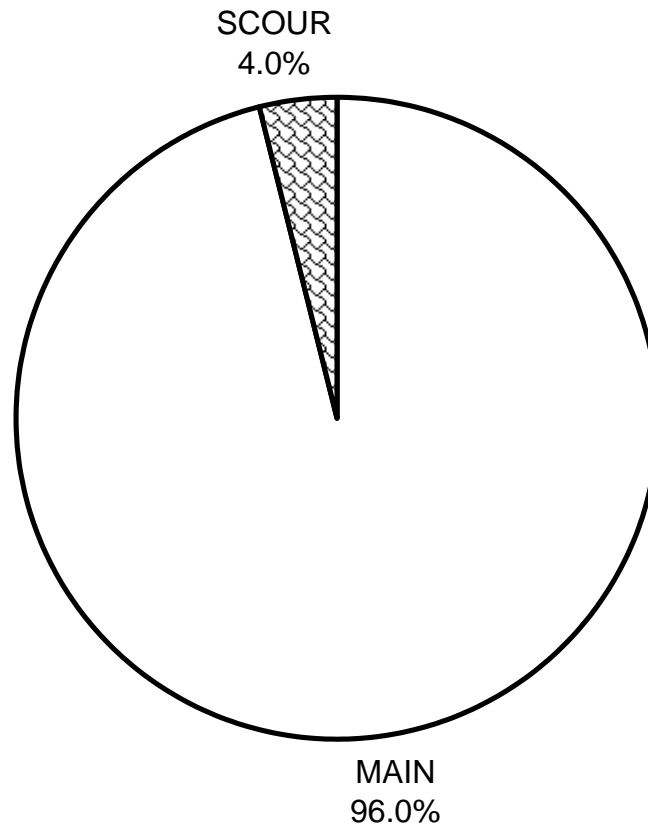
GRAPH 4

A total of 75 pools were identified (Table 3). Main channel pools were the most frequently encountered at 96% (Graph 4), and comprised 97% of the total length of all pools (Table 3).

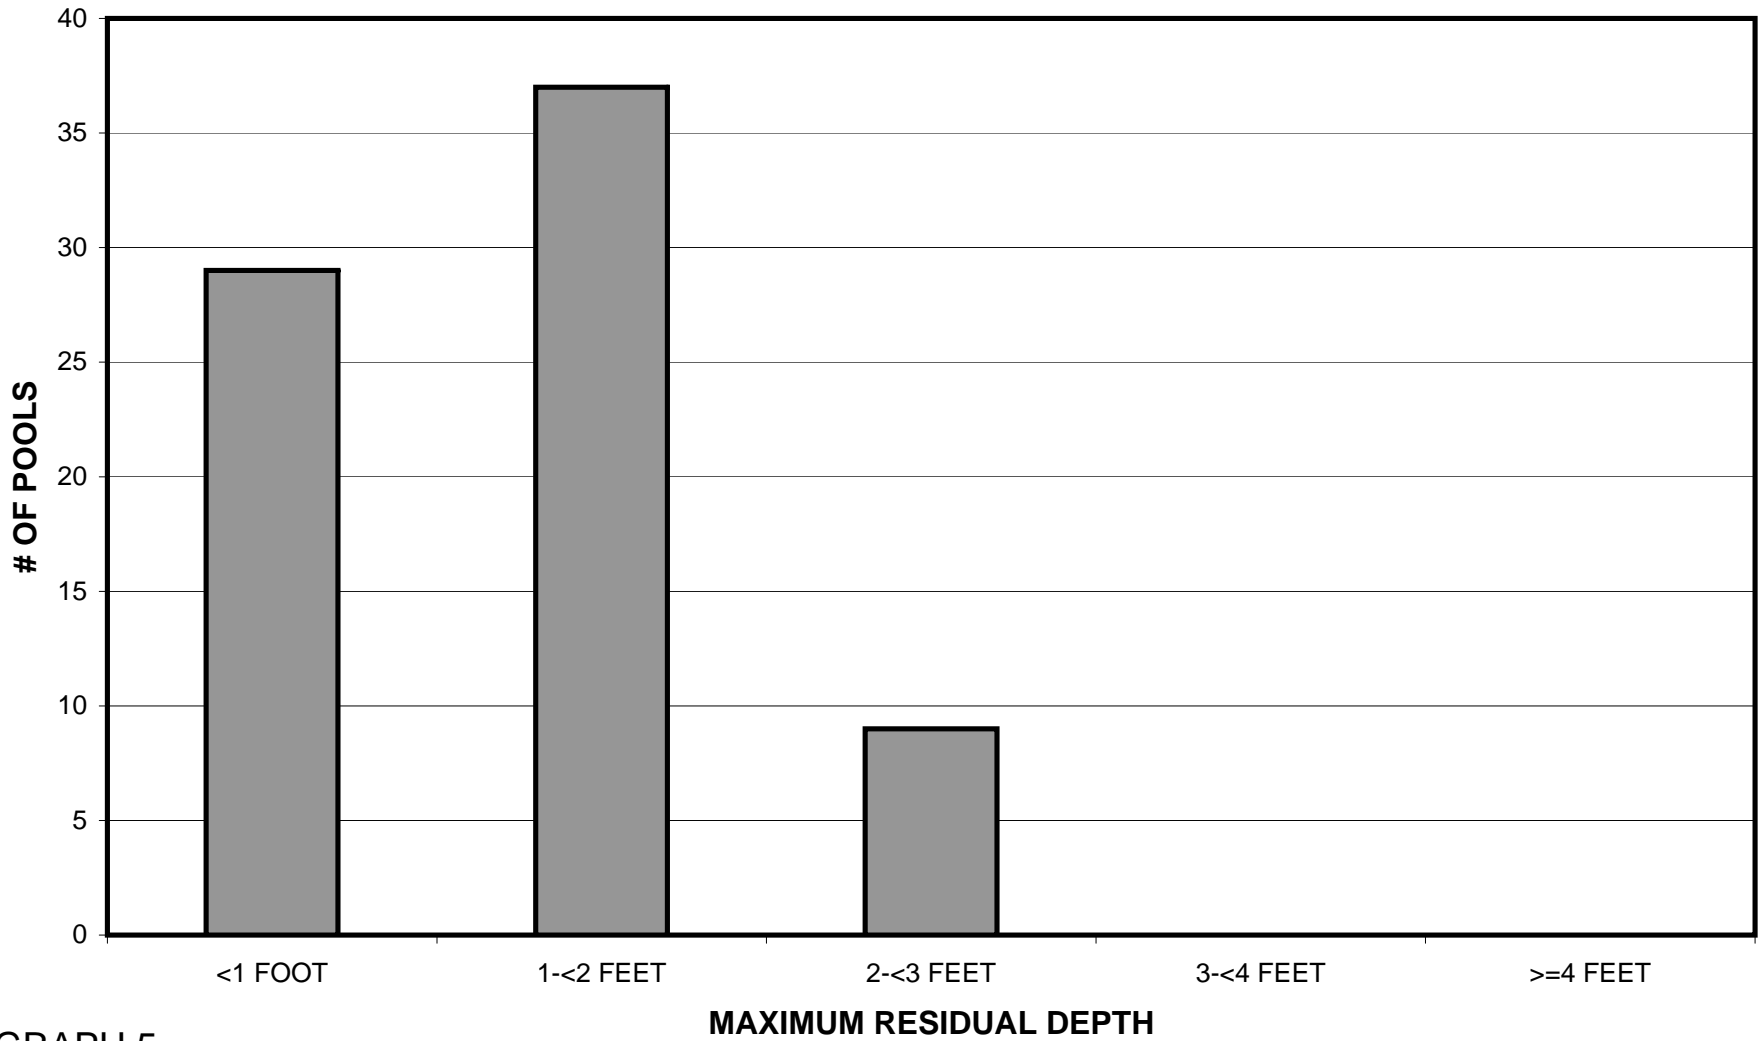
GRAPH 5

Table 4 is a summary of maximum residual pool depths by pool habitat types. Pool quality for salmonids increases with depth. Nine of the 75 pools (12%) had a residual depth of two feet or greater (Graph 5).

Flatwater habitat types comprised 43% of the total length of this survey, riffles 18%, and pools 36%. Nine of the 75 (12%) pools had a maximum residual depth greater than 2 feet. In general, pool enhancement projects are considered when primary pools comprise less than 40% of the length of total stream habitat. In first and second order streams, a primary pool is defined to have a maximum residual depth of at least two feet, occupy at least half the width of the low flow channel, and be as long as the low flow channel width. Installing large wood structures that will deepen pool habitat is recommended.

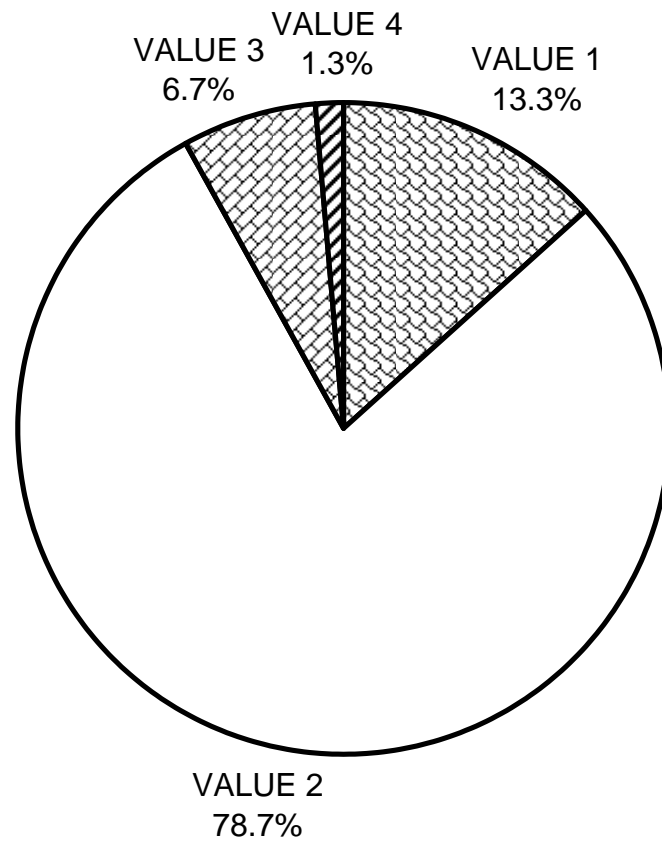
GRAPH 6

The depth of cobble embeddedness was estimated at pool tail-outs. Of the 75 pool tail-outs measured, 10 had a value of 1 (13.3%); 59 had a value of 2 (78.7%); five had a value of 3 (6.7%); one had a value of 4 (1.3%) (Graph 6). On this scale, a value of 1 indicates the best spawning conditions and a value of 4 the worst. Additionally, a value of 5 was assigned to tail-outs deemed not suitable for spawning due to inappropriate substrate such as bedrock, log sills, boulders, or other considerations.

Sixty-nine of the 75 pool tail-outs measured had embeddedness ratings of 1 or 2. Six of the pool tail-outs had embeddedness ratings of 3 or 4. None of the pool tail-outs had a rating of 5, which is considered unsuitable for spawning. Cobble embeddedness measured to be 25% or less, a rating of 1, is considered to indicate good quality spawning substrate for salmon and steelhead.

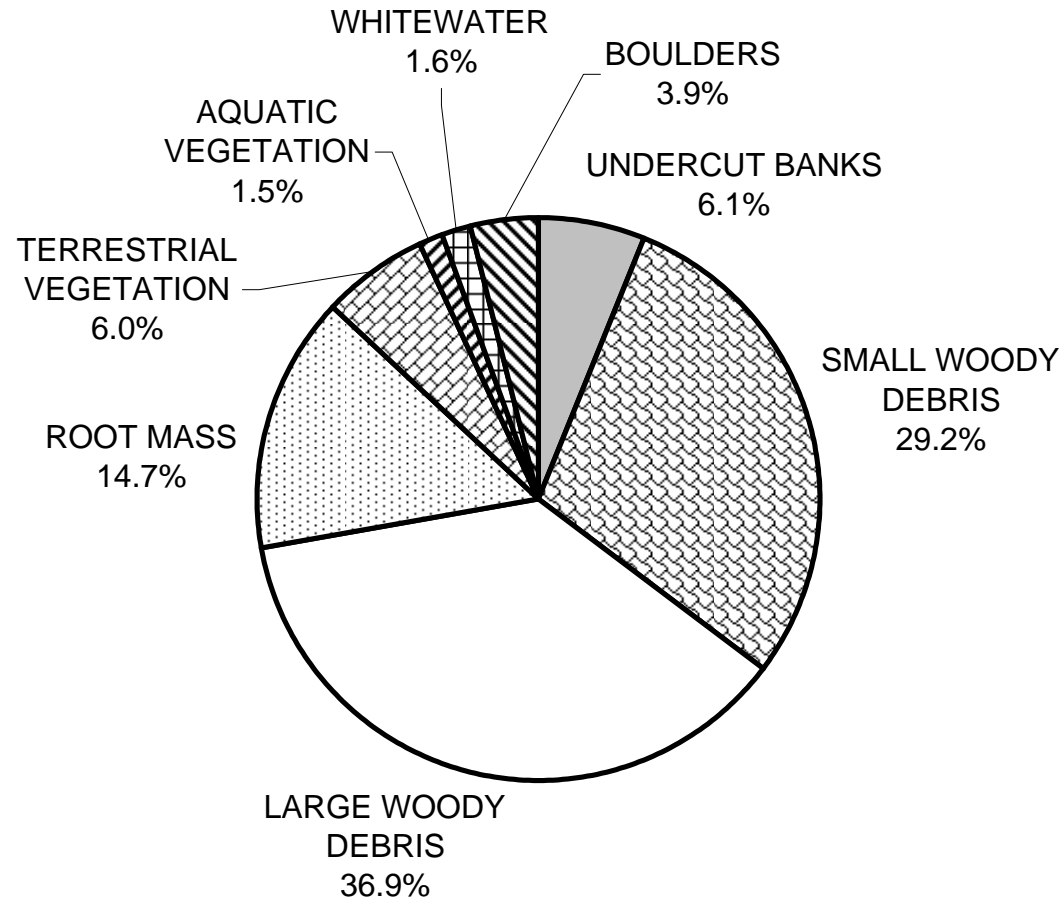
GRAPH 7

Table 5 summarizes mean percent cover by habitat type. Large woody debris is the dominant cover type in Gulch Eleven. Graph 7 describes the pool cover in Gulch Eleven. Large woody debris is the dominant pool cover type followed by small woody debris.

The mean shelter rating for pools is 38. The shelter rating in the flatwater habitats is 6. A pool shelter rating of approximately 100 is desirable. The amount of cover that now exists is being provided primarily by large woody debris in Gulch Eleven. Large woody debris is the dominant cover type in pools followed by small woody debris. Log and root wad cover structures in the pool and flatwater habitats would enhance both summer and winter salmonid habitat. Log cover structures provide rearing fry with protection from predation, rest from water velocity, and also divide territorial units to reduce density related competition.

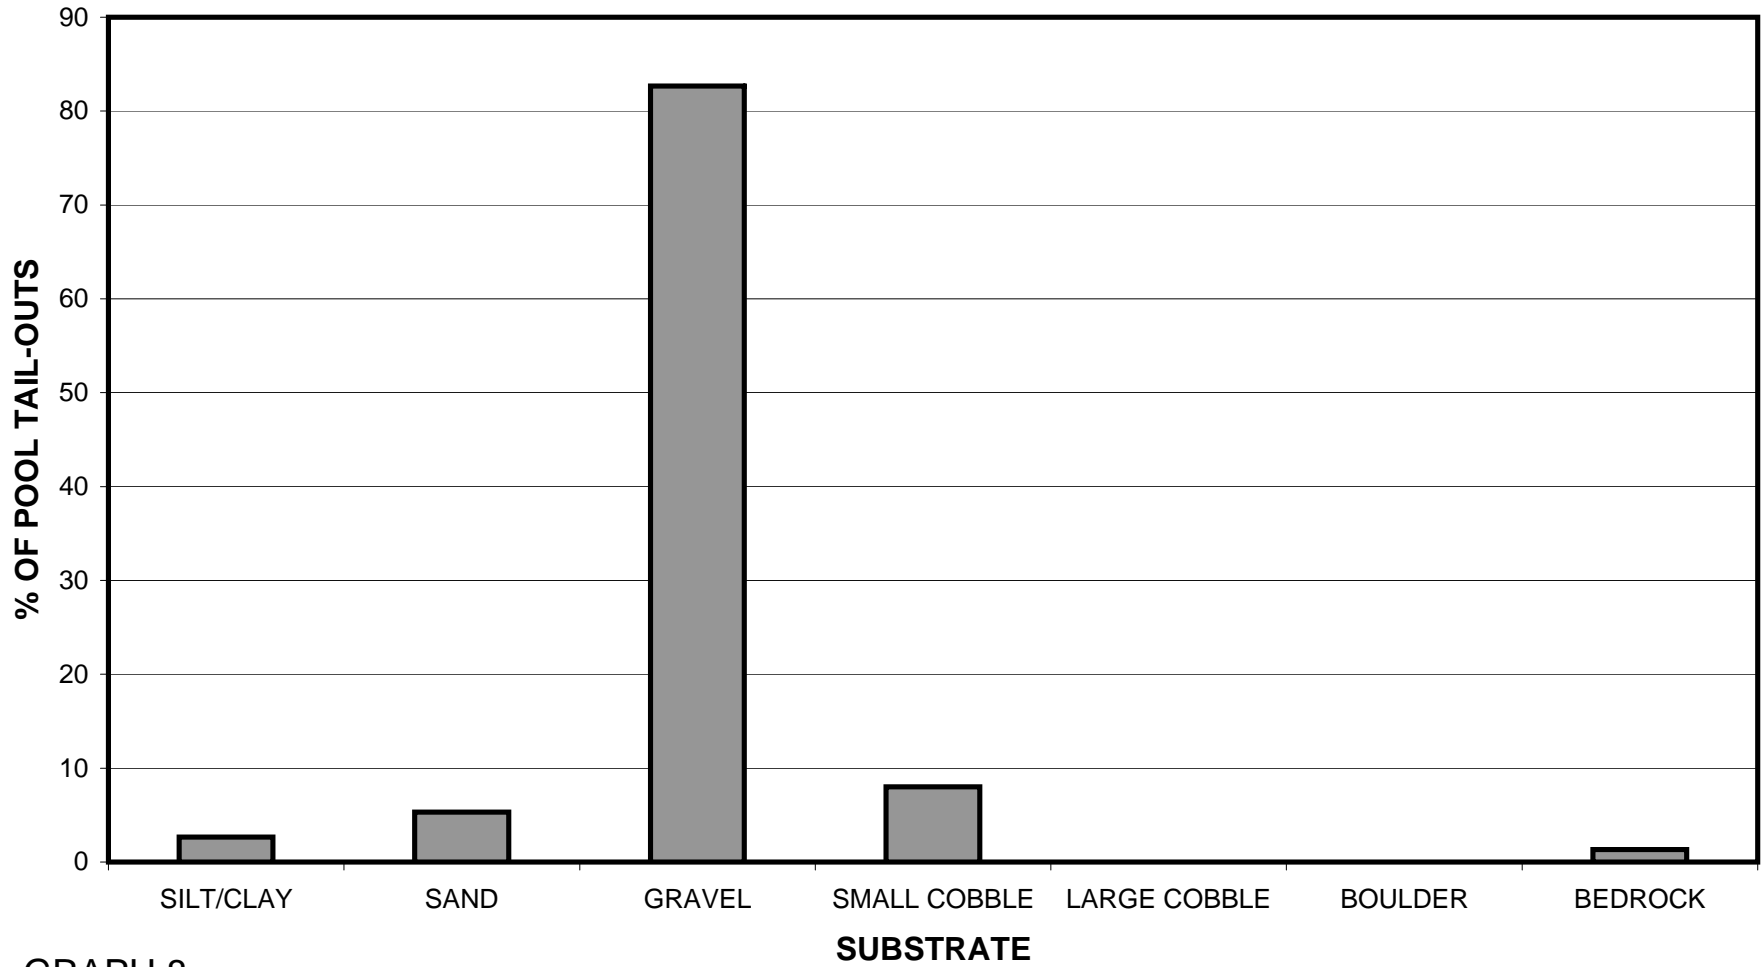
GRAPH 8

Table 6 summarizes the dominant substrate by habitat type. Graph 8 depicts the dominant substrate observed in pool tail-outs. Gravel was the dominant substrate observed in 83% of the pool tail-outs. Small cobble was the next most frequently observed dominant substrate type and occurred in 8% of the pool tail-outs.

Sixty-eight of the 75 pool tail-outs measured had gravel or small cobble as the dominant substrate. This is generally considered good for spawning salmonids.

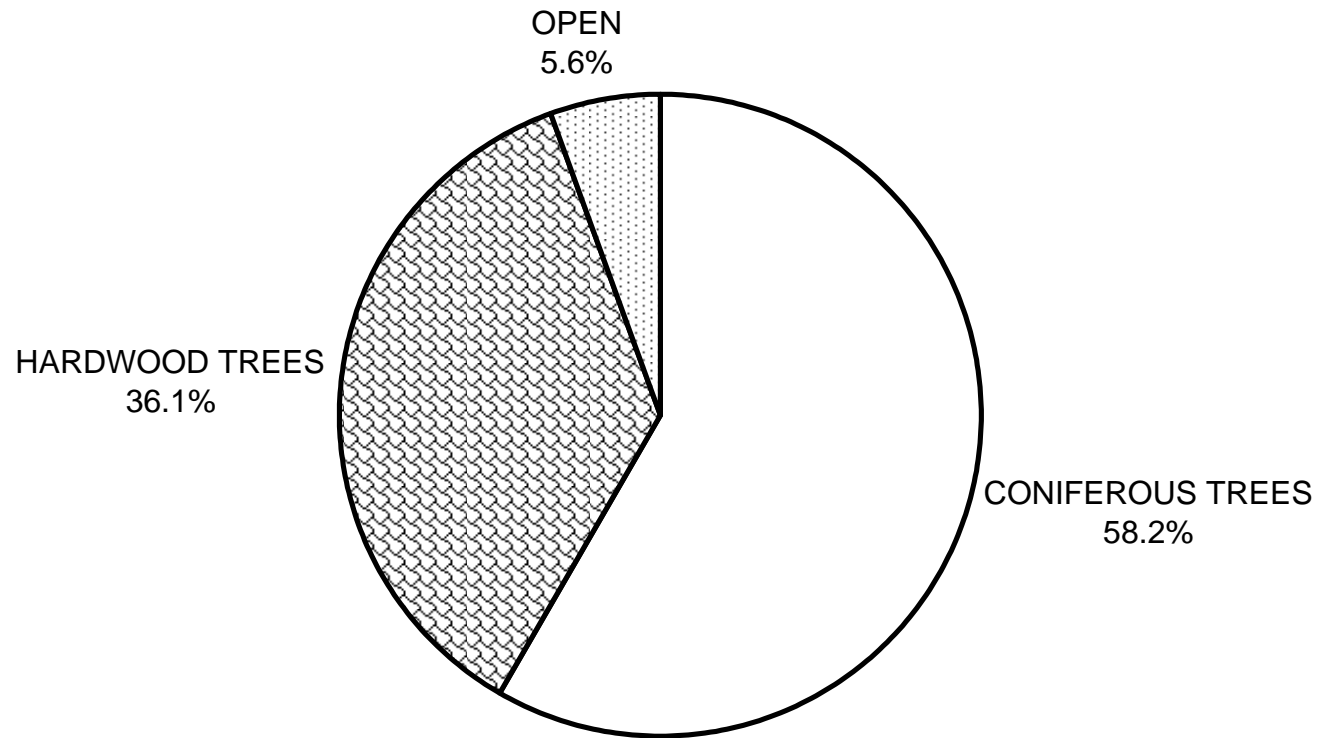
GRAPH 9

The mean percent canopy density for the surveyed length of Gulch Eleven was 94%. Six percent of the canopy was open. Of the canopy present, the mean percentages of hardwood and coniferous trees were 38% and 62%, respectively. Graph 9 describes the mean percent canopy in Gulch Eleven.

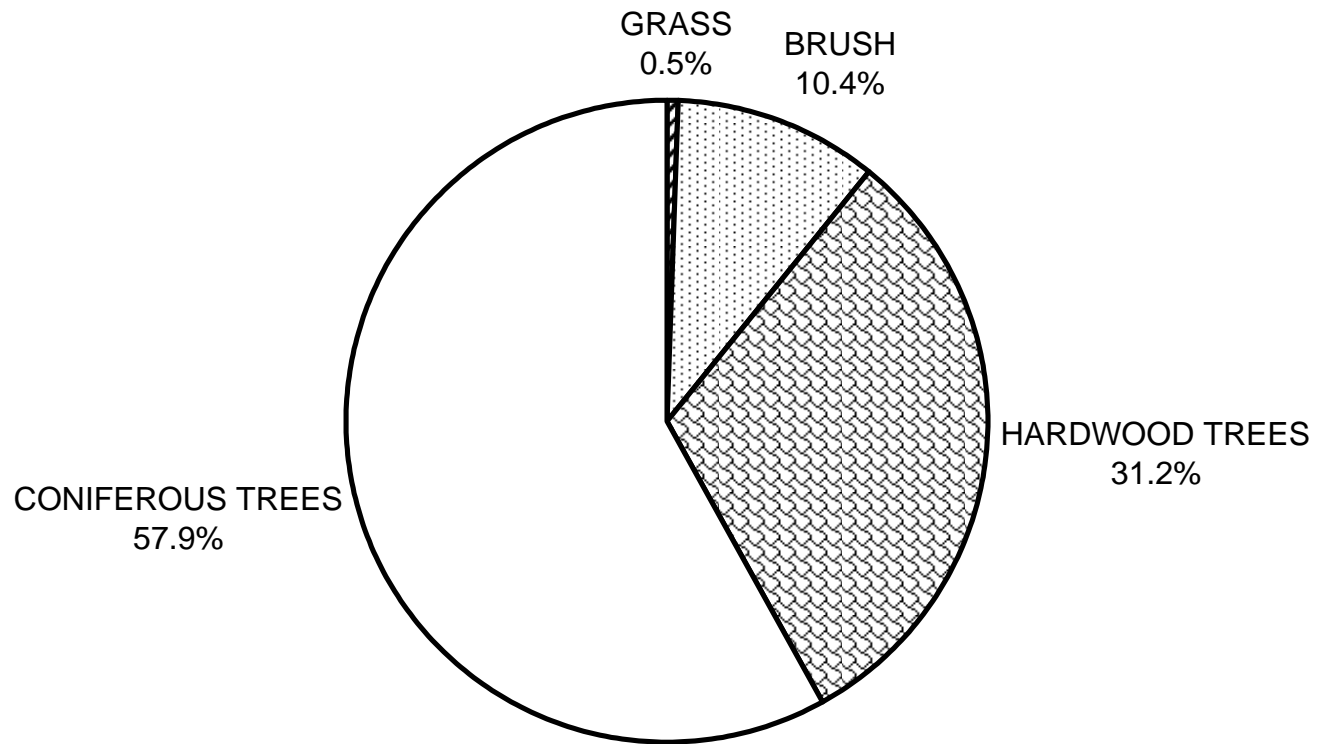
GRAPH 11

For the stream reach surveyed, the mean percent right bank vegetated was 96%. The mean percent left bank vegetated was 98%. The dominant elements composing the structure of the stream banks consisted of 54% sand/silt/clay, 38% cobble/gravel, 6% bedrock, and 3% boulders (Graph 10). Coniferous trees were the dominant vegetation type observed in 58% of the units surveyed. Additionally, 31% of the units surveyed had deciduous trees as the dominant vegetation type, and 10% had brush as the dominant vegetation type (Graph 11).
