# STREAM INVENTORY REPORT

## Gulch Eleven

A stream inventory was conducted from July 17 to July 18, 2012 on Gulch Eleven. The survey began at the confluence with South Fork Ten Mile River and extended upstream one mile. A stream inventory and report were also completed for one tributary to Gulch Eleven.

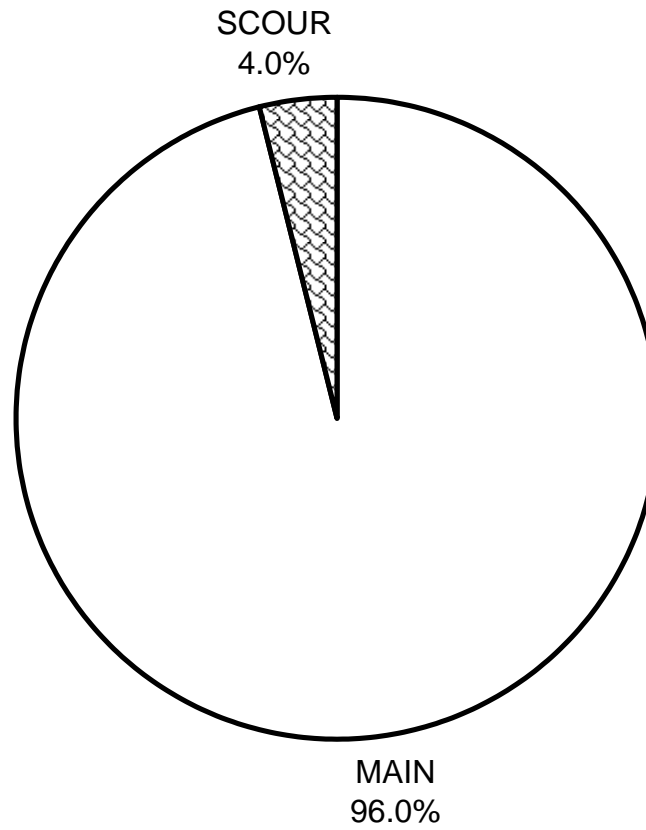
GRAPH 4

A total of 75 pools were identified (Table 3). Main channel pools were the most frequently encountered at 96% (Graph 4), and comprised 97% of the total length of all pools (Table 3).

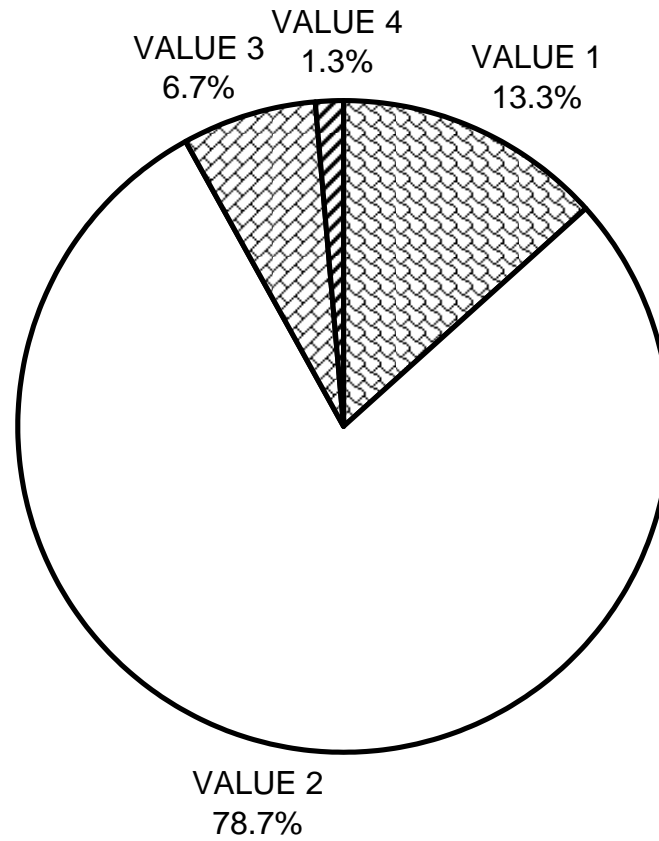
GRAPH 6

The depth of cobble embeddedness was estimated at pool tail-outs. Of the 75 pool tail-outs measured, 10 had a value of 1 (13.3%); 59 had a value of 2 (78.7%); five had a value of 3 (6.7%); one had a value of 4 (1.3%) (Graph 6). On this scale, a value of 1 indicates the best spawning conditions and a value of 4 the worst. Additionally, a value of 5 was assigned to tail-outs deemed not suitable for spawning due to inappropriate substrate such as bedrock, log sills, boulders, or other considerations.

Sixty-nine of the 75 pool tail-outs measured had embeddedness ratings of 1 or 2. Six of the pool tail-outs had embeddedness ratings of 3 or 4. None of the pool tail-outs had a rating of 5, which is considered unsuitable for spawning. Cobble embeddedness measured to be 25% or less, a rating of 1, is considered to indicate good quality spawning substrate for salmon and steelhead.

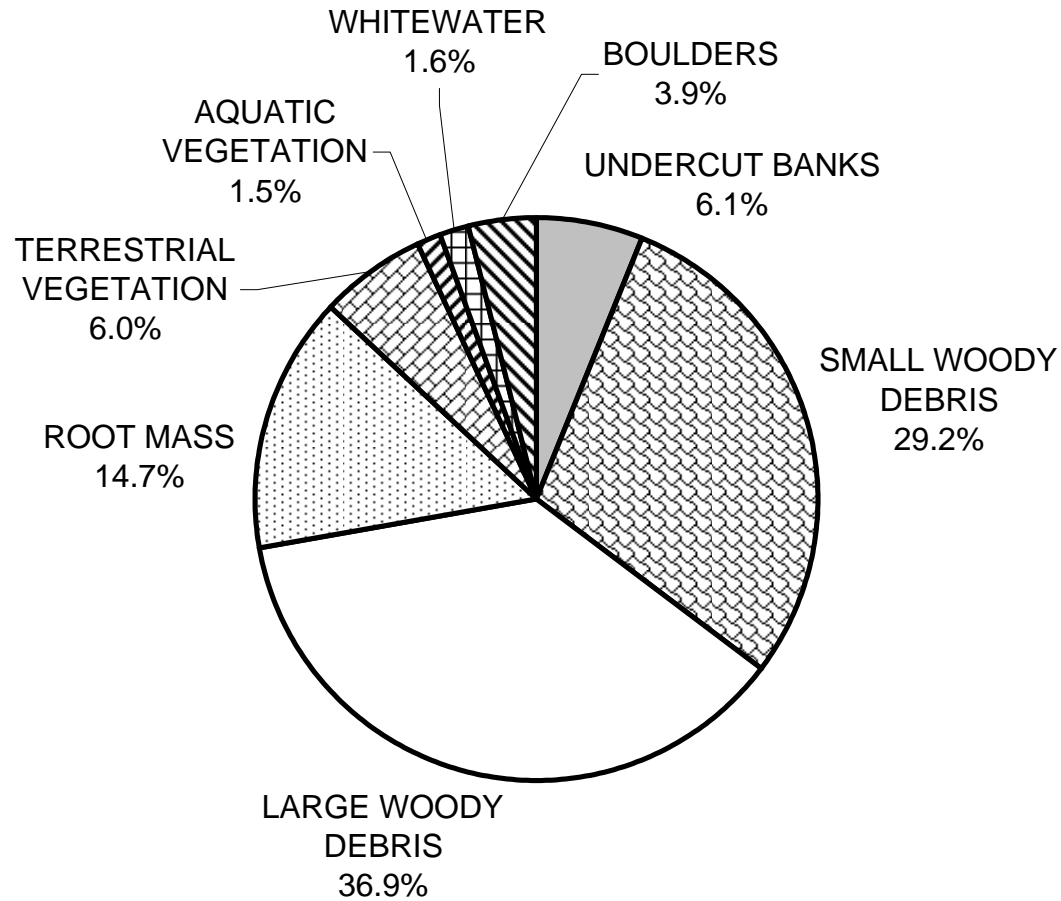
GRAPH 7

Table 5 summarizes mean percent cover by habitat type. Large woody debris is the dominant cover type in Gulch Eleven. Graph 7 describes the pool cover in Gulch Eleven. Large woody debris is the dominant pool cover type followed by small woody debris.

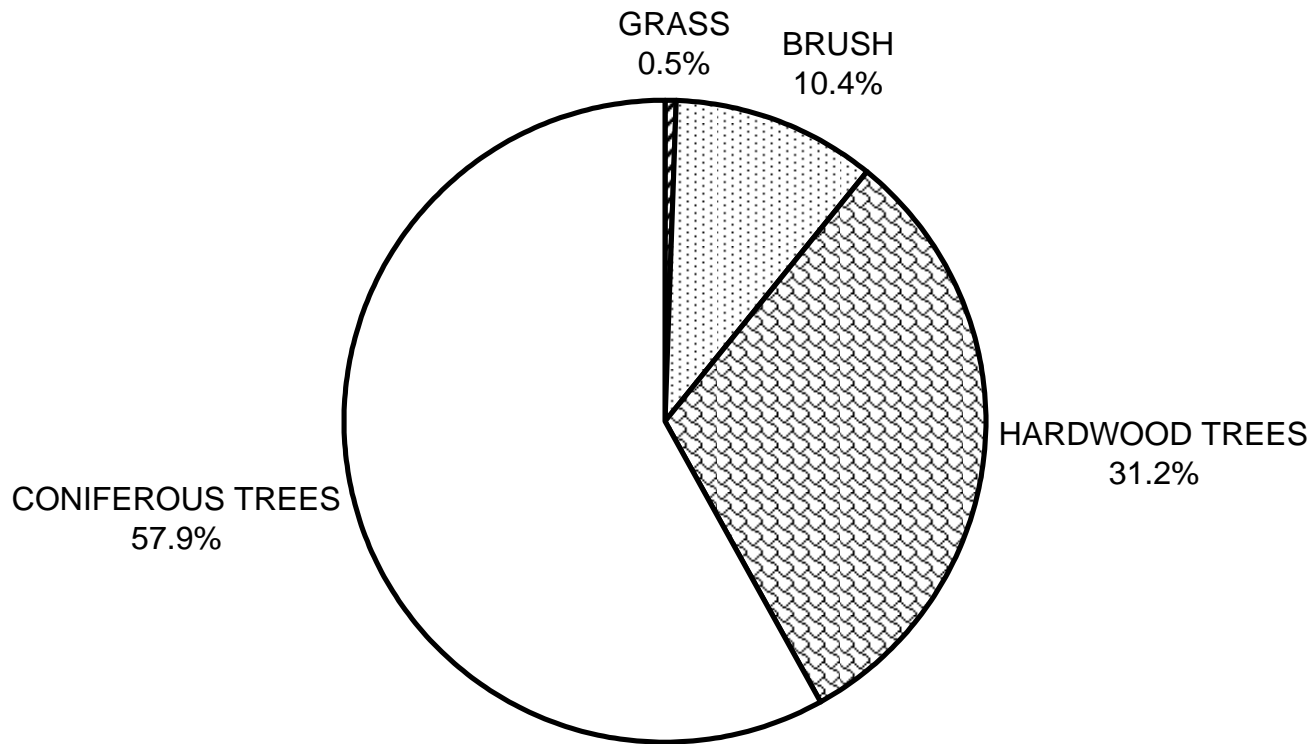
GRAPH 11

For the stream reach surveyed, the mean percent right bank vegetated was 96%. The mean percent left bank vegetated was 98%. The dominant elements composing the structure of the stream banks consisted of 54% sand/silt/clay, 38% cobble/gravel, 6% bedrock, and 3% boulders (Graph 10). Coniferous trees were the dominant vegetation type observed in 58% of the units surveyed. Additionally, 31% of the units surveyed had deciduous trees as the dominant vegetation type, and 10% had brush as the dominant vegetation type (Graph 11).
