# STREAM INVENTORY REPORT

## Mill Creek

A stream inventory was conducted from October 2 to October 10, 2012 on Mill Creek. The survey began at the confluence with Ten Mile River and extended upstream two miles.

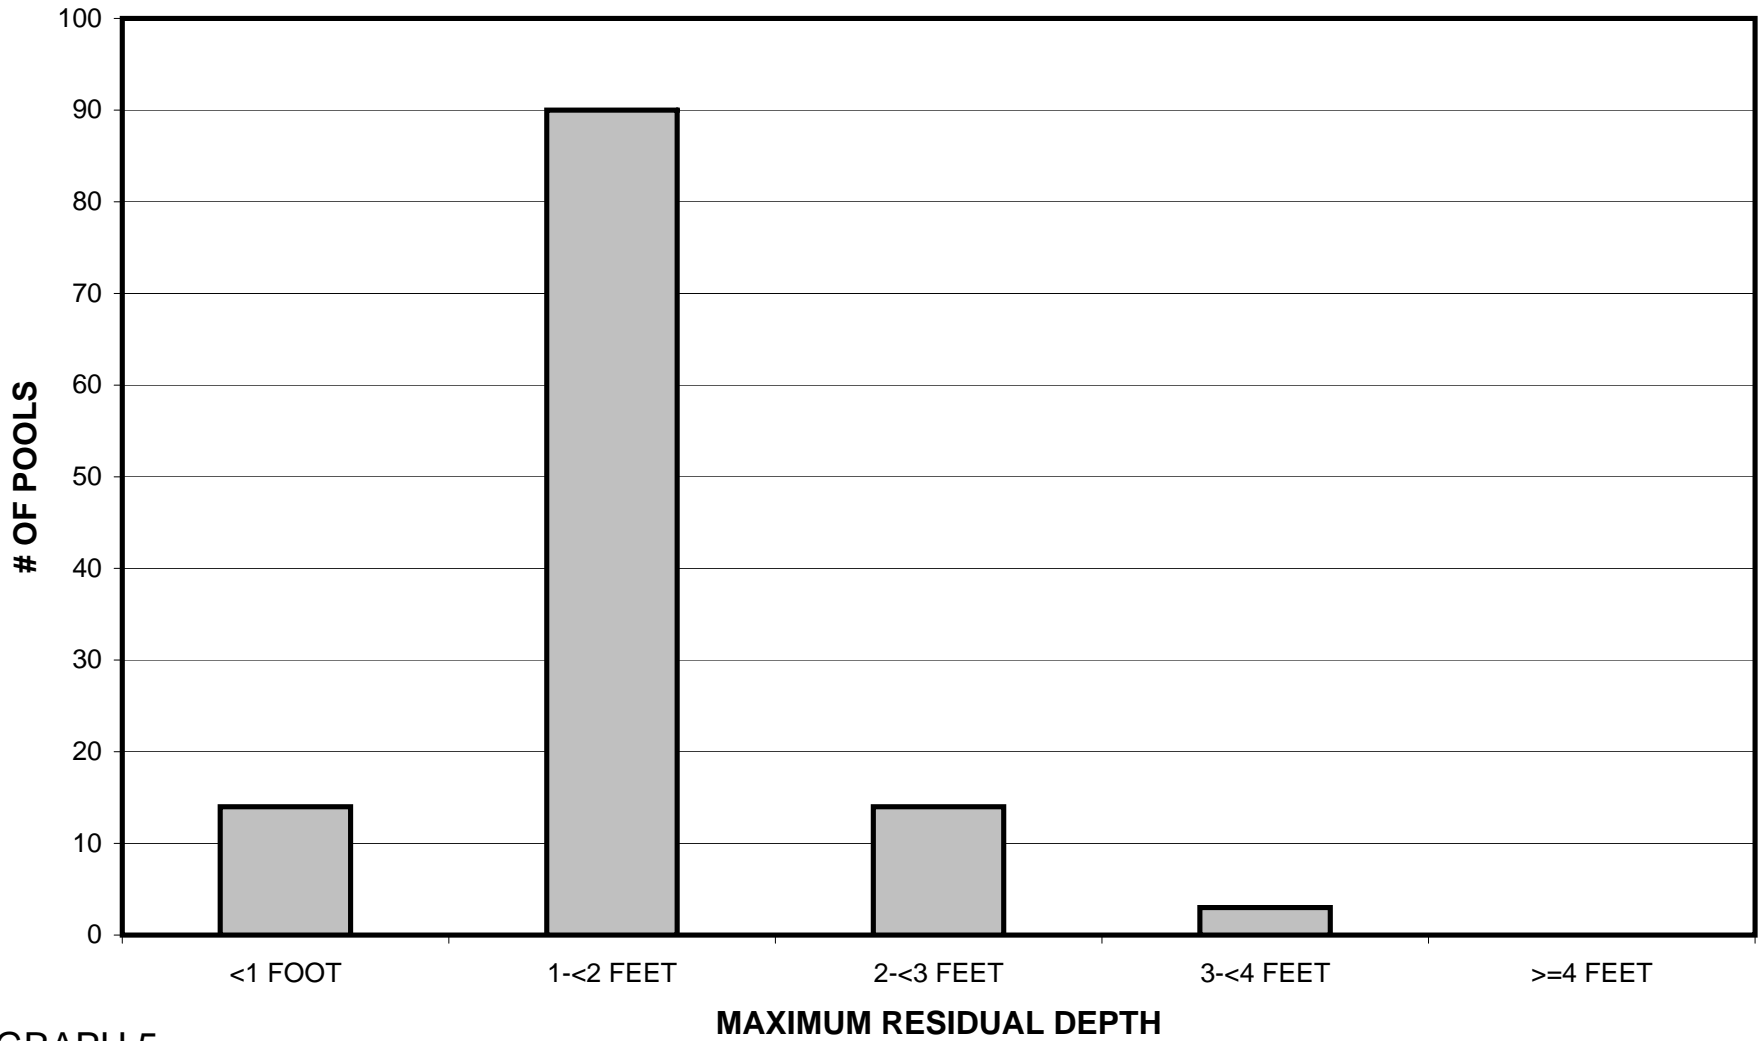
GRAPH 5

Table 4 is a summary of maximum residual pool depths by pool habitat types. Pool quality for salmonids increases with depth. Seventeen of the 121 pools (14%) had a residual depth of two feet or greater (Graph 5).

Flatwater habitat types comprised 43% of the total length of this survey, riffles 19%, and pools 32%. Seventeen of the 121 (14%) pools had a maximum residual depth greater than two feet. In general, pool enhancement projects are considered when primary pools comprise less than 40% of the length of total stream habitat. In first and second order streams, a primary pool is defined to have a maximum residual depth of at least two feet, occupy at least half the width of the low flow channel, and be as long as the low flow channel width. Installing log structure that will increase or deepen pool habitat is recommended.

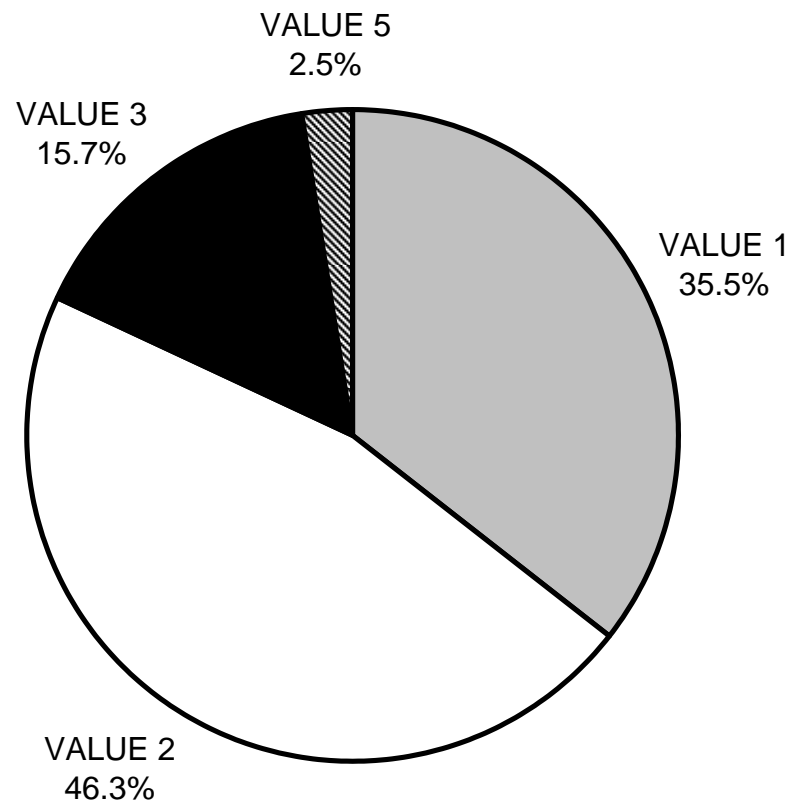
GRAPH 6

The depth of cobble embeddedness was estimated at pool tail-outs. Of the 121 pool tail-outs measured, 43 had a value of 1 (35.5%); 56 had a value of 2 (46.3%); 19 had a value of 3 (15.7%); three had a value of 5 (2.5%) (Graph 6). On this scale, a value of 1 indicates the best

spawning conditions and a value of 4 the worst. Additionally, a value of 5 was assigned to tail-outs deemed not suitable for spawning due to inappropriate substrate such as bedrock, log sills, boulders, or other considerations.

Ninety-nine of the 121 pool tail-outs measured had embeddedness ratings of 1 or 2. Nineteen of the pool tail-outs had embeddedness ratings of 3 or 4. Three of the pool tail-outs had a rating of 5, which is considered not suitable for spawning. Cobble embeddedness measured to be 25% or less, a rating of 1, is considered to indicate good quality spawning substrate for salmon and steelhead.

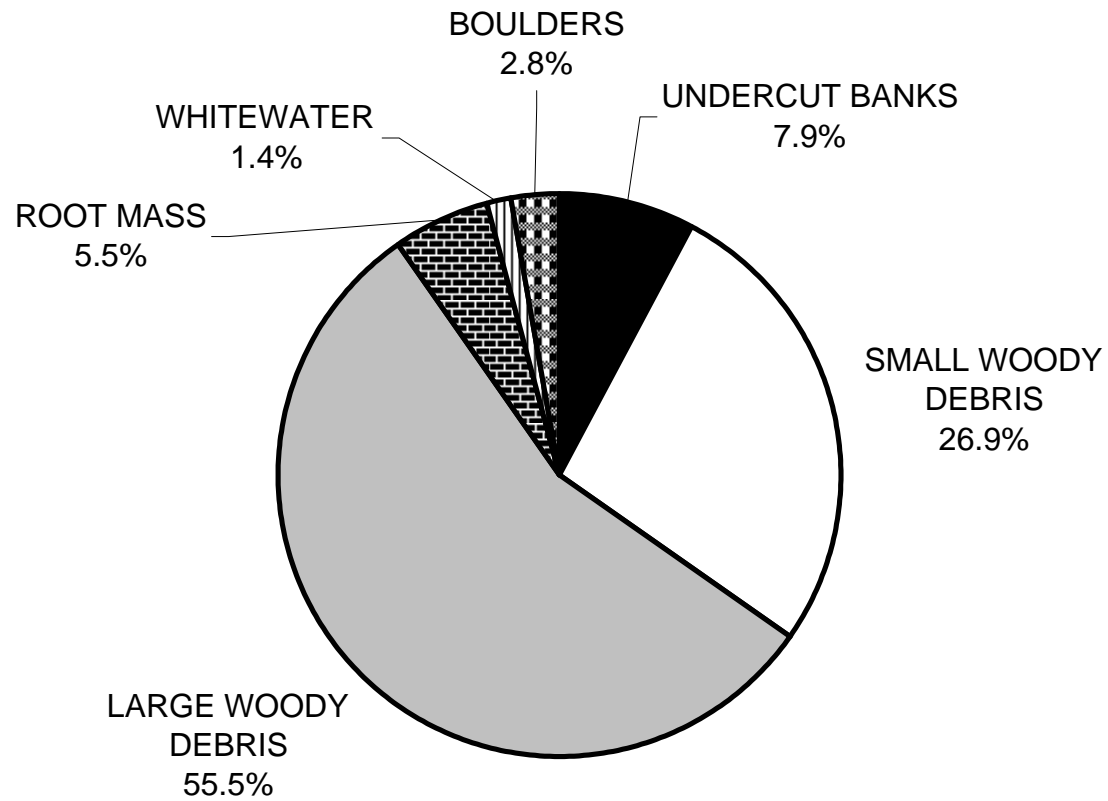
GRAPH 7

Table 5 summarizes mean percent cover by habitat type. Large woody debris is the dominant cover type in Mill Creek. Graph 7 describes the pool cover in Mill Creek. Large woody debris is the dominant pool cover type followed by small woody debris.

The mean shelter rating for pools is 10. The shelter rating in the flatwater habitats is 0. A pool shelter rating of approximately 100 is desirable. The amount of cover that now exists is being provided primarily by large woody debris in Mill Creek. Large woody debris is the dominant cover type in pools followed by small woody debris. Log and root wad cover structures in the pool and flatwater habitats would enhance both summer and winter salmonid habitat. Log cover structures provides rearing fry with protection from predation, rest from water velocity, and also divides territorial units to reduce density related competition.

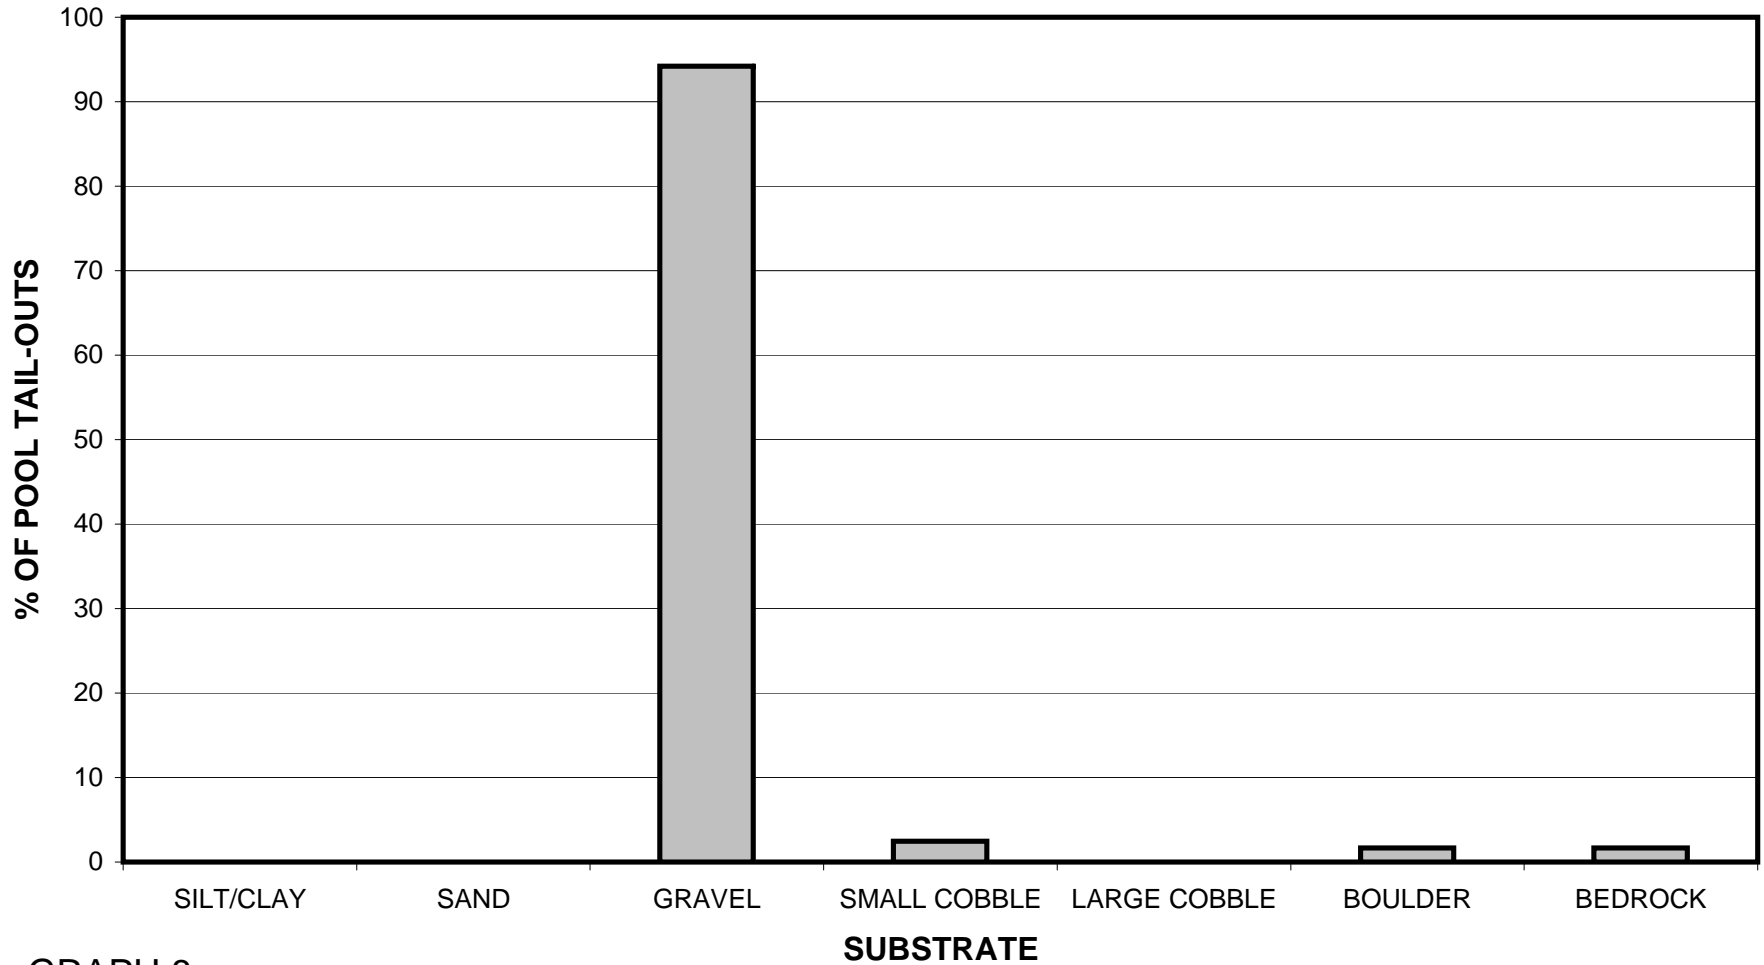
GRAPH 8

Table 6 summarizes the dominant substrate by habitat type. Graph 8 depicts the dominant substrate observed in pool tail-outs. Gravel was the dominant substrate observed in 94% of the pool tail-outs. Small cobble was the next most frequently observed dominant substrate type and occurred in 2% of the pool tail-outs.

One hundred seventeen of the 121 pool tail-outs measured had gravel or small cobble as the dominant substrate. This is generally considered good for spawning salmonids.
