# STREAM INVENTORY REPORT

## Mill Creek

A stream inventory was conducted from October 2 to October 10, 2012 on Mill Creek. The survey began at the confluence with Ten Mile River and extended upstream two miles.

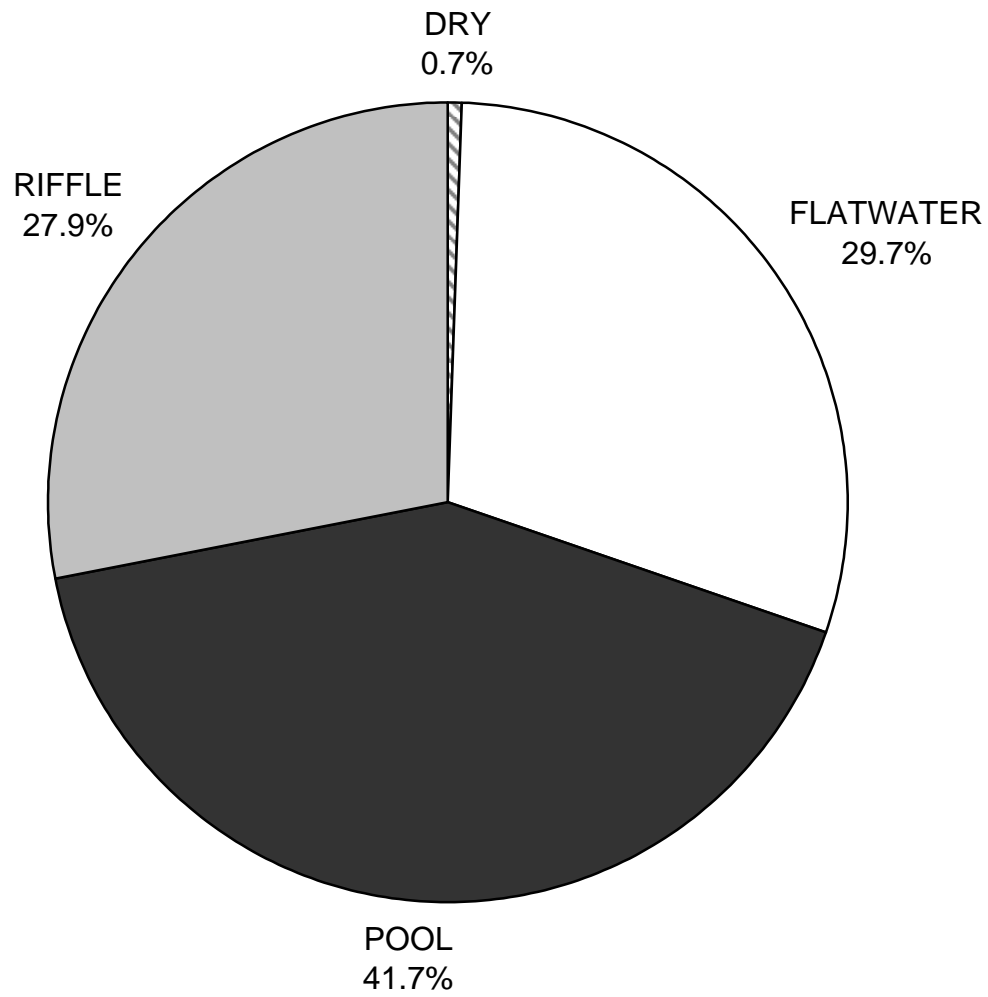
GRAPH 1

Table 1 summarizes the Level II riffle, flatwater, and pool habitat types. Based on frequency of occurrence there were 42% pool units, 30% flatwater units, 28% riffle units, and 1% dry units (Graph 1). Based on total length of Level II habitat types there were 43% flatwater units, 32% pool units, 19% riffle units, and 6% dry units, (Graph 2).

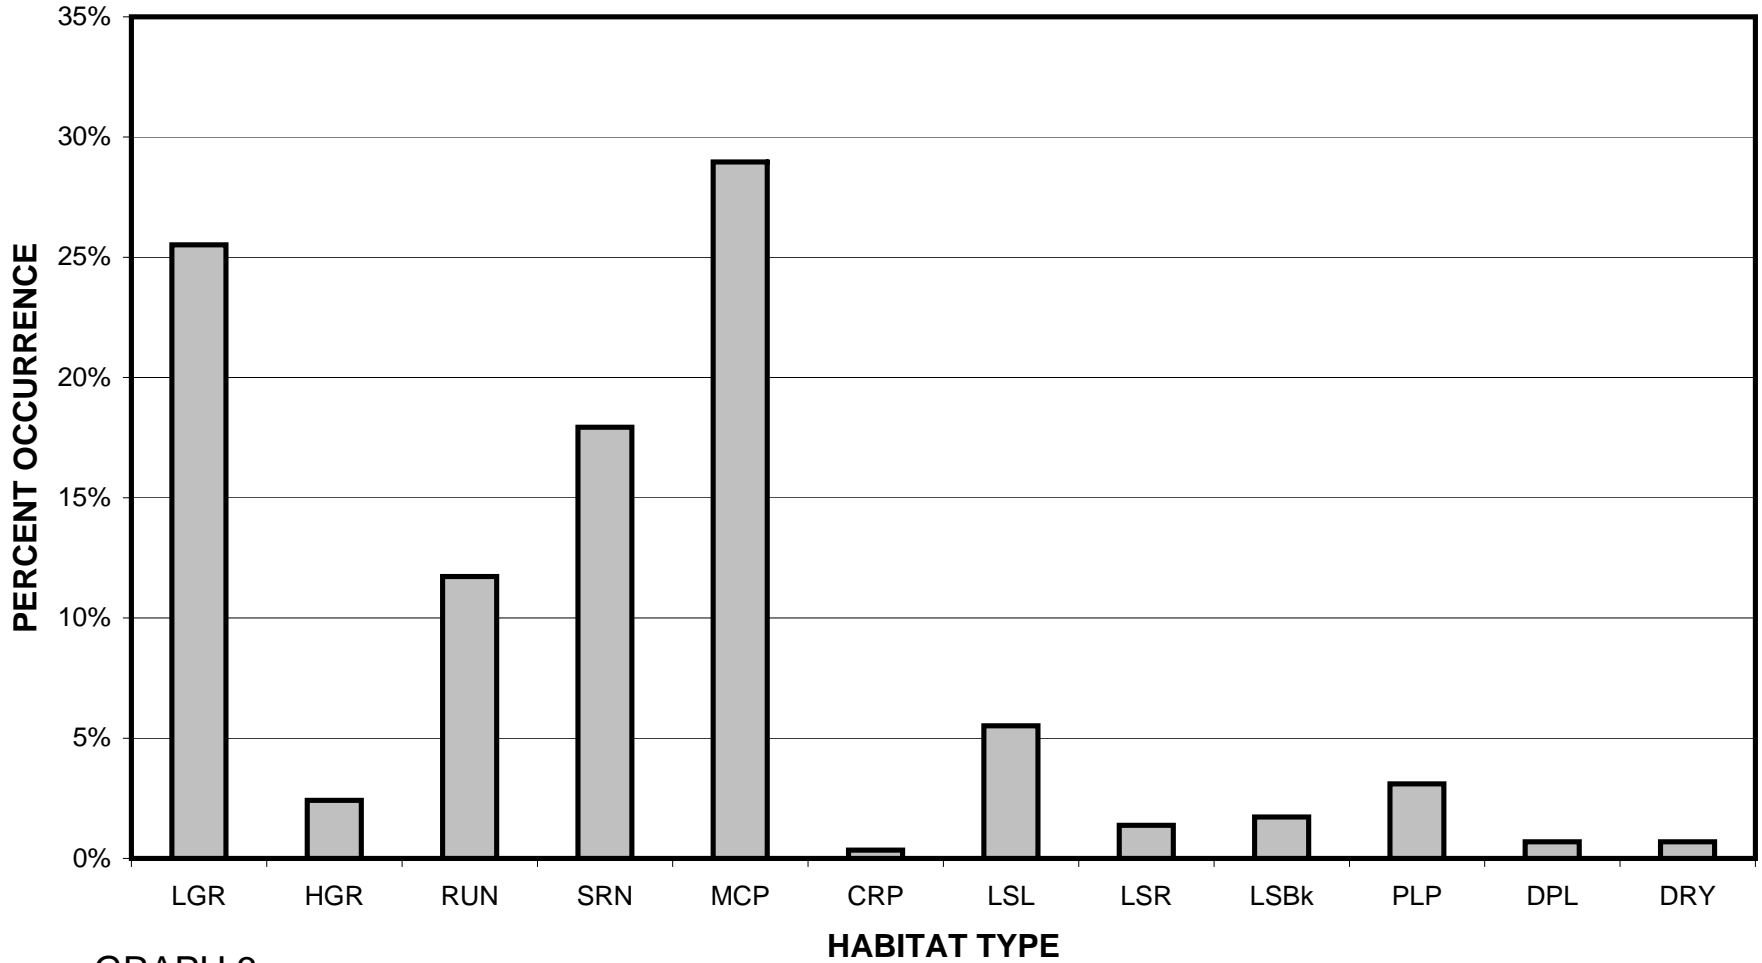
GRAPH 3

Twelve Level IV habitat types were identified (Table 2). The most frequent habitat types by percent occurrence were mid-channel pool units, 29%; low gradient riffle units, 26%; and step run units, 18% (Graph 3). Based on percent total length, step run units made up 34%, mid-channel pool units 24%, and low gradient riffle units 18%.

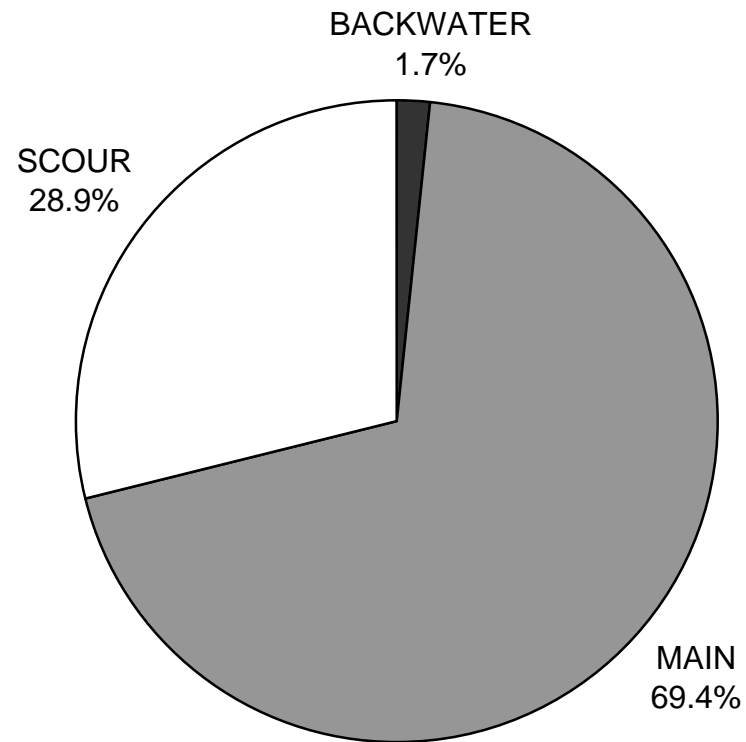
GRAPH 4

A total of 121 pools were identified (Table 3). Main channel pools were the most frequently encountered at 69% (Graph 4), and comprised 74% of the total length of all pools (Table 3).

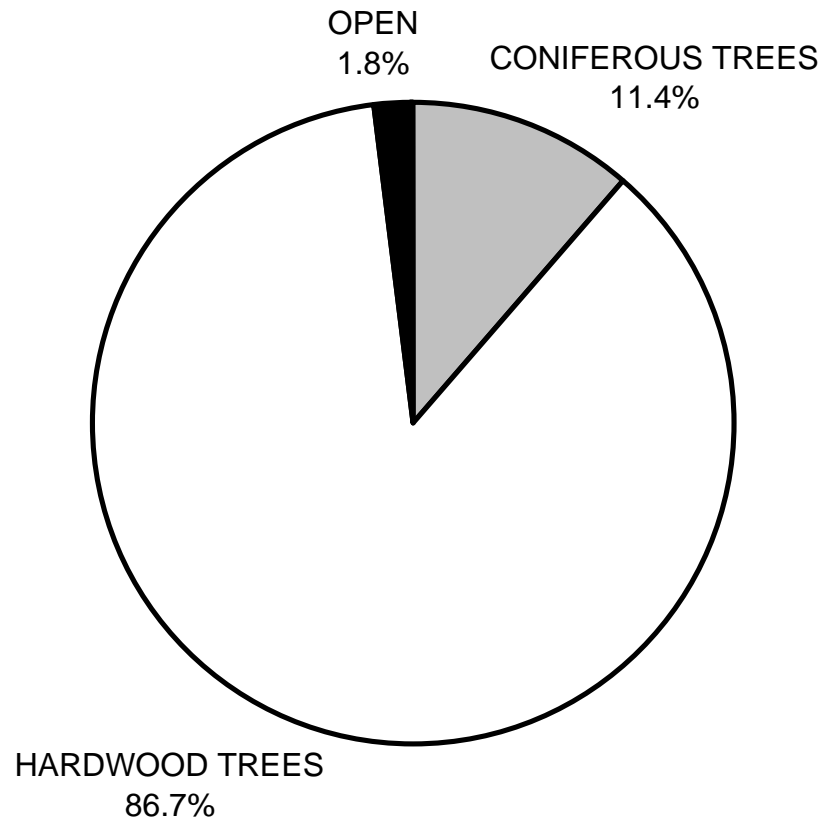
GRAPH 9

The mean percent canopy density for the surveyed length of Mill Creek was 98%. Two percent of the canopy was open. Of the canopy present, the mean percentages of hardwood and coniferous trees were 88% and 12%, respectively. Graph 9 describes the mean percent canopy in Mill Creek.

The mean percent canopy density for the stream was 98%. Reach 1 had a canopy density of 98% and Reach 2 had a canopy density of 98%. The percentage of right and left bank covered with vegetation was 99% and 98%, respectively.

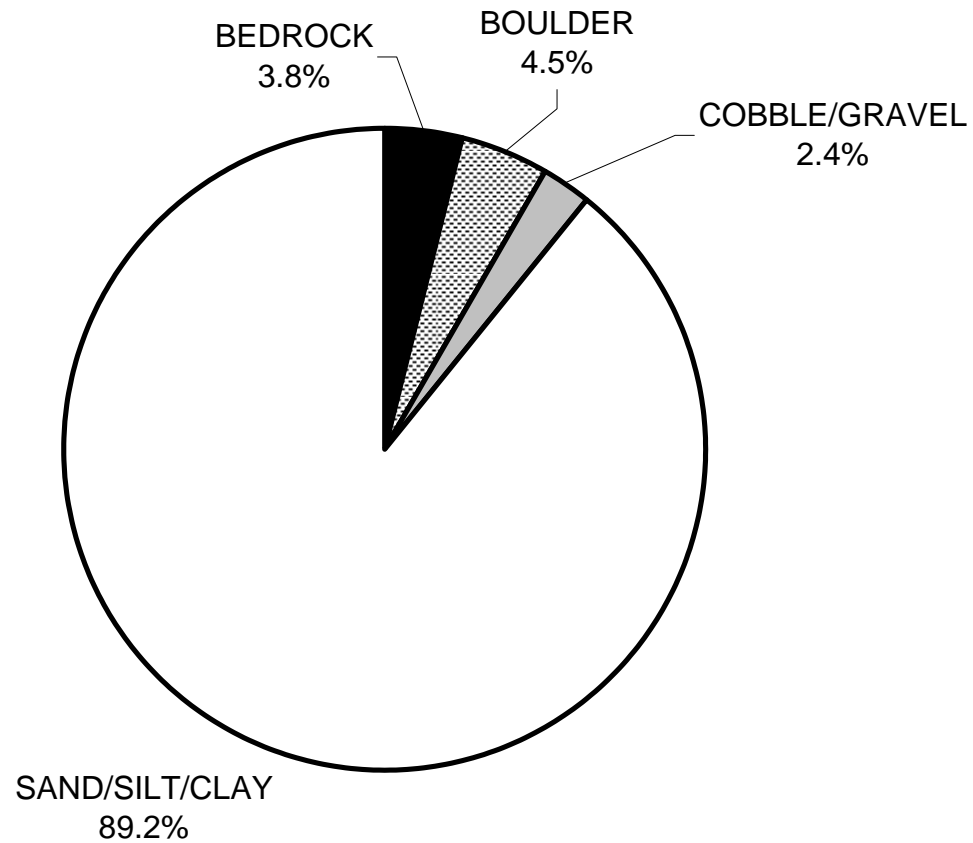
GRAPH 10

For the stream reach surveyed, the mean percent right bank vegetated was 99%. The mean percent left bank vegetated was 98%. The dominant elements composing the structure of the stream banks consisted of 89% sand/silt/clay, 5% boulders, 4% bedrock, and 2% cobble/gravel (Graph 10). Deciduous trees were the dominant vegetation type observed in 57% of the units surveyed. Additionally, 35% of the units surveyed had brush as the dominant vegetation type, and 7% had coniferous trees as the dominant vegetation type (Graph 11).
