STREAM INVENTORY REPORT

Martin Slough

2006

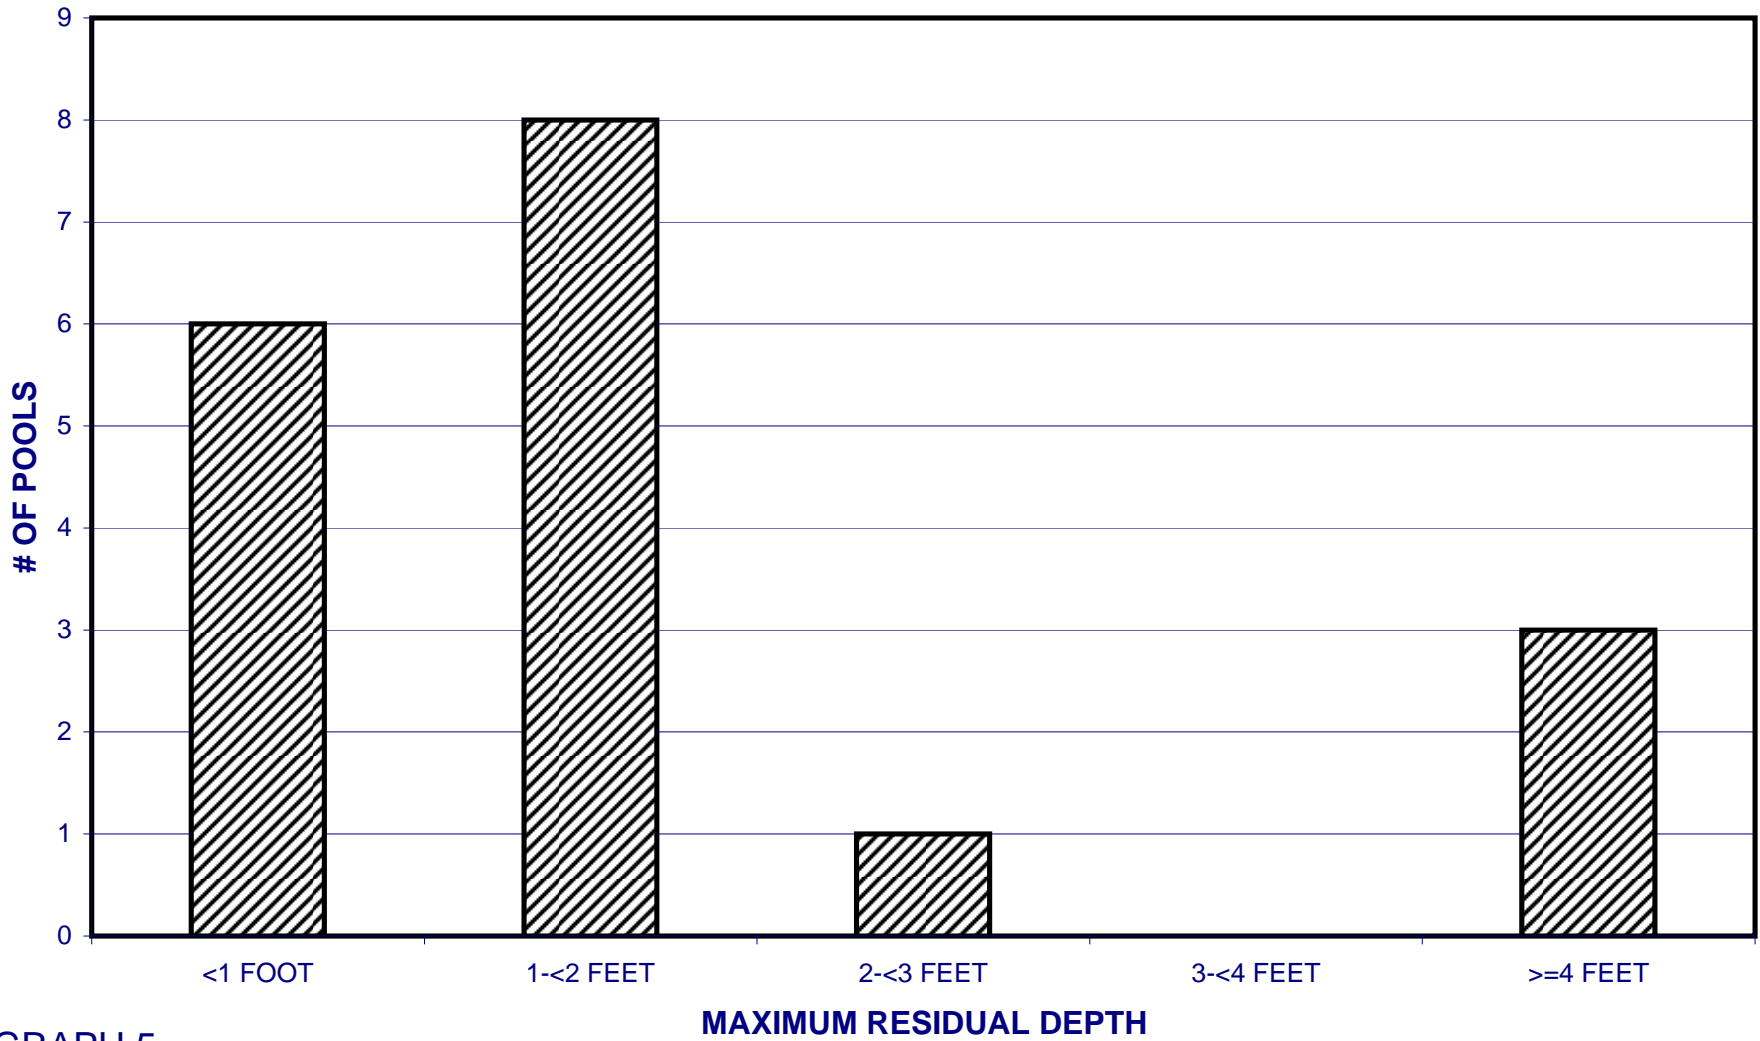
GRAPH 5

Table 4 is a summary of maximum residual pool depths by pool habitat types. Pool quality for salmonids increases with depth. Three of the 18 pools (17%) had a residual depth of three feet or greater (Graph 5).

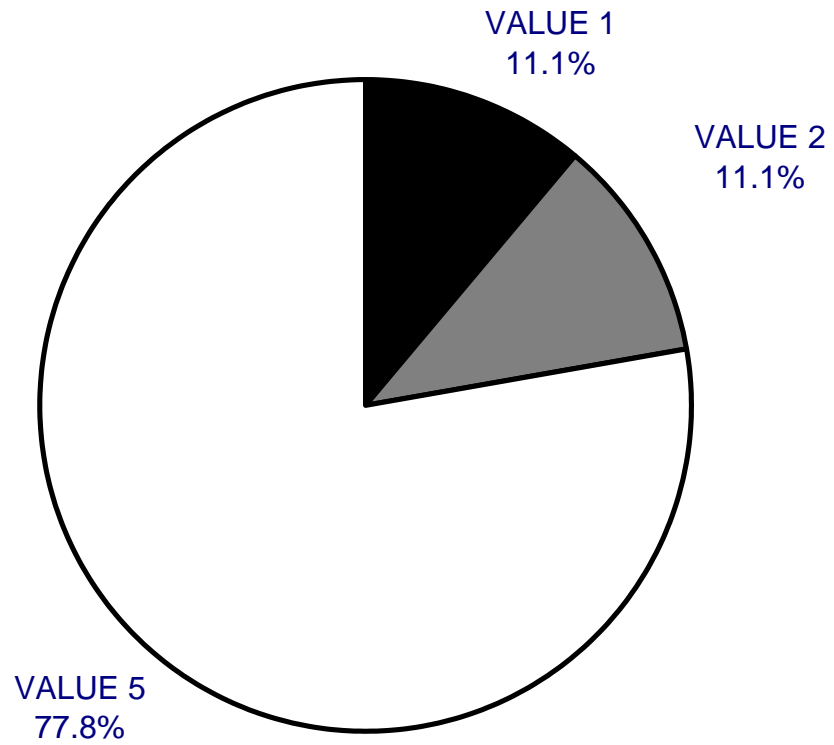
GRAPH 6

The depth of cobble embeddedness was estimated at pool tail-outs. Of the 18 pool tail-outs measured, 2 had a value of 1 (11%); 2 had a value of 2 (11%); 14 had a value of 5 (78%) (Graph 6). On this scale, a value of 1 indicates the best spawning conditions and a value of 4 the worst. Additionally, a value of 5 was assigned to tail-outs deemed unsuited for spawning due to inappropriate substrate such as bedrock, log sills, boulders, or other considerations.

Four of the 18 pool tail-outs measured had embeddedness ratings of 1 or 2. None of the pool tail-outs had embeddedness ratings of 3 or 4. Fourteen of the pool tail-outs had a rating of 5, which is considered unsuitable for spawning. Cobble embeddedness measured to be 25% or less, a rating of 1, is considered to indicate good quality spawning substrate for salmon and steelhead. Sediment sources in Martin Slough should be mapped and rated according to their potential sediment yields, and control measures should be taken.

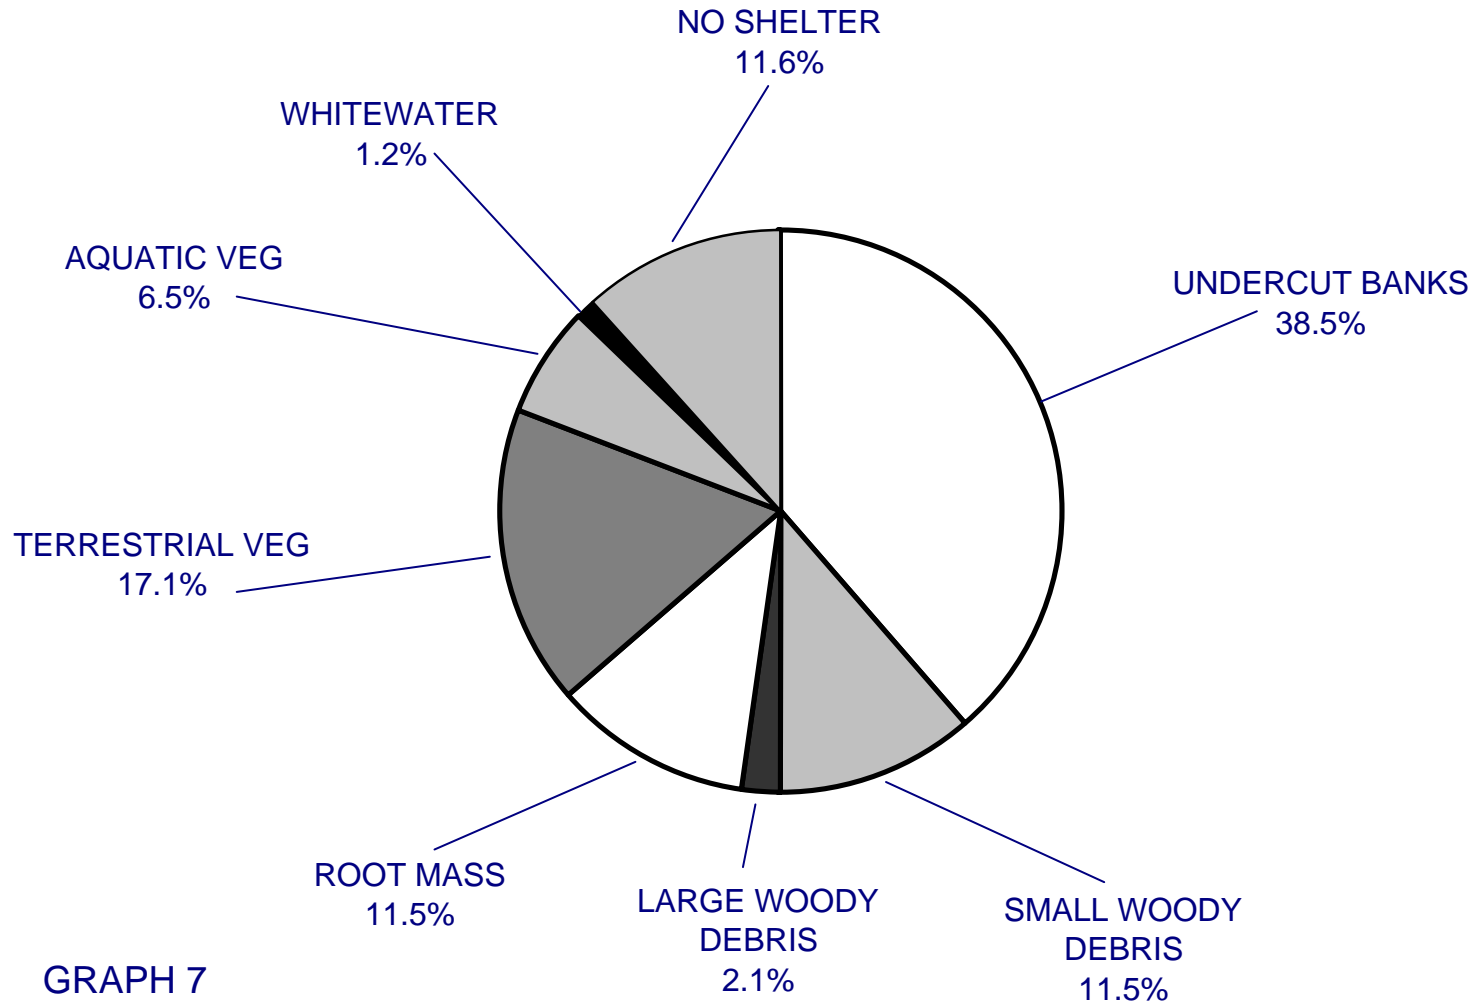
GRAPH 7

Table 5 summarizes mean percent cover by habitat type. Terrestrial vegetation is the dominant cover type in Martin Slough. Graph 7 describes the pool cover in Martin Slough. Undercut bank is the dominant pool cover type followed by terrestrial vegetation.

- 4) Increase woody cover in the pools and flatwater habitat units. Most of the existing cover in the pools is from undercut banks. Adding high quality complexity with woody cover in the pools is desirable.

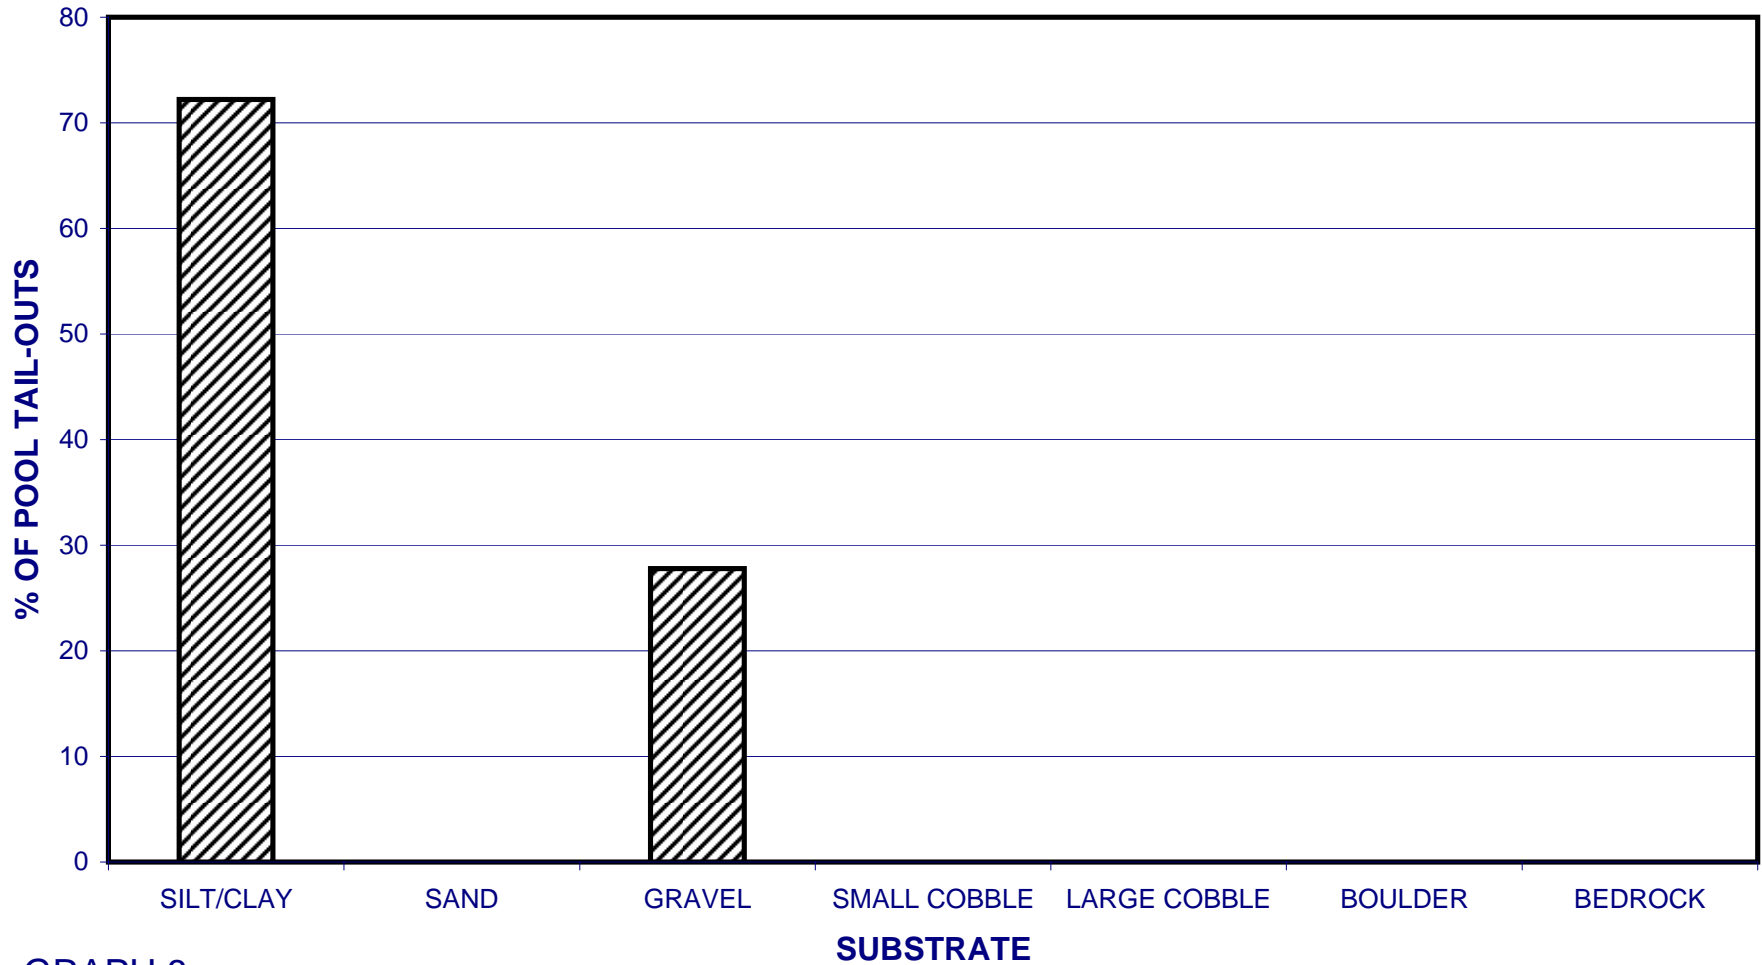
GRAPH 8

Table 6 summarizes the dominant substrate by habitat type. Graph 8 depicts the dominant substrate observed in pool tail-outs. A silt/clay substrate type was observed in 72% of pool tail-outs and gravel was observed in 28% of pool tail-outs.

Thirteen of the 18 pool tail-outs had silt or sand as the dominant substrate. This is generally considered unsuitable for spawning salmonids.

- 5) Suitable size spawning substrate on Martin Slough is limited to relatively few reaches. Projects should be designed at suitable sites to trap and sort spawning gravel.

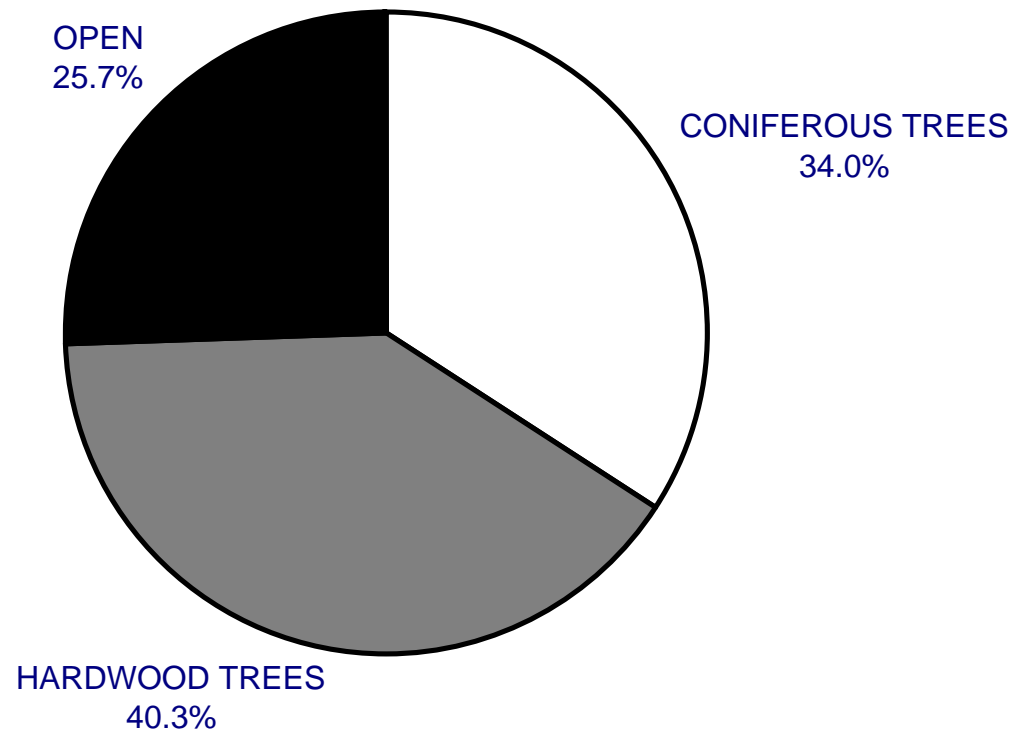
GRAPH 9

The mean percent canopy density for the surveyed length of Martin Slough was 74%. Twenty-six percent of the canopy was open. The mean percentages of hardwood and coniferous trees were 54% and 46%, respectively. Graph 9 describes the mean percent canopy in Martin Slough.

The mean percent canopy density for the stream was 74%. In general, revegetation projects are considered when canopy density is less than 80%. The percentage of right and left bank covered with vegetation was 86% and 93%, respectively.

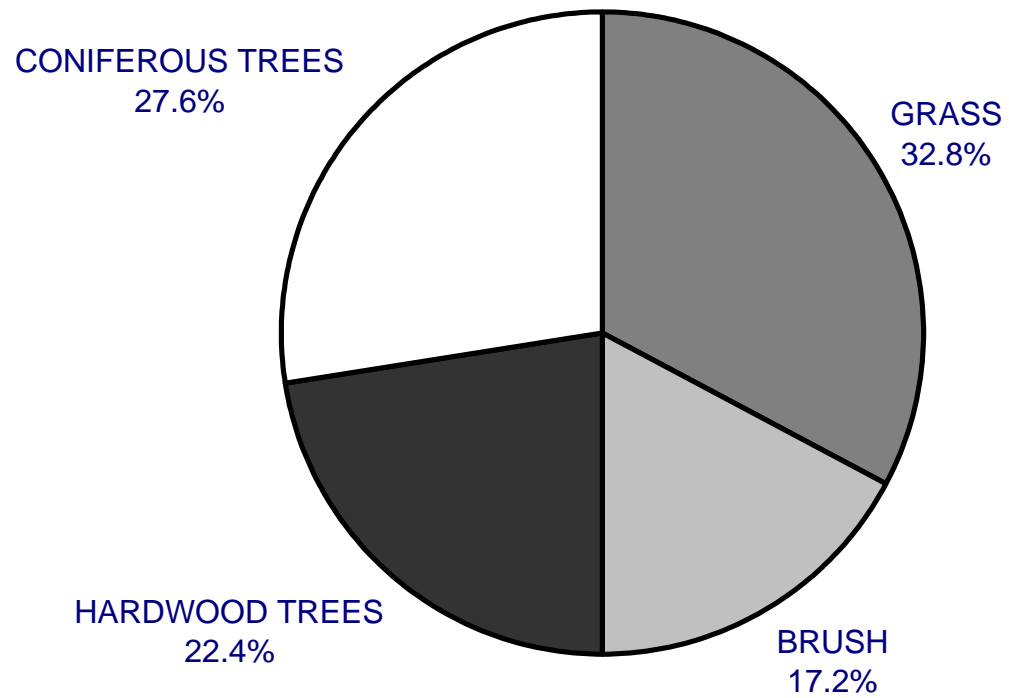
GRAPH 11

For the stream reach surveyed, the mean percent right bank vegetated was 86%. The mean percent left bank vegetated was 93%. The dominant elements composing the structure of the stream banks consisted of 98% sand/silt/clay and 2% cobble/gravel (Graph 10). Grass was the dominant vegetation type observed in 33% of the units surveyed. Additionally, 28% of the units surveyed had coniferous trees as the dominant vegetation type, and 22% had deciduous trees as the dominant vegetation (Graph 11).
