STREAM INVENTORY REPORT

Unnamed tributary to the Mad River

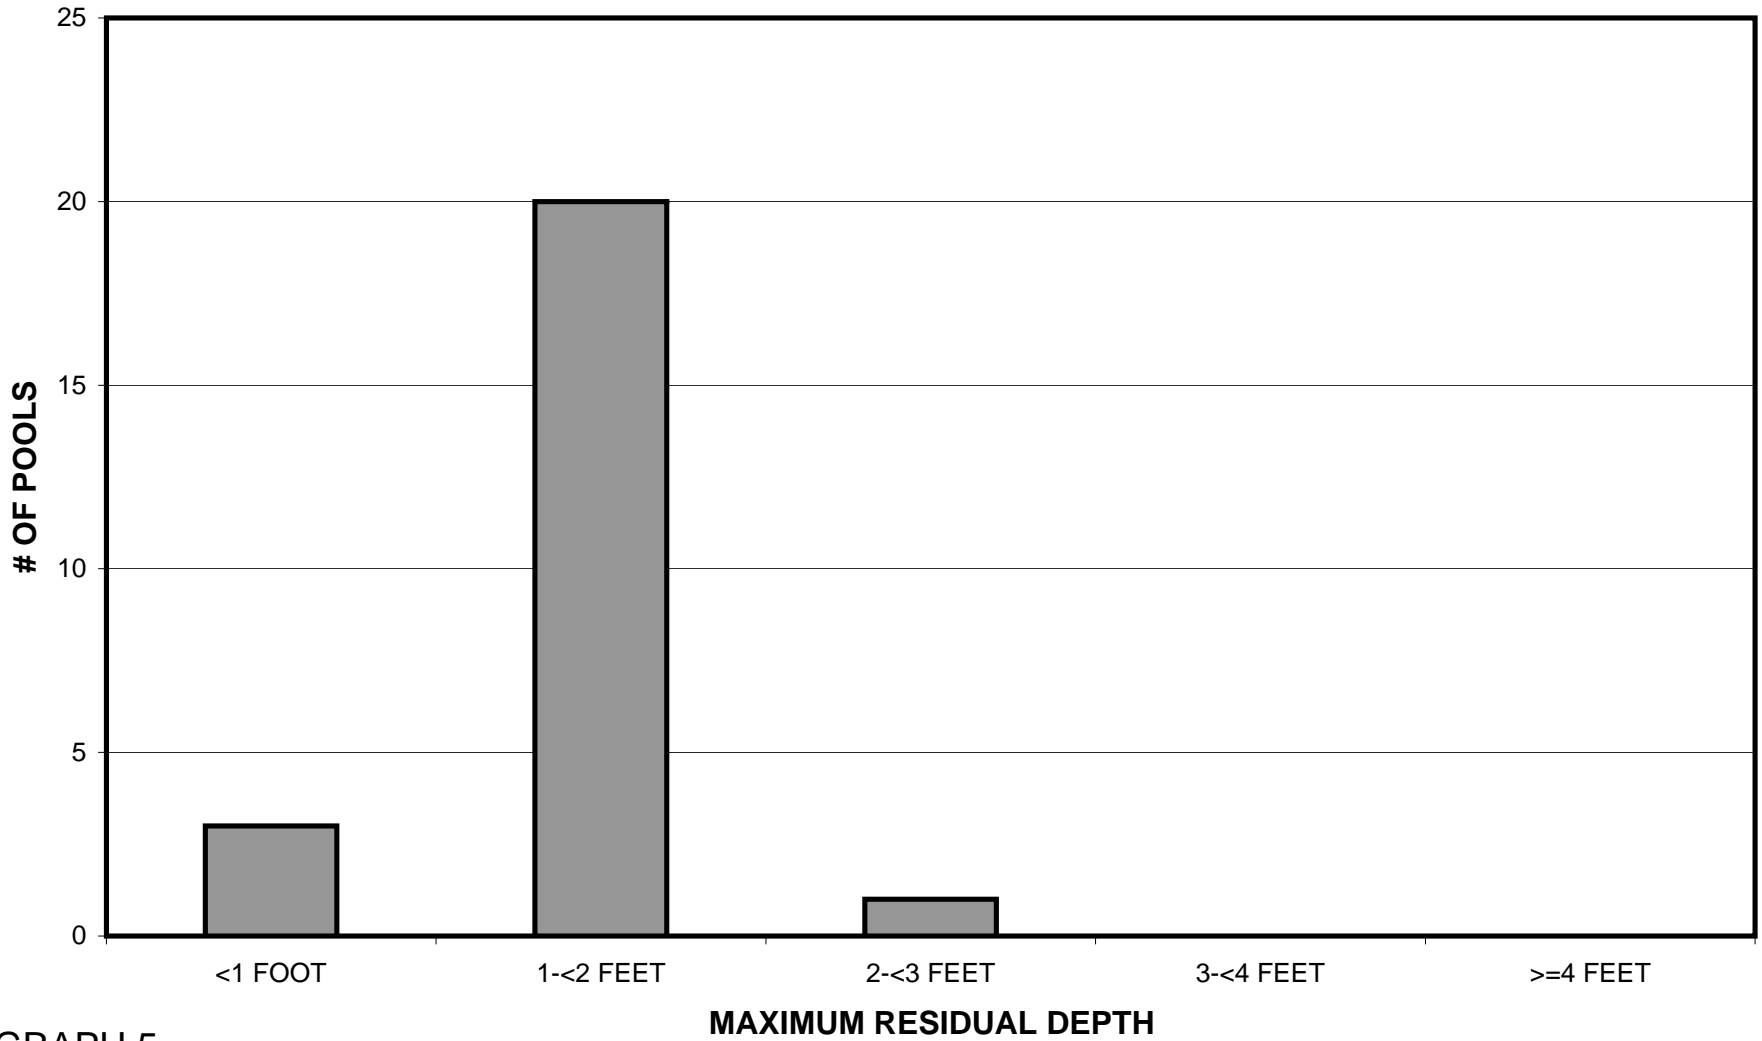
GRAPH 5

Table 4 is a summary of maximum residual pool depths by pool habitat types. Pool quality for salmonids increases with depth. One of the 24 pools (4%) had a residual depth of two feet or greater (Graph 5).

Flatwater habitat types comprised 27% of the total length of this survey, riffles 47%, and pools 25%. One of the 24 (4%) pools had a maximum residual depth greater than 2 feet. In general, pool enhancement projects are considered when primary pools comprise less than 40% of the length of total stream habitat. In first and second order streams, a primary pool is defined to have a maximum residual depth of at least two feet, occupy at least half the width of the low flow channel, and be as long as the low flow channel width. Installing large wood structures that will increase or deepen pool habitat is recommended for Reach 1.

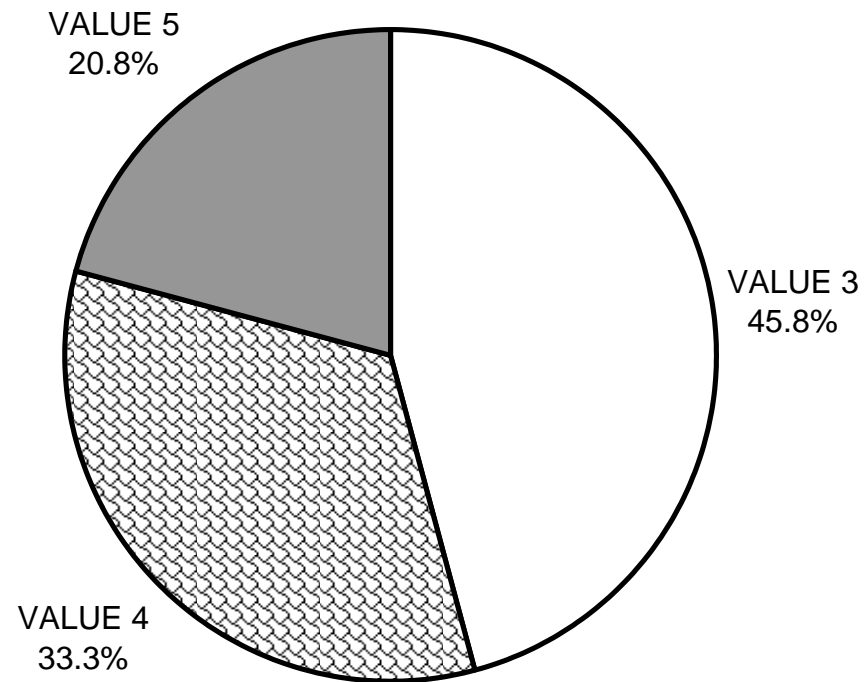
GRAPH 6

The depth of cobble embeddedness was estimated at pool tail-outs. Of the 24 pool tail-outs measured, 11 had a value of 3 (45.8%); eight had a value of 4 (33.3%); five had a value of 5

(20.8%); (Graph 6). On this scale, a value of 1 indicates the best spawning conditions and a value of 4 the worst. Additionally, a value of 5 was assigned to tail-outs deemed not suitable for spawning due to inappropriate substrate such as bedrock, log sills, boulders, or other considerations.

None of the 24 pool tail-outs measured had embeddedness ratings of 1 or 2. Nineteen of the pool tail-outs had embeddedness ratings of 3 or 4. Five of the pool tail-outs had a rating of 5, which is considered unsuitable for spawning. Cobble embeddedness measured to be 25% or less, a rating of 1, is considered to indicate good quality spawning substrate for salmon and steelhead. Sediment sources in the unnamed tributary should be mapped and rated according to their potential sediment yields, and control measures should be taken.

- 4) Active and potential sediment sources related to the road system need to be identified, mapped, and treated according to their potential for sediment yield to the stream and its tributaries.

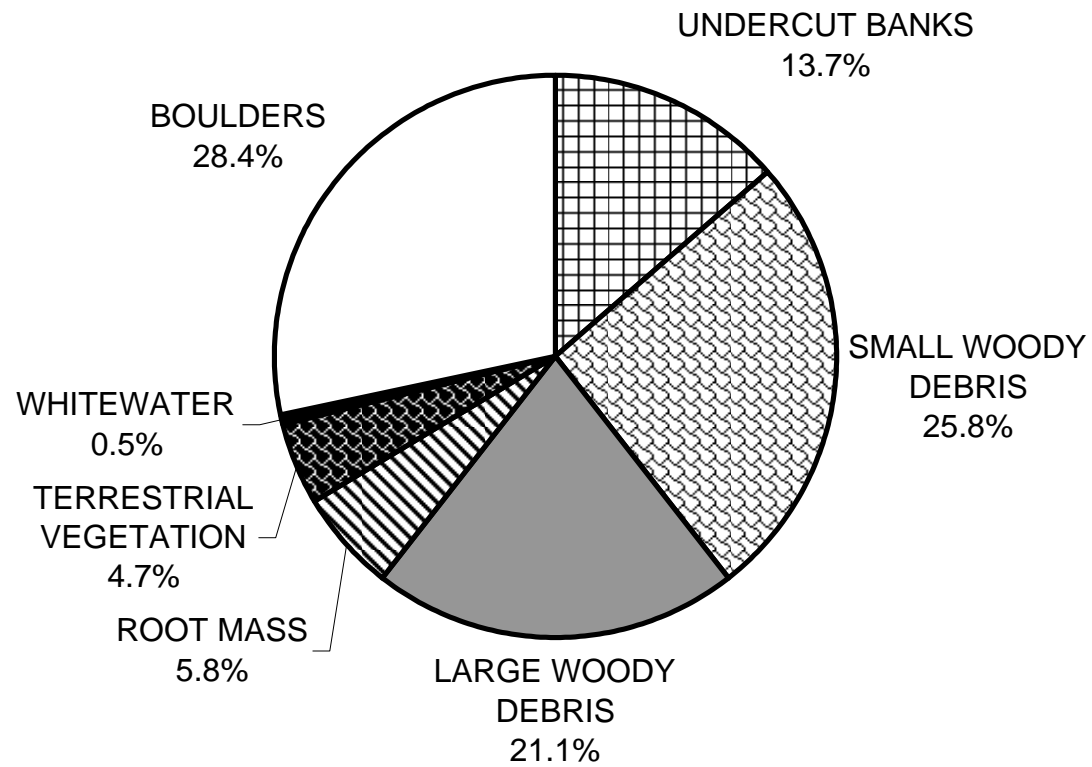
GRAPH 7

Table 5 summarizes mean percent cover by habitat type. Boulders are the dominant cover type in the unnamed tributary. Graph 7 describes the pool cover in the unnamed tributary. Boulders are the dominant pool cover type followed by small woody debris.

The mean shelter rating for pools is 14. The shelter rating in the flatwater habitats is 2. A pool shelter rating of approximately 100 is desirable. The amount of cover that now exists is being provided primarily by boulders in the unnamed tributary. Boulders are the dominant cover type in pools followed by small woody debris. Log and root wad cover structures in the pool and flatwater habitats would enhance both summer and winter salmonid habitat. Log cover structures provide rearing fry with protection from predation, rest from water velocity, and also divide territorial units to reduce density related competition.

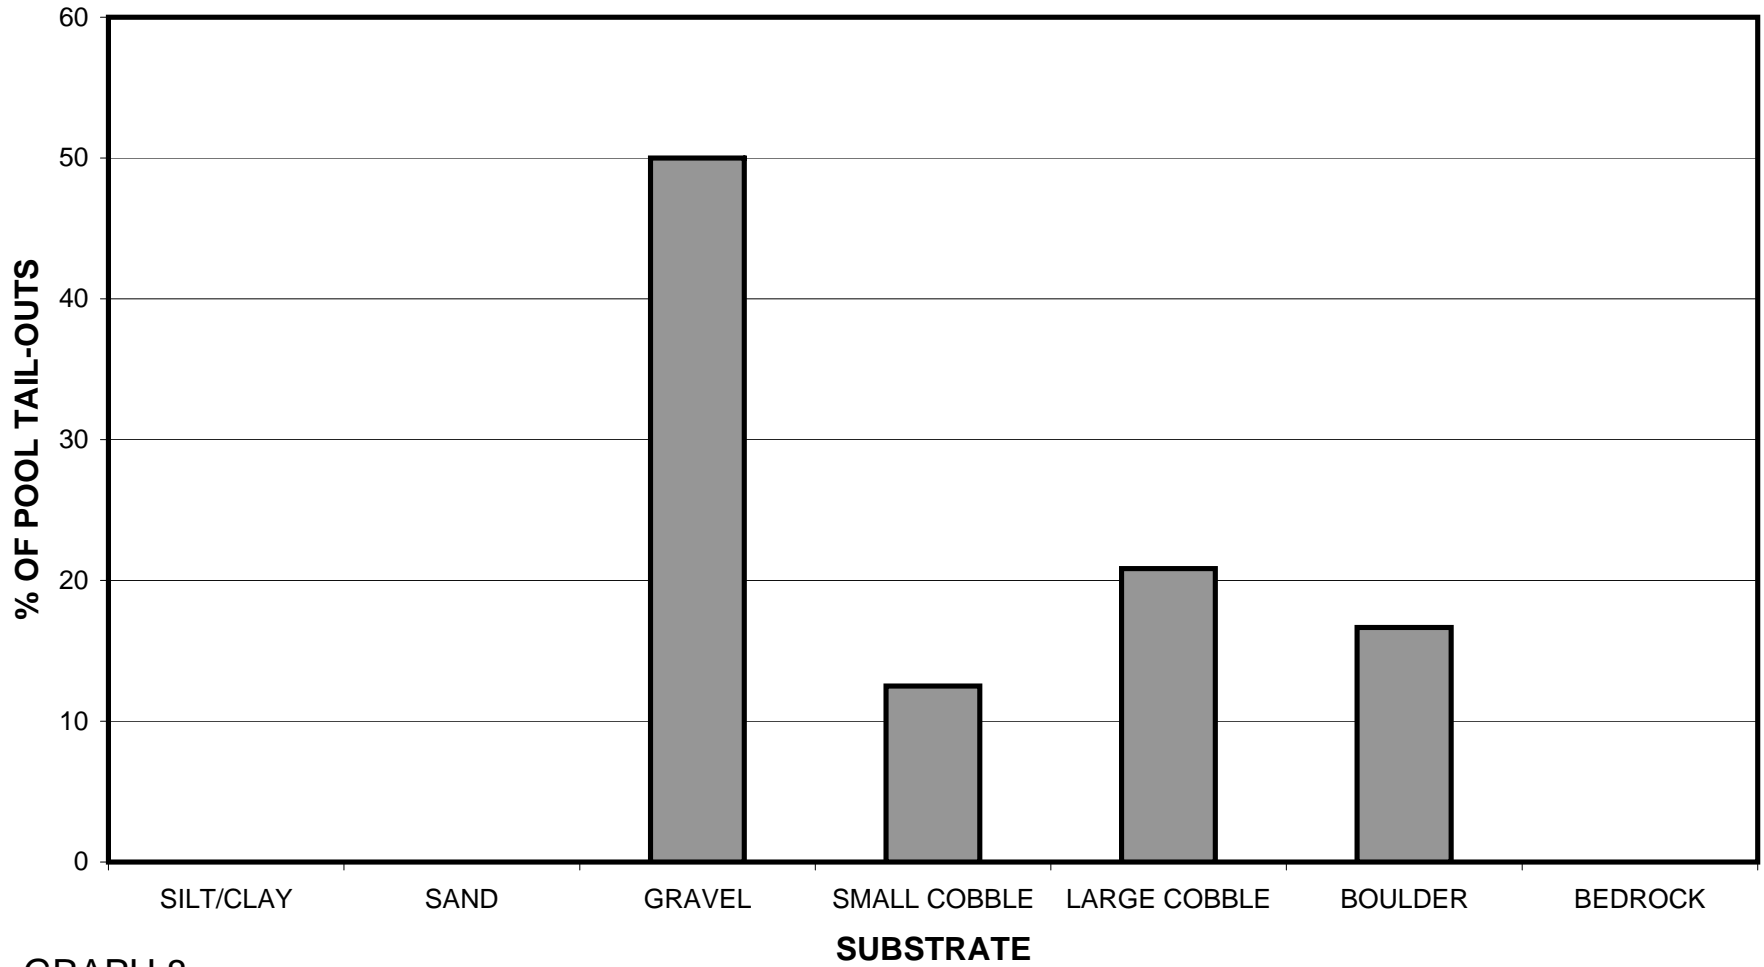
GRAPH 8

Table 6 summarizes the dominant substrate by habitat type. Graph 8 depicts the dominant substrate observed in pool tail-outs. Gravel was the dominant substrate observed in 50% of the pool tail-outs. Large cobble was the next most frequently observed dominant substrate type and occurred in 21% of the pool tail-outs.

Twelve of the 24 pool tail-outs measured had gravel as the dominant substrate. This is generally considered fair for spawning salmonids.
