# STREAM INVENTORY REPORT

## Mill Creek

A stream inventory was conducted on July 9, 2007 on Mill Creek. The survey began at the confluence with Hall Creek and extended upstream 0.5 miles.

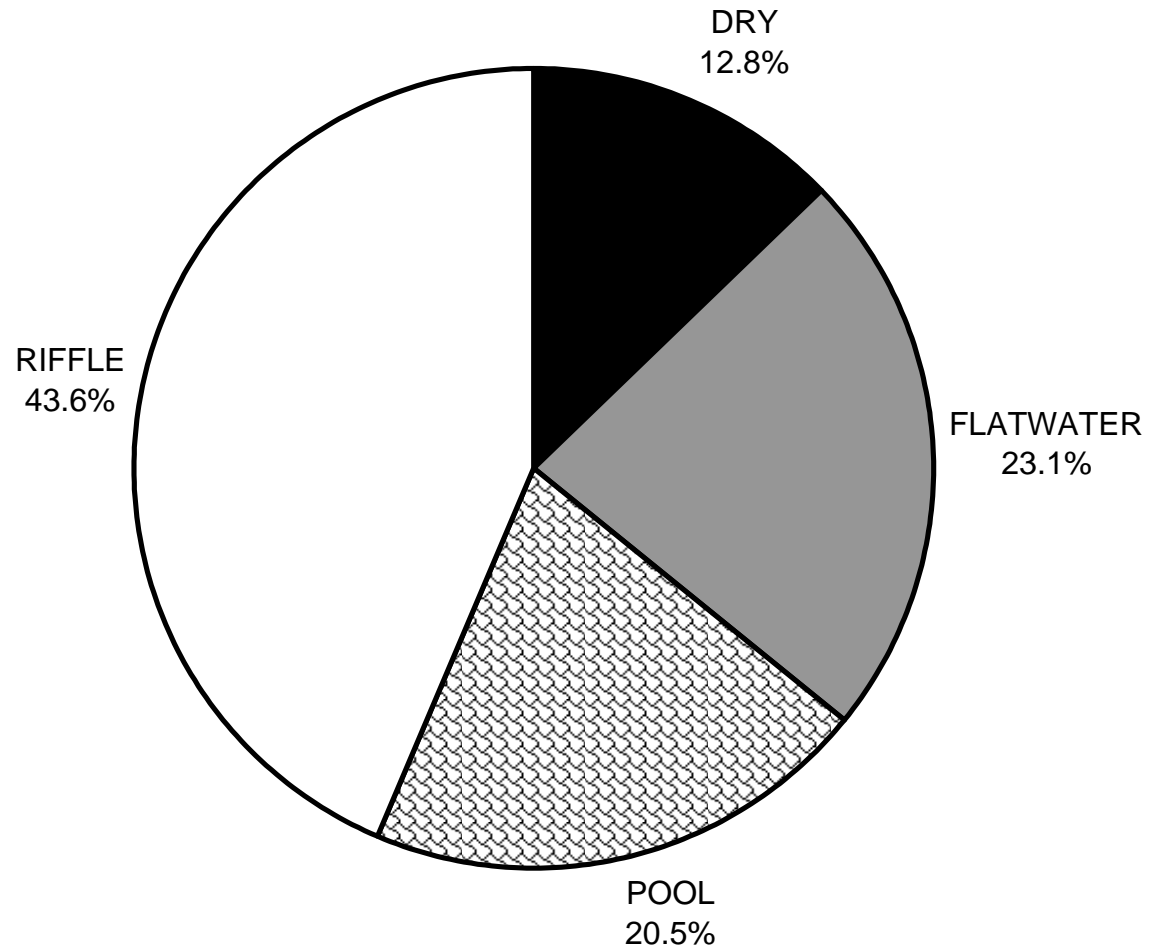
GRAPH 1

Table 1 summarizes the Level II riffle, flatwater, and pool habitat types. Based on frequency of occurrence there were 44% riffle units, 23% flatwater units, 21% pool units, and 13% dry units (Graph 1). Based on total length of Level II habitat types there were 58% dry units, 27% riffle units, 9% flatwater units, and 5% pool units (Graph 2).

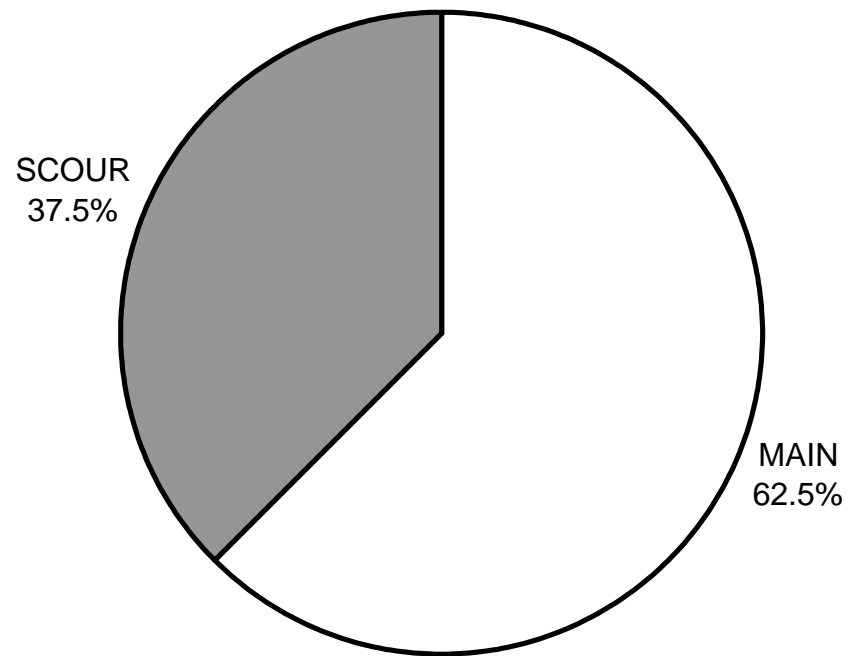
GRAPH 4

A total of 8 pools were identified (Table 3). Main channel pools were the most frequently encountered, at 62% (Graph 4), and comprised 65% of the total length of all pools (Table 3).

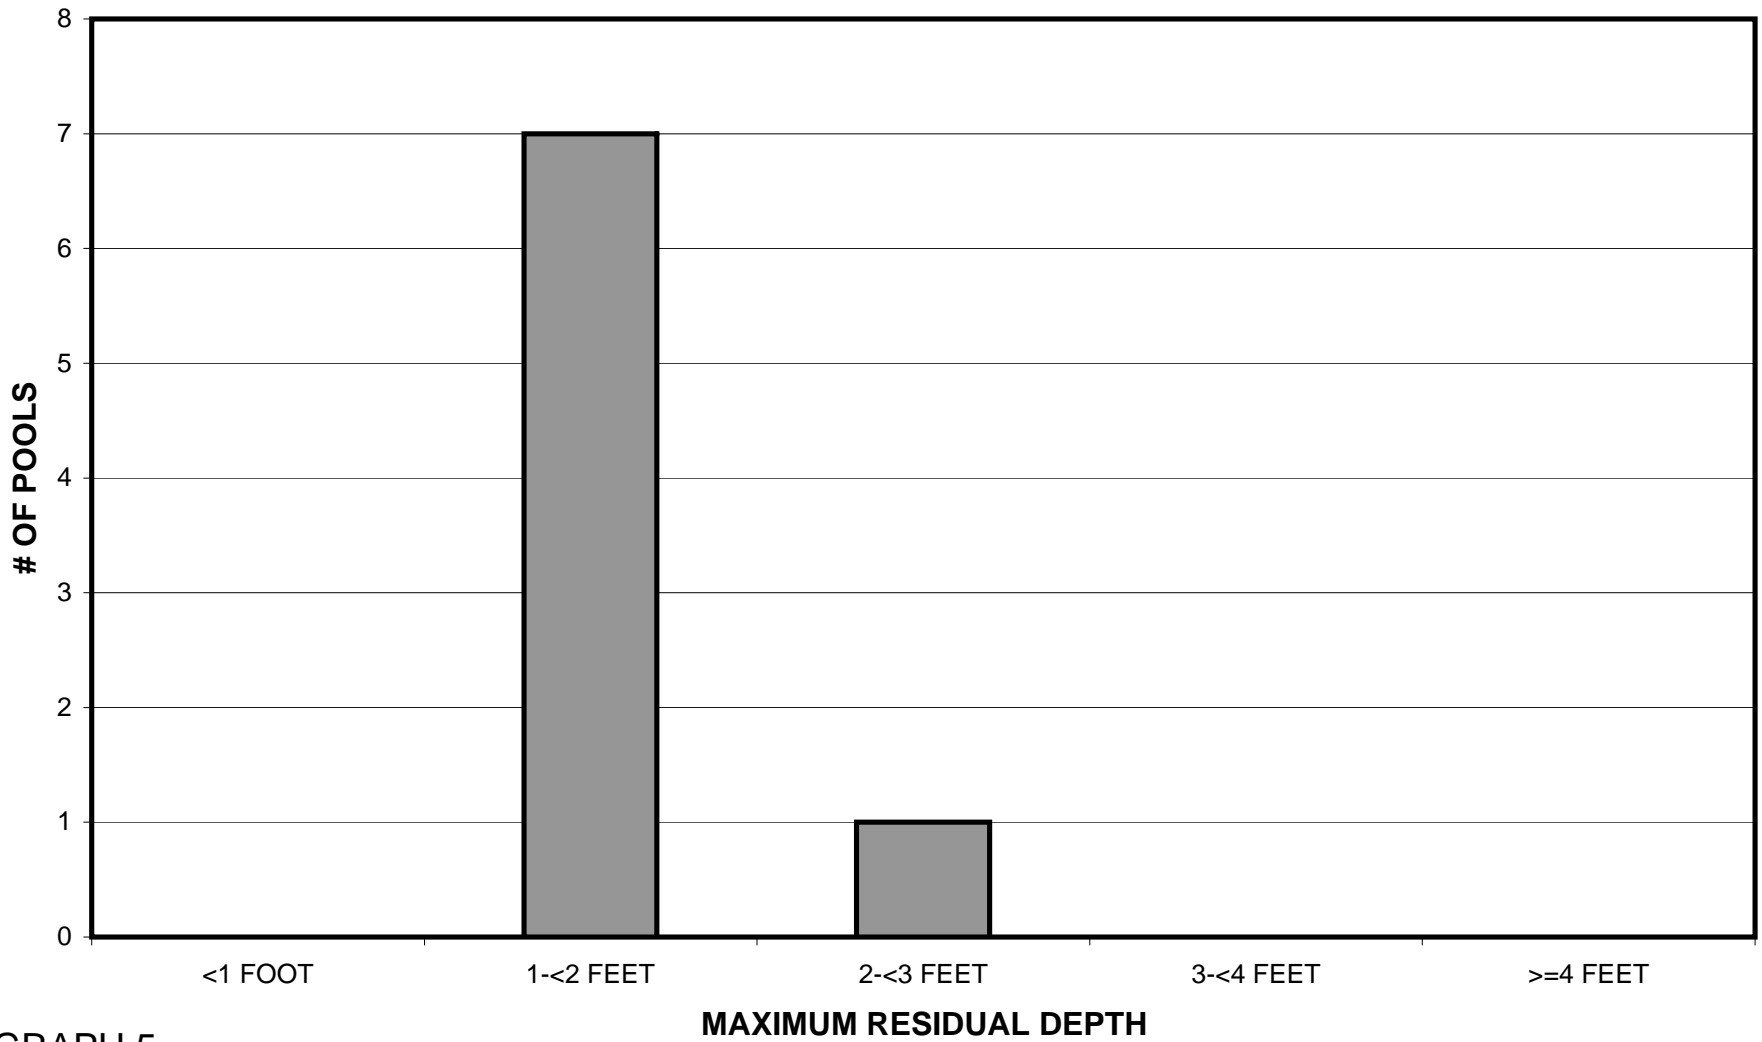
GRAPH 5

Table 4 is a summary of maximum residual pool depths by pool habitat types. Pool quality for salmonids increases with depth. One of the 8 pools (12%) had a residual depth of two feet or greater (Graph 5).

Flatwater habitat types comprised 9% of the total length of this survey, riffles 27%, and pools 5%. The pools are relatively shallow, with only 1 of the 8 (12%) pools having a maximum residual depth greater than 2 feet. In general, pool enhancement projects are considered when primary pools comprise less than 40% of the length of total stream habitat. In first and second order streams, a primary pool is defined to have a maximum residual depth of at least two feet, occupy at least half the width of the low flow channel, and be as long as the low flow channel width. Installing structures that will increase or deepen pool habitat is recommended.

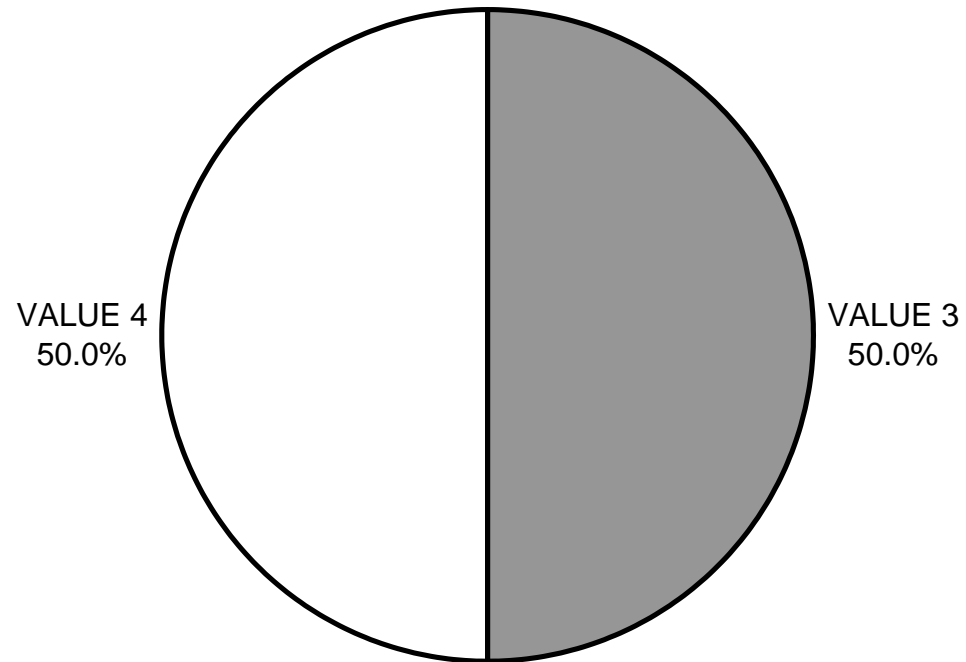
GRAPH 6

The depth of cobble embeddedness was estimated at pool tail-outs. Of the 8 pool tail-outs measured, 4 had a value of 3 (50%) and 4 had a value of 4 (50%) (Graph 6). On this scale, a value of 1 indicates the best spawning conditions and a value of 4 the worst.

None of the 8 pool tail-outs measured had embeddedness ratings of 1 or 2. Eight of the pool tail-outs had embeddedness ratings of 3 or 4. None of the pool tail-outs had a rating of 5, which is considered unsuitable for spawning. Cobble embeddedness measured to be 25% or less, a rating of 1, is considered to indicate good quality spawning substrate for salmon and steelhead. Sediment sources in Mill Creek should be mapped and rated according to their potential sediment yields, and control measures should be taken.

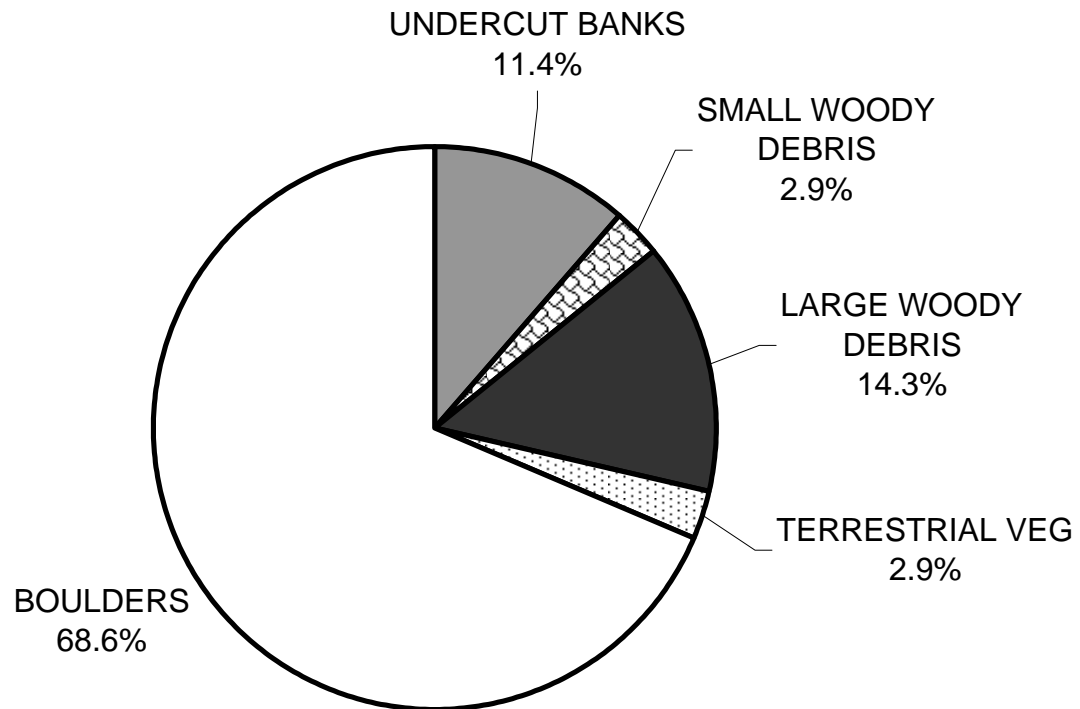
GRAPH 7

Table 5 summarizes mean percent cover by habitat type. Boulders are the dominant cover types in Mill Creek. Graph 7 describes the pool cover in Mill Creek. Boulders are the dominant pool cover type followed by large woody debris.

The mean shelter rating for pools was 10. The shelter rating in the flatwater habitats was 2. A pool shelter rating of approximately 100 is desirable. The amount of cover that now exists is being provided primarily by boulders in Mill Creek. Boulders are the dominant cover type in pools followed by large woody debris. Log and root wad cover structures in the pool and flatwater habitats would enhance both summer and winter salmonid habitat. Log cover structure provides rearing fry with protection from predation, rest from water velocity, and also divides territorial units to reduce density related competition.

- 3) Increase woody cover in the pools and flatwater habitat units. Most of the existing cover in the pools is from boulders. Adding high quality complexity with woody cover in the pools is desirable.
- 4) The limited water temperature data available suggest that maximum temperatures are within the acceptable range for juvenile salmonids. To establish more complete and meaningful temperature regime information, 24-hour monitoring during the July and August temperature extreme period should be performed for 3 to 5 years.

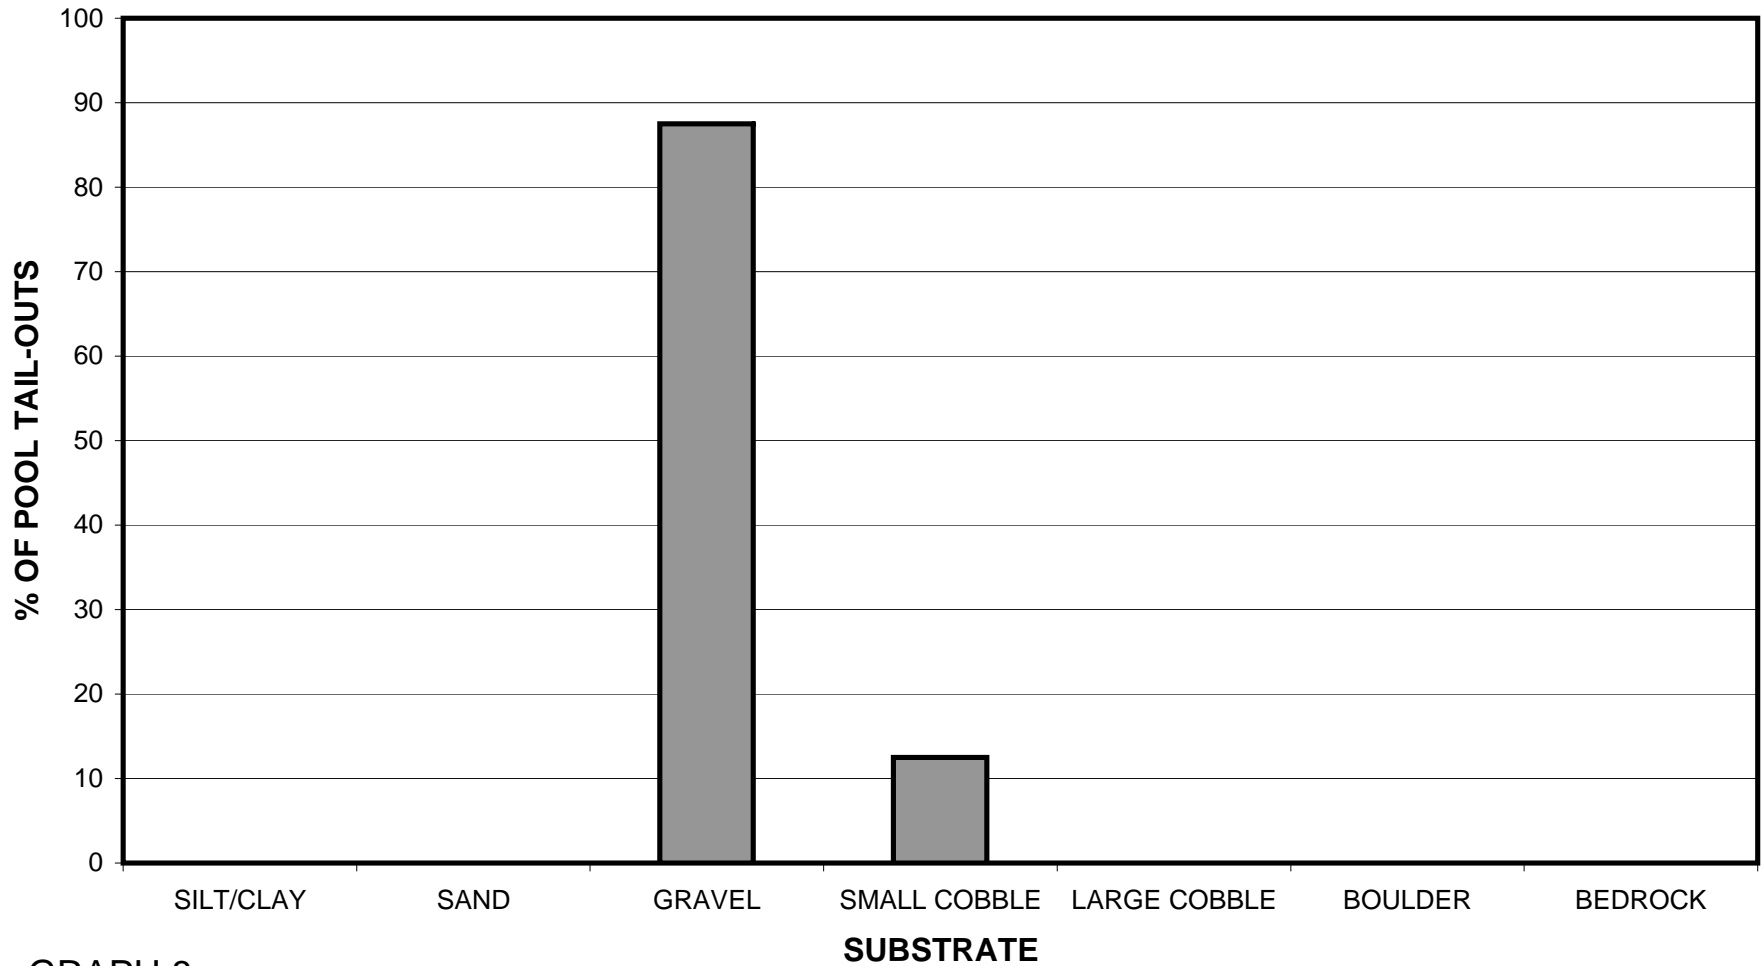
GRAPH 8

Table 6 summarizes the dominant substrate by habitat type. Graph 8 depicts the dominant substrate observed in pool tail-outs. Gravel was observed in 88% of pool tail-outs and small cobble was observed in 12% of pool tail-outs.

The 8 pool tail-outs measured had gravel or small cobble as the dominant substrate. This is generally considered good for spawning salmonids.

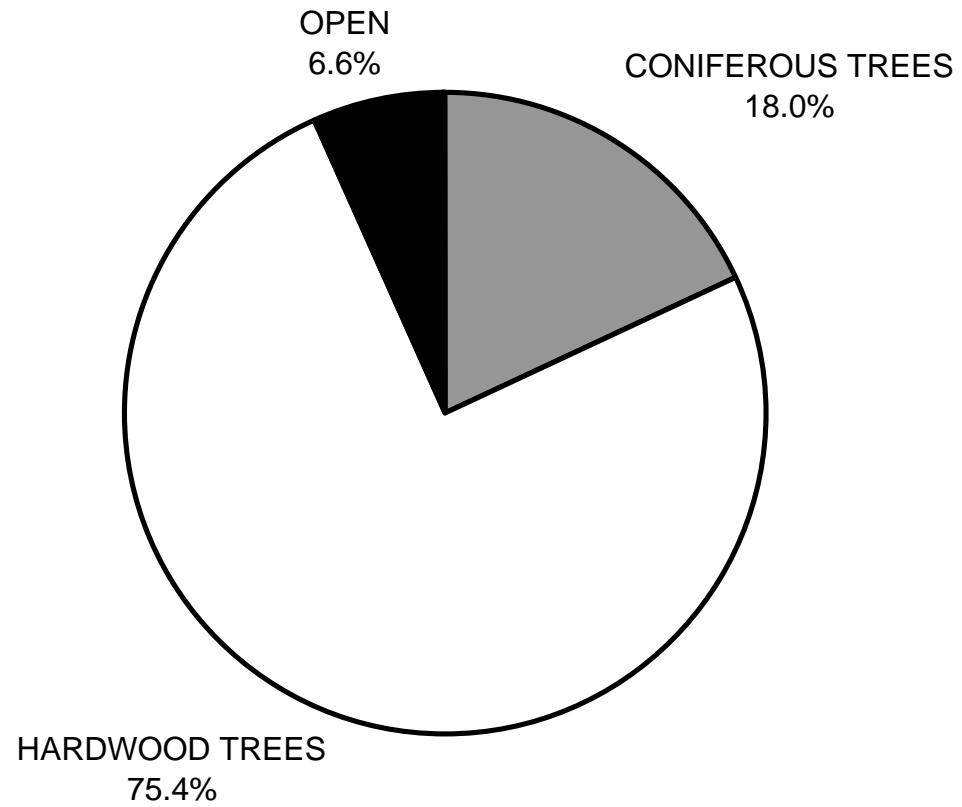
GRAPH 9

The mean percent canopy density for the surveyed length of Mill Creek was 93%. Seven percent of the canopy was open. Of the canopy present, the mean percentages of hardwood and coniferous trees were 81% and 19%, respectively. Graph 9 describes the mean percent canopy in Mill Creek.

The mean percent canopy density for the stream was 93%. In general, revegetation projects are considered when canopy density is less than 80%.

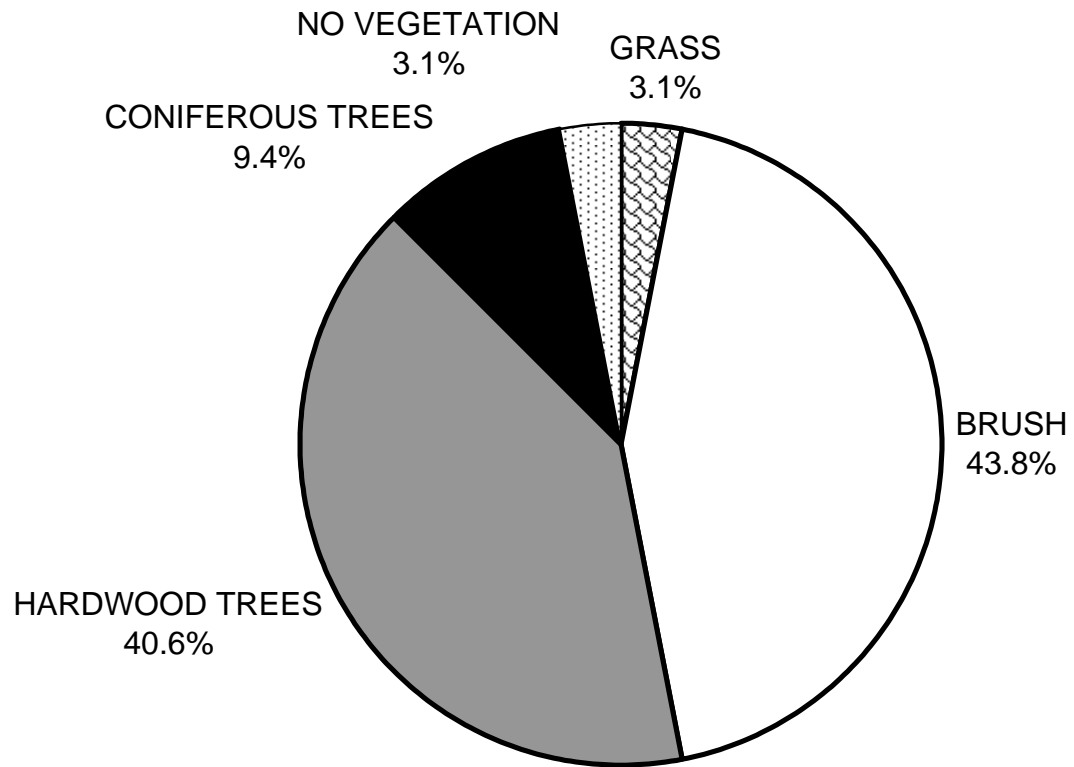
GRAPH 11

For the stream reach surveyed, the mean percent right bank vegetated was 100%. The mean percent left bank vegetated was 94%. The dominant elements composing the structure of the stream banks consisted of 72% sand/silt/clay, 22% cobble/gravel, 3% bedrock, and 3% boulder (Graph 10). Brush was the dominant vegetation type observed in 44% of the units surveyed. Additionally, 41% of the units surveyed had deciduous trees as the dominant vegetation type, 9% had coniferous trees as the dominant vegetation, and 3% had grass as the dominant vegetation (Graph 11).
