STREAM INVENTORY REPORT

Lindsay Creek

A stream inventory was conducted from July 19, 2006 to September 12, 2006 on Lindsay Creek. The survey began approximately 2.3 miles upstream from the confluence with Mad River and extended upstream 6.8 miles.

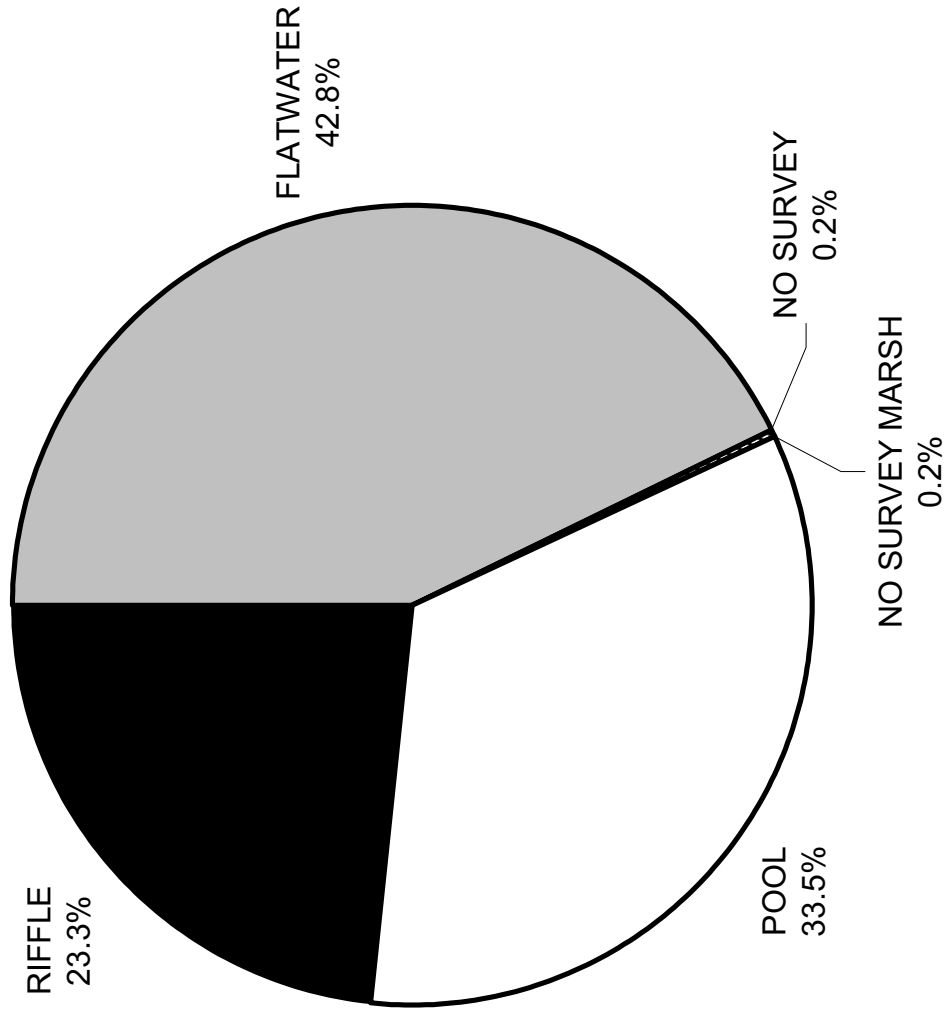
GRAPH 1

Table 1 summarizes the Level II riffle, flatwater, and pool habitat types. Based on frequency of occurrence there were 43% flatwater units, 34% pool units, and 23% riffle units (Graph 1). Based on total length of Level II habitat types there was 49% flatwater units, 37% pool units, and 15% riffle units, (Graph 2).

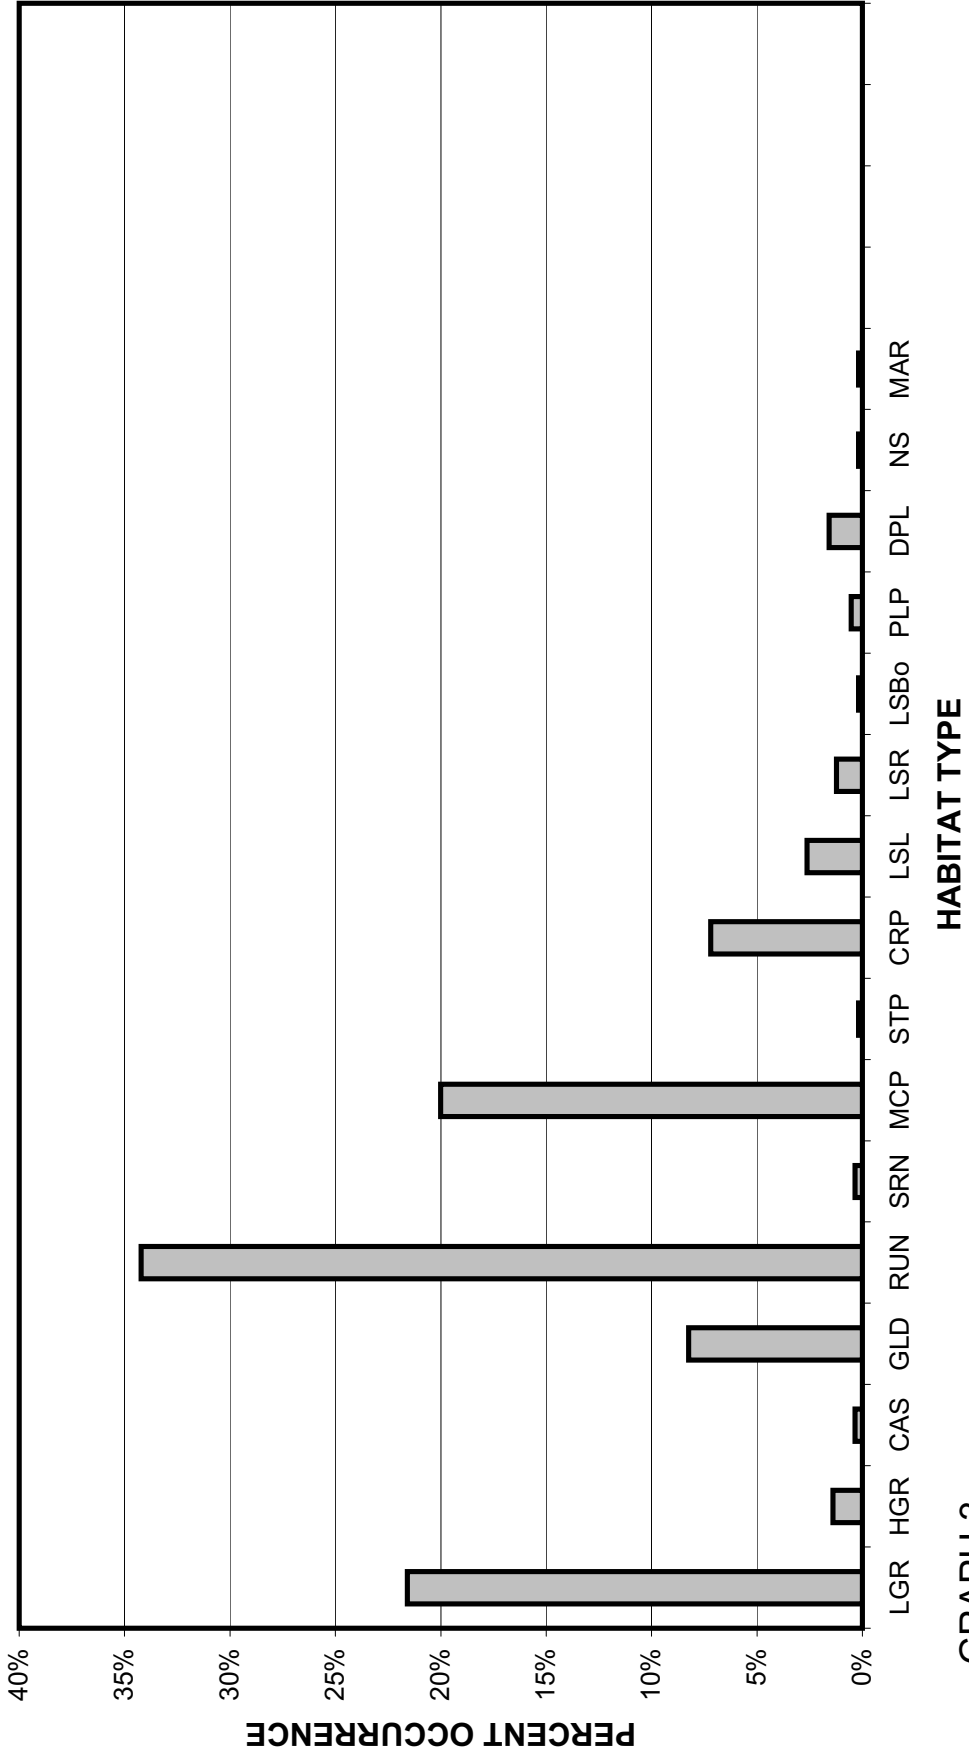
GRAPH 3

Fourteen Level IV habitat types were identified (Table 2). The most frequent habitat types by percent occurrence were 34% run units, 22% low gradient riffle units and 20% mid-channel pool units (Graph 3). Based on percent total length of surveyed stream, run units 33%, mid-channel pool units 23% and 16% glide units.

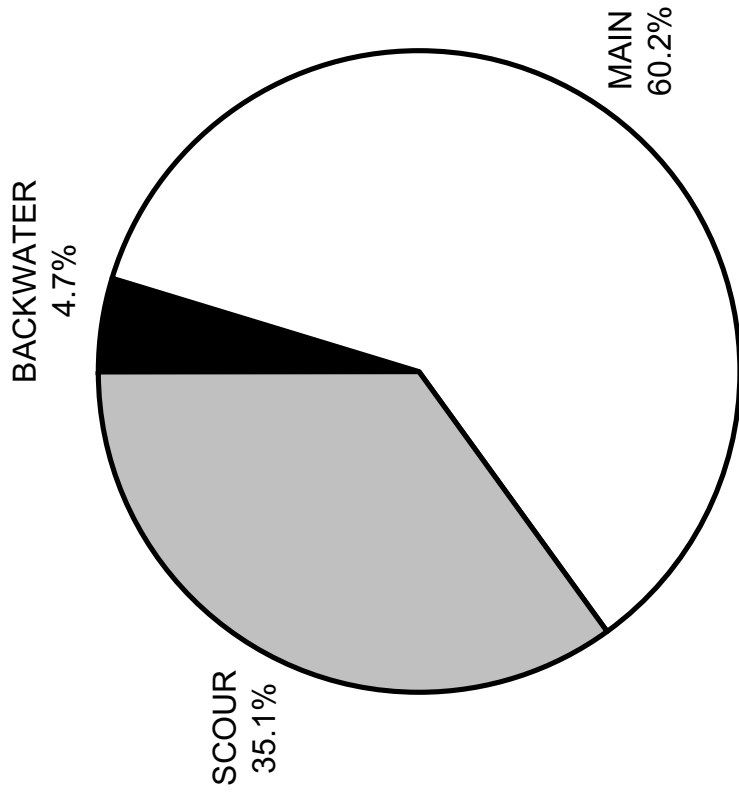
GRAPH 4

A total of 191 pools were identified (Table 3). Main channel pools were the most frequently encountered, at 60% (Graph 4), and comprised 62% of the total length of all pools (Table 3).

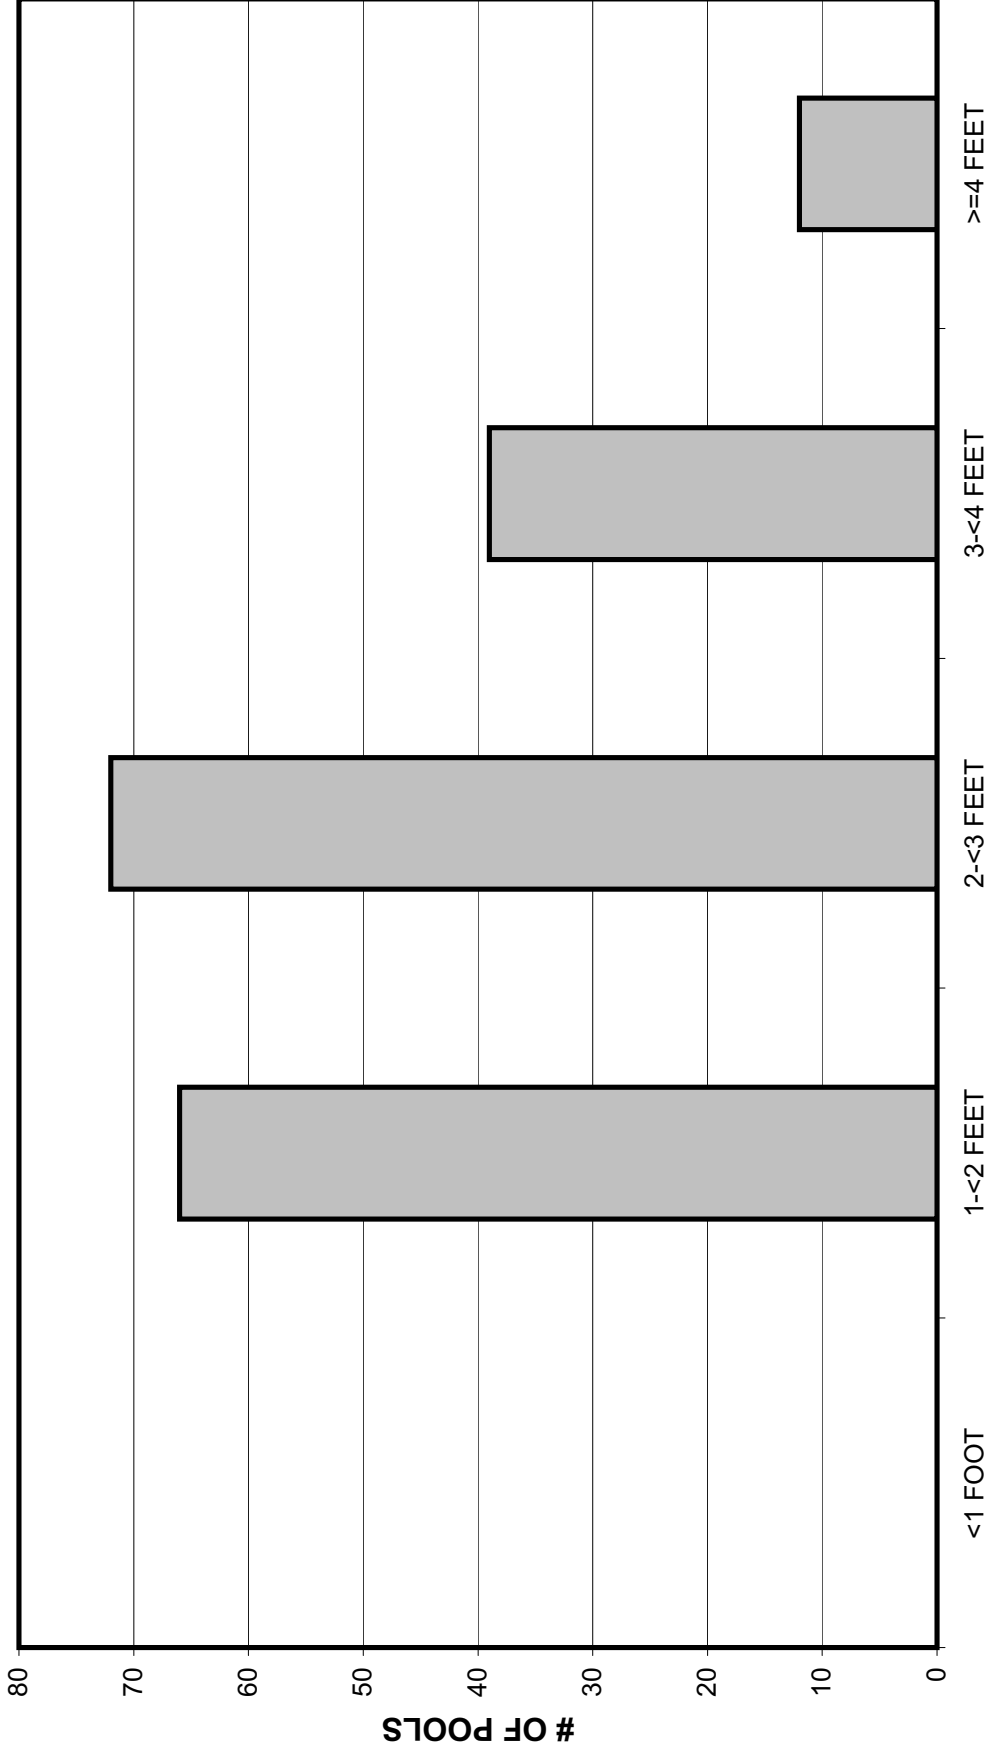
GRAPH 5

Table 4 is a summary of maximum residual pool depths by pool habitat types. Pool quality for salmonids increases with depth. Fifty-one of the 189 non side-channel pools (27%) had a residual depth of three feet or greater (Graph 5).

Flatwater habitat types comprised 49% of the total length of this survey, riffles 15%, and pools 37%. The pools are relatively shallow, with 51 of the 189 pools (27%) pools having a maximum residual depth greater than 3 feet. In general, pool enhancement projects are considered when primary pools comprise less than 40% of the length of total stream habitat. In third and fourth

order streams, a primary pool is defined to have a maximum residual depth of at least three feet, and occupy at least half the width of the low flow channel. Installing structure that will deepen pool habitat is recommended.

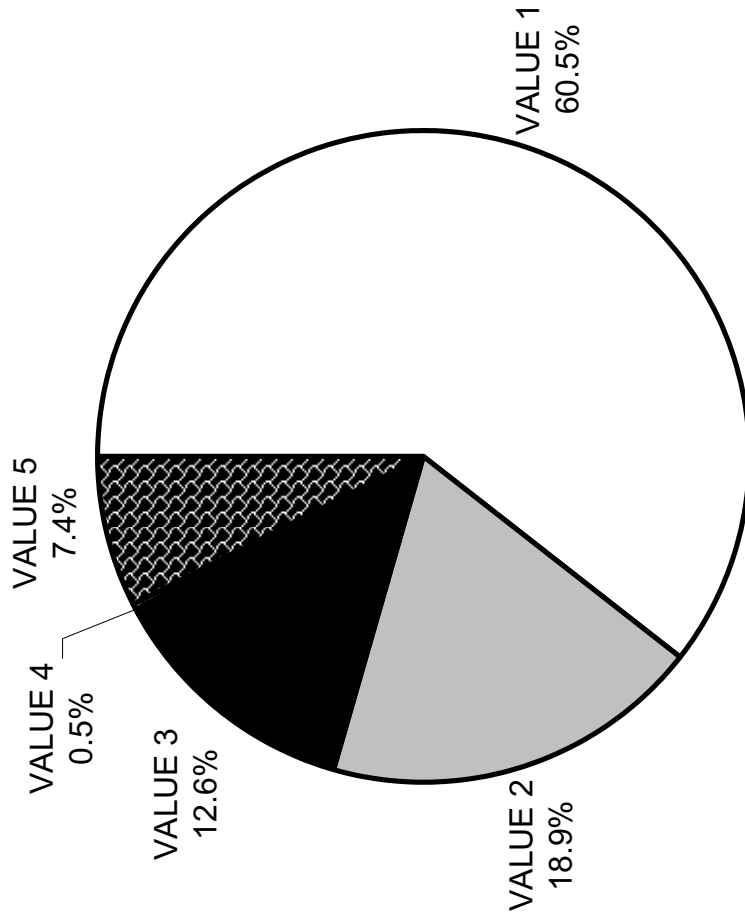
GRAPH 6

The depth of cobble embeddedness was estimated at pool tail-outs. Of the 190 pool tail-outs measured, 115 had a value of 1 (60.5%); 36 had a value of 2 (18.9%); 24 had a value of 3 (12.6%); 1 had a value of 4 (0.5%); 14 had a value of 5 (7.4%) (Graph 6). On this scale, a value of 1 indicates the best spawning conditions and a value of 4 the worst. Additionally, a value of 5 was assigned to tail-outs deemed unsuited for spawning due to inappropriate substrate such as bedrock, log sills, boulders, or other considerations.

One hundred and forty-nine of the 188 pool tail-outs measured had embeddedness ratings of 1 or 2. Twenty-five of the pool tail-outs had embeddedness ratings of 3 or 4. Fourteen of the pool tail-outs had a rating of 5, which is considered unsuitable for spawning. Cobble embeddedness measured to be 25% or less, a rating of 1, is considered to indicate good quality spawning substrate for salmon and steelhead.

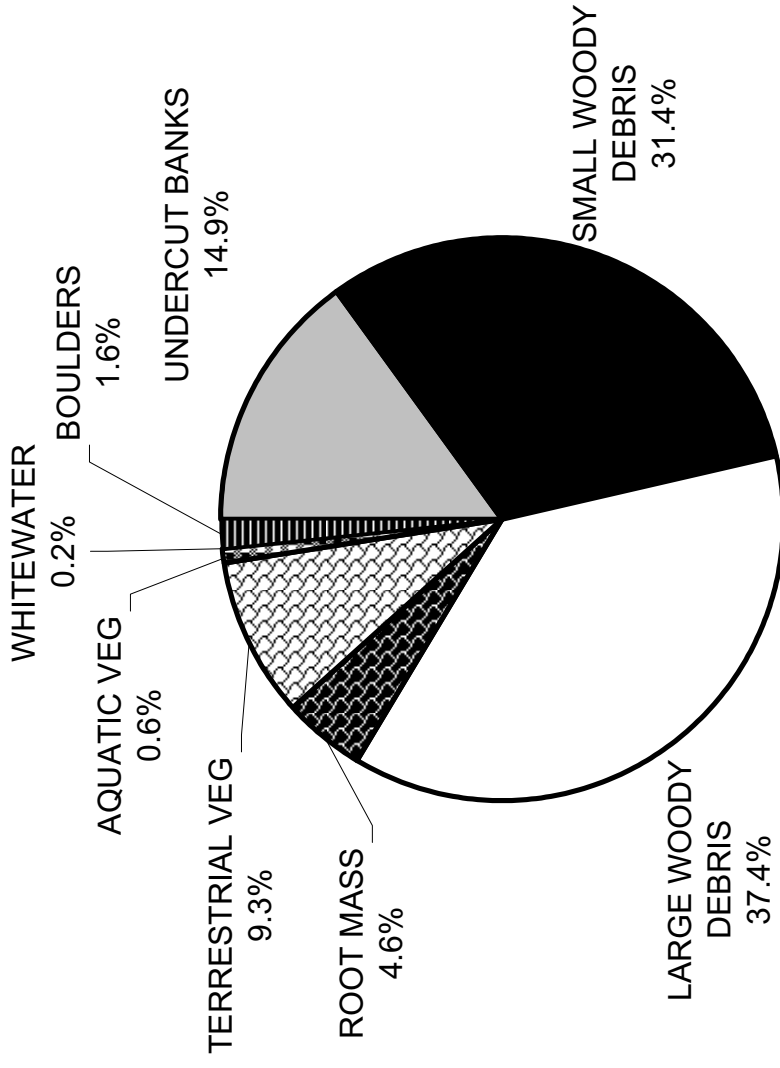
GRAPH 7

Table 5 summarizes mean percent cover by habitat type. Large woody debris was the dominant cover types in Lindsay Creek. Graph 7 describes the pool cover in Lindsay Creek. Large woody debris was the dominant pool cover type followed by small woody debris.

The mean shelter rating for pools was 24. The shelter rating in the flatwater habitats was 7. A pool shelter rating of approximately 100 is desirable. The amount of cover that now exists is being provided primarily by large woody debris in Lindsay Creek. Large woody debris is the dominant cover type in pools followed by small woody debris. Log and root wad cover structures in the pool and flatwater habitats would enhance both summer and winter salmonid habitat. Log cover structure provides rearing fry with protection from predation, rest from water velocity, and also divides territorial units to reduce density related competition.

- 1) Lindsay Creek should be managed as an anadromous, natural production stream.
- 2) Increase woody cover in the pools and flatwater habitat units. Most of the existing cover in the pools is from large woody debris. Adding high quality complexity with woody cover in the pools is desirable.
- 4) The limited water temperature data available suggest that maximum temperatures are within the acceptable range for juvenile salmonids. To establish more complete and meaningful temperature regime information, 24-hour monitoring during the July and August temperature extreme period should be performed for 3 to 5 years.

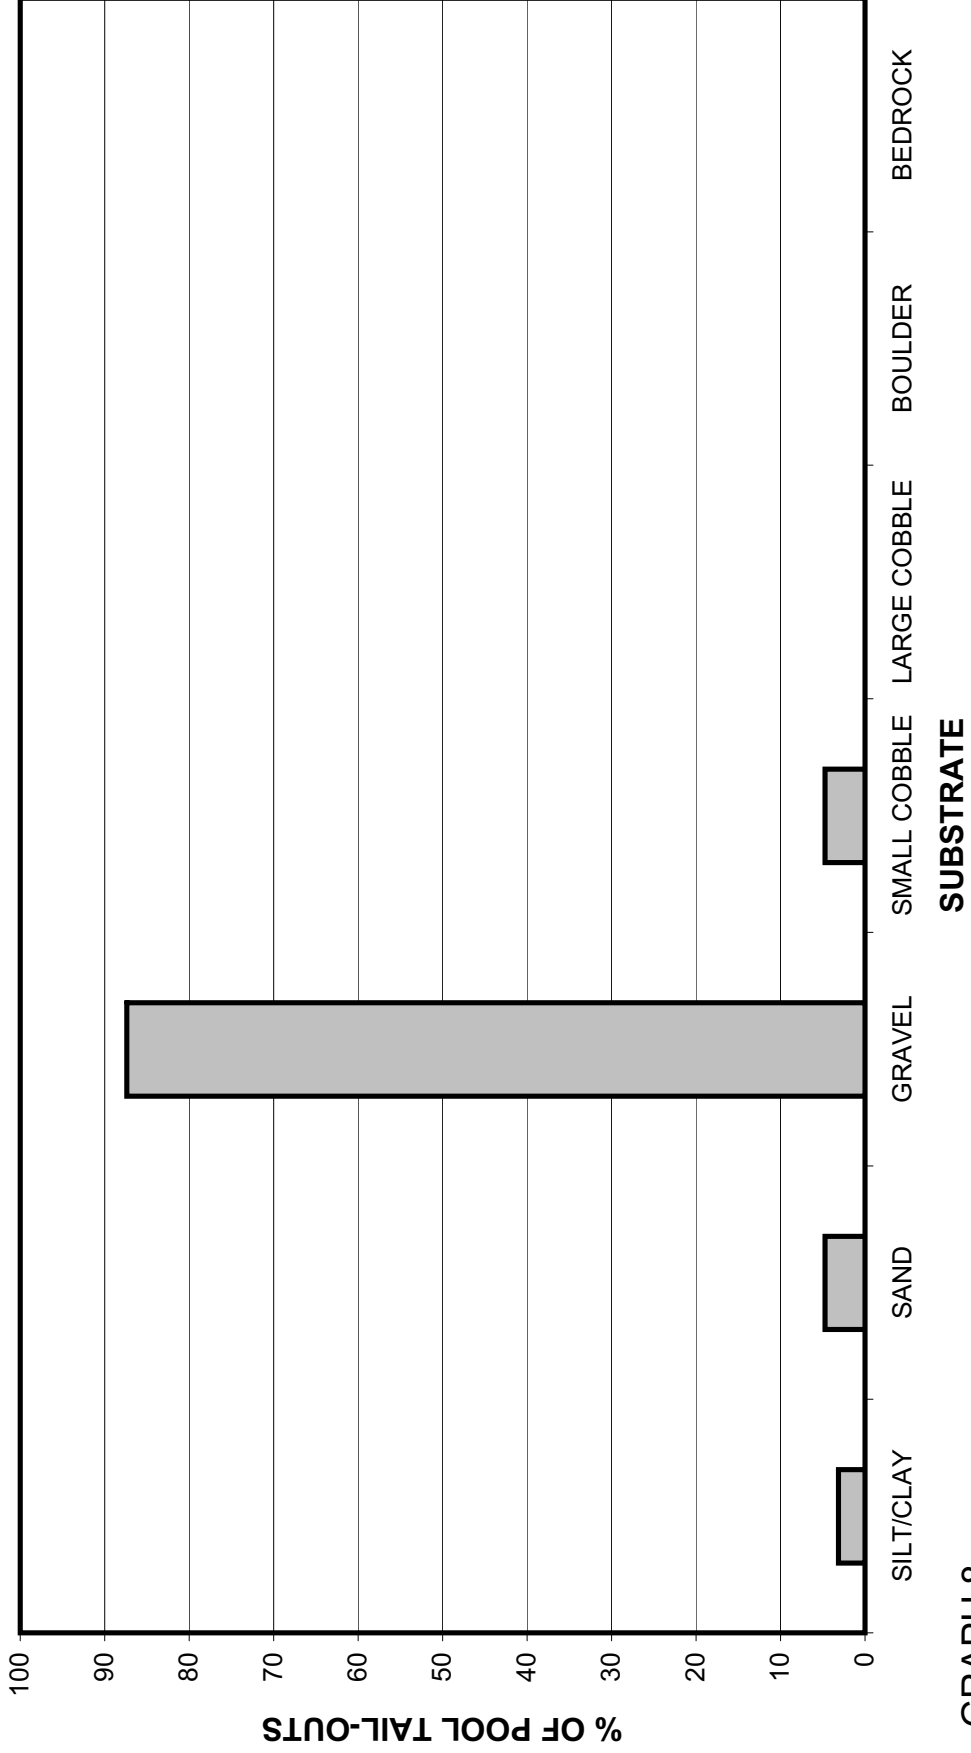
GRAPH 8

Table 6 summarizes the dominant substrate by habitat type. Graph 8 depicts the dominant substrate observed in pool tail-outs. Gravel was observed in 87% of pool tail-outs, sand was observed in 5% of pool tail-outs and small cobble was observed in 5% of pool tail-outs.

One hundred and seventy-five of the 190 pool tail-outs measured had gravel or small cobble as the dominant substrate. This is generally considered good for spawning salmonids.

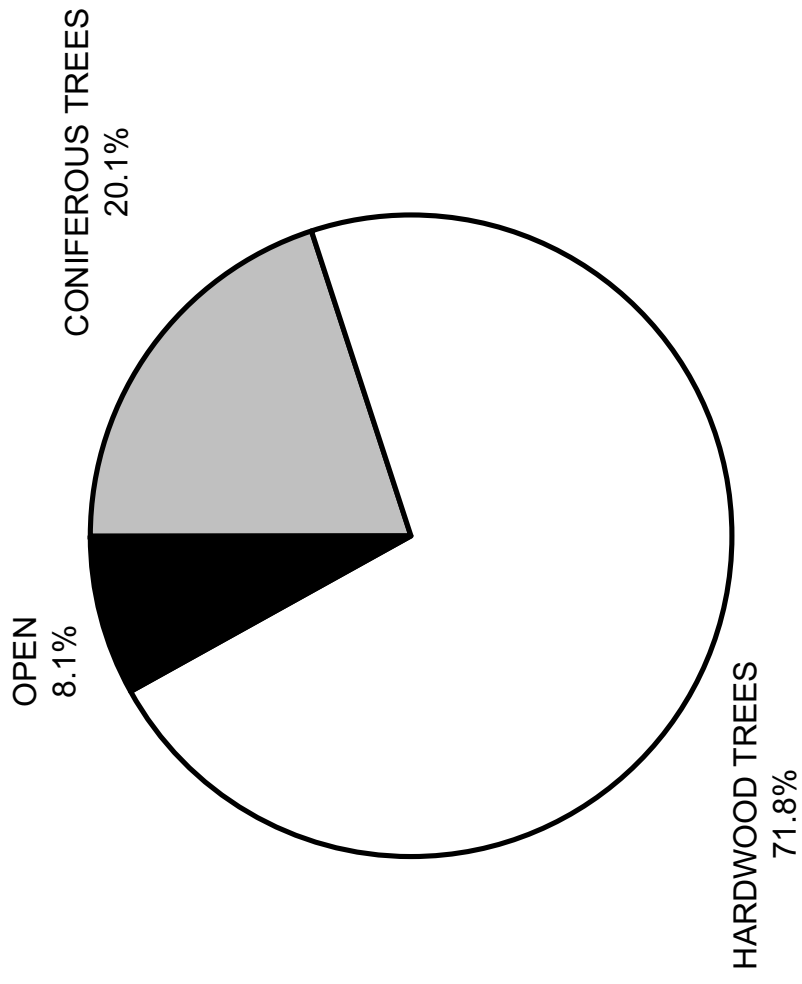
GRAPH 9

The mean percent canopy density for the surveyed length of Lindsay Creek was 92%. Eight percent of the canopy was open. Of the canopy present, the mean percentages of hardwood and coniferous trees were 78% and 22%, respectively. Graph 9 describes the mean percent canopy in Lindsay Creek.

The mean percent canopy density for the stream was 92%. Reach 1 had a canopy density of 76%, reach 2 had a canopy density of 90%, reach 3 had a canopy density of 90%, reach 5 had a canopy density of 90%, reach 6 had a canopy density of 93%, reach 7 had a canopy density of 94%, and reach 8 had a canopy density of 98%. In general, revegetation projects are considered when canopy density is less than 80%. The percentage of right and left bank covered with vegetation was 96% and 96%, respectively.

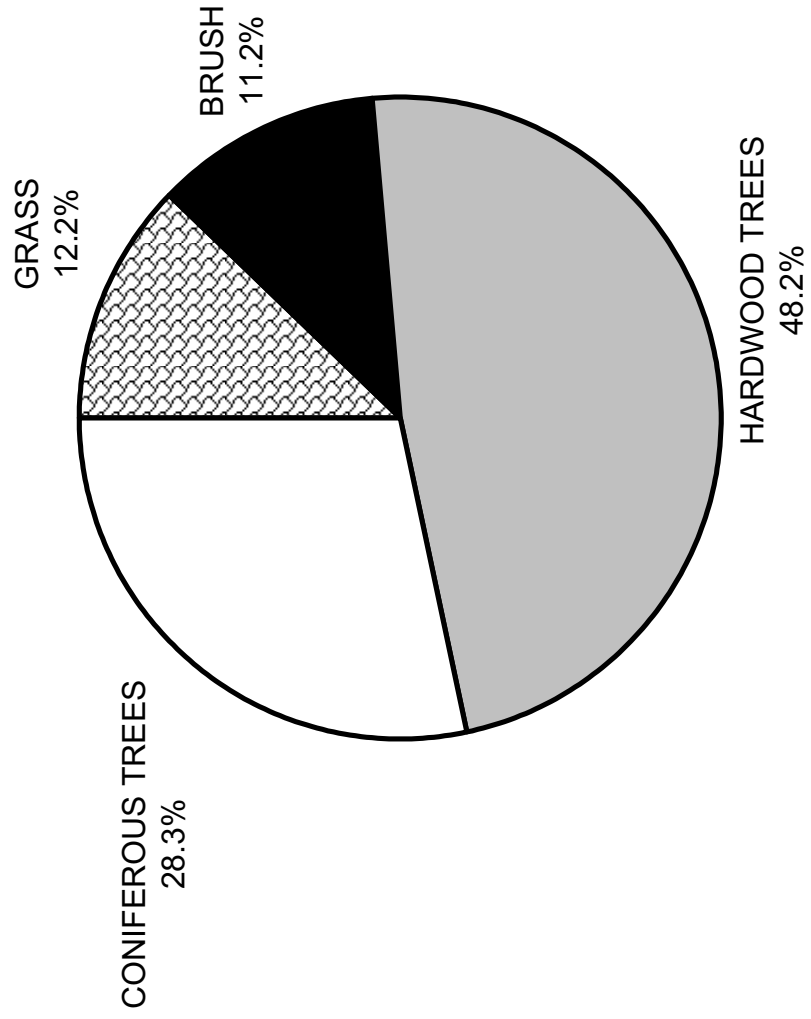
GRAPH 11

For the stream reach surveyed, the mean percent right bank vegetated was 96%. The mean percent left bank vegetated was 96%. The dominant elements composing the structure of the stream banks consisted of 61% sand/silt/clay, 37% cobble/gravel, and 2% boulder (Graph 10). Deciduous trees were the dominant vegetation type observed in 48% of the units surveyed. Additionally, 28% of the units surveyed had coniferous trees as the dominant vegetation type, and 12% had grass as the dominant vegetation (Graph 11).
