**California Department of Fish and Wildlife  
Sonoma County  
Russian River Watershed  
Stream Habitat Assessment Reports**

# **Mill Creek**

*Surveyed 2012*

# STREAM INVENTORY REPORT

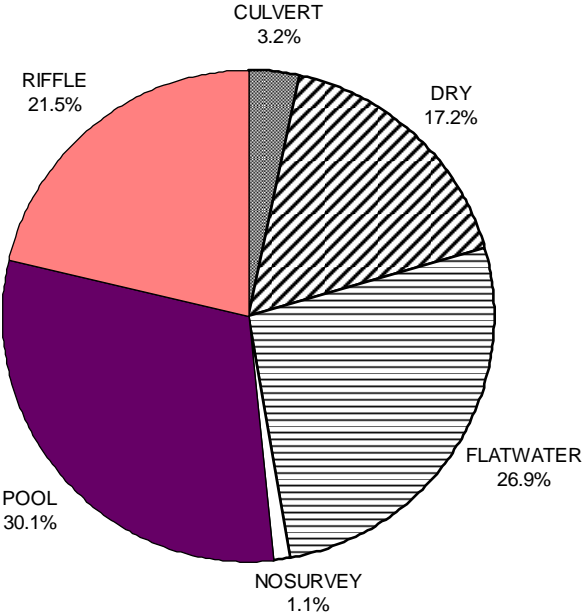
GRAPH 1

Table 1 summarizes the Level II riffle, flatwater, and pool habitat types. Based on frequency of occurrence there were 30% pool units, 27% flatwater units, 22% riffle units, 17% dry units, 3% culvert units and 1% not surveyed units, (Graph 1). Based on total length of Level II habitat types, there were 42% dry units, 22% flatwater units, 16% not surveyed units, 11% pool units, 9% riffle units and 1% culvert units (Graph 2).

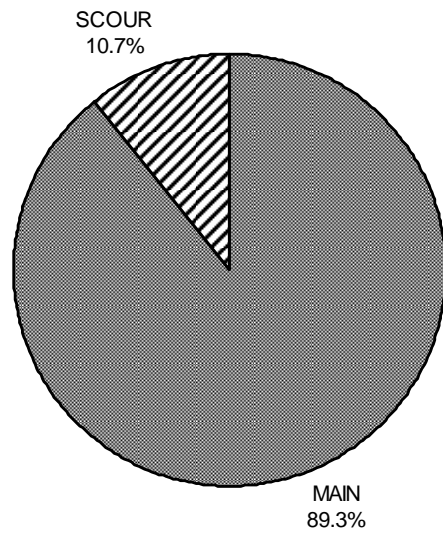
GRAPH 4

A total of 28 pools were identified (Table 3). Main channel pools were the most frequently encountered at 89% (Graph 4), and comprised 92% of the total length of all pools (Table 3).

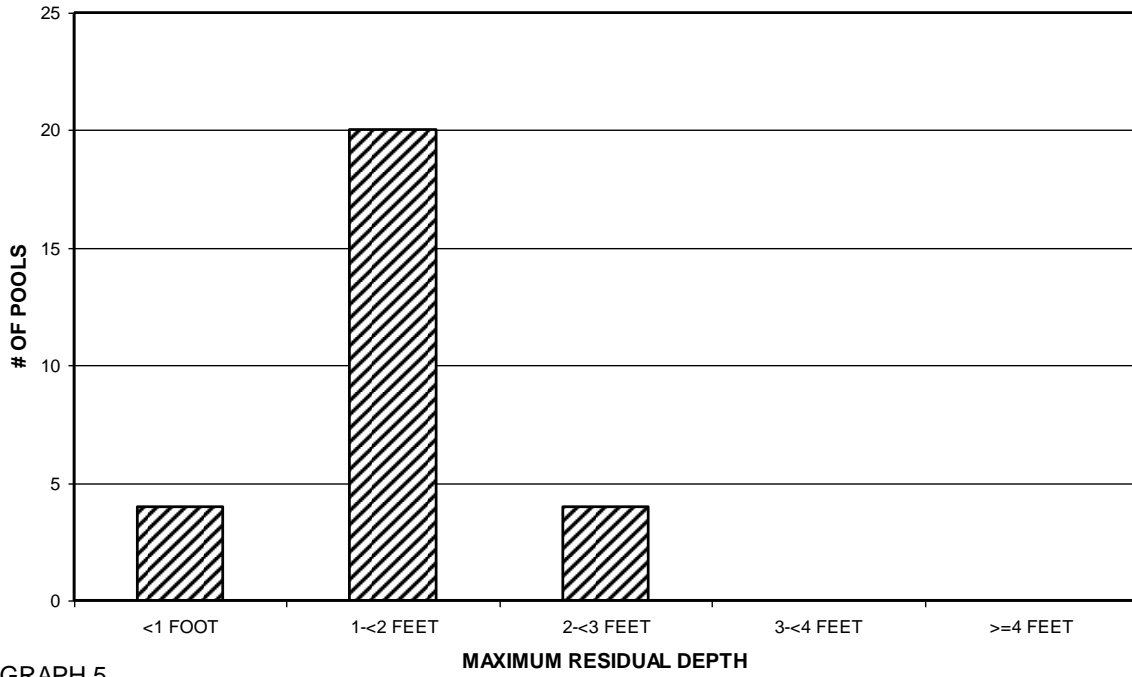
GRAPH 5

Table 4 is a summary of maximum residual pool depths by pool habitat types. Pool quality for salmonids increases with depth. Four of the 28 pools (14%) had a residual depth of two feet or greater (Graph 5).

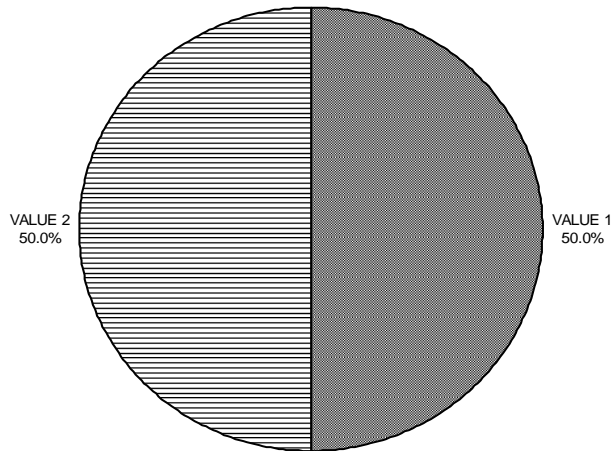
GRAPH 6

The depth of cobble embeddedness was estimated at pool tail-outs. Of the 28 pool tail-outs measured, 14 had a value of 1 (50%) and 14 had a value of 2 (50%) (Graph 6). On this scale, a value of 1 indicates the best spawning conditions and a value of 4 the worst. Additionally, a value of 5 was assigned to tail-outs deemed unsuited for spawning due to inappropriate substrate such as bedrock, log sills, boulders, or other considerations.

Twenty-eight of the 28 pool tail-outs measured had embeddedness ratings of 1 or 2. Zero of the pool tail-outs had embeddedness ratings of 3 or 4. Zero of the pool tail-outs had a rating of 5, which is considered unsuitable for spawning. Cobble embeddedness measured to be 25% or less, a rating of 1, is considered to indicate good quality spawning substrate for salmon and steelhead. Sediment sources in Mill Creek should be mapped and rated according to their potential sediment yields, and control measures should be taken.

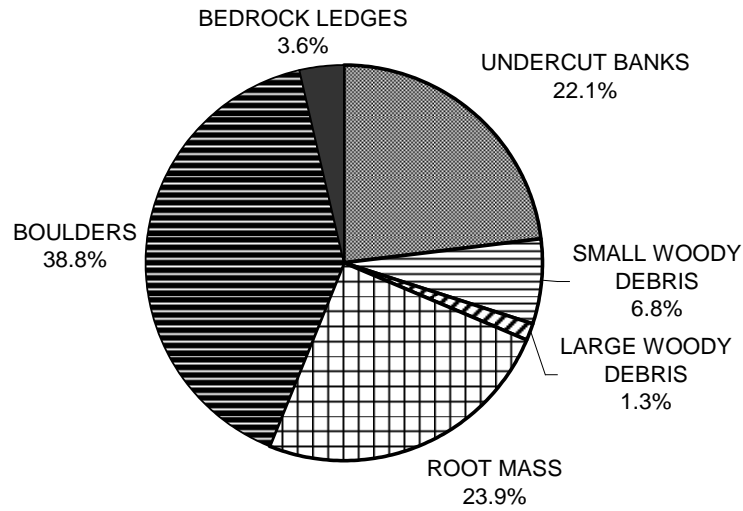
GRAPH 7

Table 5 summarizes mean percent cover by habitat type. Boulders are the dominant cover type in Mill Creek. Graph 7 describes the pool cover in Mill Creek. Boulders are the dominant pool cover type, followed by root masses.

The mean shelter rating for pools is 28. The shelter rating in the flatwater habitats is 8. A pool shelter rating of approximately 100 is desirable. The amount of cover that now exists is being provided primarily by boulders in Mill Creek. Boulders are the dominant cover type in pools, followed by root masses. Log and root wad cover structures in the pool and flatwater habitats would enhance both summer and winter salmonid habitat. Log cover structure provides rearing fry with protection from predation, rest from water velocity, and also divides territorial units to reduce density related competition.

- 1) Increase woody cover in the pools and flatwater habitat units. Most of the existing cover in the pools is from boulders. Adding high quality complexity with woody cover in the pools is desirable.

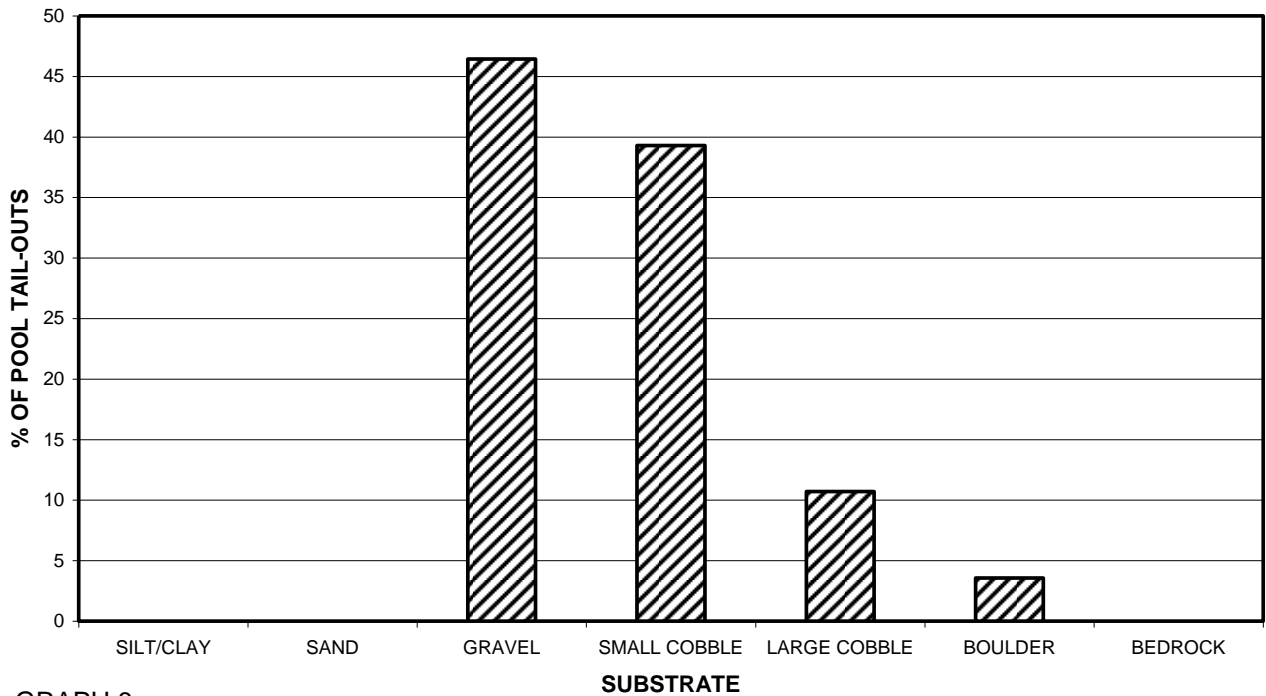
GRAPH 8

Table 6 summarizes the dominant substrate by habitat type. Graph 8 depicts the dominant substrate observed in pool tail-outs. Gravel substrate was observed in 46% of pool tail-outs; and small cobble substrate was observed in 39% of pool tail-outs.

Twenty-four of the 28 pool tail-outs measured had gravel and small cobble as the dominant substrate. This is generally considered good for spawning salmonids.

- 2) Suitable size spawning substrate on Mill Creek is limited to relatively few reaches. Projects should be designed at suitable sites to trap and sort spawning gravel.

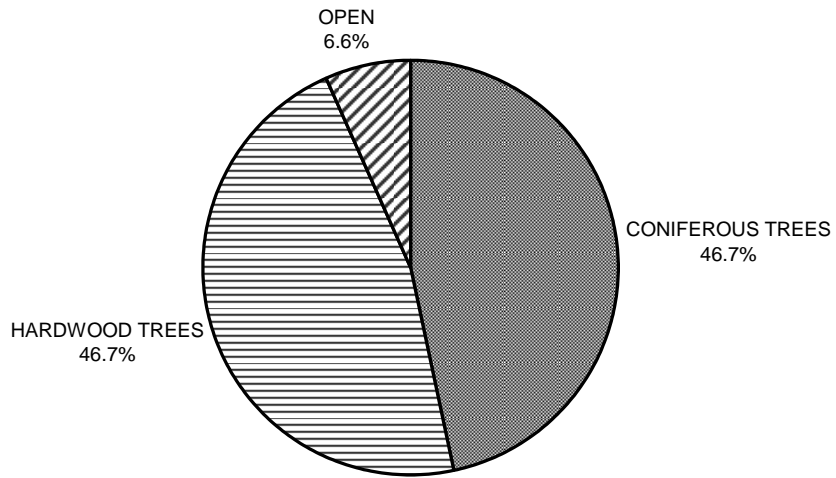
GRAPH 9

The mean percent canopy density for the surveyed length of Mill Creek was 93%. Of the canopy present, the mean percentages of hardwood and coniferous trees were 50% and 50%, respectively. Seven percent of the canopy was open. Graph 9 describes the mean percent canopy in Mill Creek.

The mean percent canopy density for the stream was 93%. Reach 1 had a canopy density of 94.3%, Reach 2 had a canopy density of 93%, Reach 3 had a canopy density of 83%, Reach 4

had a canopy density of N/A, and Reach 5 had a canopy density of 85%. In general, revegetation projects are considered when canopy density is less than 80%.

- 5) Increase the canopy on Mill Creek particularly throughout Reaches 3, 4, and 5, by planting appropriate native vegetation like willow, alder, redwood, and Douglas fir along the stream where shade canopy is not at acceptable levels. The reaches above this survey section should be inventoried and treated as well, since the water flowing

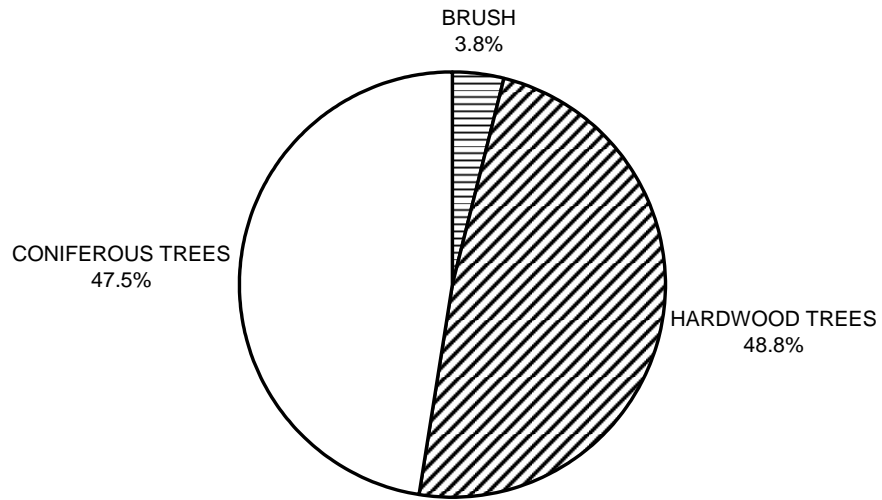
GRAPH 11

For the stream reach surveyed, the mean percent right bank vegetated was 85%. The mean percent left bank vegetated was 82% (Table 7). The dominant elements composing the structure of the stream banks consisted of 45% boulder, 29% cobble/gravel, 16% bedrock and 10% sand/silt/clay (Graph 10). Deciduous trees were the dominant vegetation type observed in 49% of the units surveyed. Additionally, 48% of the units surveyed had coniferous trees as the dominant vegetation type, and 4% had brush as the dominant vegetation type (Graph 11).
