CALIFORNIA DEPARTMENT OF FISH AND GAME  
STREAM INVENTORY REPORT

Russian River

Assessment Completed 2003

Report Completed 2006

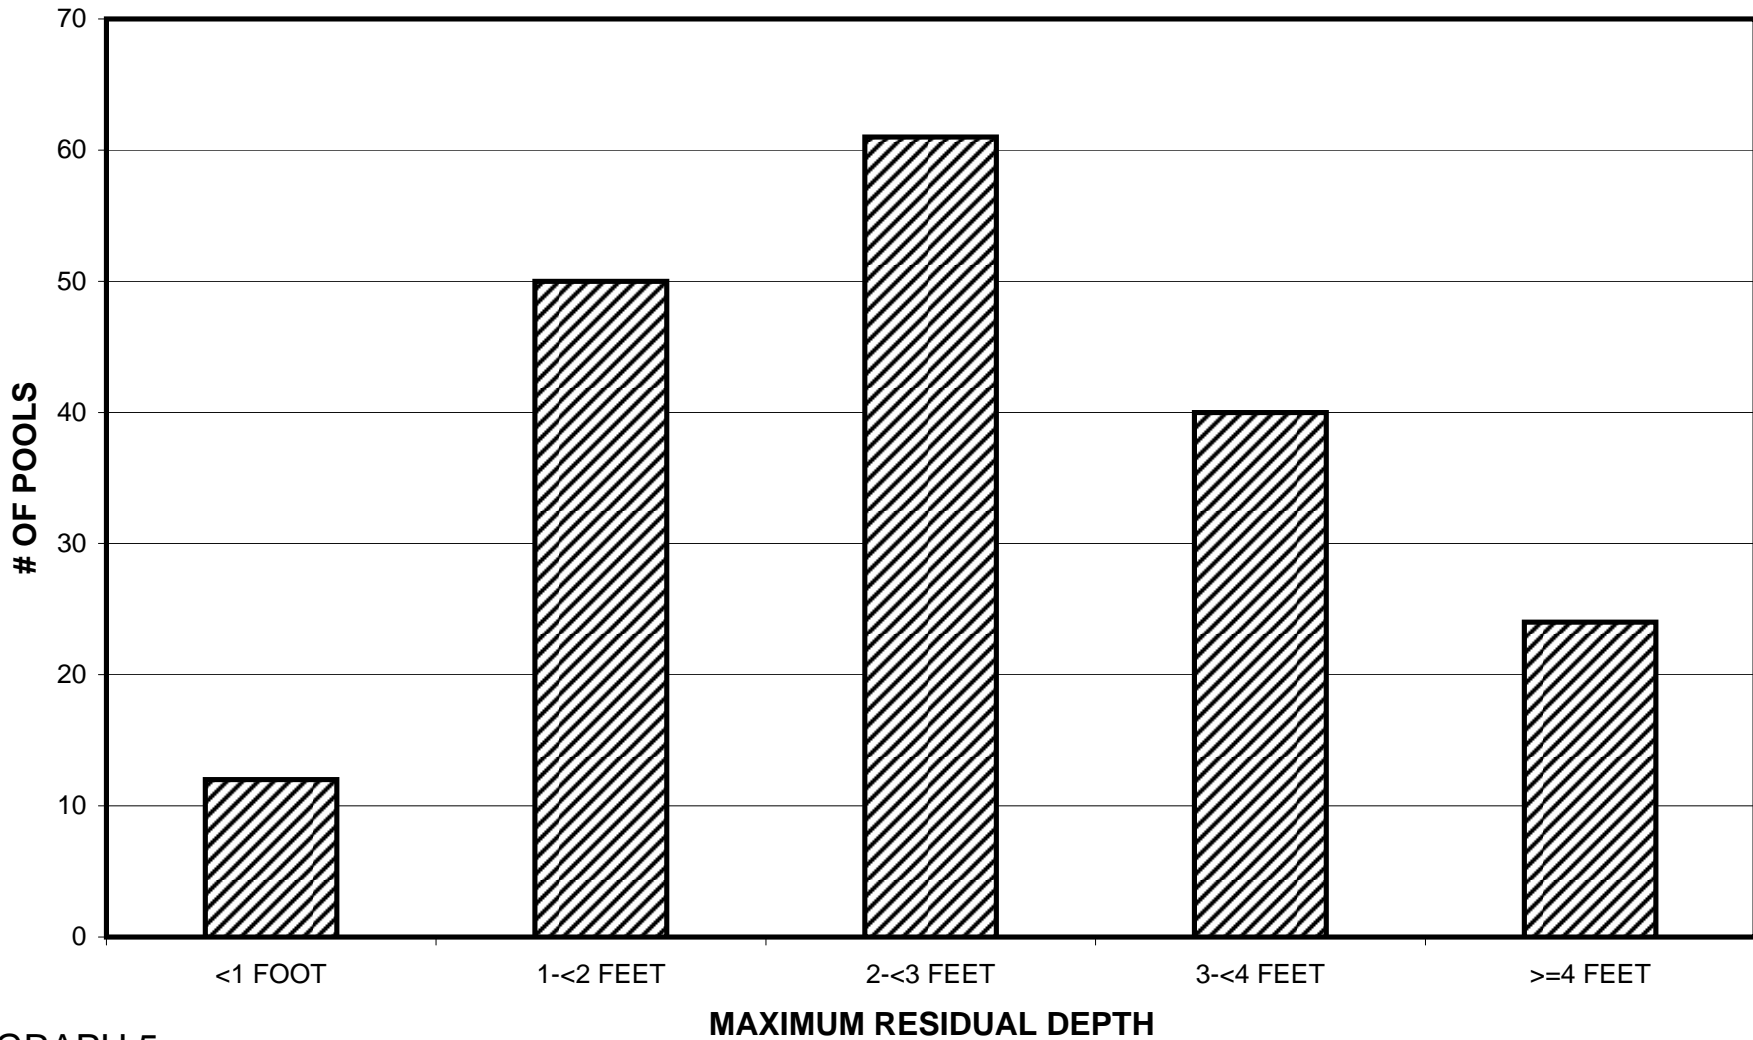
GRAPH 5

Table 4 is a summary of maximum residual pool depths by pool habitat types. Pool quality for salmonids increases with depth. Sixty four of the 187 pools (34% ) had a residual depth of three feet or greater (Graph 5).

Flatwater habitat types comprised 46% of the total length of this survey, riffles 16%, and pools 14%. The pools are relatively shallow, with only 64 of the 187 (32% ) pools having a maximum residual depth greater than 3 feet. In general, pool enhancement projects are considered when primary pools comprise less than 40% of the length of total stream habitat. In third and fourth order streams, a primary pool is defined to have a maximum residual depth of at least three feet, occupy at least half the width of the low flow channel, and be as long as the low flow channel width. Installing structures that will increase or deepen pool habitat is recommended for locations where their installation will not be threatened by high stream energy, or where their installation will not conflict with the modification of the numerous log debris accumulations (LDA's) in the stream.

- 6) Where feasible, design and engineer pool enhancement structures to increase the number of pools. This must be done where the banks are stable or in conjunction with stream bank armor to prevent erosion.

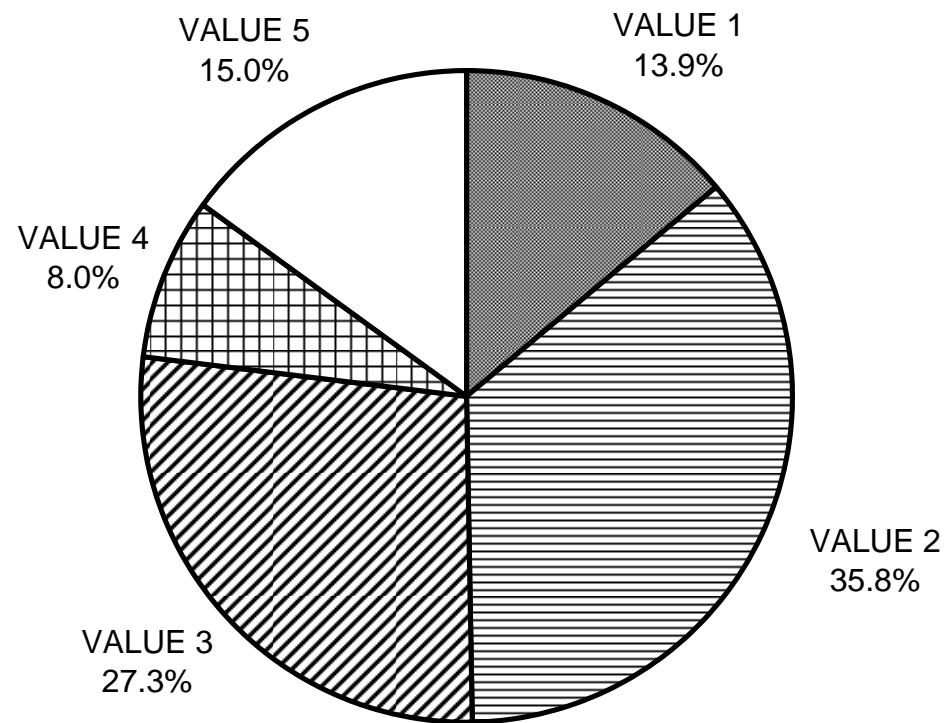
GRAPH 6

The depth of cobble embeddedness was estimated at pool tail-outs. Of the 187 pool tail-outs measured, 26 had a value of 1 (13.9%); 67 had a value of 2 (35.8%); 51 had a value of 3 (27.3%); 15 had a value of 4 (8%); 28 had a value of 5 (15%), (Graph 6). On this scale, a value of 1 indicates the best spawning conditions and a value of 4 the worst. Additionally, a value of 5 was assigned to tail-outs deemed unsuited for spawning due to inappropriate substrate like bedrock, log sills, or boulders.

Ninety-three of the 187 pool tail-outs measured had embeddedness ratings of 1 or 2. Sixty-six of the pool tail-outs had embeddedness ratings of 3 or 4. Twenty-eight of the pool tail-outs had a rating of 5, which is considered unsuitable for spawning. Cobble embeddedness measured to be 25% or less, a rating of 1, is considered to indicate good quality spawning substrate for salmon and steelhead. Sediment sources in the West Branch Russian River should be mapped and rated according to their potential sediment yields, and control measures should be taken.

- 5) Inventory and map sources of stream bank erosion and prioritize them according to present and potential sediment yield. Identified sites should then be treated to reduce the amount of fine sediments entering the stream.

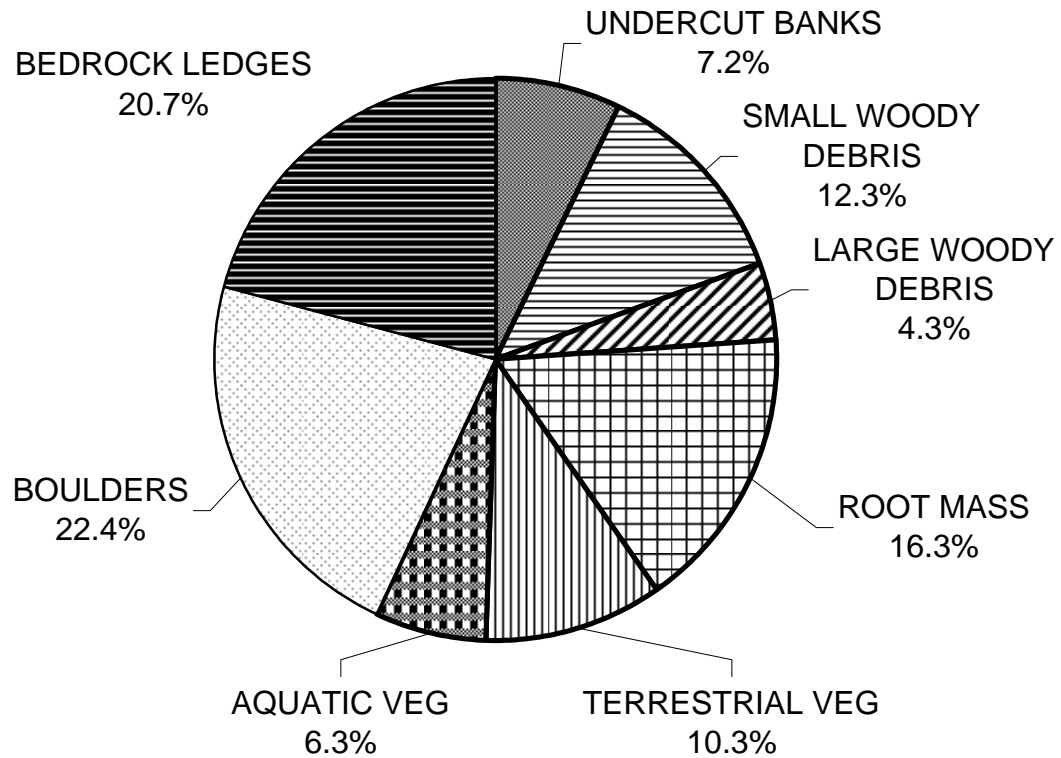
GRAPH 7

Table 5 summarizes mean percent cover by habitat type. Boulders are the dominant cover types in the West Branch Russian River. Graph 7 describes the pool cover in Russian River. Boulders

are the dominant pool cover type followed by bedrock ledges.

The mean shelter rating for pools was 26. The shelter rating in the flatwater habitats was 15. A pool shelter rating of approximately 100 is desirable. The amount of cover that now exists is being provided primarily by boulders in the West Branch Russian River. Boulders are the dominant cover type in pools followed by bedrock ledges . Log and root wad cover structures in the pool and flatwater habitats would enhance both summer and winter salmonid habitat. Log cover structure provides rearing fry with protection from predation, rest from water velocity, and also divides territorial units to reduce density related competition.

- 7) Increase woody cover in the pools and flatwater habitat units. Most of the existing cover is from boulders. Adding high quality complexity with woody cover is desirable.
- 8) The limited water temperature data available suggest that maximum temperatures are above the acceptable range for juvenile salmonids. To establish more complete and meaningful temperature regime information, 24-hour monitoring during the July and August temperature extreme period should be performed for 3 to 5 years.

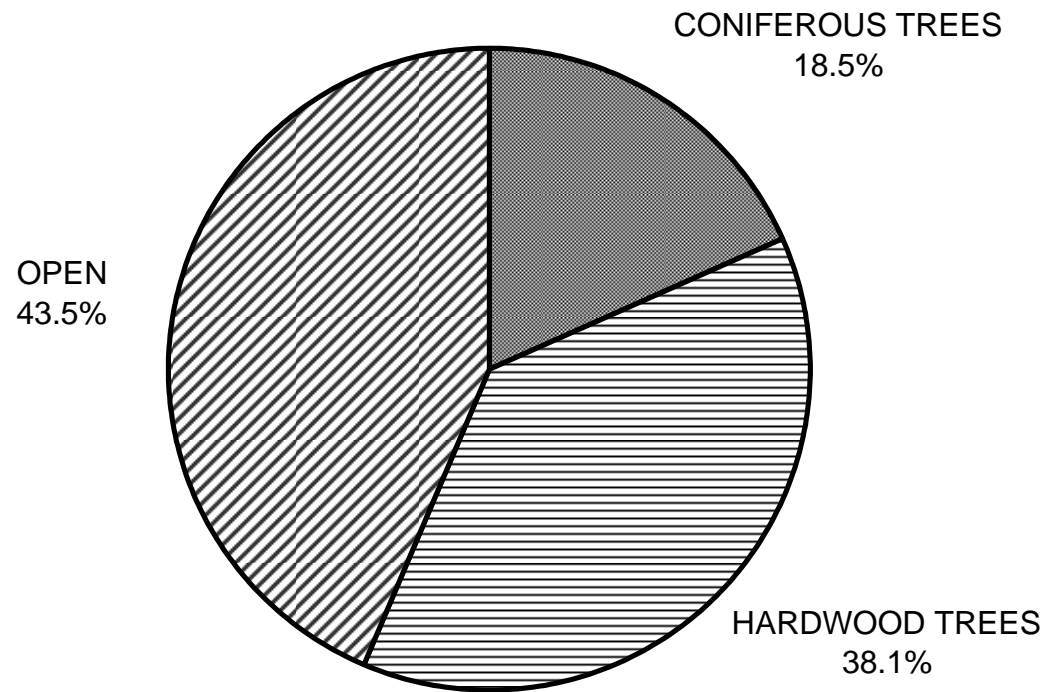
GRAPH 9

The mean percent canopy density for the surveyed length of Russian River was 57%. The mean percentages of hardwood and coniferous trees were 67% and 33%, respectively. Forty-three percent of the canopy was open. Graph 9 describes the mean percent canopy in Russian River.

The mean percent canopy density for the stream was 57%. Reach 1 had a canopy density of

47%, Reach 2 had a canopy density of 42%, Reach 3 had a canopy density of 11%, Reach 4 had a canopy density of 48%, Reach 5 had a canopy density of 42%, Reach 6 had a canopy density of 79%, Reach 7 had a canopy density of 83%, and Reach 8 had a canopy density of 92%. In general, revegetation projects are considered when canopy density is less than 80%.

- 1) Increase the canopy on Russian River by planting appropriate native vegetation like willow, alder, redwood, and Douglas fir along the stream where shade canopy is not at acceptable levels. The reaches above this survey section should be inventoried and treated as well, since the water flowing here is affected from upstream. In many cases, planting will need to be coordinated to follow bank stabilization or upslope erosion control projects.

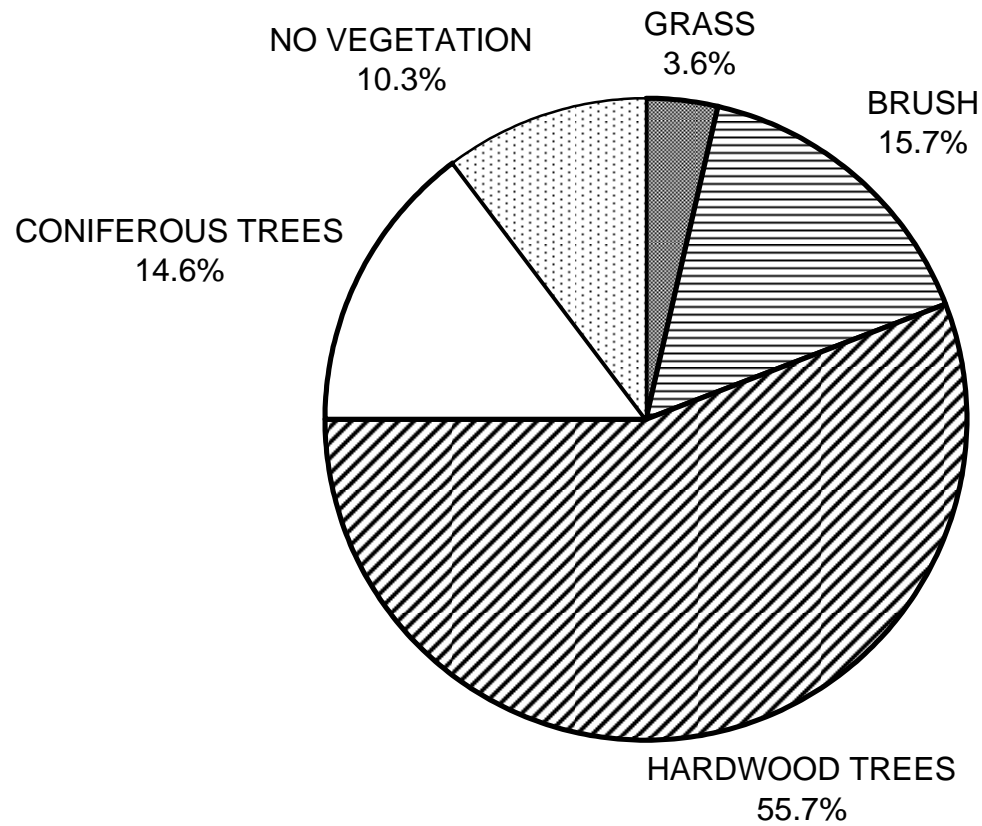
GRAPH 11

For the stream reach surveyed, the mean percent right bank vegetated was 48%. The mean percent left bank vegetated was 48%. The dominant elements composing the structure of the stream banks consisted of 33% bedrock, 2% boulder, 45% cobble/gravel, 20% sand/silt/clay, (Graph 10). Brush was the dominant vegetation type observed in 16% of the units surveyed. Additionally, 56% of the units surveyed had hardwood trees as the dominant vegetation type, and 15% had coniferous trees as the dominant vegetation (Graph 11).

The percentage of right and left bank covered with vegetation was LOW at 48% and 48%, respectively. In areas of stream bank erosion or where bank vegetation is sparse, planting endemic species of coniferous and hardwood trees, in conjunction with bank stabilization, is recommended.
