CALIFORNIA DEPARTMENT OF FISH AND GAME
STREAM INVENTORY REPORT

Bidwell Creek
Report Revised April 14, 2006
Report Completed 2000
Assessment Completed 1996

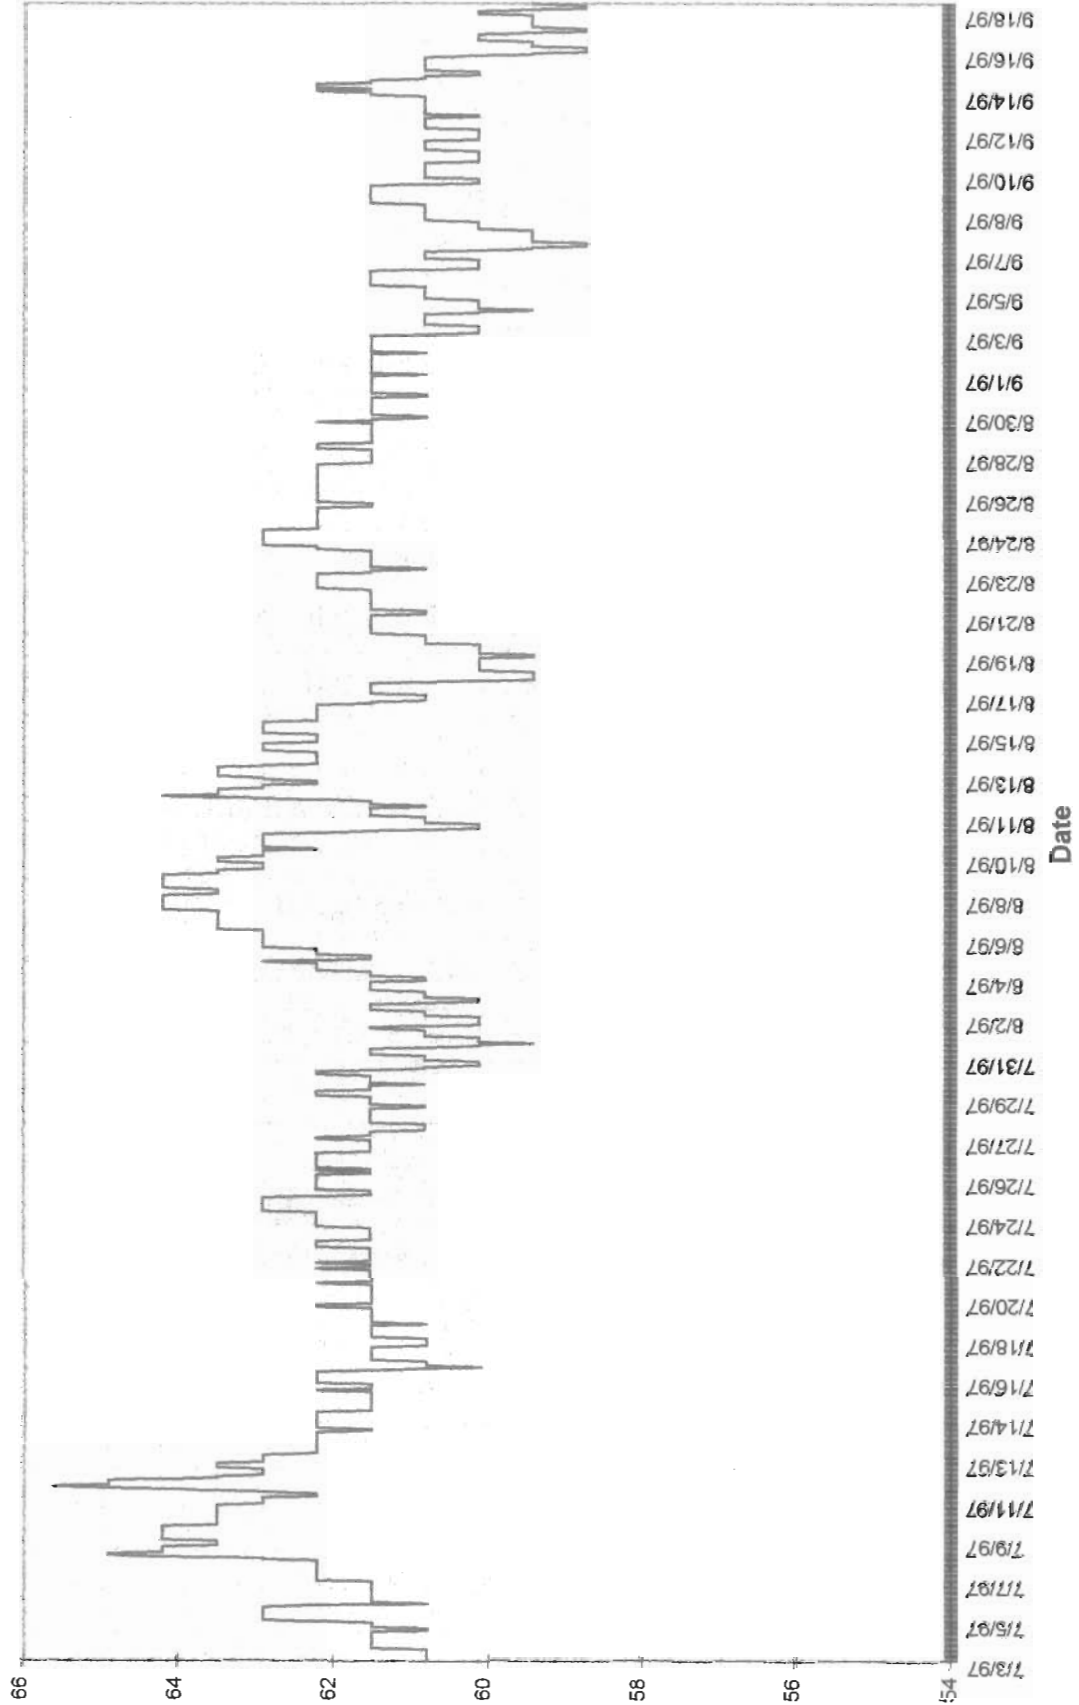
Bidwell Creek Water Temperatures

Summer temperatures measured using a remote temperature recorder placed in a pool ranged from 54° to 61°F. The Temperature Summary graph shows that for much of the summer (July through August) the lower watershed exhibited temperatures above the optimal for salmonids. In July the extreme temperatures were above optimal.

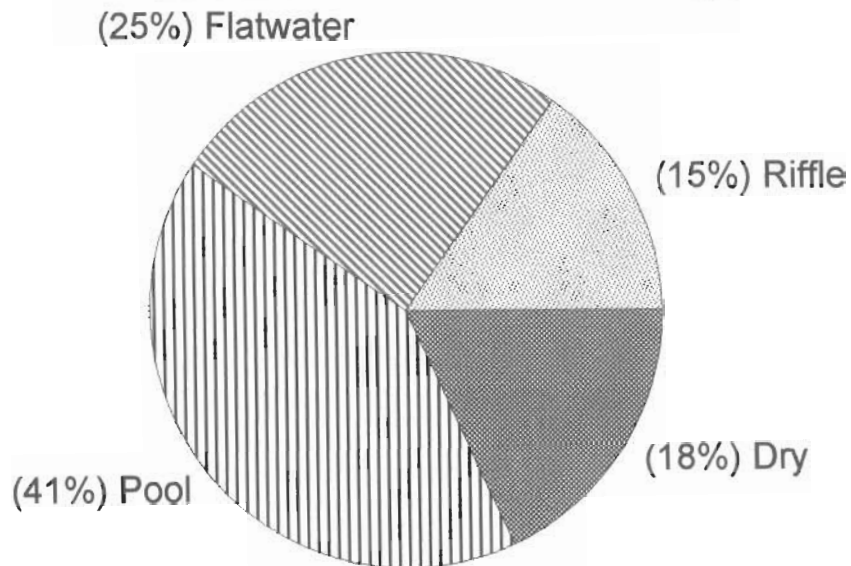
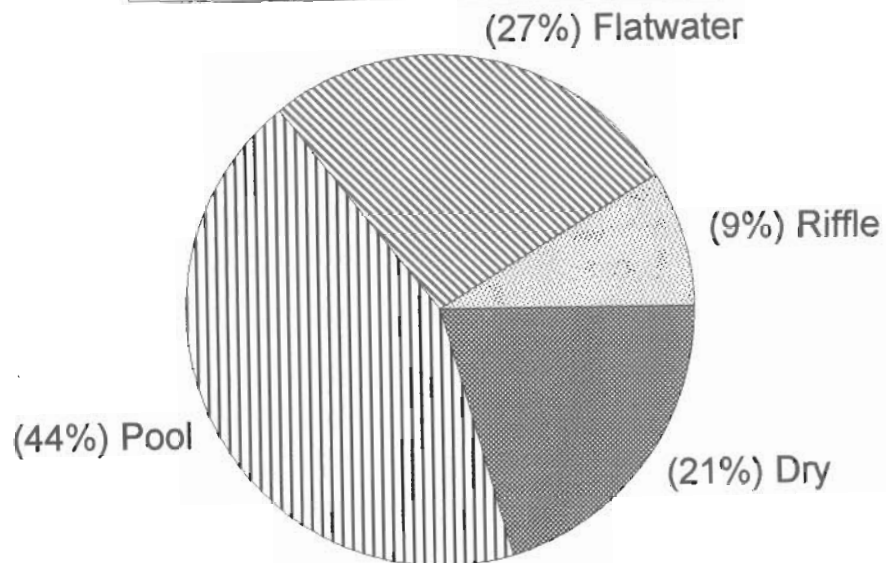
Level II Habitat Types

Table 1 summarizes the Level II riffle, flatwater, and pool habitat types. Based on frequency of **occurrence** there were 41% pool units, 25% flatwater units, 18% dry streambed units, and 15% riffle units. Based on total **length** there were 44% pool units, 27% flatwater units, 21% dry streambed units, and 9% riffle units (Graph 1).

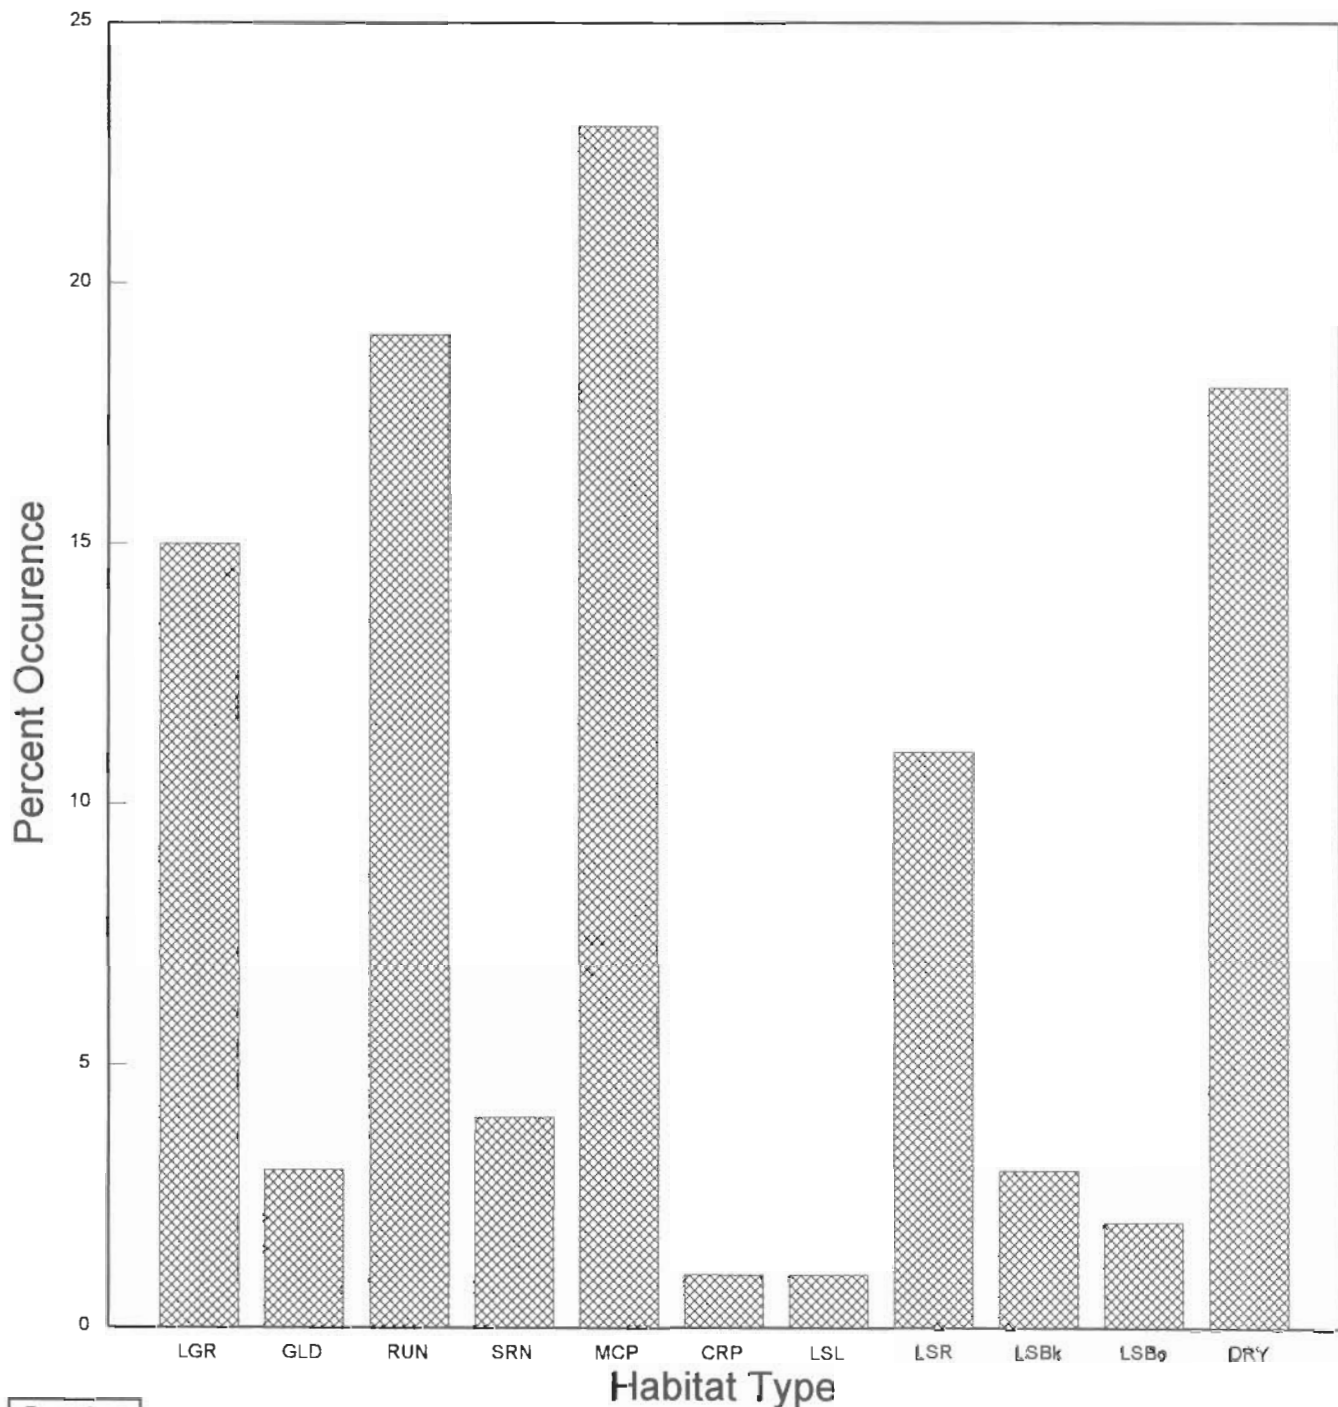
Graph 2

types by percent **occurrence** were mid-channel pools at 23%, runs 19%, dry streambed 18% and low gradient riffles 15% (Graph 2). By percent total **length**, mid-channel pools made up 29%, dry streambed 21%, runs 20%, and root wad scour pools 10%.

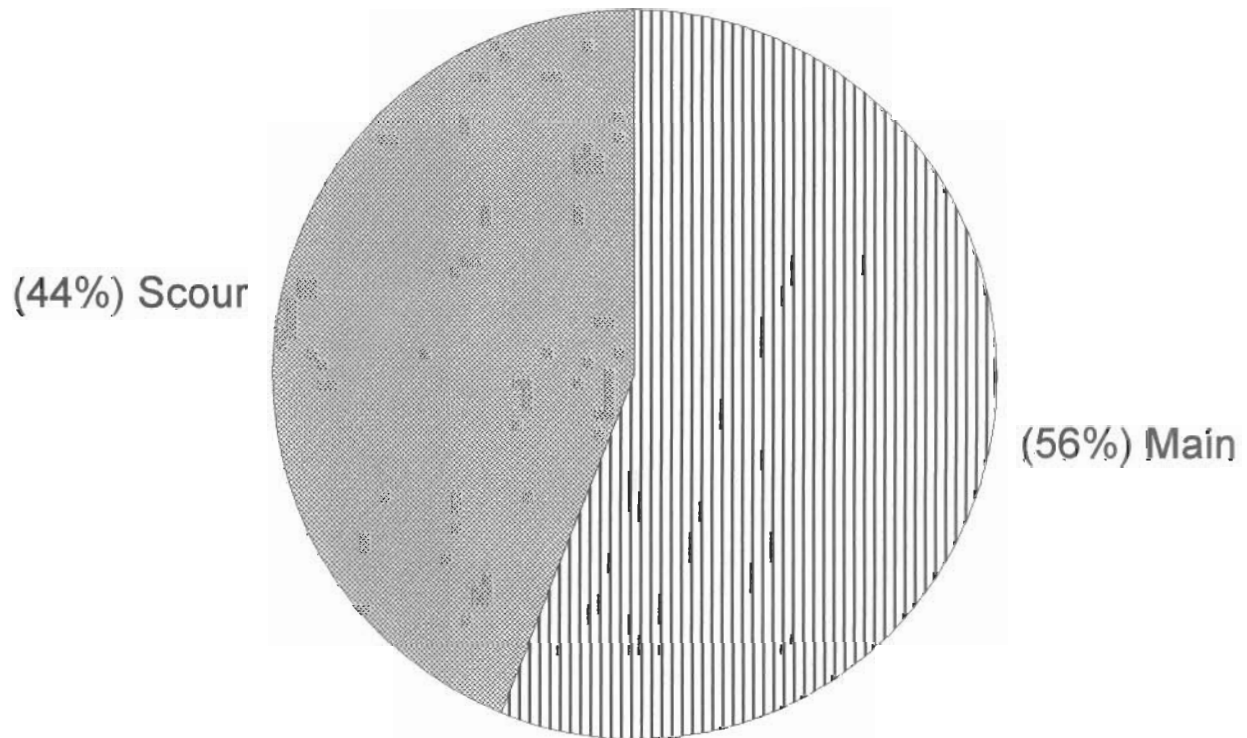
Graph 3

Sixty two pools were identified (Table 3). Main Channel pools were most often encountered at 56%, and comprised 66% of the total length of pools (Graph 3).

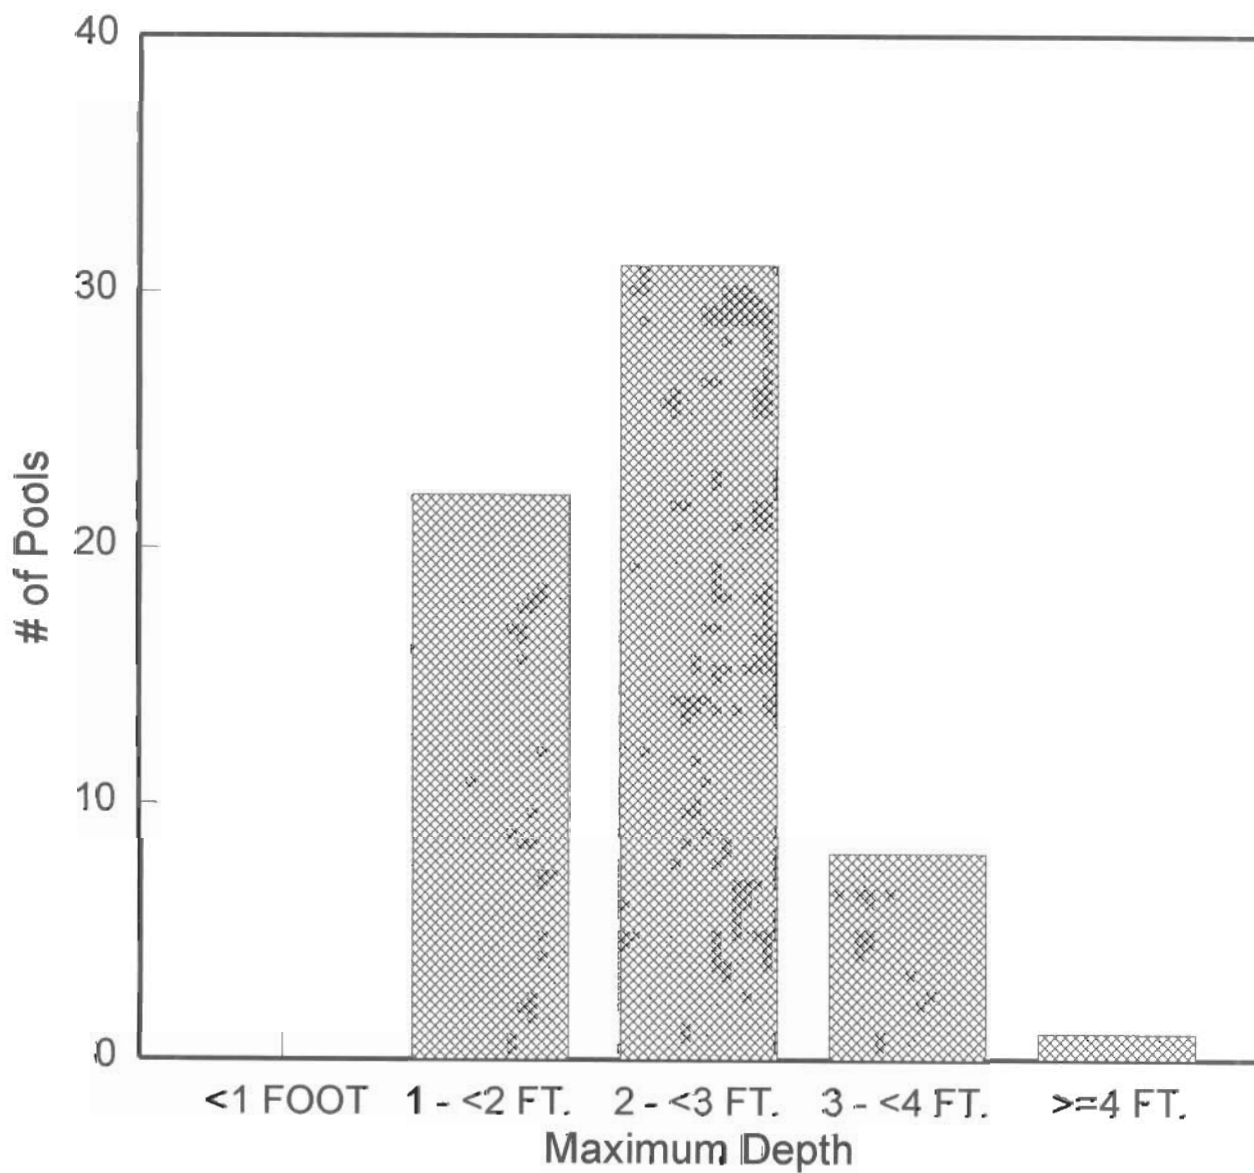
Graph 4

Table 4 is a summary of maximum pool depths by pool habitat types. Pool quality for salmonids increases with depth. Forty of the 62 pools (65%) had a depth of two feet or greater (Graph 4). These deeper pools comprised 33% of the total length of stream habitat.

Pools comprised 44% of the total **length** of this survey. In first and second order streams a primary pool is defined to have a maximum depth of at least two feet, occupy at least half the width of the low flow channel, and be as long as the low flow channel width. In Bidwell Creek, the pools are relatively deep with 65% having a maximum depth of at least 2 feet. These pools comprised 33% of the total length of stream habitat. However, in coastal coho and steelhead streams, it is generally desirable to have primary pools comprise approximately 50% of total habitat length. Therefore, installing structures that will increase pool habitat is recommended for locations where their installation will not jeopardize any unstable stream banks, or subject the structures to high stream energy.

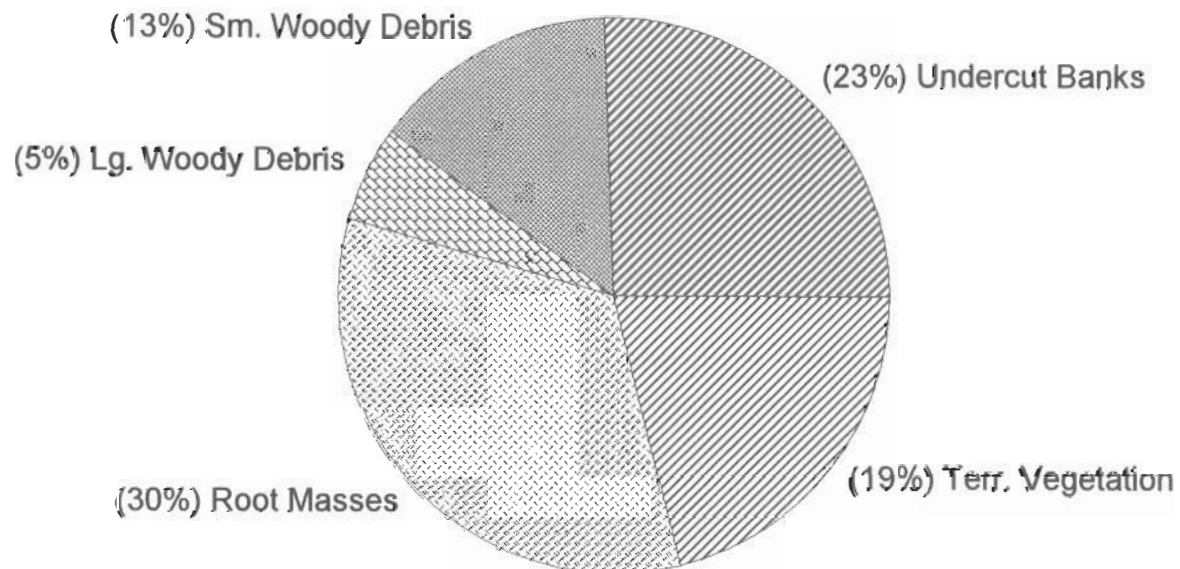
Table 5 summarizes fish shelter by habitat type. By percent area, the dominant pool shelter types were root masses at 30%, undercut banks 23%, terr. vegetation 19%, and small woody debris 13%. Graph 5 describes the pool shelter in Bidwell Creek.

The mean shelter rating for pools was 17. However, a pool shelter rating of approximately 80 is desirable. The relatively small amount of pool shelter that now exists is being provided primarily by root masses (30%), undercut banks (23%), terrestrial vegetation (19%), and small woody debris (13%). Log and root wad cover structures in the pool and flatwater habitats are needed to improve both summer and winter salmonid habitat. Log cover structures provide rearing fry with protection from predation, rest from water velocity, and also divide territorial units to reduce density related competition.

- 3) Where feasible, increase woody cover in the pool and flatwater habitat units along the entire stream. Most of the existing shelter is from vegetation and undercut banks. Adding high quality complexity with larger woody cover is desirable. Combination cover/scour structures constructed with boulders and woody debris would be effective in many flatwater and pool locations in the lower and upper reaches. In some areas the material is at hand.

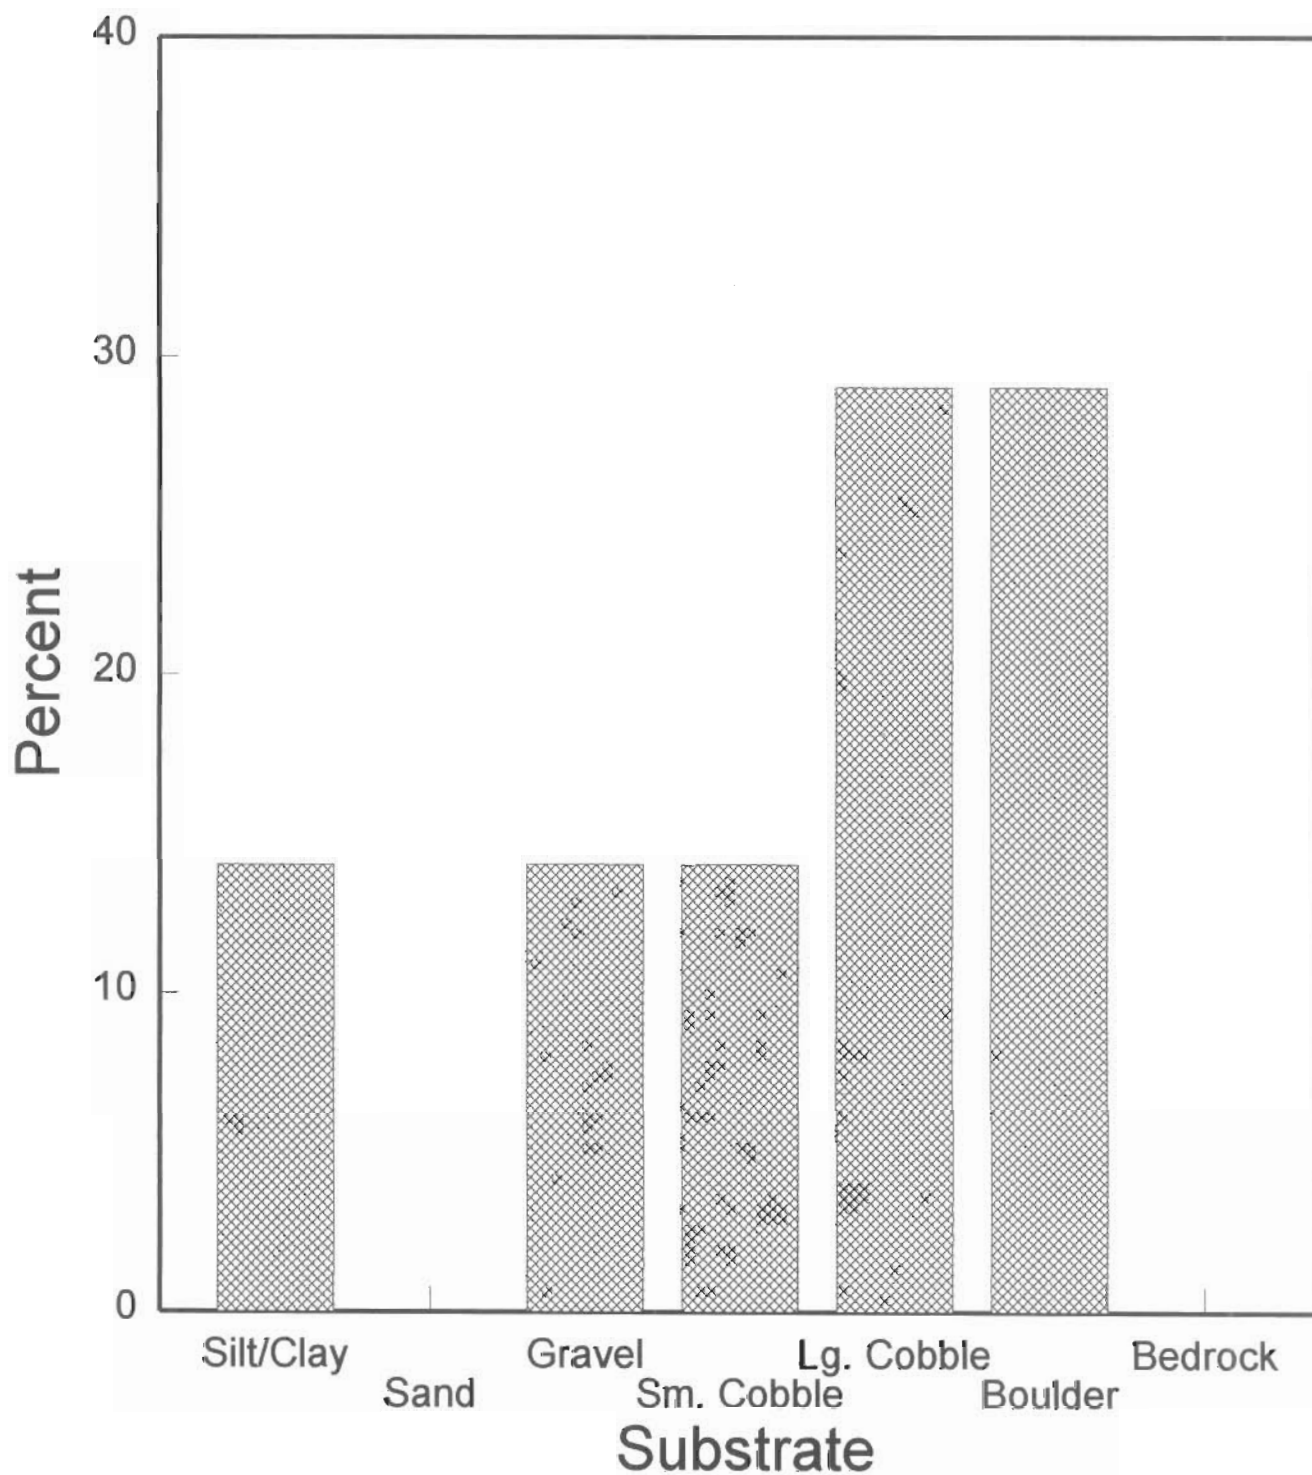
Graph 6

Table 6 summarizes the dominant substrate by habitat type. Gravel was the dominant substrate observed in 1 of the 7 low gradient riffles measured. Small cobble was dominant in one of the low gradient riffles (Graph 6).

Two of the seven low gradient riffles measured (29%) had either gravel or small cobble as the dominant substrate. This is generally considered poor for spawning salmonids.

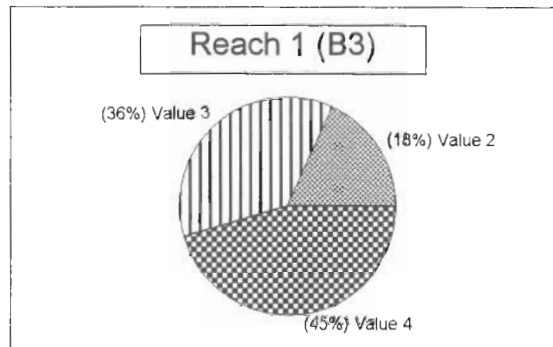
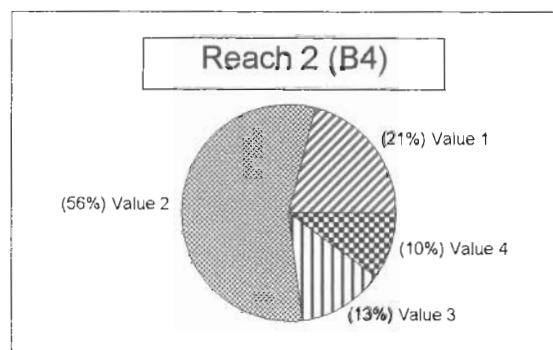
Graph 7

The depth of cobble embeddedness was estimated at pool tail-outs. Of the 61 pool tail-outs measured, 8 had a value of 1 (13%); 26 had a value of 2 (43%); 13 had a value of 3 (21%); and 14 had a value of 4 (23%). On this scale, a value of one is best for fisheries.

Forty four of the pool tail-outs measured had embeddedness ratings of either 3 or 4. Only 13% had a rating of 1. Cobble embeddedness measured to be 25% or less, a rating of 1, is considered best for the needs of salmon and steelhead. In a reach comparison, Reach 2 had the best ratings and Reach 1 had the poorest ratings.

The higher the percent of fine sediment, the lower the probability that eggs will survive to hatch. This is due to the reduced quantity of oxygenated water able to percolate through the gravel, or because of fine sediment capping the redd and preventing fry emergence. In Bidwell Creek Reach 1 and Reach 2 sediment sources should be mapped and rated according to their potential sediment yields, and control measures taken.

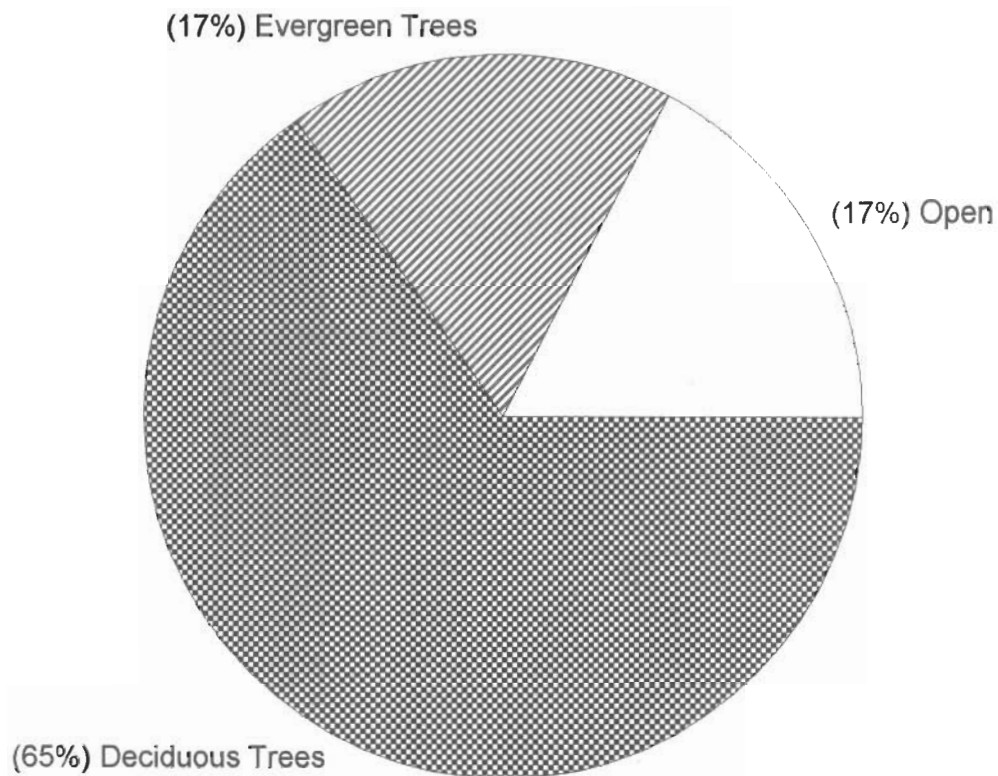
The mean percent canopy density for the stream reach surveyed was 83%. The mean percentages of deciduous and evergreen trees were 79% and 21%, respectively. Graph 8 describes the canopy for the entire survey and graph 9 describes the canopy by reach.

The mean percent canopy for the entire survey was 83%. This is good, since 80 percent is generally considered desirable. However, the riparian buffer is thin or nearly absent in areas with livestock or agriculture. Riparian removal, increased grazing or vineyard development within the riparian corridor could all lead to less stream canopy, channel incision causing bank erosion and higher water temperatures. Large trees required to contribute shade also provide a long term source of large woody debris needed for instream structure and bank stability.

- 1) Increase the canopy on Bidwell Creek by planting willow, alder, redwood, and Douglas fir along the stream where shade canopy is not at acceptable levels (portions of Reach 1). In many cases, planting will need to be coordinated to follow bank stabilization or upslope erosion control projects.

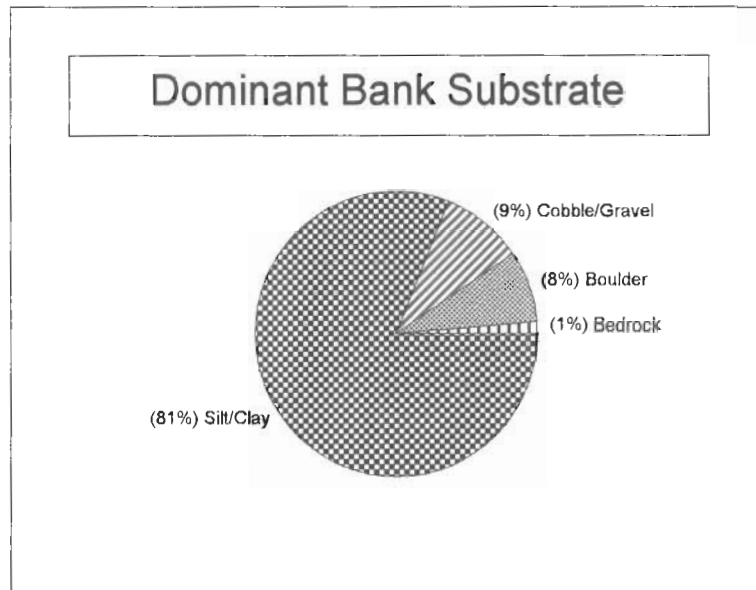
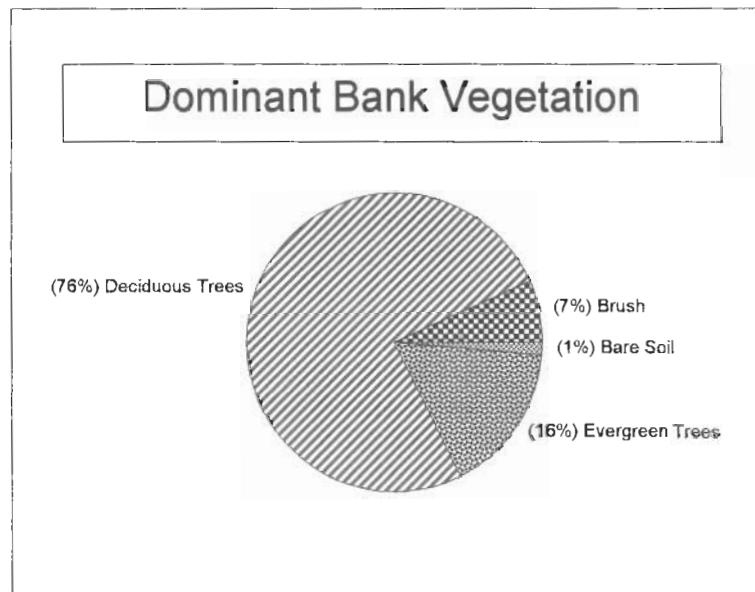
Graph 10

brush, 1% bare soil and 0% grass (Graph 11). The dominant substrate for the stream banks were: 81% silt/clay/sand, 9% cobble/gravel, 8% boulder and 1% bedrock (Graph 10).
