**CALIFORNIA DEPARTMENT OF FISH AND GAME
STREAM INVENTORY REPORT**

Icaria Creek

Report Revised April 14, 2006

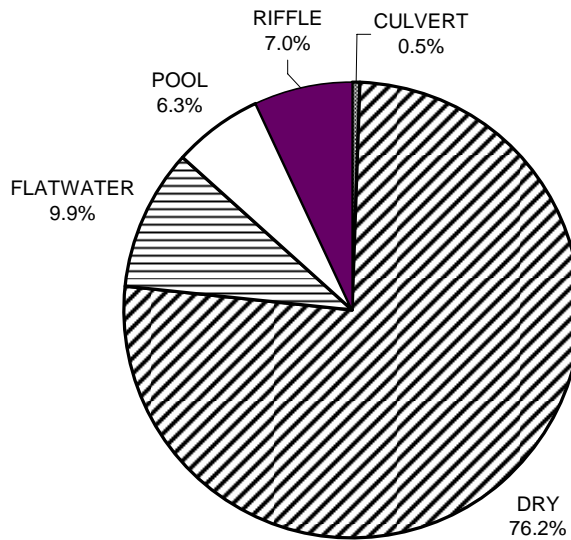
GRAPH 2: Level II habitat types by percent total length

Table 1 summarizes the Level II riffle, flatwater, and pool habitat types. Based on frequency of **occurrence** there were 28% dry units, 22% pool units, 28% flatwater units, 20% riffle units, 2% culvert units, (Graph 1). Based on total **length** of Level II habitat types there were 76% dry units, 6% pool units, 10% flatwater units, 7% riffle units, 1% culvert units, (Graph 2).

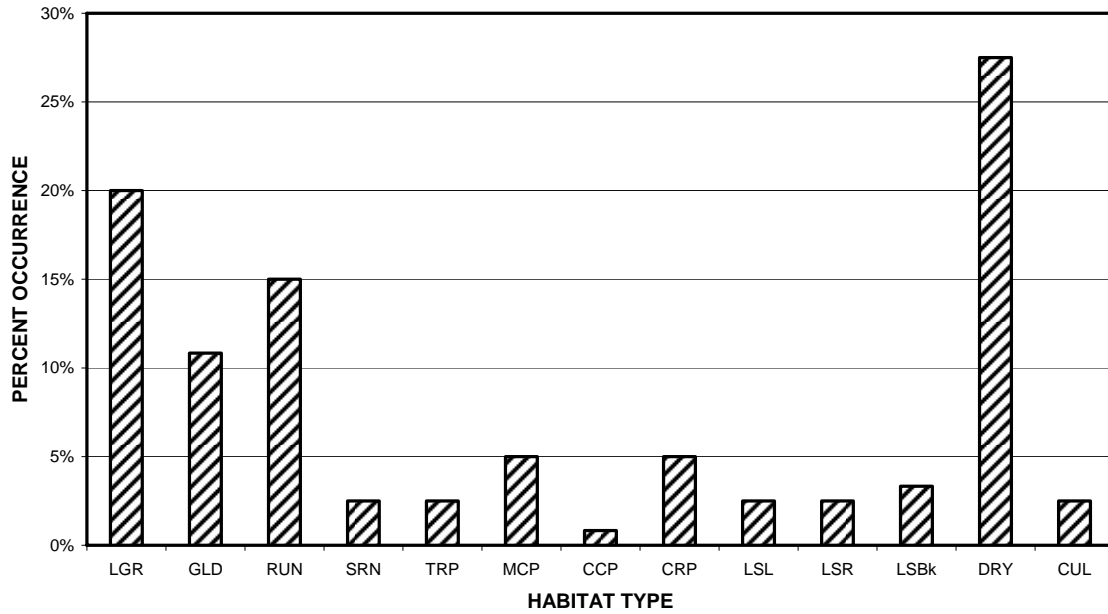
GRAPH 3: Level IV habitat types by percent occurrence

Twelve Level IV habitat types were identified (Table 2). The most frequent habitat types by percent **occurrence** were 28% Dry units, 5% Mid-Channel Pool units, 1% Channel Confluence Pool units, 15% Run units, 11% Glide units, 20% Low Gradient Riffle units, 2% Lateral Scour Pool - Root Wad Enhanced units, 3% Lateral Scour Pool - Bedrock Formed units, 5% Corner Pool units, 2% Trench Pool units, 2% Lateral Scour Pool - Log Enhanced units, 2% Culvert

units, 2% Step Run units, (Graph 3). Based on percent total **length**, 76% Dry units, 1% Mid-Channel Pool units, 6% Run units, 3% Glide units, 7% Low Gradient Riffle units, 1% Lateral Scour Pool - Root Wad Enhanced units, 1% Lateral Scour Pool - Bedrock Formed units, 2% Corner Pool units, 1% Trench Pool units, 1% Lateral Scour Pool - Log Enhanced units, 1% Culvert units, 1% Step Run units.

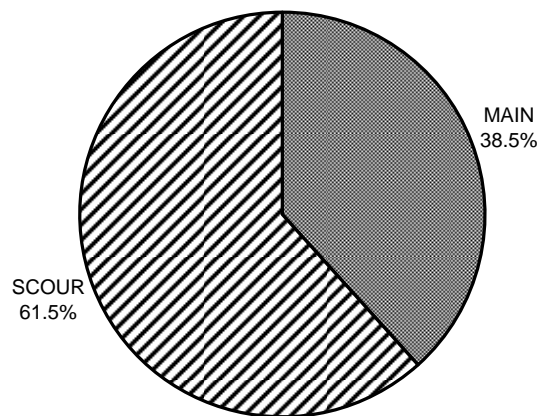
GRAPH 4: Level I pool types by percent occurrence

A total of 26 pools were identified (Table 3). Scour pools were the most frequently encountered, at 62%, and comprised 62% of the total length of all pools (Graph 4).

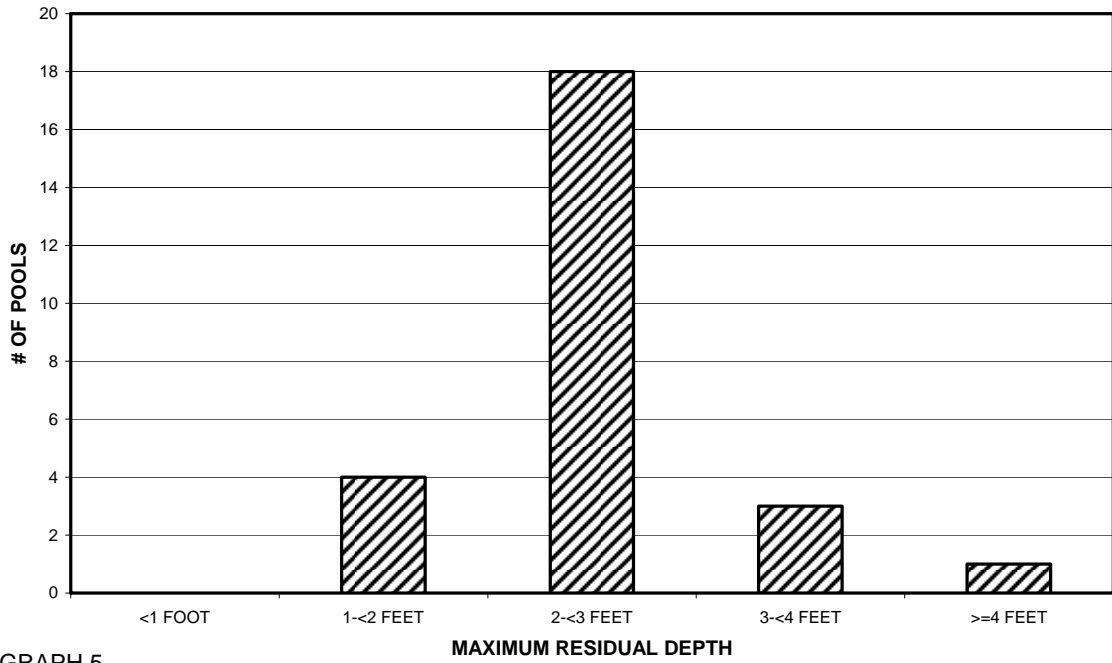
GRAPH 5

Table 4 is a summary of maximum residual pool depths by pool habitat types. Pool quality for salmonids increases with depth. Twenty-two of the 26 pools (85%) had a residual depth of two feet or greater (Graph 5).

Flatwater habitat types comprised 10% of the total length of this survey, riffles 7%, and pools 6%. The pools are relatively deep, with only 22 of the 26 (85%) pools having a maximum residual depth greater than 2 feet. In general, pool enhancement projects are considered when primary pools comprise less than 40% of the length of total stream habitat. In first and second order streams, a primary pool is defined to have a maximum residual depth of at least two feet, occupy at least half the width of the low flow channel, and be as long as the low flow channel width. Installing structures that will increase or deepen pool habitat is recommended for locations where their installation will not be threatened by high stream energy, or where their installation will not conflict with the modification of the numerous log debris accumulations (LDA's) in the stream.

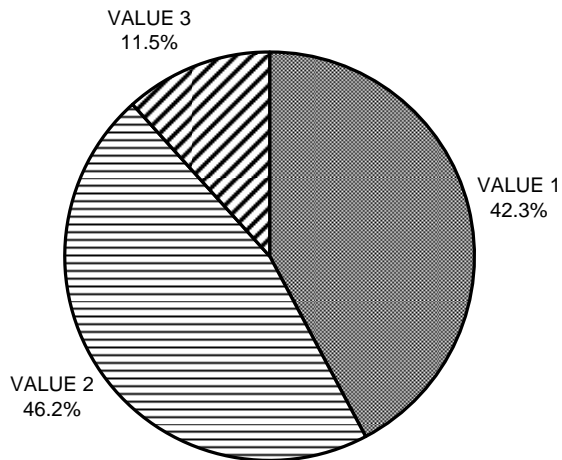
GRAPH 6

The depth of cobble embeddedness was estimated at pool tail-outs. Of the 26 pool tail-outs measured, eleven had a value of 1 (42.3%); twelve had a value of 2 (46.2%); three had a value of 3 (11.5%); (Graph 6). On this scale, a value of 1 indicates the best spawning conditions and a value of 4 the worst. Additionally, a value of 5 was assigned to tail-outs deemed unsuited for spawning due to inappropriate substrate like bedrock, log sills, boulders.

Twenty-three of the 26 pool tail-outs measured had embeddedness ratings of 1 or 2. Three of the pool tail-outs had embeddedness ratings of 3 or 4. None of the pool tail-outs had a rating of 5, which is considered unsuitable for spawning. Cobble embeddedness measured to be 25% or less, a rating of 1, is considered to indicate good quality spawning substrate for salmon and steelhead. Sediment sources in Icaria Creek should be mapped and rated according to their potential sediment yields, and control measures should be taken.

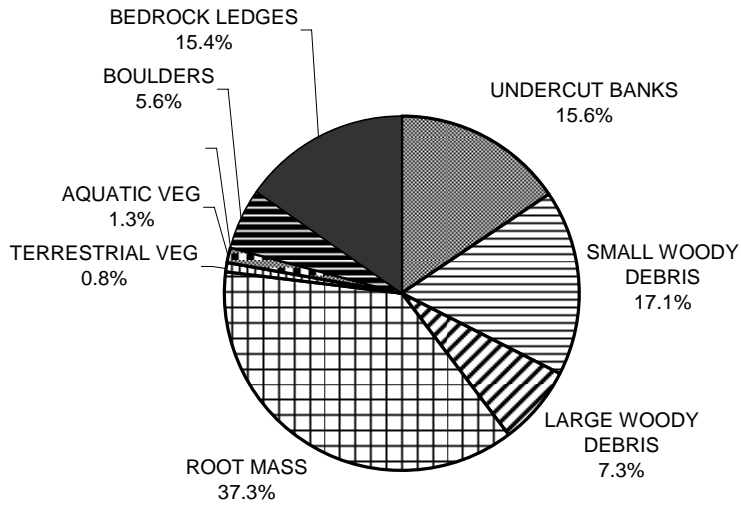
GRAPH 7

Table 5 summarizes mean percent cover by habitat type. Root Mass are the dominant cover types in Icaria Creek. Graph 7 describes the pool cover in Icaria Creek. Root Mass is the dominant pool cover type followed by small woody debris.

The mean shelter rating for pools was 56. The shelter rating in the flatwater habitats was 23. A pool shelter rating of approximately 100 is desirable. The amount of cover that now exists is being provided primarily by Root Mass in Icaria Creek. Root Mass are the dominant cover type in pools followed by small woody debris. Log and root wad cover structures in the pool and flatwater habitats would enhance both summer and winter salmonid habitat. Log cover structure provides rearing fry with protection from predation, rest from water velocity, and also divides territorial units to reduce density related competition.

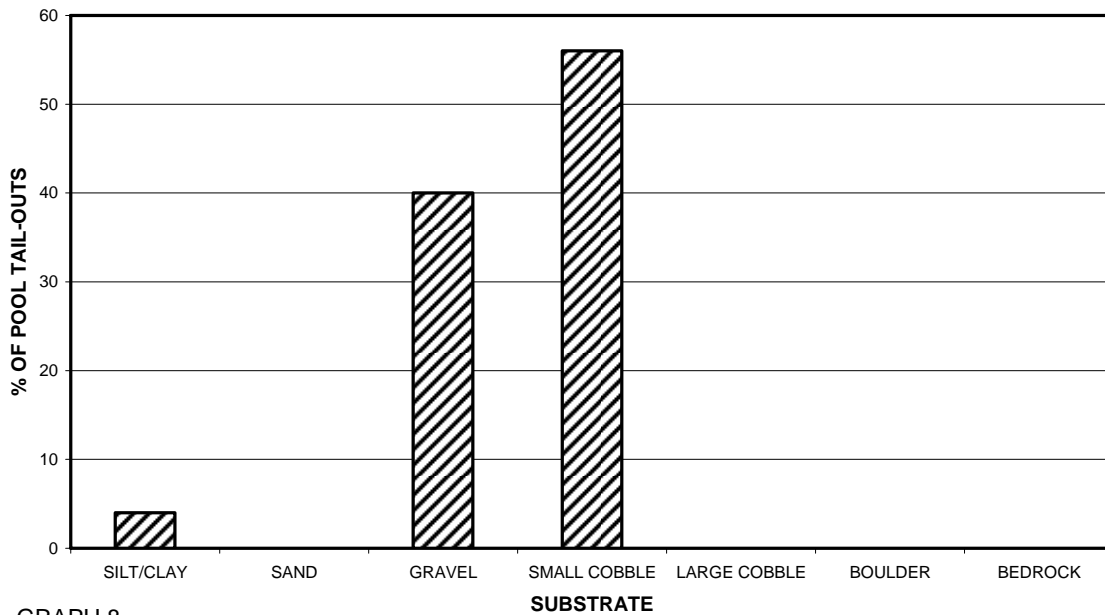
GRAPH 8

Table 6 summarizes the dominant substrate by habitat type. Graph 8 depicts the dominant substrate observed in pool tail-outs. Gravel was observed in 40% of pool tail-outs and small cobble was observed in 56% of pool tail-outs.

Twenty-four of the 25 pool tail-outs measured had gravel or small cobble as the dominant substrate. This is generally considered good for spawning salmonids.

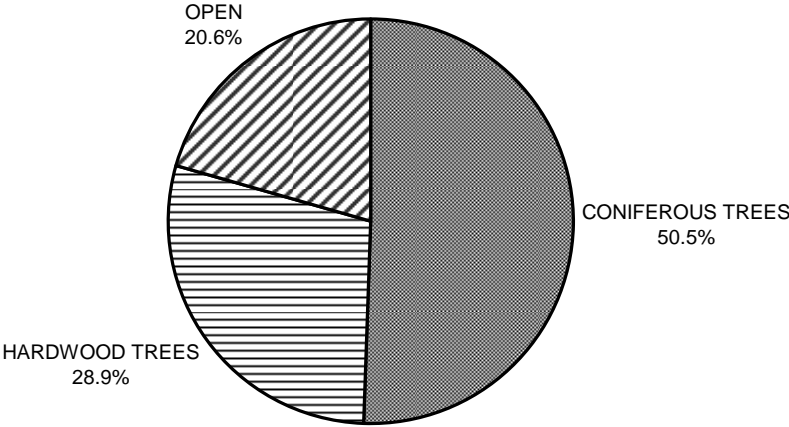
GRAPH 9

The mean percent canopy density for the surveyed length of Icaria Creek was 79%. The mean percentages of hardwood and coniferous trees were 36% and 64%, respectively. Twenty-one percent of the canopy was open. Graph 9 describes the mean percent canopy in Icaria Creek.

The mean percent canopy density for the stream was 79%. Reach 1 had a canopy density of 79.2%, Reach 2 had a canopy density of 82.3%. In general, revegetation projects are considered

when canopy density is less than 80%.

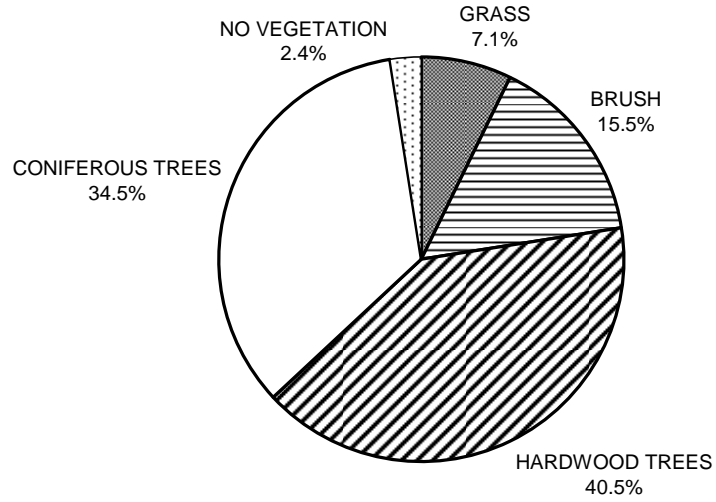
GRAPH 11

For the stream reach surveyed, the mean percent right bank vegetated was 59%. The mean percent left bank vegetated was 51%. The dominant elements composing the structure of the stream banks consisted of 12% bedrock, 11% cobble/gravel, 77% sand/silt/clay, (Graph 10). Brush was the dominant vegetation type observed in 15% of the units surveyed. Additionally, 40% of the units surveyed had hardwood trees as the dominant vegetation type, and 35% had coniferous trees as the dominant vegetation (Graph 11).

The percentage of right and left bank covered with vegetation was moderate at 59% and 51%, respectively. In areas of stream bank erosion or where bank vegetation is sparse, planting endemic species of coniferous and hardwood trees, in conjunction with bank stabilization, is recommended.

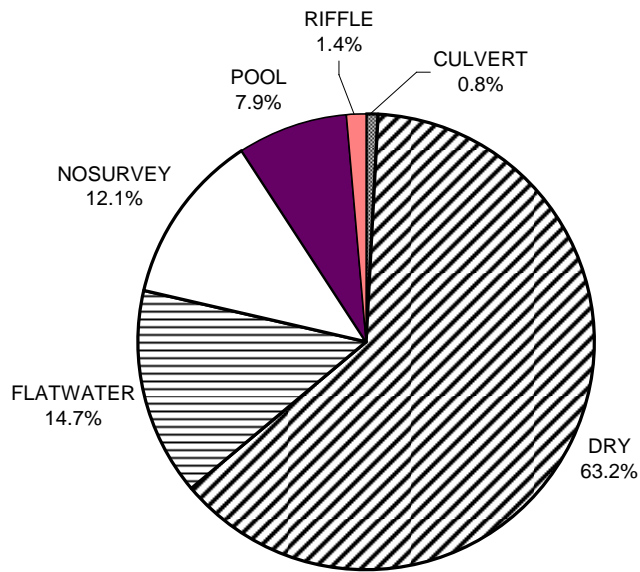
GRAPH 2b: Level II habitat types by percent total length

*Table 1b summarizes the Level II riffle, flatwater, and pool habitat types. Based on frequency of **occurrence** there were 9% riffle units, 34% pool units, 6% culvert units, 30% dry units, 19% flatwater units, 2% no survey units, (Graph 1b). Based on total **length** of Level II habitat types there were 1% riffle units, 8% pool units, 1% culvert units, 63% dry units, 15% flatwater units, 12% no survey units, (Graph 2b).*

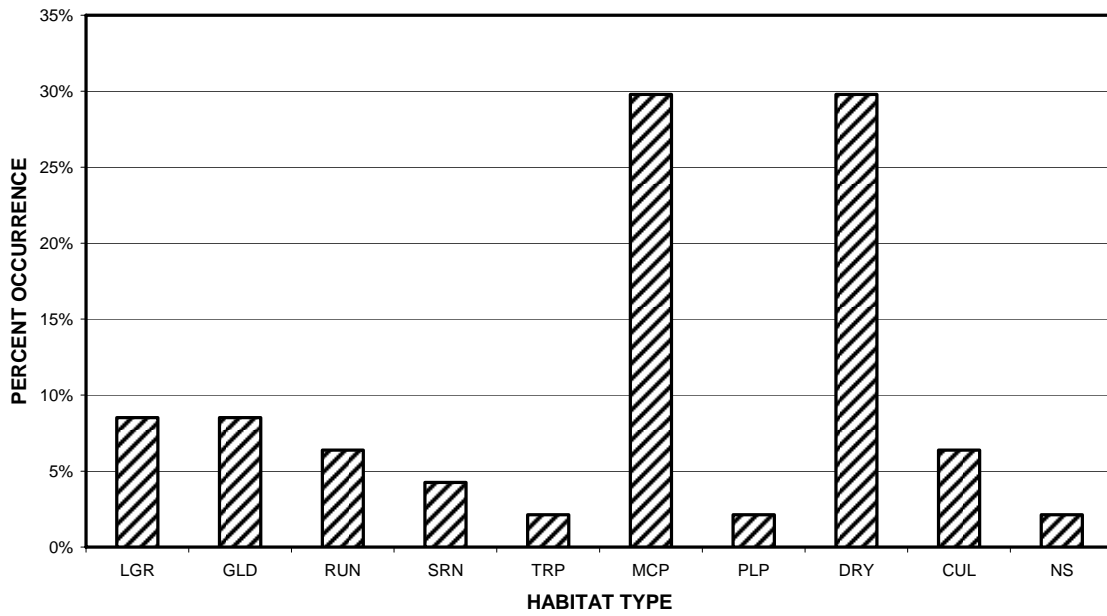
GRAPH 3b: Level IV habitat types by percent occurrence

*Eight Level IV habitat types were identified (Table 2b). The most frequent habitat types by percent **occurrence** were 9% Low Gradient Riffle units, 2% Plunge Pool units, 6% Culvert units, 30% Mid-Channel Pool units, 30% Dry units, 6% Run units, 2% Trench Pool units, 9% Glide units, 4% Step Run units, 2% Not Surveyed units, (Graph 3b). Based on percent total **length**, 1% Low Gradient Riffle units, 1% Culvert units, 7% Mid-Channel Pool units, 63% Dry units, 3% Run units, 1% Trench Pool units, 3% Glide units, 9% Step Run units, 12% Not Surveyed units.*

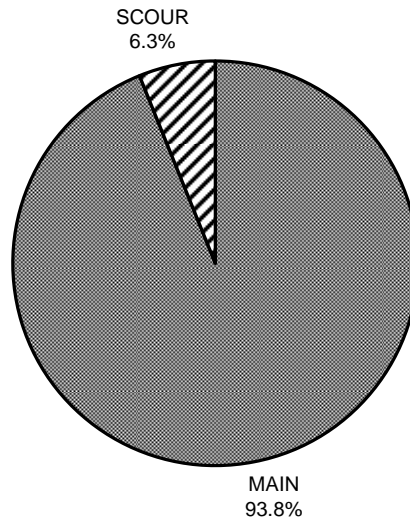
GRAPH 4b: Level I pool types by percent occurrence

A total of 16 pools were identified (Table 3b). Main Channel pools were the most frequently encountered, at 94%, and comprised 95% of the total length of all pools (Graph 4b).

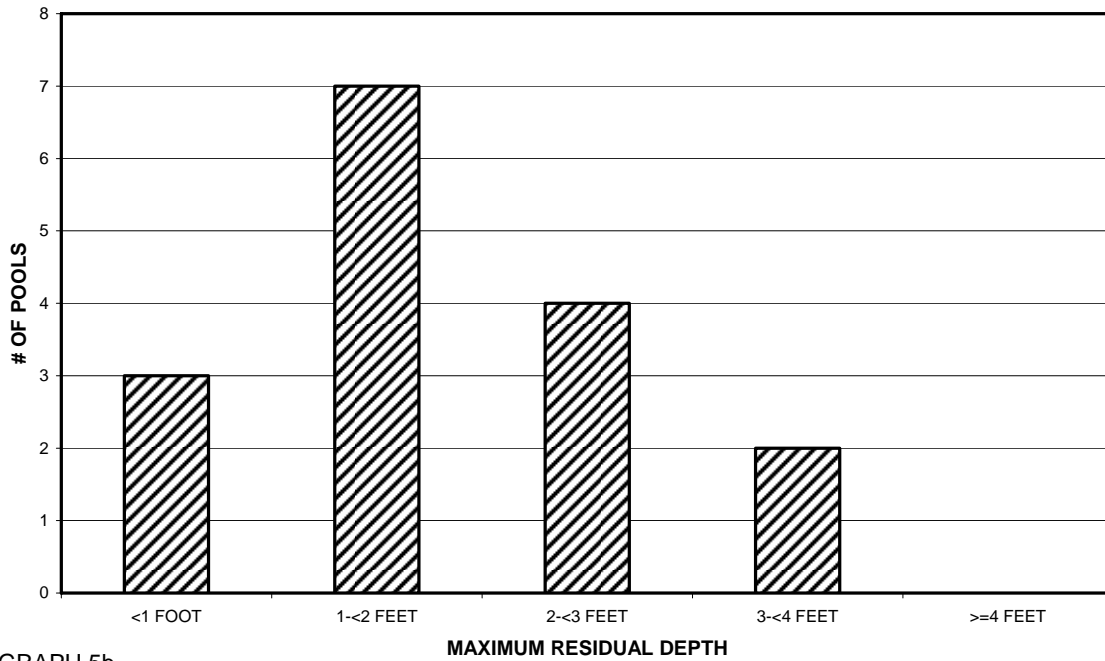
GRAPH 5b

Table 4b is a summary of maximum residual pool depths by pool habitat types. Pool quality for salmonids increases with depth. Six of the 16 pools (38%) had a residual depth of two feet or greater (Graph 5b).

Flatwater habitat types comprised 15% of the total length of this survey, riffles 1%, and pools 8%. The pools are relatively shallow, with only 6 of the 16 (38%) pools having a maximum residual depth greater than 2 feet. In general, pool enhancement projects are considered when primary pools comprise less than 40% of the length of total stream habitat. In first and second order streams, a primary pool is defined to have a maximum residual depth of at least two feet, occupy at least half the width of the low flow channel, and be as long as the low flow channel width. Installing structures that will increase or deepen pool habitat is recommended for locations where their installation will not be threatened by high stream energy, or where their installation will not conflict with the modification of the numerous log debris accumulations (LDA's) in the stream.

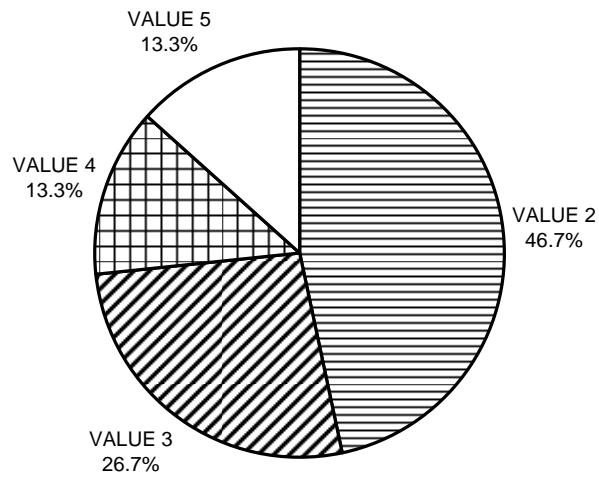
GRAPH 6b

The depth of cobble embeddedness was estimated at pool tail-outs. Of the 15 pool tail-outs measured, seven had a value of 2 (46.7%); four had a value of 3 (26.7%); two had a value of 4 (13.3%); two had a value of 5 (13.3%); (Graph 6b). On this scale, a value of 1 indicates the best spawning conditions and a value of 4 the worst. Additionally, a value of 5 was assigned to tail-outs deemed unsuited for spawning due to inappropriate substrate like bedrock, log sills,

boulders.

Seven of the 15 pool tail-outs measured had embeddedness ratings of 1 or 2. Six of the pool tail-outs had embeddedness ratings of 3 or 4. Two of the pool tail-outs had a rating of 5, which is considered unsuitable for spawning. Cobble embeddedness measured to be 25% or less, a rating of 1, is considered to indicate good quality spawning substrate for salmon and steelhead. Sediment sources in Icaria Creek, Trib B should be mapped and rated according to their potential sediment yields, and control measures should be taken.

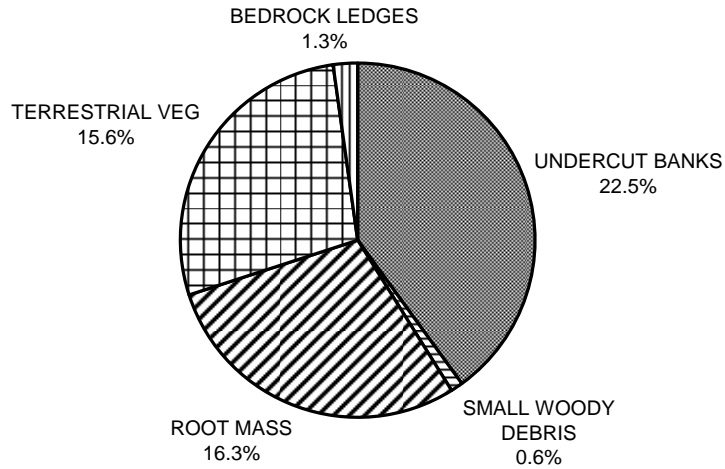
GRAPH 7b

Table 5b summarizes mean percent cover by habitat type. Undercut Banks are the dominant cover types in Icaria Creek, Trib B. Graph 7b describes the pool cover in Icaria Creek, Trib B. Undercut Banks is the dominant pool cover type followed by root mass.

The mean shelter rating for pools was 16. The shelter rating in the flatwater habitats was 33. A

pool shelter rating of approximately 100 is desirable. The amount of cover that now exists is being provided primarily by Undercut Banks in Icaria Creek, Trib B. Undercut Banks are the dominant cover type in pools followed by root mass. Log and root wad cover structures in the pool and flatwater habitats would enhance both summer and winter salmonid habitat. Log cover structure provides rearing fry with protection from predation, rest from water velocity, and also divides territorial units to reduce density related competition.

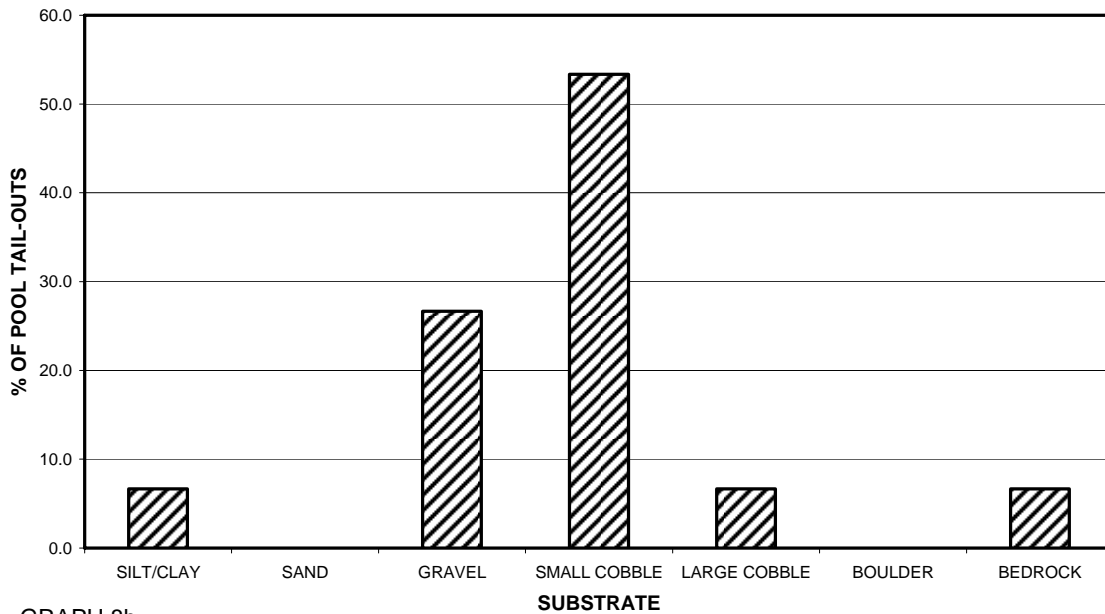
GRAPH 8b

Table 6b summarizes the dominant substrate by habitat type. Graph 8b depicts the dominant substrate observed in pool tail-outs. Gravel was observed in 27% of pool tail-outs and small cobble was observed in 53% of pool tail-outs.

Twelve of the 15 pool tail-outs measured had gravel or small cobble as the dominant substrate. This is generally considered good for spawning salmonids.

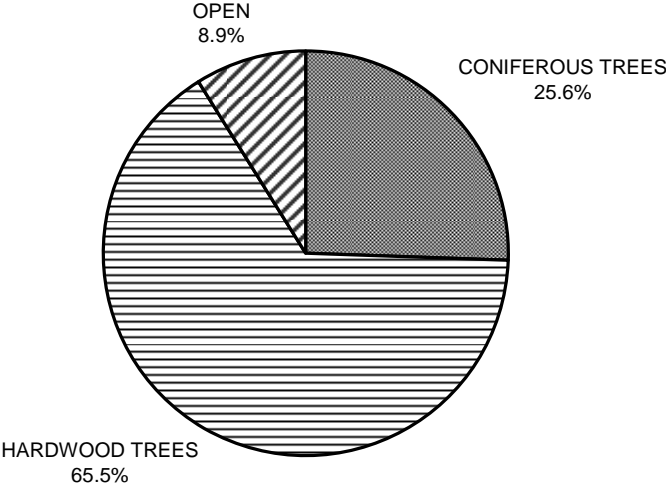
GRAPH 9b

The mean percent canopy density for the surveyed length of Icaria Creek, Trib B was 91%. The mean percentages of hardwood and coniferous trees were 72% and 28%, respectively. Nine percent of the canopy was open. Graph 9b describes the mean percent canopy in Icaria Creek, Trib B.

The mean percent canopy density for the stream was 91%. In general, revegetation projects are considered when canopy density is less than 80%.

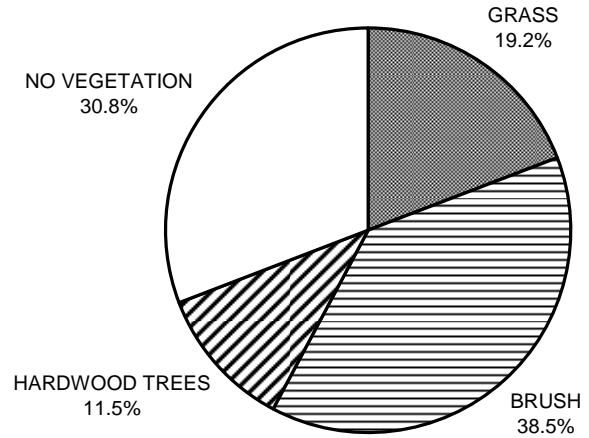
GRAPH 11b

For the stream reach surveyed, the mean percent right bank vegetated was 8%. The mean percent left bank vegetated was 34%. The dominant elements composing the structure of the stream banks consisted of 15% bedrock, 19% cobble/gravel, 65% sand/silt/clay, (Graph 10b). Brush was the dominant vegetation type observed in 38% of the units surveyed. Additionally, 12% of the units surveyed had hardwood trees as the dominant vegetation type, and none had coniferous trees as the dominant vegetation (Graph 11b).

The percentage of right and left bank covered with vegetation was low at 8% and 34%, respectively. In areas of stream bank erosion or where bank vegetation is sparse, planting endemic species of coniferous and hardwood trees, in conjunction with bank stabilization, is recommended.
