**CALIFORNIA DEPARTMENT OF FISH AND GAME
STREAM INVENTORY REPORT**

Martin Creek

Report Revised April 14, 2006

Assessment Completed 2001

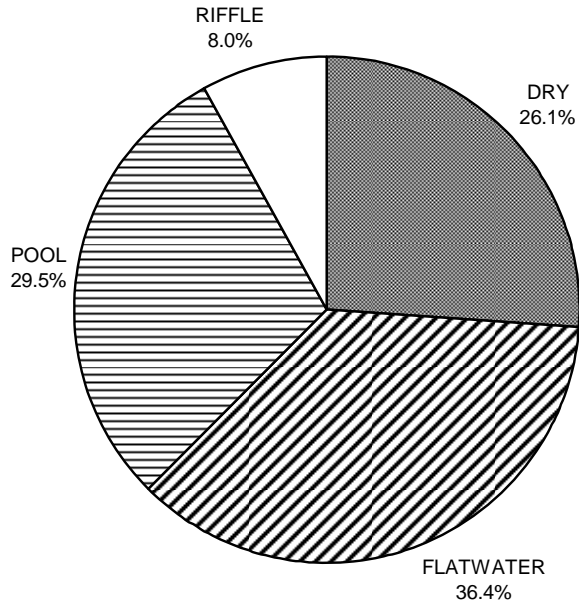
GRAPH 1

Table 1 summarizes the Level II riffle, flatwater, and pool habitat types. Based on frequency of *occurrence* there were 36.4% Flatwater units, 29.5% Pool units, 26.1% Dry units and 8.0% Riffle units. Based on total *length* there were 59.6% Dry units, 19.8% Flatwater units, 13.7% Pool units and 6.9% Riffle units (Graph 2).

Of the eighty-eight habitat units, which were measured, 43% were completely sampled. Fourteen Level IV habitat types were identified. The data is summarized in Table 2. By percent total *length*, Dry at 26.1%, Run at 18.2%, Glide at 18.2% and Bedrock Sheet at 6.8%. The most frequent habitat types by percent *occurrence* were Dry at 26%, Run at 18%, Glide at 18% and Lateral Scour Pool - Bedrock Formed at 10%. (Graph 1)

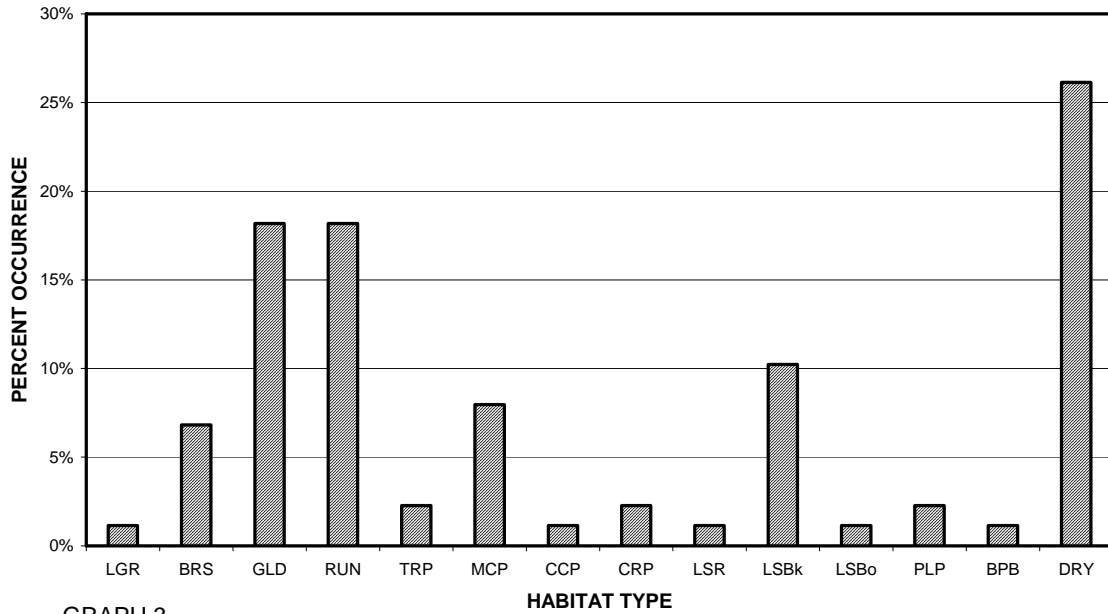
GRAPH 3

Twenty-six pools were identified (Table 3). Lateral Scour Pool - Bedrock Formed pools were

most often encountered at 10% (Graph 3), and comprised 36% of the total length of pools.

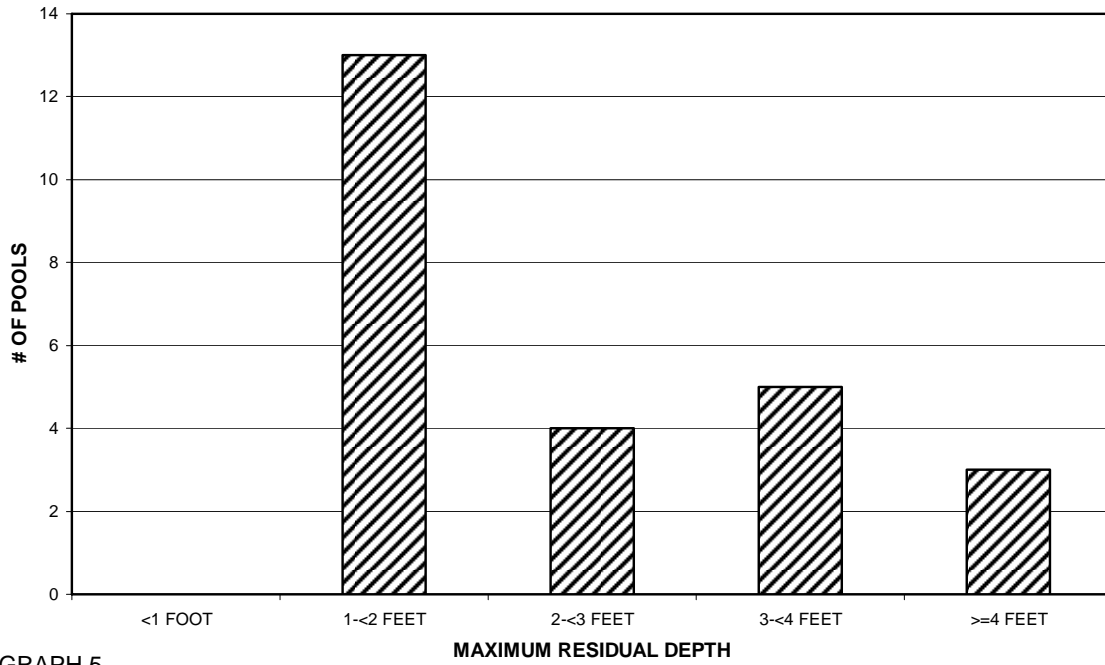
GRAPH 5

Table 4 is a summary of maximum pool depths by pool habitat types. Pool quality for salmonids increases with depth. Eight of the 25 pools (32%) had a depth of three feet or greater (Graph 5).

Pools comprised 14% of the total length of this survey. In third order streams a primary pool is defined to have a maximum depth of at least three feet, occupy at least half the width of the low flow channel, and be as long as the low flow channel width. In Martin Creek, the pools are relatively deep with 32% having a maximum depth of at least three feet. These pools comprised 12% of the total length of stream habitat. In coastal coho and steelhead streams, it is generally desirable to have primary pools comprise approximately 50% of total habitat length.

6. Where feasible, design and engineer pool enhancement structures to increase the number of pools in the upper reaches. This must be done where the banks are stable or in conjunction with stream bank armor to prevent erosion.

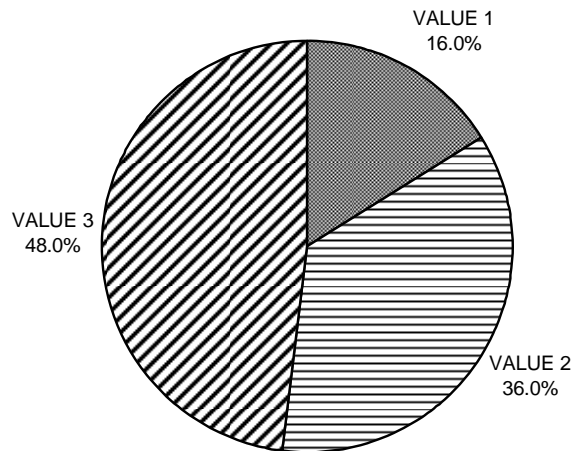
GRAPH 6

The depth of cobble embeddedness was estimated at pool tail-outs. Of the twenty-six pool tail-outs measured, four had a value of 1 (16%), nine had a value of 2 (36%) and thirteen had a value of 3 (48%). Riffles rated a five are unsuitable substrate type for spawning. On this scale, a value of one is best for fisheries. Table 8 describes percent embeddedness by reach. Small Cobble was the dominant substrate observed at pool tail-outs (Graph 8).

Fifty percent of the pool tail-outs measured had embeddedness ratings of either 3 or 4. Only 15% had a rating of 1. Cobble embeddedness measured to be 25% or less (a rating of 1) is considered best for the needs of salmon and steelhead.

2. Map sources of upslope and in-channel erosion, and prioritize them according to present and potential sediment yield. Identified sites should then be treated to reduce the amount of fine sediments entering the stream. Near-stream riparian planting along any portion of the stream should be encouraged to provide bank stability and a buffering against agricultural, grazing and urban runoff.

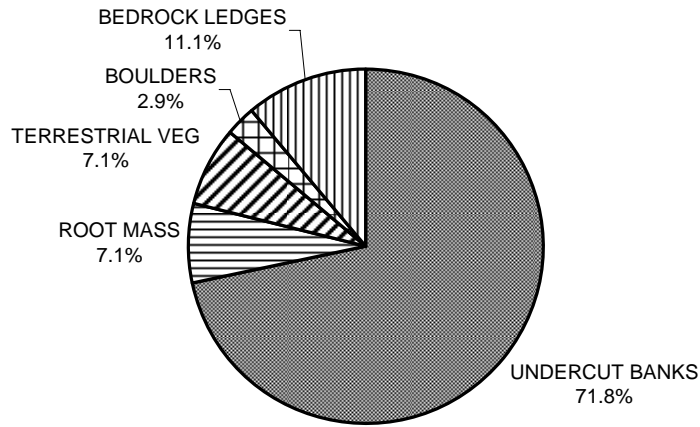
GRAPH 7

Table 5 summarizes fish shelter by habitat type. By percent area, the dominant pool shelter types were Undercut Banks at 72%, Bedrock at 10%, Terrestrial Vegetation Root Mass at 7% each and Boulders at 3%. Graph 7 describes the pool shelter in Martin Creek.

The mean shelter rating for pools was 10. However, a pool shelter rating of approximately 80 is desirable. The relatively small amount of pool shelter that now exists is being provided primarily by Undercut Banks at 72%, Bedrock at 11% and Terrestrial Vegetation at 7%. Log cover provides rearing fry with protection from predation, rest from water velocity, and also divides territorial units to reduce density related competition.

5. Where feasible, increase woody cover in the pool and flatwater habitat units along the entire stream. Most of the existing shelter is from vegetation and undercut banks. Adding high quality complexity with larger woody cover is desirable. Combination cover/scour structures constructed with boulders and woody debris would be effective in many flatwater and pool locations in the upper reaches. This must be done where the banks are stable or in conjunction with stream bank armor to prevent erosion. In some areas the material is at hand.

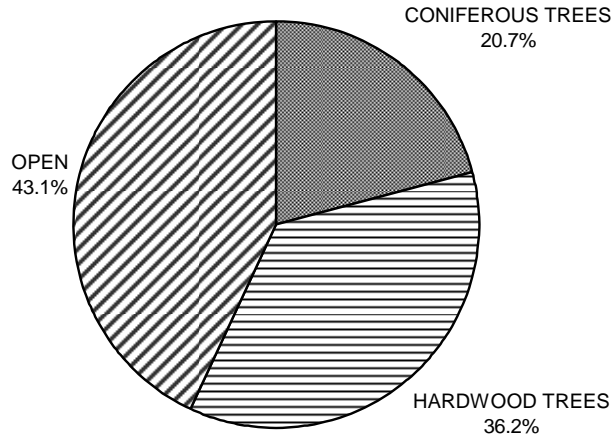
GRAPH 9

The mean percent canopy density for the stream reach surveyed was 57%. The mean percentages of deciduous and evergreen trees were 63% and 37%, respectively. Graph 9 describes the canopy for the entire survey.

The mean percent canopy for the survey was 54%. This is a low percentage of canopy, since 80 percent is generally considered desirable. Cooler water temperatures are desirable in Martin Creek. Elevated water temperatures could be reduced by increasing stream canopy. The large trees required for adequate stream canopy would also eventually provide a long term source of large woody debris needed for instream shelter and bank stability.

1. Increase the canopy on Martin Creek by planting willow, alder, redwood, and Douglas fir along the stream where shade canopy is not at acceptable levels. The reach above the survey section should be assessed for planting and treated as well, since water temperatures throughout are effected from upstream. In many cases, planting will need to be coordinated to follow bank stabilization or upslope erosion control projects.

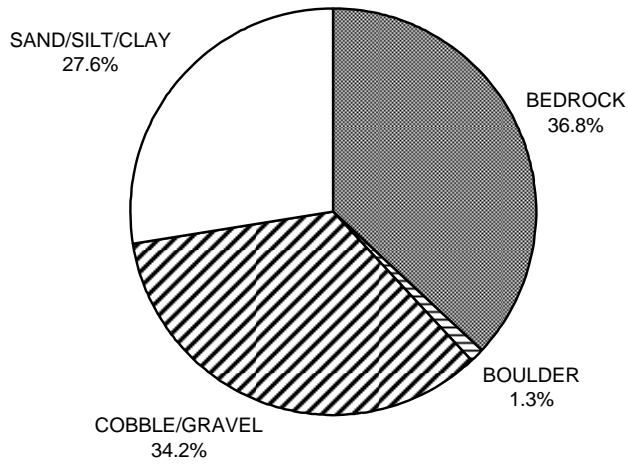
GRAPH 10

For the entire stream reach surveyed, the mean percent right bank vegetated was 43% and the mean percent left bank vegetated was 43% (Table 7). For the habitat units measured, the dominant vegetation types for the stream banks were: 38% Brush, 29% Deciduous Trees, 21% Evergreen Trees and 12% Grass (Graph 11). The dominant substrate for the stream banks were: 37% Bedrock, 34% Cobble & Gravel and 28% sand silt and clay (Graph 10).
