**California Department of Fish and Wildlife  
Sonoma County  
Russian River Watershed  
Stream Habitat Assessment Reports**

# **The North Fork of Mark West Creek**

*Surveyed 2012*

### STREAM INVENTORY REPORT

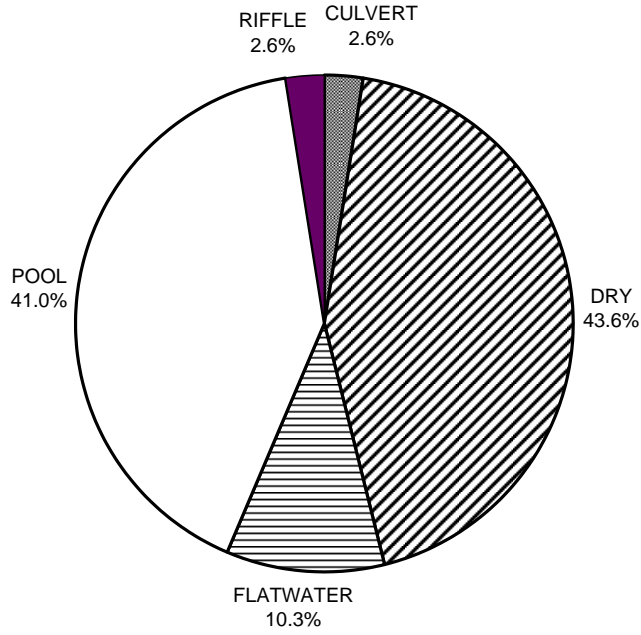
GRAPH 1

Table 1 summarizes the Level II riffle, flatwater, and pool habitat types. Based on frequency of occurrence there were 44% dry units, 41% pool units, 10% flatwater units, 3% riffle units, and 3% culvert units (Graph 1). Based on total length of Level II habitat types, there were 75% dry units, 14% flatwater units, 7% pool units, 2% riffle units, and 1% culvert units (Graph 2).

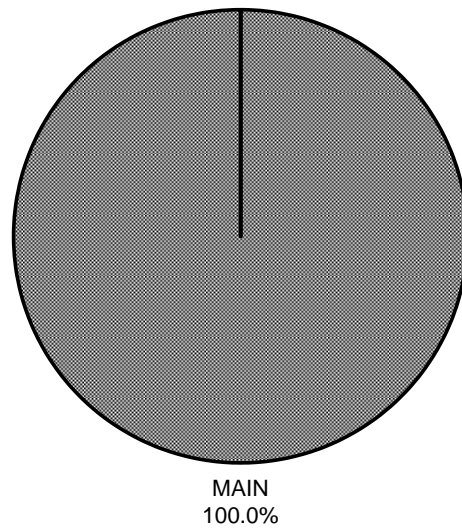
GRAPH 4

A total of 16 pools were identified (Table 3). Main channel pools were the most frequently encountered at 100% (Graph 4), and comprised 100% of the total length of all pools (Table 3).

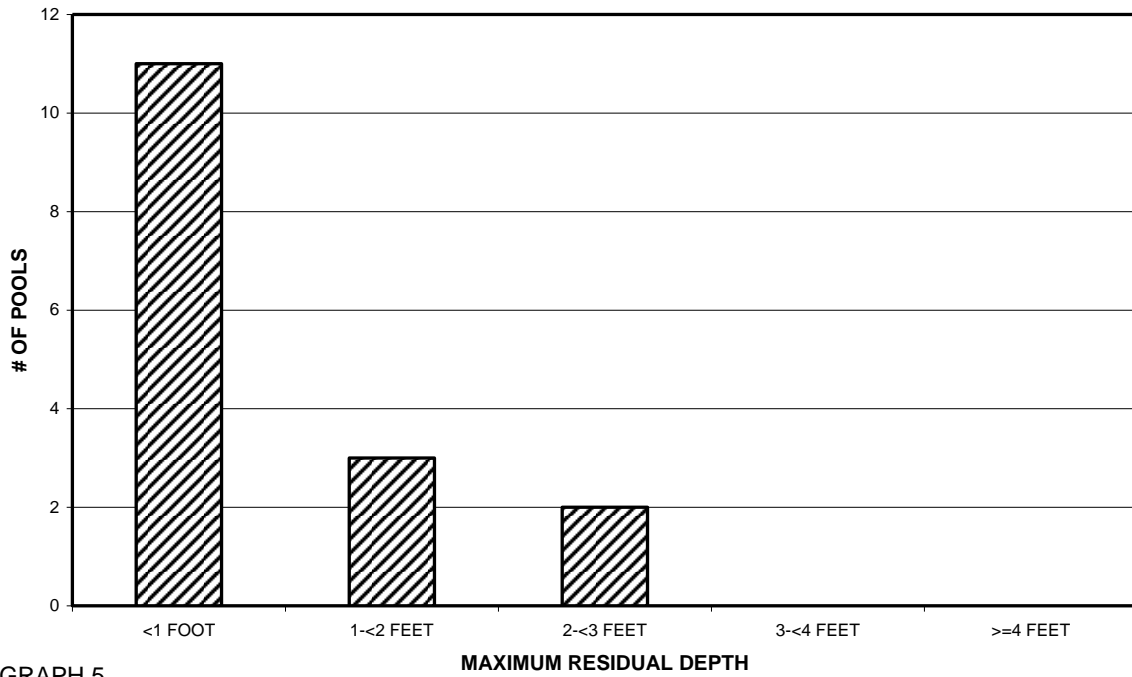
GRAPH 5

Table 4 is a summary of maximum residual pool depths by pool habitat types. Pool quality for salmonids increases with depth. Two of the 16 pools (12%) had a residual depth of two feet or greater (Graph 5).

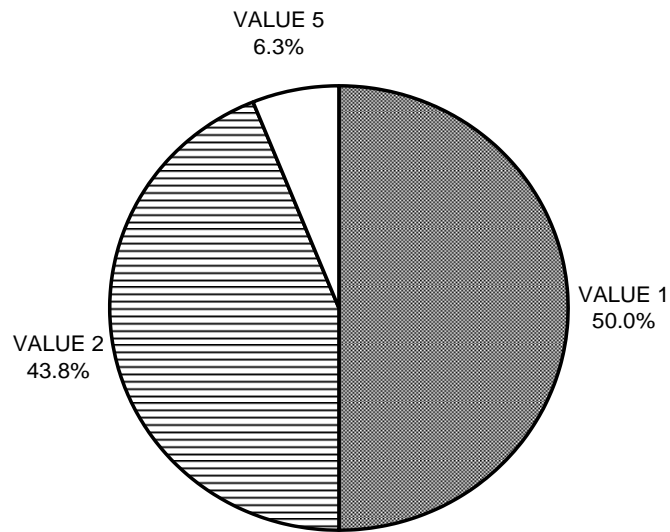
GRAPH 6

The depth of cobble embeddedness was estimated at pool tail-outs. Of the 16 pool tail-outs measured, 8 had a value of 1 (50%), 7 had a value of 2 (44%), 1 had a value of 5 (6%) (Graph 6). On this scale, a value of 1 indicates the best spawning conditions and a value of 4 the worst. Additionally, a value of 5 was assigned to tail-outs deemed unsuited for spawning due to inappropriate substrate such as bedrock, log sills, boulders, or other considerations.

Fifteen of the 16 pool tail-outs measured had embeddedness ratings of 1 or 2. Zero of the pool tail-outs had embeddedness ratings of 3 or 4. One of the pool tail-outs had a rating of 5, which is

considered unsuitable for spawning. Cobble embeddedness measured to be 25% or less, a rating of 1, is considered to indicate good quality spawning substrate for salmon and steelhead. Sediment sources in North Fork Mark West Creek should be mapped and rated according to their potential sediment yields, and control measures should be taken.

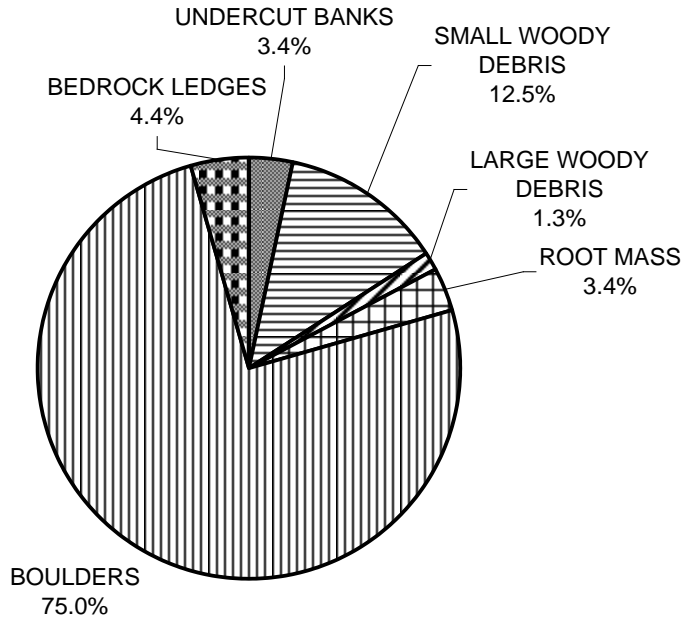
GRAPH 7

North Fork Mark West Creek. Graph 7 describes the pool cover in North Fork Mark West Creek. Boulders are the dominant pool cover type, followed by small woody debris.

The mean shelter rating for pools is 15. The shelter rating in the flatwater habitats is 5. A pool shelter rating of approximately 100 is desirable. The amount of cover that now exists is being provided primarily by boulders in North Fork Mark West Creek. Boulders are the dominant cover type in pools, followed by small woody debris. Log and root wad cover structures in the pool and flatwater habitats would enhance both summer and winter salmonid habitat. Log cover structure provides rearing fry with protection from predation, rest from water velocity, and also divides territorial units to reduce density related competition.

- 2) Increase woody cover in the pools and flatwater habitat units. Most of the existing cover in the pools is from Boulders. Adding high quality complexity with woody cover in the pools is desirable.
- 3) Due to the natural high gradient of the stream throughout Reach 1, access for migrating salmonids is an ongoing potential problem. Good water temperature and flow regimes exist in the stream and it offers good conditions for rearing fish. Fish passage should be monitored and improved where possible.
- 4) There are several log debris accumulations present on the North Fork of Mark West Creek that are retaining large quantities of fine sediment. The modification of these debris accumulations is desirable, but must be done carefully, over time, to avoid excessive sediment loading in downstream reaches.

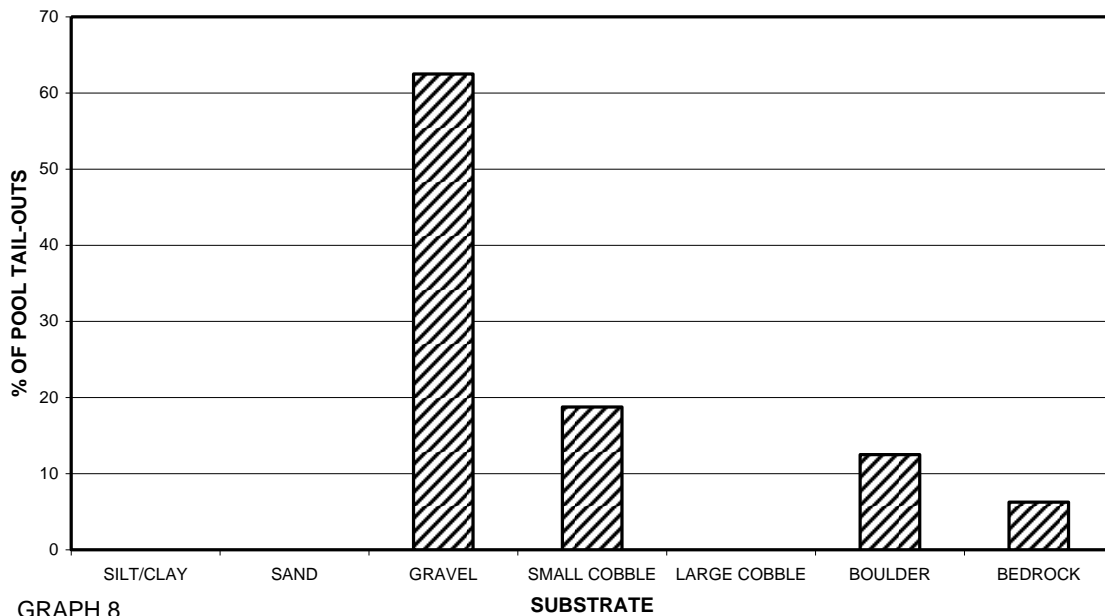
GRAPH 8

Table 6 summarizes the dominant substrate by habitat type. Graph 8 depicts the dominant substrate observed in pool tail-outs. Gravel substrate was observed in 63% of pool tail-outs; and small cobble substrate was observed in 19% of pool tail-outs.

Thirteen of the 16 pool tail-outs measured had gravel and small cobble as the dominant substrate. This is generally considered good for spawning salmonids.

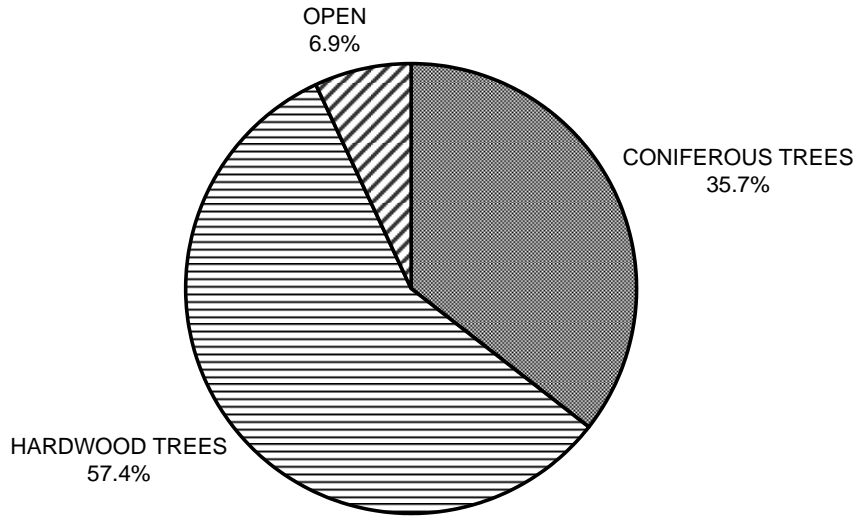
GRAPH 9

The mean percent canopy density for the surveyed length of North Fork Mark West Creek was 93%. Of the canopy present, the mean percentages of hardwood and coniferous trees were 62% and 38%, respectively. Seven percent of the canopy was open. Graph 9 describes the mean percent canopy in North Fork Mark West Creek.

The mean percent canopy density for the stream was 93%. In general, revegetation projects are considered when canopy density is less than 80%.

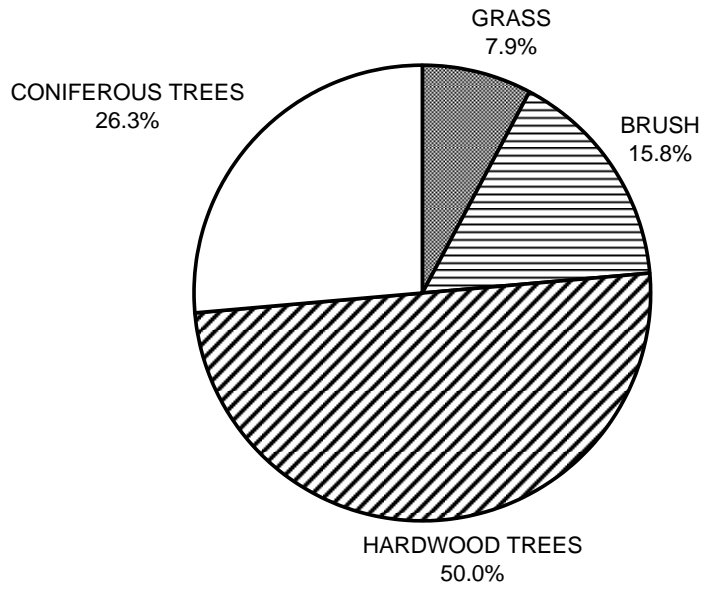
GRAPH 11

For the stream reach surveyed, the mean percent right bank vegetated was 72%. The mean percent left bank vegetated was 72% (Table 7). The dominant elements composing the structure of the stream banks consisted of 39% bedrock, 26% cobble/gravel, 24% sand/silt/clay, and 11% boulder (Graph 10). Deciduous trees were the dominant vegetation type observed in 50% of the units surveyed. Additionally, 26% of the units surveyed had coniferous trees as the dominant vegetation type, and 16% had brush as the dominant vegetation type (Graph 11).

The percentage of right and left bank covered with vegetation was 72% and 72%, respectively. In areas of stream bank erosion or where bank vegetation is sparse, planting endemic species of coniferous and hardwood trees, in conjunction with bank stabilization, is recommended.
