**California Department of Fish and Wildlife  
Sonoma County  
Russian River Watershed  
Stream Habitat Assessment Reports**

**Porter Creek**  
*(Tributary to Mark West Creek)*

*Surveyed 2012*

# STREAM INVENTORY REPORT

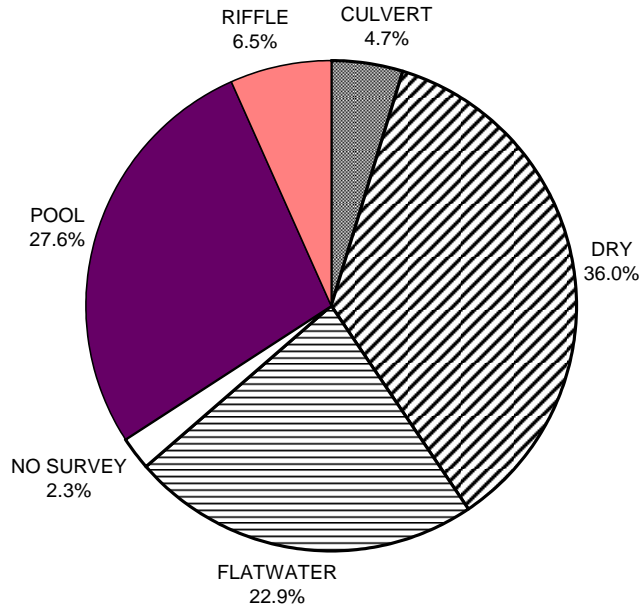
GRAPH 1

Table 1 summarizes the Level II riffle, flatwater, and pool habitat types. Based on frequency of occurrence there were 36% dry units, 28% pool units, 23% flatwater units, 7% riffle units, 5% culvert units, and 2% not surveyed units (Graph 1). Based on total length of Level II habitat types, there were 47% dry units, 31% not surveyed units, 10% flatwater units, 9% pool units, 2% riffle units, and 1% culvert units (Graph 2).

**PORTER CREEK 2012  
HABITAT TYPES BY PERCENT OCCURRENCE**

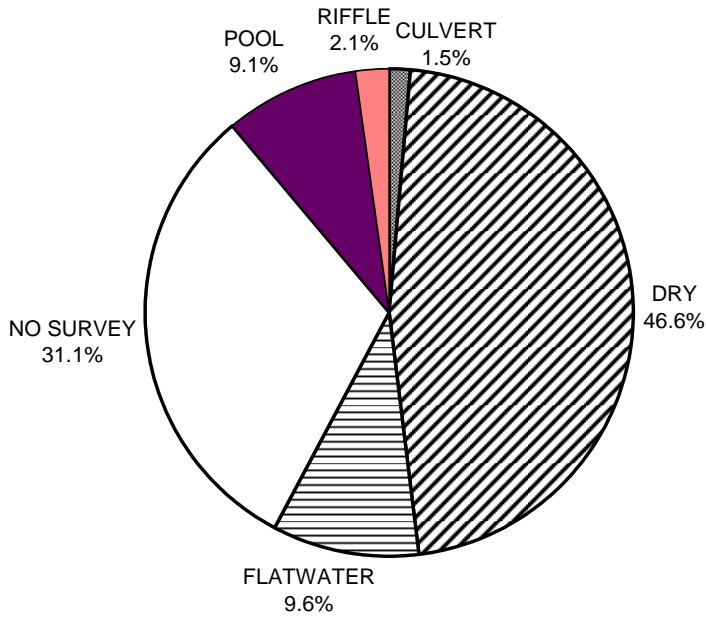
GRAPH 2

**PORTER CREEK 2012  
HABITAT TYPES BY PERCENT TOTAL LENGTH**

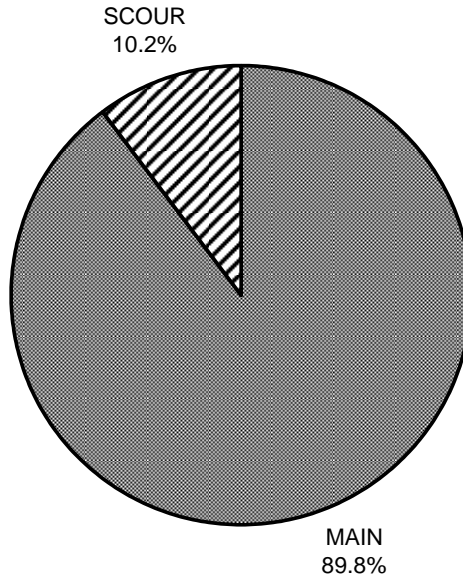
GRAPH 4

A total of 59 pools were identified (Table 3). Main channel pools were the most frequently encountered at 90% (Graph 4), and comprised 94% of the total length of all pools (Table 3).

**PORTER CREEK 2012  
POOL TYPES BY PERCENT OCCURRENCE**

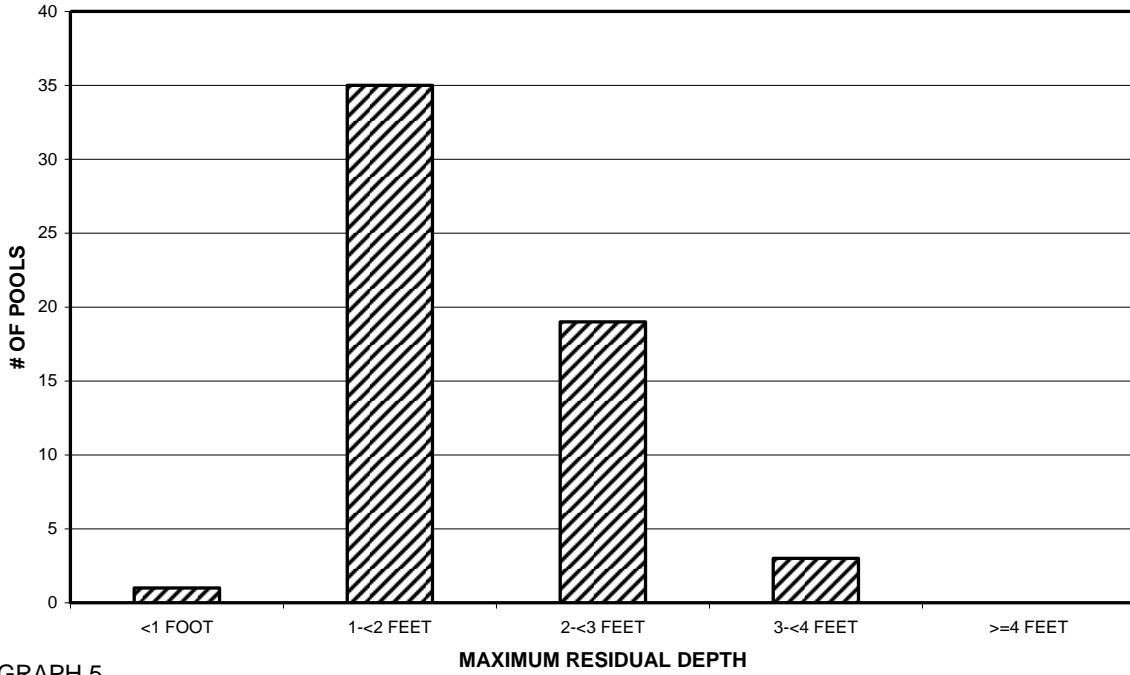
GRAPH 5

Table 4 is a summary of maximum residual pool depths by pool habitat types. Pool quality for salmonids increases with depth. Twenty-two of the 59 pools (38%) had a residual depth of two feet or greater (Graph 5).

Flatwater habitat types comprised 10% of the total length of this survey, riffles 2%, and pools 9%. The pools are relatively shallow, with 22 of the 59 (38%) pools having a maximum residual depth greater than two feet. In general, pool enhancement projects are considered when primary pools comprise less than 40% of the length of total stream habitat. In first and second order streams, a primary pool is defined to have a maximum residual depth of at least two feet, occupy at least half the width of the low flow channel, and be as long as the low flow channel width. Installing structures that will increase or deepen pool habitat is recommended for locations where their installation will not be threatened by high stream energy, or where their installation will not conflict with the modification of the numerous log debris accumulations (LDA's) in the stream.

PORTER CREEK 2012  
MAXIMUM DEPTH IN POOLS

- 7) Where feasible, design and engineer pool enhancement structures to increase the number of pools. This must be done where the banks are stable or in conjunction with stream bank armor to prevent erosion.

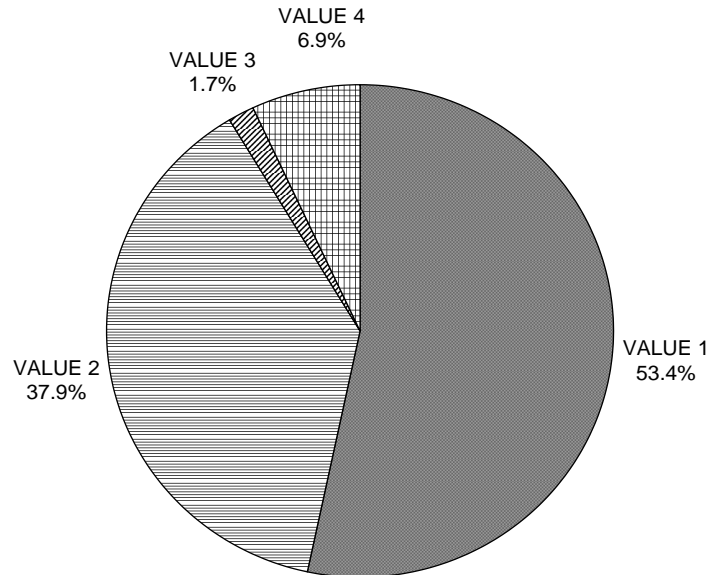
GRAPH 6

The depth of cobble embeddedness was estimated at pool tail-outs. Of the 59 pool tail-outs measured, 31 had a value of 1 (53%), 22 had a value of 2 (37%), 1 had a value of 3 (2%), 4 had a value of 4 (7%) (Graph 6). On this scale, a value of 1 indicates the best spawning conditions and a value of 4 the worst. Additionally, a value of 5 was assigned to tail-outs deemed unsuited for spawning due to inappropriate substrate such as bedrock, log sills, boulders, or other considerations.

Fifty-three of the 59 pool tail-outs measured had embeddedness ratings of 1 or 2. Five of the pool tail-outs had embeddedness ratings of 3 or 4. Zero of the pool tail-outs had a rating of 5, which is considered unsuitable for spawning. Cobble embeddedness measured to be 25% or less, a rating of 1, is considered to indicate good quality spawning substrate for salmon and steelhead. Sediment sources in Porter Creek should be mapped and rated according to their potential sediment yields, and control measures should be taken.

PORTER CREEK 2012  
PERCENT EMBEDDEDNESS

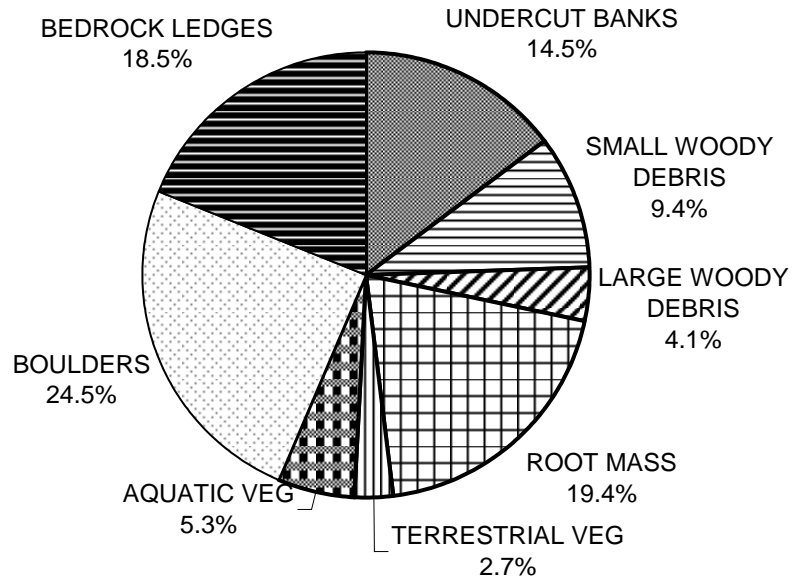
GRAPH 7

Table 5 summarizes mean percent cover by habitat type. Boulders are the dominant cover type in Porter Creek. Graph 7 describes the pool cover in Porter Creek. Boulders are the dominant pool cover type, followed by root masses.

The mean shelter rating for pools is 20. The shelter rating in the flatwater habitats is 7. A pool shelter rating of approximately 100 is desirable. The amount of cover that now exists is being provided primarily by boulders in Porter Creek. Boulders are the dominant cover type in pools, followed by root masses. Log and root wad cover structures in the pool and flatwater habitats would enhance both summer and winter salmonid habitat. Log cover structure provides rearing fry with protection from predation, rest from water velocity, and also divides territorial units to reduce density related competition.

### PORTER CREEK 2012 MEAN PERCENT COVER TYPES IN POOLS

- 3) Increase woody cover in the pools and flatwater habitat units. Most of the existing cover in the pools is from Boulders. Adding high quality complexity with woody cover in the pools is desirable.

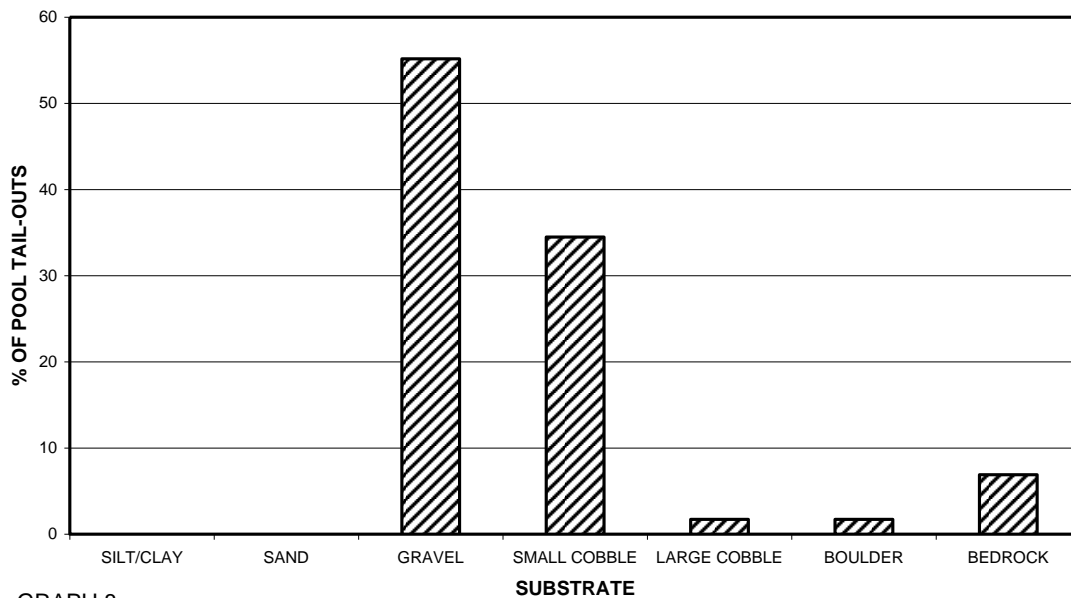
GRAPH 8

Table 6 summarizes the dominant substrate by habitat type. Graph 8 depicts the dominant substrate observed in pool tail-outs. Gravel substrate was observed in 55% of pool tail-outs; and small cobble substrate was observed in 34% of pool tail-outs.

Fifty-two of the 59 pool tail-outs measured had gravel and small cobble as the dominant substrate. This is generally considered good for spawning salmonids.

### PORTER CREEK 2012 SUBSTRATE COMPOSITION IN POOL TAIL-OUTS

- 5) Suitable size spawning substrate on Porter Creek is limited in reach 3. Projects should be designed at suitable sites to trap and sort spawning gravel.

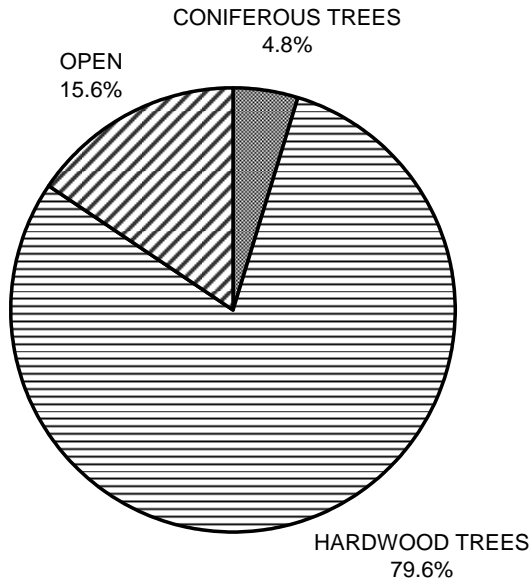
GRAPH 9

The mean percent canopy density for the surveyed length of Porter Creek was 84%. Of the canopy present, the mean percentages of hardwood and coniferous trees were 94% and 6%, respectively. Sixteen percent of the canopy was open. Graph 9 describes the mean percent canopy in Porter Creek.

The mean percent canopy density for the stream was 84%. Reach 1 had a canopy density of 89.3%, Reach 2 had a canopy density of N/A, Reach 3 had a canopy density of 31.6%, Reach 4 had a canopy density of N/A, Reach 5 had a canopy density of 66.1%, Reach 6 had a canopy density of N/A, Reach 7 had a canopy density of 85.3%, Reach 8 had a canopy density of N/A, Reach 9 had a canopy density of 91%, Reach 10 had a canopy density of N/A, and Reach 11 had a canopy density of 74.7%. In general, revegetation projects are considered when canopy density is less than 80%.

**PORTER CREEK 2012  
MEAN PERCENT CANOPY**

- 4) Increase the canopy on Porter Creek especially throughout Reaches 1- 5, by planting appropriate native vegetation like willow, alder, redwood, and Douglas fir along the stream where shade canopy is not at acceptable levels. The reaches above this survey section should be inventoried and treated as well, since the water flowing here is affected from upstream. In many cases, planting will need to be coordinated to follow bank stabilization or upslope erosion control projects.

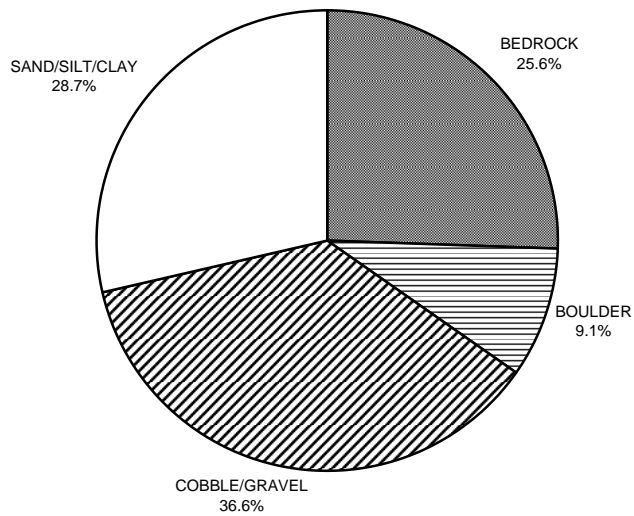
GRAPH 10

of the stream banks consisted of 37% cobble/gravel, 29% sand/silt/clay, 26% bedrock, and 9% boulder (Graph 10). Deciduous trees were the dominant vegetation type observed in 86% of the units surveyed. Additionally, 9% of the units surveyed had brush as the dominant vegetation type, and 4% had coniferous trees as the dominant vegetation type (Graph 11).

**PORTER CREEK 2012  
DOMINANT BANK COMPOSITION IN SURVEY REACH**

The percentage of right and left bank covered with vegetation was 88% and 89%, respectively. In areas of stream bank erosion or where bank vegetation is sparse, planting endemic species of coniferous and hardwood trees, in conjunction with bank stabilization, is recommended.

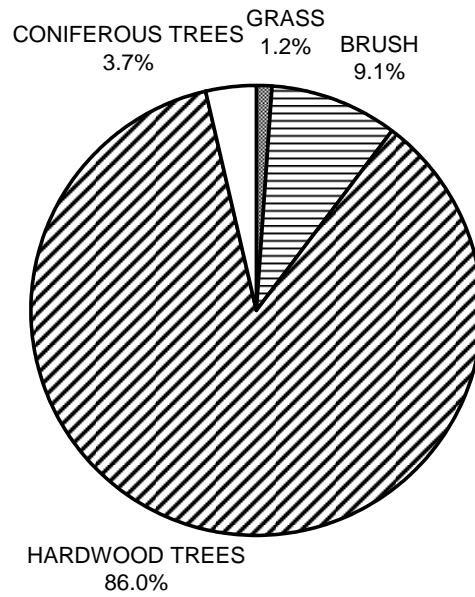
GRAPH 11

**PORTER CREEK 2012  
DOMINANT BANK VEGETATION IN SURVEY REACH**
