**California Department of Fish and Wildlife  
Sonoma County  
Russian River Watershed  
Stream Habitat Assessment Reports**

**Porter Creek  
(Rio Dell)**

*Surveyed 2012*

# STREAM INVENTORY REPORT

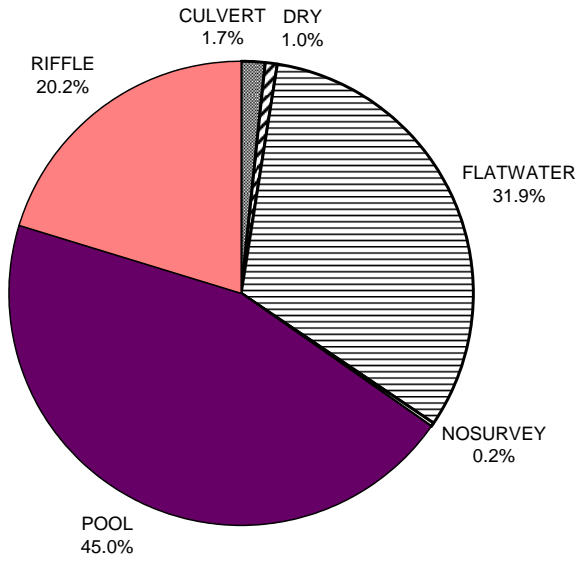
GRAPH 1

Table 1 summarizes the Level II riffle, flatwater, and pool habitat types. Based on frequency of occurrence there were 45% pool units, 32% flatwater units, 20% riffle units, 2% culvert units, 1% dry units, 0% not surveyed units, (Graph 1). Based on total length of Level II habitat types, there were 43% flatwater units, 27% pool units, 14% not surveyed units, 12% riffle units, 2% dry

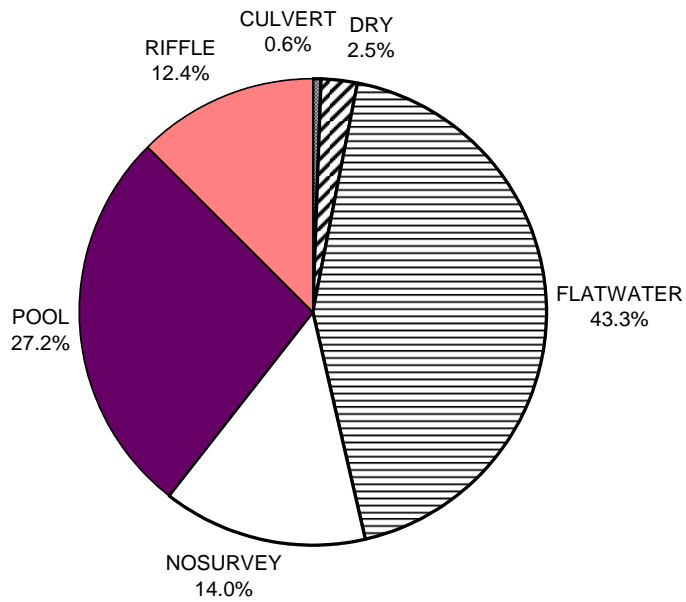
GRAPH 2

units, 1% culvert units (Graph 2).

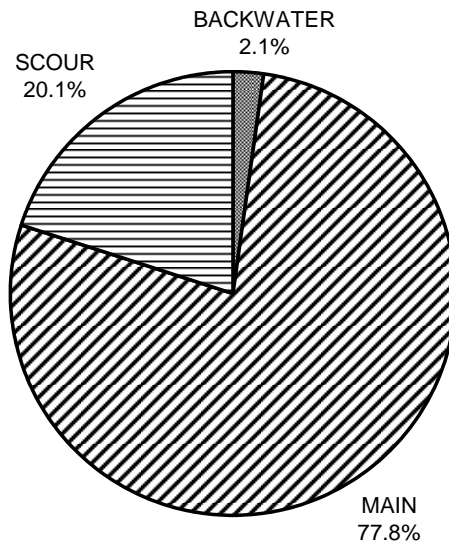
GRAPH 4

A total of 189 pools were identified (Table 3). Main channel pools were the most frequently encountered at 78% (Graph 4), and comprised 83% of the total length of all pools (Table 3).

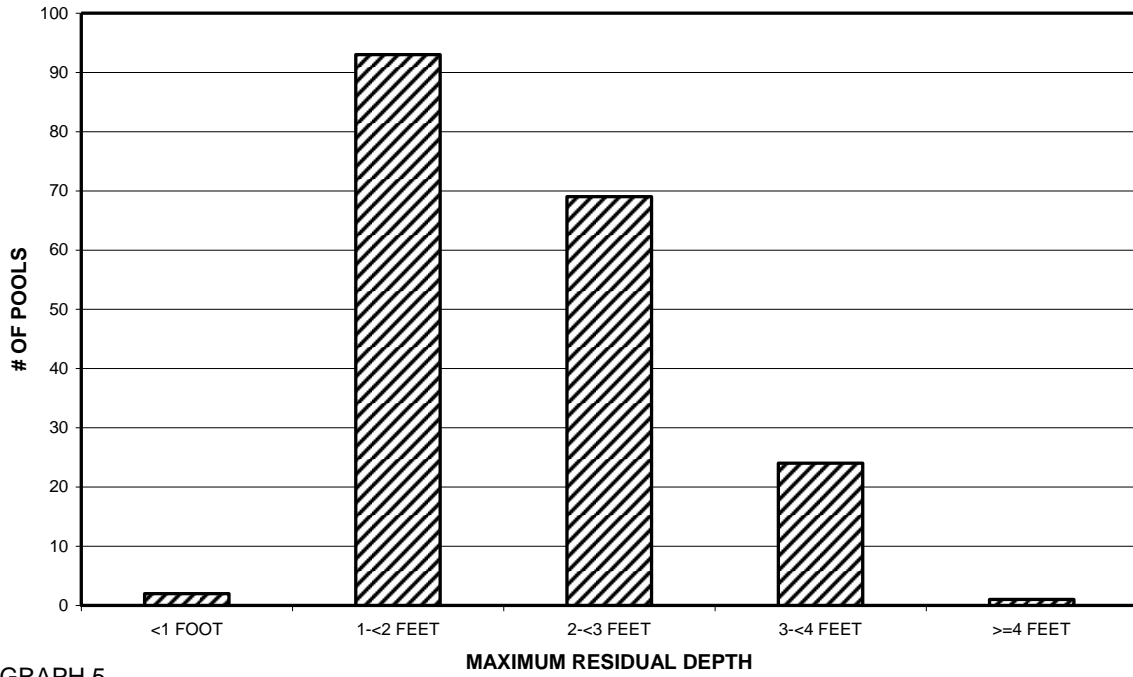
GRAPH 5

Table 4 is a summary of maximum residual pool depths by pool habitat types. Pool quality for salmonids increases with depth. Ninety-two of the 189 pools (49%) had a residual depth of two feet or greater (Graph 5).

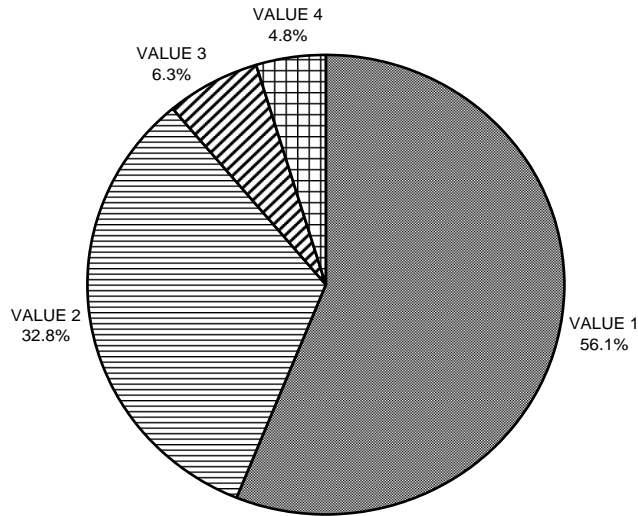
GRAPH 6

The depth of cobble embeddedness was estimated at pool tail-outs. Of the 189 pool tail-outs measured, 106 had a value of 1 (56%), 62 had a value of 2 (33%), 12 had a value of 3 (6%), 9 had a value of 4 (5%) (Graph 6). On this scale, a value of 1 indicates the best spawning conditions and a value of 4 the worst. Additionally, a value of 5 was assigned to tail-outs deemed unsuited for spawning due to inappropriate substrate such as bedrock, log sills, boulders, or other considerations.

One hundred sixty-eight of the 189 pool tail-outs measured had embeddedness ratings of 1 or 2. Twenty-one of the pool tail-outs had embeddedness ratings of 3 or 4. Zero of the pool tail-outs had a rating of 5, which is considered unsuitable for spawning. Cobble embeddedness measured to be 25% or less, a rating of 1, is considered to indicate good quality spawning substrate for salmon and steelhead. Sediment sources in Porter Creek should be mapped and rated according to their potential sediment yields, and control measures should be taken.

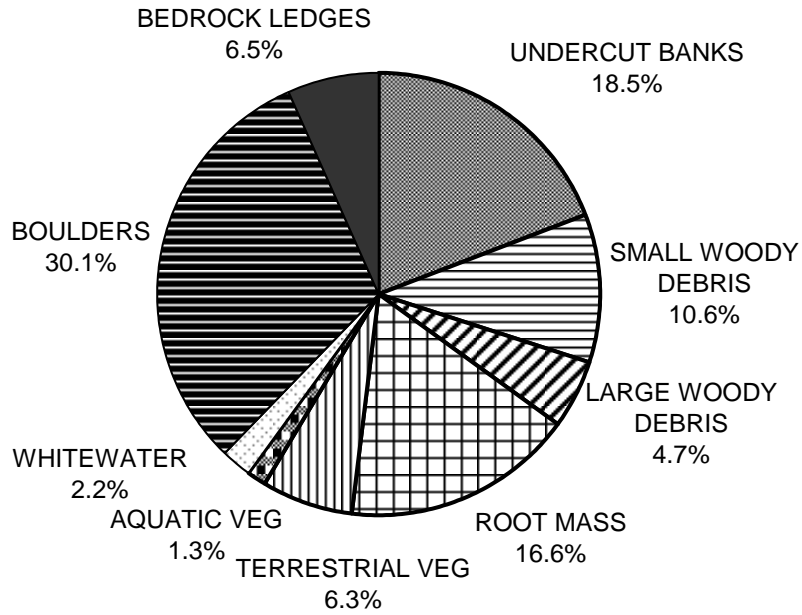
GRAPH 7

Table 5 summarizes mean percent cover by habitat type. Boulders are the dominant cover type in Porter Creek. Graph 7 describes the pool cover in Porter Creek. Boulders are the dominant pool cover type, followed by undercut banks.

- 1) Increase woody cover in the pools and flatwater habitat units. Most of the existing cover in the pools is from Boulders and Root Masses. Adding high quality complexity with woody cover in the pools is desirable.

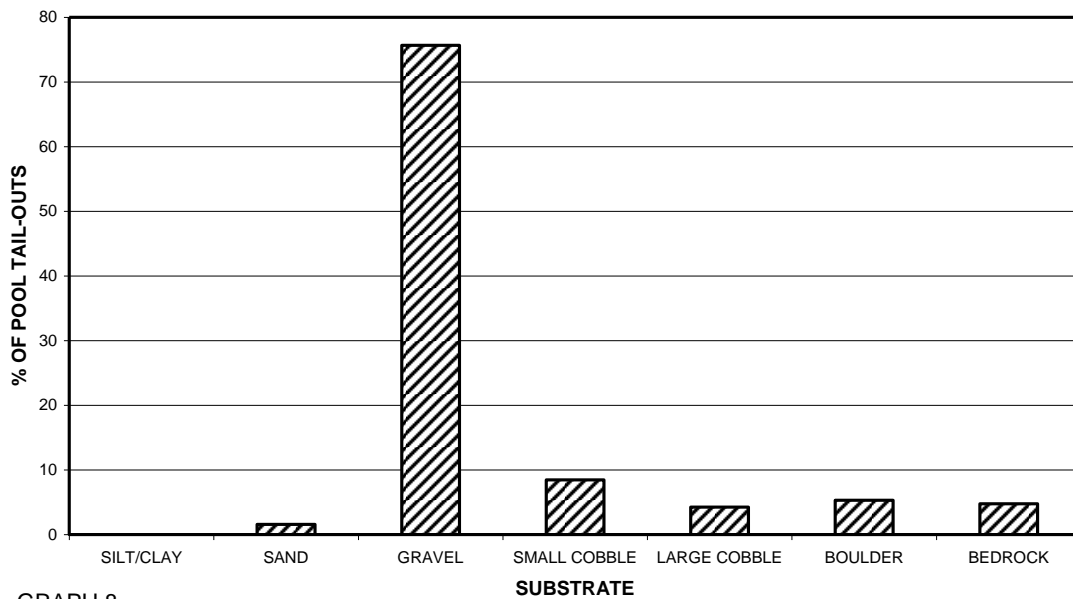
GRAPH 8

Table 6 summarizes the dominant substrate by habitat type. Graph 8 depicts the dominant substrate observed in pool tail-outs. Gravel substrate was observed in 76% of pool tail-outs; and small cobble substrate was observed in 8% of pool tail-outs.

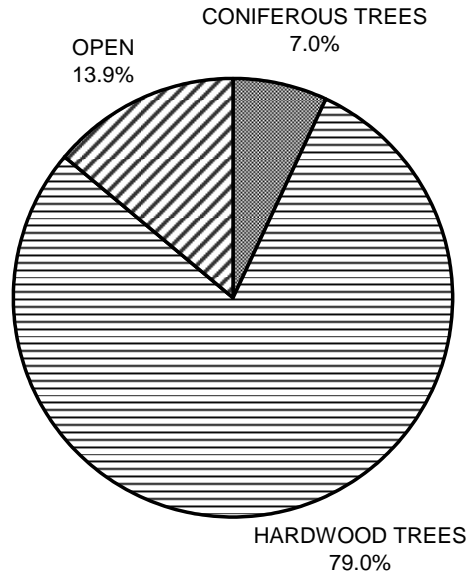
GRAPH 9

The mean percent canopy density for the surveyed length of Porter Creek was 86%. Of the canopy present, the mean percentages of hardwood and coniferous trees were 92% and 8%, respectively. Fourteen percent of the canopy was open. Graph 9 describes the mean percent canopy in Porter Creek.

The mean percent canopy density for the stream was 86%. Reach 1 had a canopy density of 85.6%, Reach 2 had a canopy density of 81.3%, Reach 3 had a canopy density of 92.3%, Reach 4 had a canopy density of 88.5%, Reach 5 had a canopy density of %, and Reach 6 had a canopy density of 88.7%. In general, revegetation projects are considered when canopy density is less than 80%.

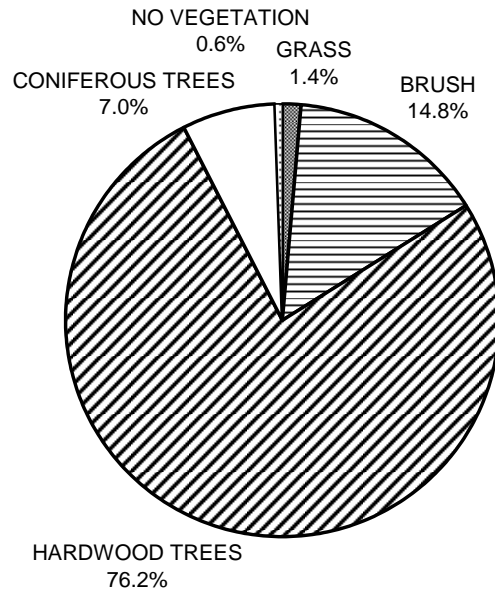
GRAPH 11

For the stream reach surveyed, the mean percent right bank vegetated was 90%. The mean percent left bank vegetated was 88% (Table 7). The dominant elements composing the structure of the stream banks consisted of 35% sand/silt/clay, 29% cobble/gravel, 21% bedrock, 15% boulder (Graph 10). Deciduous trees were the dominant vegetation type observed in 76% of the units surveyed. Additionally, 15% of the units surveyed had brush as the dominant vegetation

type, and 7% had coniferous trees as the dominant vegetation type (Graph 11).

The percentage of right and left bank covered with vegetation was 90% and 88%, respectively. In areas of stream bank erosion or where bank vegetation is sparse, planting endemic species of coniferous and hardwood trees, in conjunction with bank stabilization, is recommended.
