**CALIFORNIA DEPARTMENT OF FISH AND GAME
STREAM INVENTORY REPORT**

Ackerman Creek

Report Revised April 14, 2006

Assessment Completed 1999

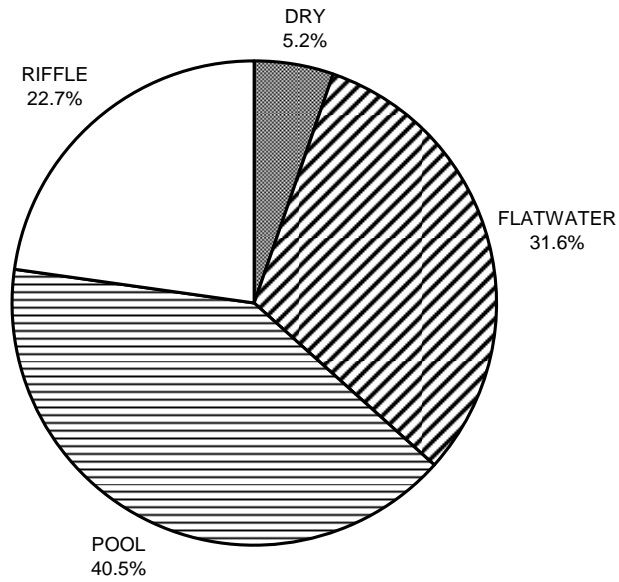
GRAPH 1

Table 1 summarizes the Level II riffle, flatwater, and pool habitat types. Based on frequency of *occurrence* there were 40% pool units, 32% flatwater units, 23% riffle units, and 5% dry streambed units (Graph 1). Based on total *length* there were 41% flatwater units, 26% pool units, 26% riffle units, and 7% dry streambed units (Graph 2).

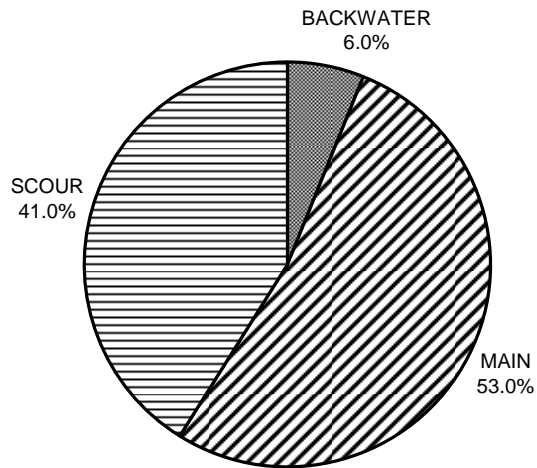
GRAPH 4

Two hundred and fifty-one pools were identified (Table 3). Main Channel pools were most often encountered at 53%, and comprised 56% of the total length of pools (Graph 4).

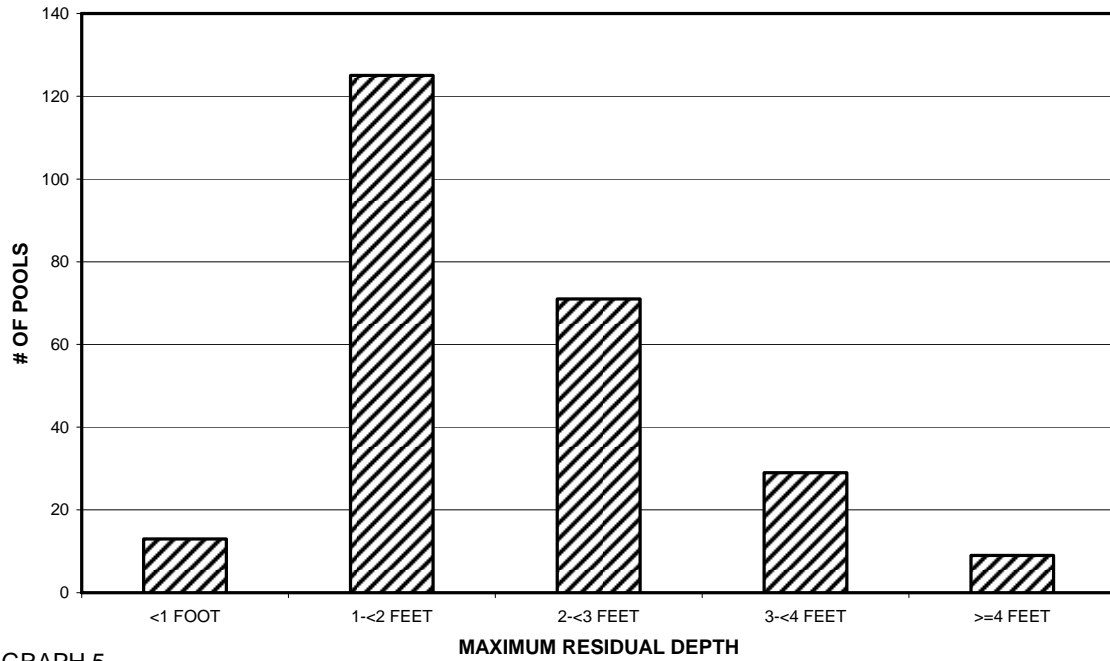
GRAPH 5

Table 4 is a summary of maximum residual pool depths by pool habitat types. Pool quality for salmonids increases with depth. Thirty-eight of the 247 pools measured (15%) had a depth of three feet or greater (Graph 5).

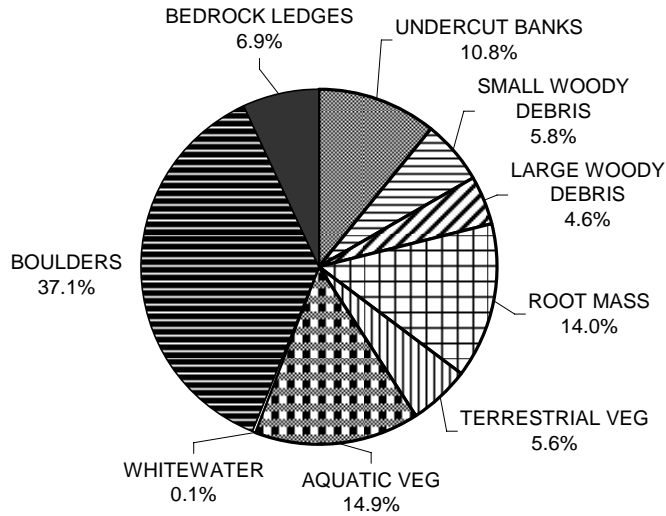
GRAPH 7

Table 5 summarizes mean percent cover by habitat type. Boulders are the dominant pool cover type followed by aquatic vegetation. Graph 7 describes the pool shelter in Ackerman Creek.

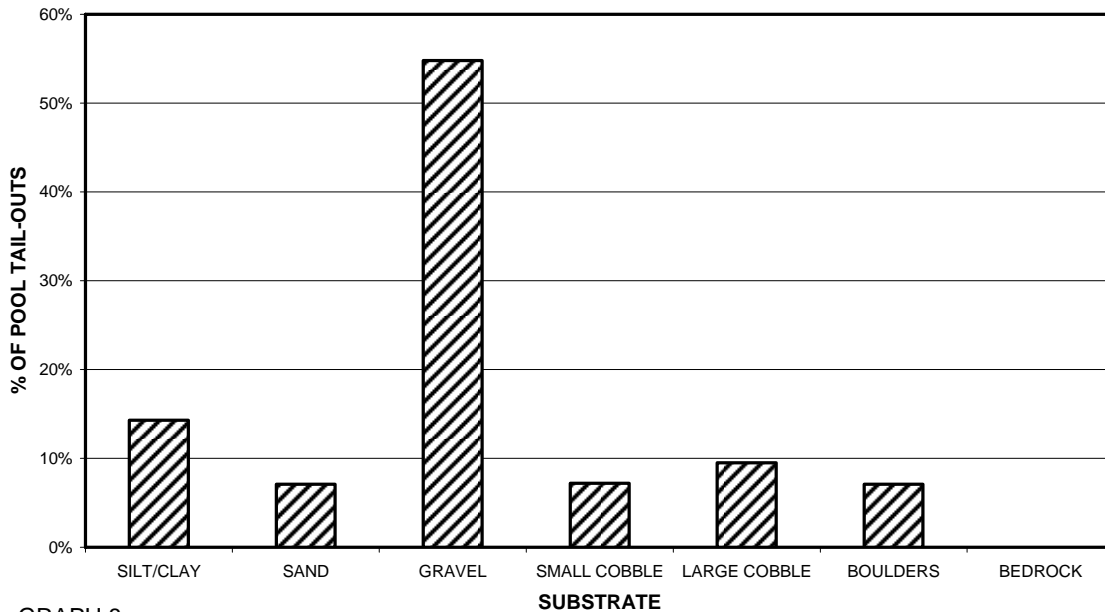
GRAPH 8

Table 6 summarizes the dominant substrate by habitat type. Graph 8 depicts the dominant substrate observed in pool tail-outs. Pool tail-out substrates were only collected in Reaches 1, 2 and part of Reach 3.

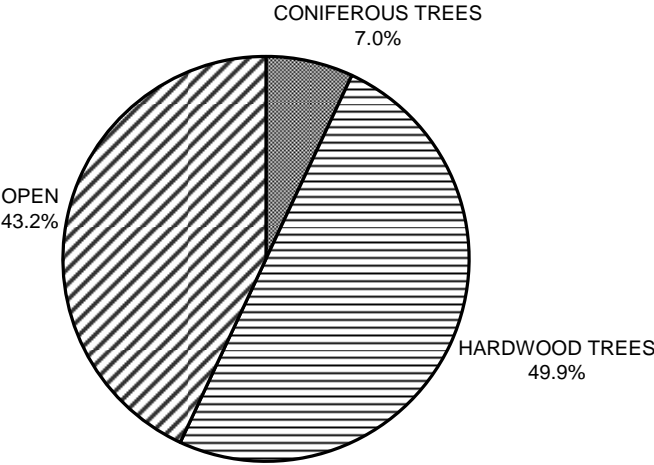
GRAPH 9

The mean percent canopy density for the stream reach surveyed was 57%. The mean percentages of hardwood and coniferous trees were 50% and 7%, respectively. 43% of the canopy was open. Graph 9 describes the mean percent canopy in Ackerman Creek.

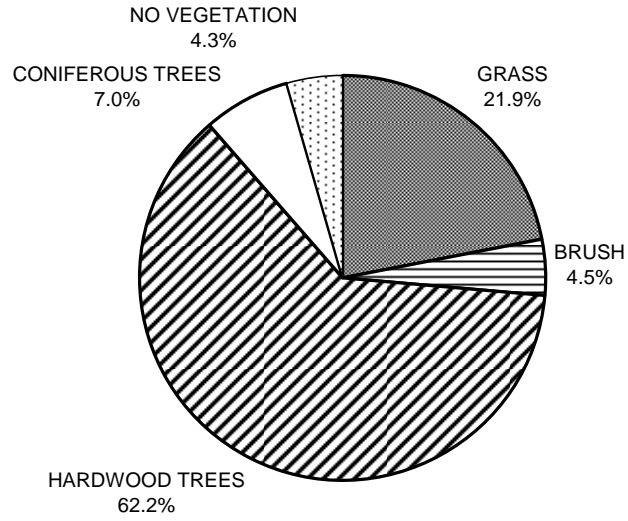
GRAPH 11

For the stream reach surveyed, the mean percent right bank vegetated was 56% and the mean percent left bank vegetated was 54%. The dominant substrate for the stream banks were: 34% cobble/gravel, 32% silt/clay/sand, 17% boulder and 17% bedrock (Graph 10). Hardwood trees were the dominant vegetation type observed in 62% of the units surveyed. Additionally, 22% of the units had grass as the dominant vegetation type and 7% had coniferous trees as the dominant vegetation (Graph 11).
