**CALIFORNIA DEPARTMENT OF FISH AND GAME
STREAM INVENTORY REPORT**

Coleman Creek

Report Revised April 14, 2006

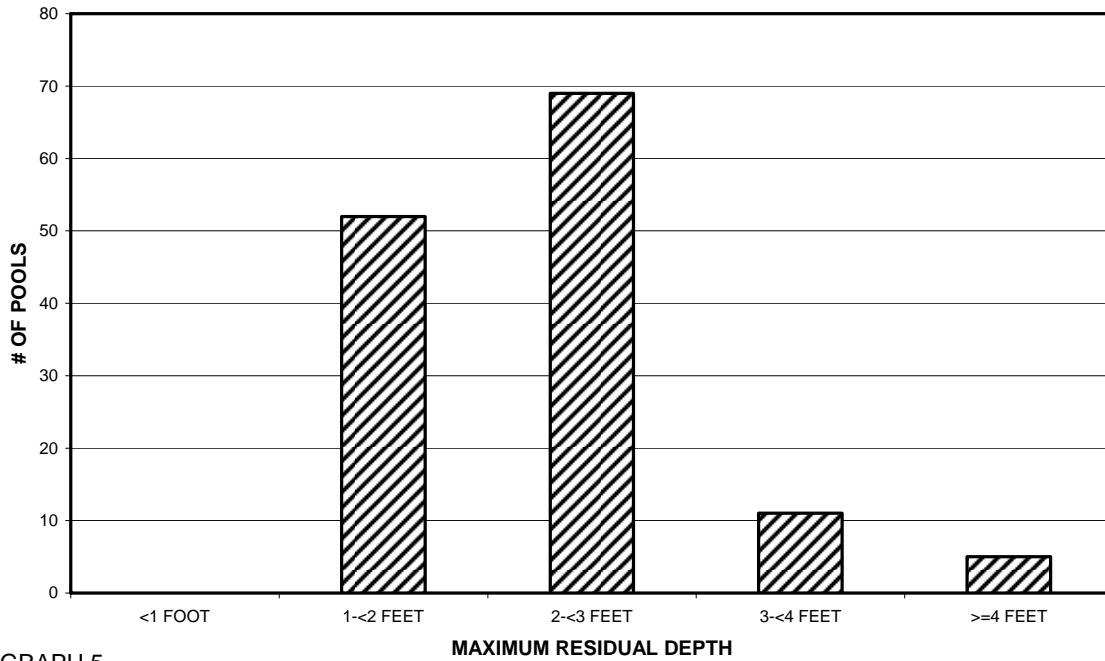
GRAPH 5

Table 4 is a summary of maximum residual pool depths by pool habitat types. Pool quality for salmonids increases with depth. Sixteen of the 137 pools (12%) had a residual depth of three feet or greater (Graph 5).

Flatwater habitat types comprised 66% of the total length of this survey, riffles 10%, and pools 13%. The pools are relatively shallow, with only 16 of the 137 (12%) pools having a maximum residual depth greater than 3 feet. In general, pool enhancement projects are considered when

5. Where feasible, design and engineer pool enhancement structures to increase the number of pools in the upper reaches. This must be done where the banks are stable or in conjunction with stream bank armor to prevent erosion.

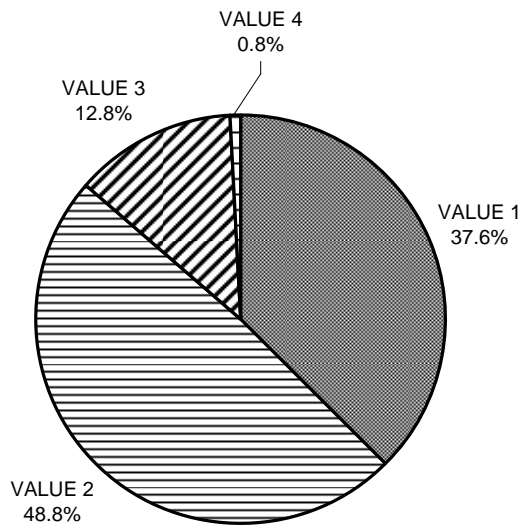
GRAPH 6

The depth of cobble embeddedness was estimated at pool tail-outs. Of the 119 pool tail-outs measured, 43 had a value of 1 (36.1%); 59 had a value of 2 (49.6%); 16 had a value of 3 (13.4%); one had a value of 4 (0.8%); (Graph 6). On this scale, a value of 1 indicates the best spawning conditions and a value of 4 the worst. Additionally, a value of 5 was assigned to tail-outs deemed unsuited for spawning due to inappropriate substrate like bedrock, log sills, boulders.

One-hundred two of the 119 pool tail-outs measured had embeddedness ratings of 1 or 2. Seventeen of the pool tail-outs had embeddedness ratings of 3 or 4. None of the pool tail-outs had a rating of 5, which is considered unsuitable for spawning. Cobble embeddedness measured to be 25% or less, a rating of 1, is considered to indicate good quality spawning substrate for salmon and steelhead. Sediment sources in Coleman Creek should be mapped and rated according to their potential sediment yields, and control measures should be taken.

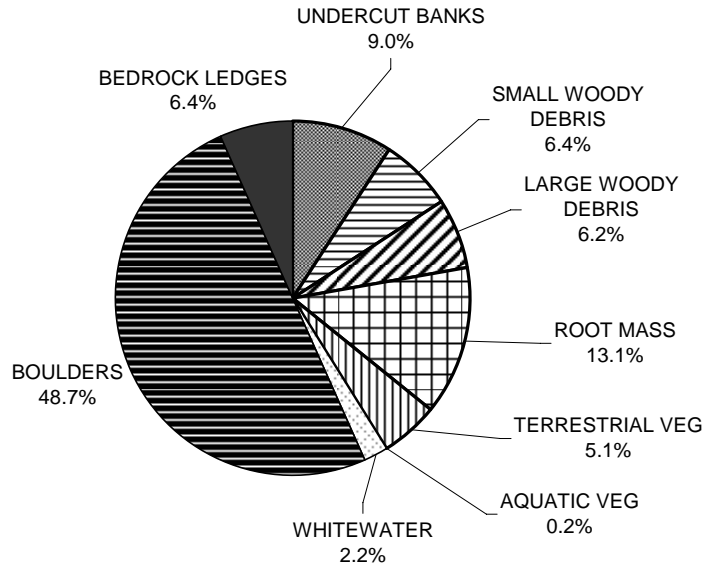
GRAPH 7

Table 5 summarizes mean percent cover by habitat type. Boulders are the dominant cover types in Coleman Creek. Graph 7 describes the pool cover in Coleman Creek. Boulders are the dominant pool cover type followed by root mass.

The mean shelter rating for pools was 16. The shelter rating in the flatwater habitats was 9. A pool shelter rating of approximately 100 is desirable. The amount of cover that now exists is being provided primarily by Boulders in Coleman Creek. Boulders are the dominant cover type in pools followed by root mass. Log and root wad cover structures in the pool and flatwater habitats would enhance both summer and winter salmonid habitat. Log cover structure provides rearing fry with protection from predation, rest from water velocity, and also divides territorial units to reduce density related competition.

4. Where feasible, increase woody cover in the pool and flatwater habitat units along the entire stream. Most of the existing shelter is from vegetation and undercut banks. Adding high quality complexity with larger woody cover is desirable. Combination cover/scour structures constructed with boulders and woody debris would be effective in many flatwater and pool locations in the upper reaches. This must be done where the banks are stable or in conjunction with stream bank armor to prevent erosion. In some areas the material is at hand.

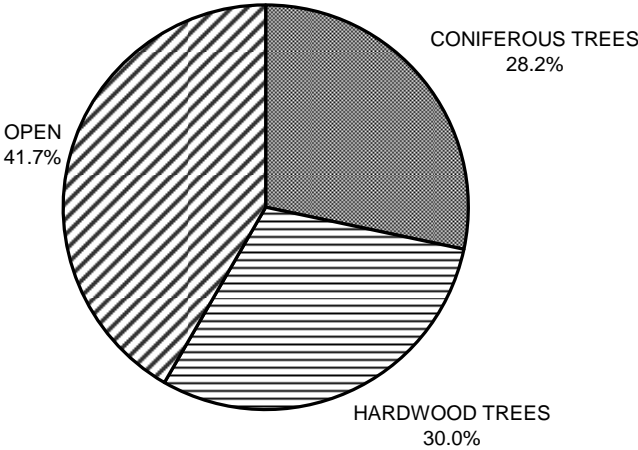
GRAPH 9

The mean percent canopy density for the surveyed length of Coleman Creek was 58%. The mean percentages of hardwood and coniferous trees were 51% and 48%, respectively. Forty-two percent of the canopy was open. Graph 9 describes the mean percent canopy in Coleman Creek.

The mean percent canopy density for the stream was 58%. Reach 1 had a canopy density of 27.3%, Reach 2 had a canopy density of 70.6%, Reach 3 had a canopy density of 75%, Reach 4 had a canopy density of 88.8%. In general, revegetation projects are considered when canopy density is less than 80%.

2. Increase the canopy on Coleman Creek by planting willow, alder, redwood, and Douglas fir along the stream where shade canopy is not at acceptable levels. The reach above the survey section should be assessed for planting and treated as well, since water temperatures throughout are effected from upstream. In many cases, planting will need to be coordinated to follow bank stabilization or upslope erosion control projects.

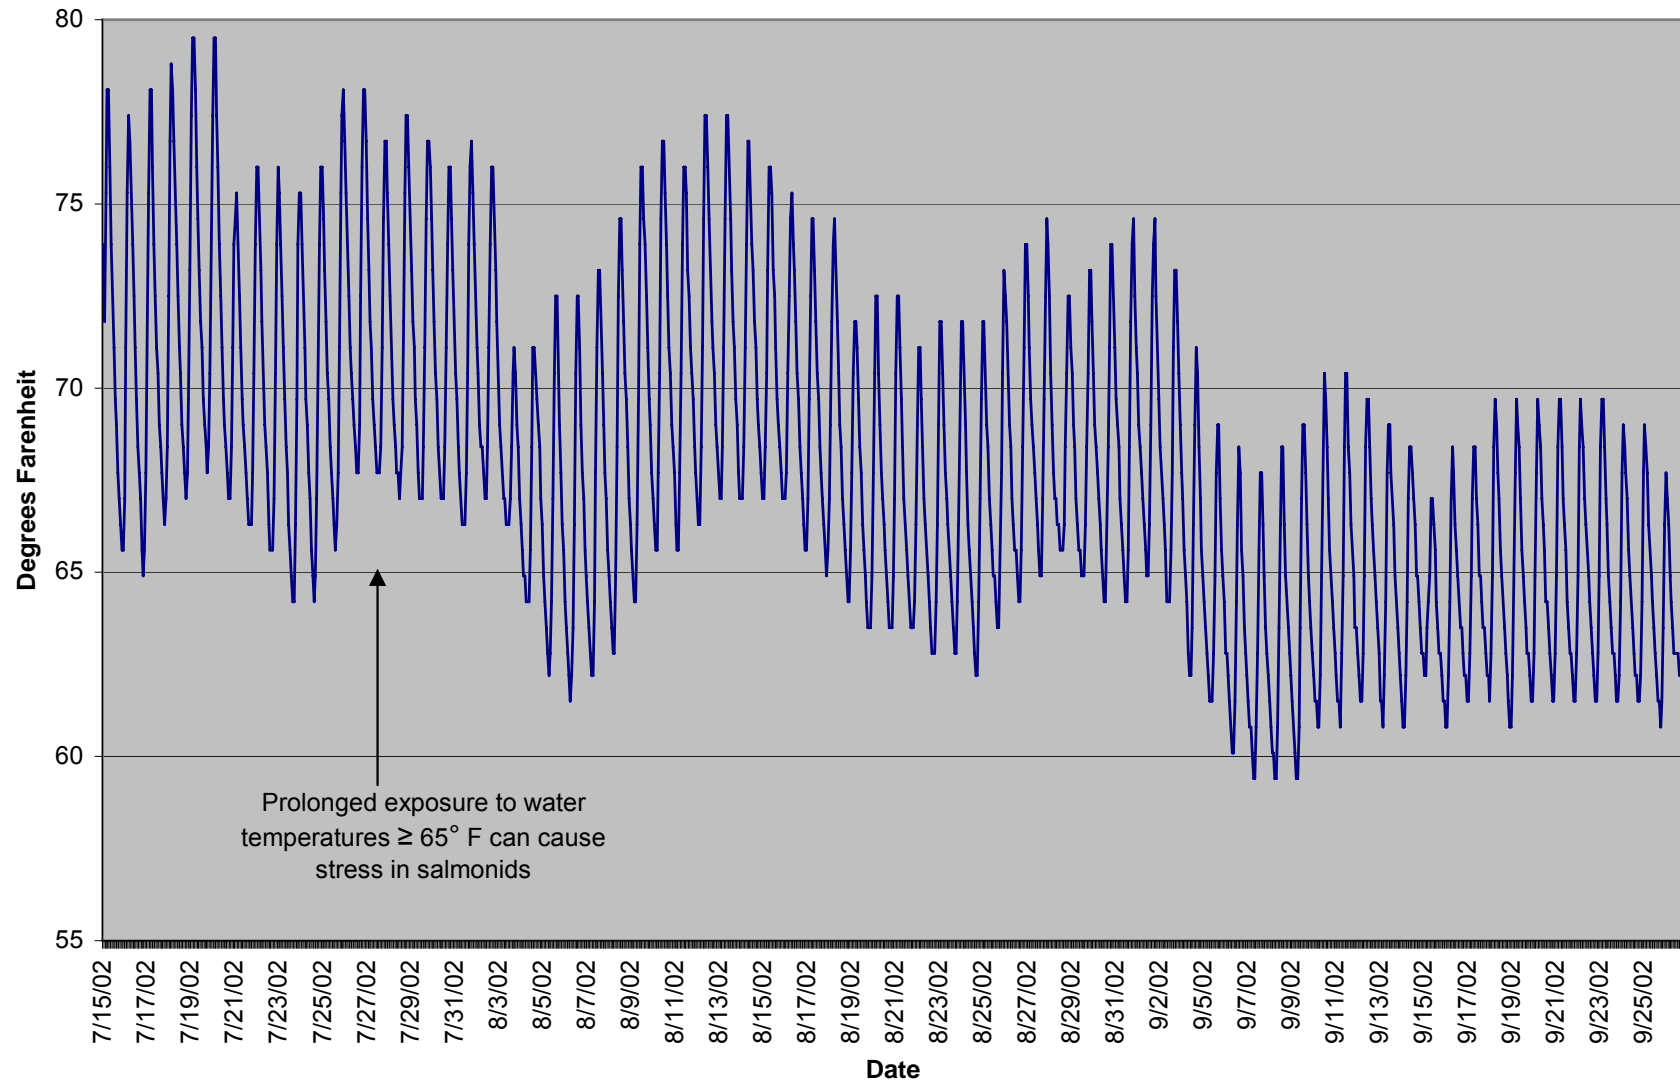
Coleman Creek Water Temperature 2002 (Reach 1)

Summer temperatures measured using a remote temperature recorder in Reach 1 ranged from 59.4° to 79.5°F. The Temperature Summary graph shows that for much of the summer (July through August) the lower watershed exhibited temperatures above the optimal for salmonids. It is unknown if this thermal regime is typical. To make any further conclusions, temperatures would need to be monitored throughout the warm summer months in more locations, and extensive biological sampling would need to be conducted.

6. If riparian areas are not improved temperatures in Coleman Creek should be monitored to determine if they are having a deleterious effect upon juvenile salmonids. To achieve this,
