**CALIFORNIA DEPARTMENT OF FISH AND GAME  
STREAM INVENTORY REPORT**

Mariposa Creek

*Report Completed April 14, 2006*

*Assesment Completed 2001*

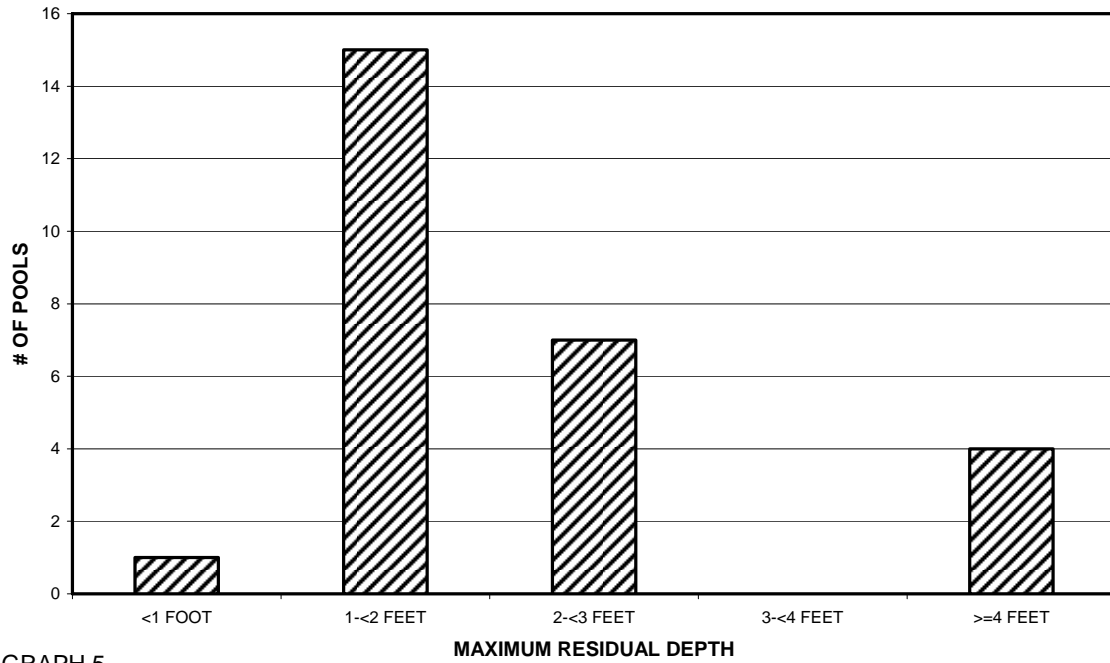
GRAPH 5

Eleven of the 27 pools (40.1%) had a depth of two feet or greater (Graph 5). These deeper pools comprised 8.6% of the total length of stream habitat.

Flatwater habitat types comprised 31% of the total length of this survey, riffles 1%, and pools 13%. The pools are relatively shallow, with only eleven of the twenty seven (41%) pools having a maximum residual depth greater than 2 feet. In first and second order streams, a primary pool is defined to have a maximum residual depth of at least two feet, occupy at least half the width of the low flow channel, and be as long as the low flow channel width. Pools comprised 8.6% of the total length of the stream surveyed. In general, pool enhancement projects are considered when primary pools comprise less than 40% of the length of total stream habitat. Installing structures that will increase or deepen pool habitat is recommended for locations where their installation will not be threatened by high stream energy, or where their installation will not conflict with the modification of the numerous log debris accumulations (LDA's) in the stream.

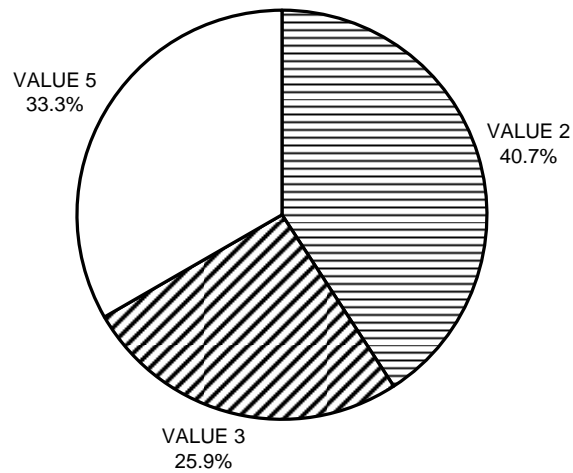
GRAPH 6

The depth of cobble embeddedness was estimated at pool tail-outs. On this scale, a value of one is best for fisheries. Of the twenty seven pool tail-outs measured, eleven had a value of 2 (41%) and seven had a value of 3 (26%). Nine riffles (33%) rated a 5 (unsuitable substrate type for spawning). Gravel and bedrock were the dominant substrates observed at pool tail-outs. Graph 6 describes percent embeddedness by reach.

Eleven of the twenty seven pool tail-outs measured had embeddedness ratings of 2. Seven of the pool tail-outs had embeddedness ratings of 3. Nine of the pool tail-outs had a rating of 5, which is considered unsuitable for spawning. Cobble embeddedness measured to be 25% or less, a rating of 1, is considered to indicate good quality spawning substrate for salmon and steelhead. None of the pool tail-outs rated a 1. Sediment sources in Mariposa Creek should be mapped and rated according to their potential sediment yields, and control measures should be taken.

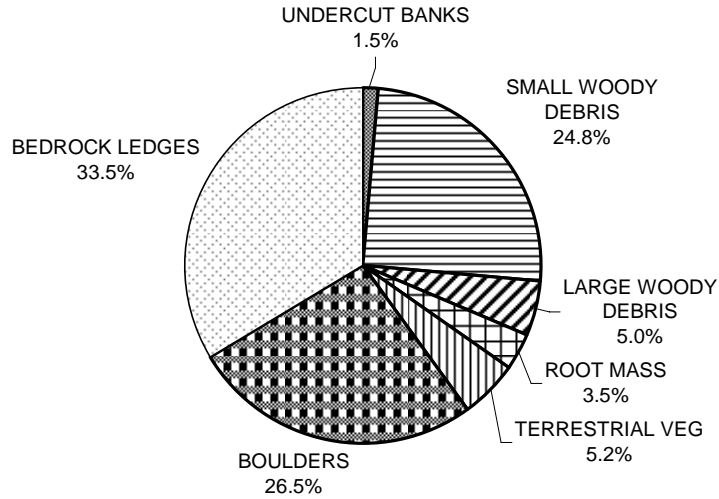
GRAPH 7

Table 5 summarizes fish shelter by habitat type. By percent area, the dominant pool shelter types were Bedrock at 40%, Boulders at 29%, Small Wood at 21%, Terrestrial Vegetation at 4%. Graph 7 describes the pool shelter in Mariposa Creek.

The mean shelter rating for pools was 9. The shelter rating in the flatwater habitats was 6. A pool shelter rating of approximately 100 is desirable. The amount of cover that now exists is being provided primarily by Bedrock Ledges in Mariposa Creek. Bedrock Ledges are the dominant cover type in pools followed by boulders. Log and root wad cover structures in the pool and flatwater habitats would enhance both summer and winter salmonid habitat. Log cover structure provides rearing fry with protection from predation, rest from water velocity, and also divides territorial units to reduce density related competition.

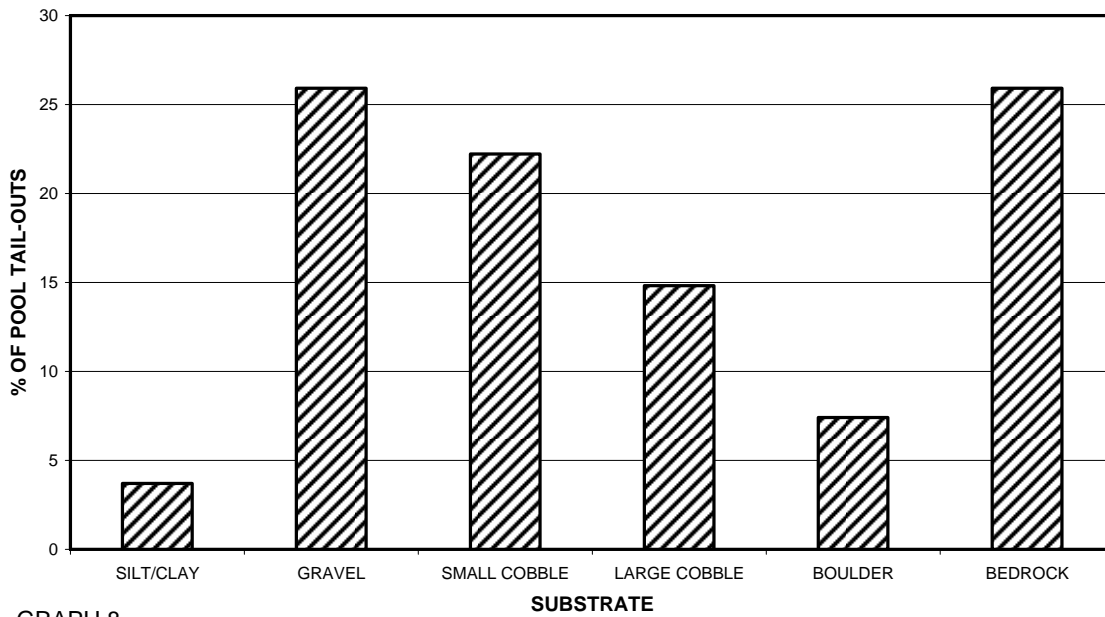
GRAPH 8

Table 6 summarizes the dominant substrate by habitat type. Graph 8 summarizes the dominant substrate in pool tail-outs. Gravel and bedrock were the dominant substrates at 25.9% each.

Fourteen of the twenty seven pool tail-outs had silt, sand, large cobble, boulders or bedrock as the dominant substrate. This is generally considered unsuitable for spawning salmonids.

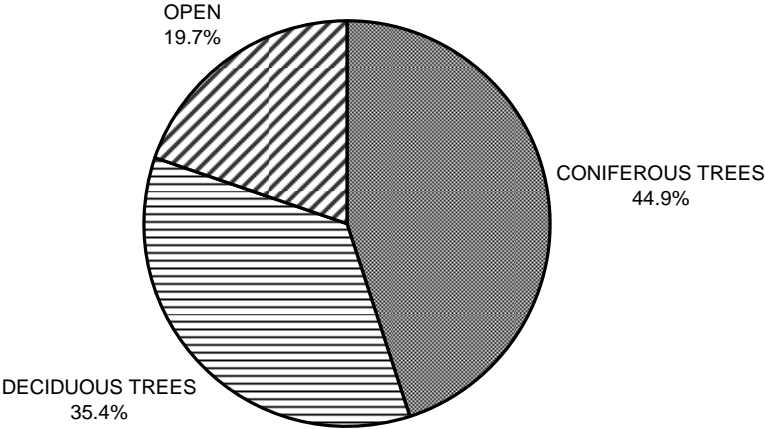
GRAPH 9

The mean percent canopy density for the stream reach surveyed was 80.3%. The mean percentages of deciduous and evergreen trees were 52% and 48%, respectively. Graph 9 describes the canopy for the entire survey.

The mean percent canopy density for the stream was 80.3%. Reach 1 had a canopy density of 71.7%, Reach 2 had a canopy density of 74.2%, Reach 3 had a canopy density of 88.6%, Reach 4 had a canopy density of 80.8%. In general, revegetation projects are considered when canopy

density is less than 80%.

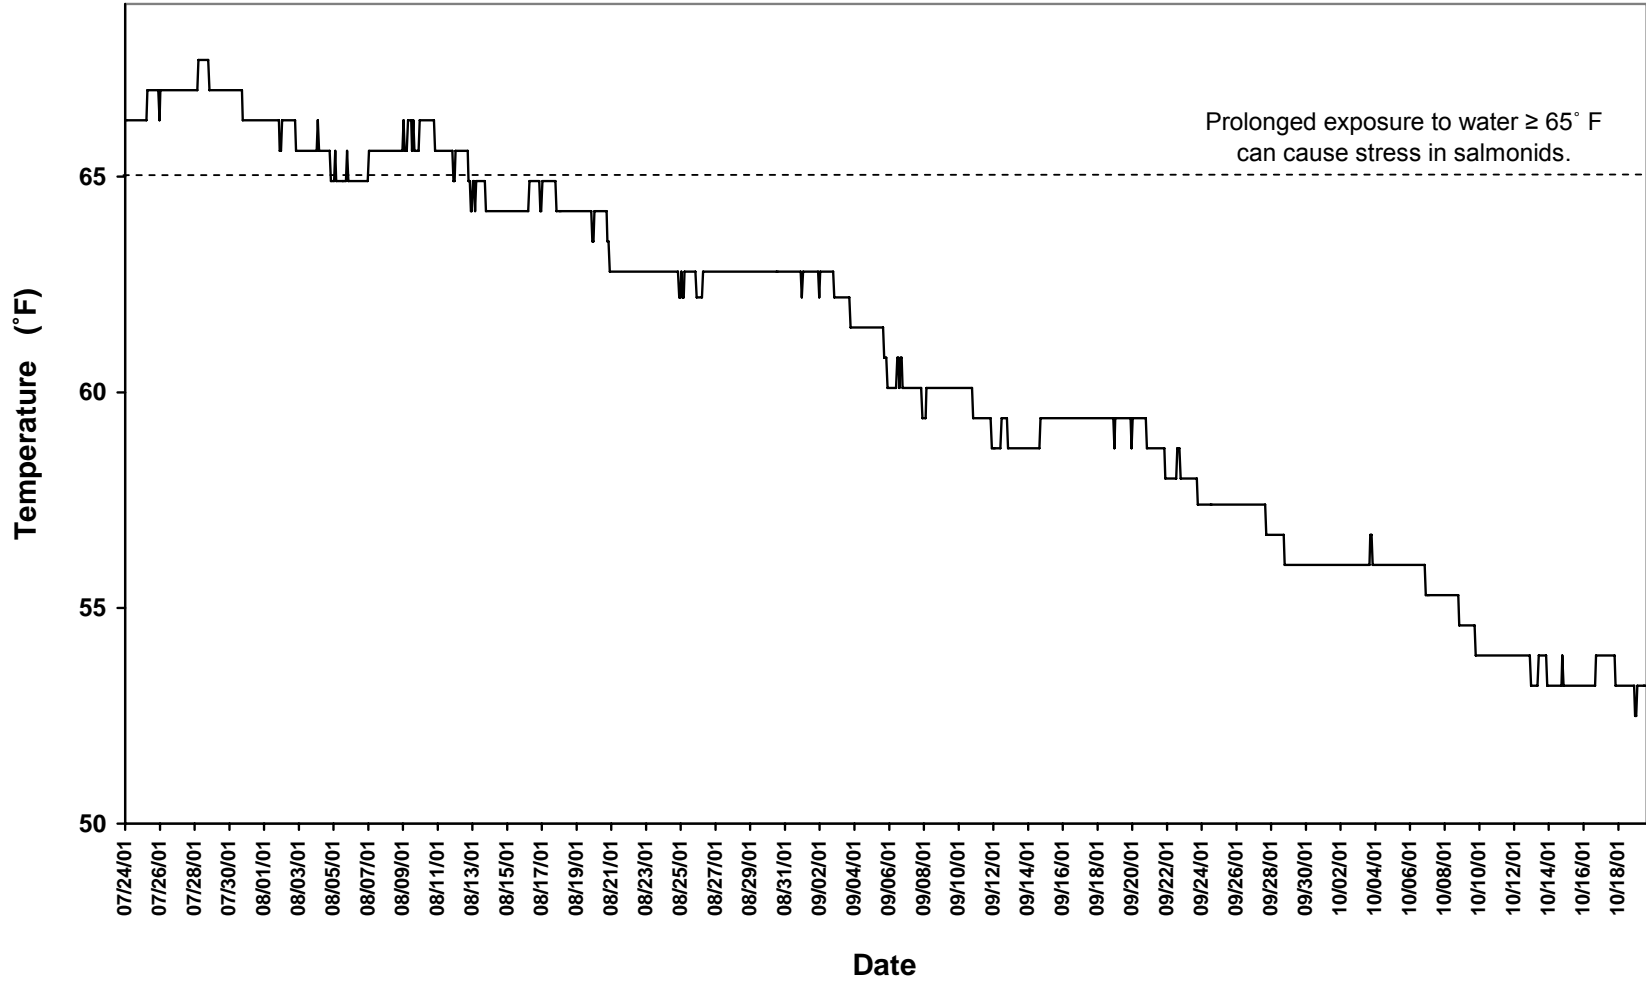
Mariposa Creek Water Temperatures

Summer temperatures were also measured using remote temperature recorders placed in pools (see Temperature Summary graphs at end of report). A recorder in Reach 1 (in the pool just downstream of the Tomki Road bridge) logged temperatures every 2 hours from July 24 – October 19 , 2001. The highest temperature recorded was 68°F on July 28 and the lowest was 53°F on October 28. The mean of the daily highs was 67.1°F for the month of July, 64.6°F for August, 59.5°F for September, and 54.7°F for October.

The water temperatures recorded on the survey days 9/5/2001 to 9/10/2001 ranged from 60 to 65 degrees Fahrenheit. Temperatures at or below 65 degrees Fahrenheit are suitable for salmonids. Air temperatures ranged from 62 to 78 degrees Fahrenheit.
