**CALIFORNIA DEPARTMENT OF FISH AND GAME
STREAM INVENTORY REPORT**

McDonald Creek

Report Revised April 14, 2006

Assessment Completed 2002

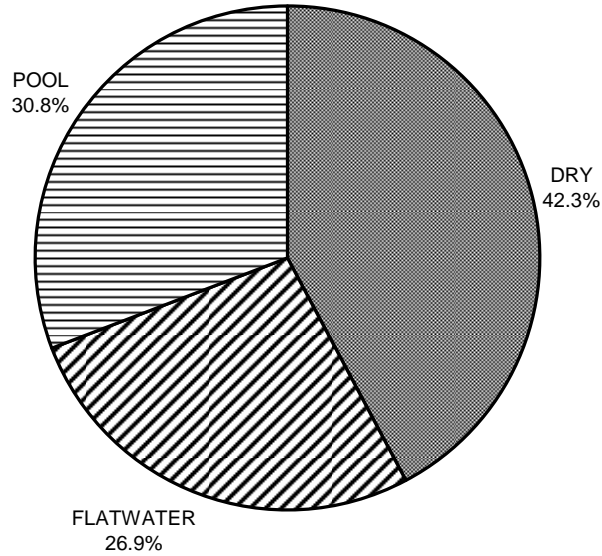
GRAPH 1: Level II habitat types by percent occurrence

Table 1 summarizes the Level II riffle, flatwater, and pool habitat types. Based on frequency of occurrence there were 42% dry units, 31% pool units, 27% flatwater units, (Graph 1). Based on total length of Level II habitat types there were 78% dry units, 5% pool units, 17% flatwater units, (Graph 2).

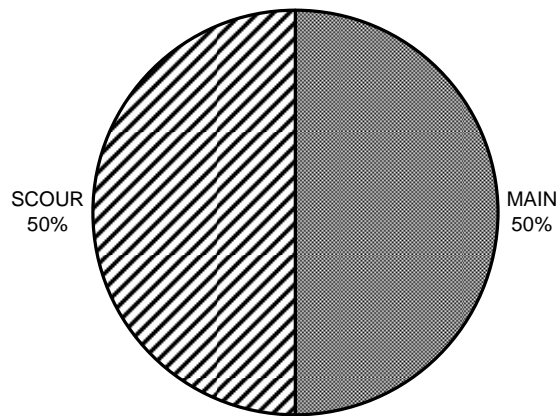
GRAPH 4: Level I pool types by percent occurrence

A total of 16 pools were identified (Table 3). Scour pools were the most frequently encountered, at

50%, and comprised 29% of the total length of all pools (Graph 4).

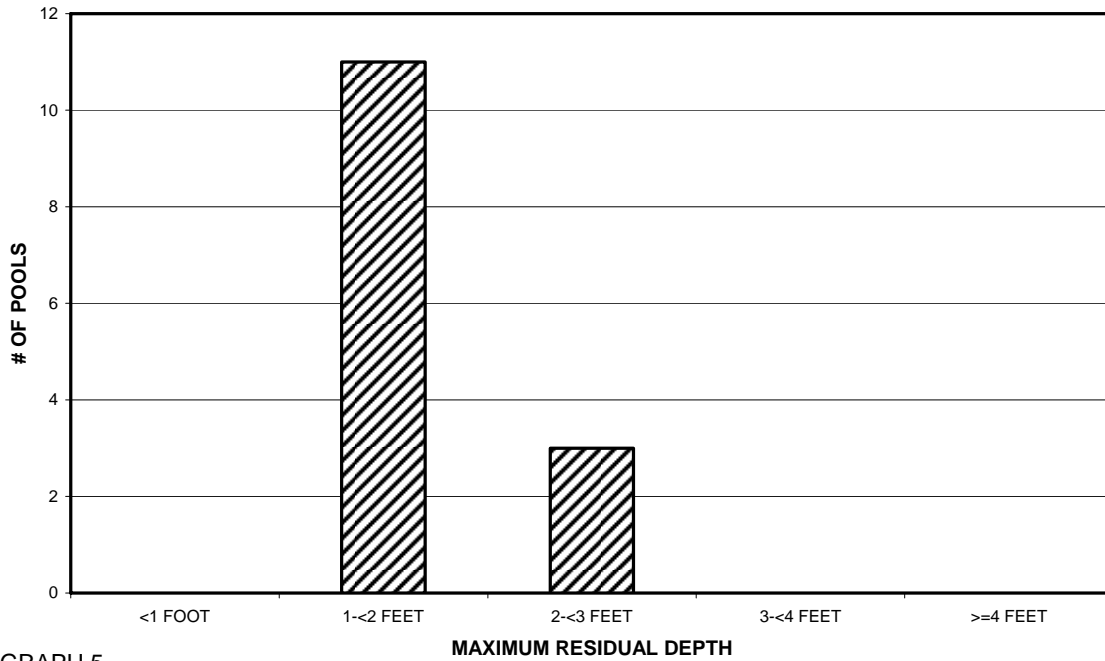
GRAPH 5

Table 4 is a summary of maximum residual pool depths by pool habitat types. Pool quality for salmonids increases with depth. Three of the 14 pools (21%) had a residual depth of two feet or greater (Graph 5).

Flatwater habitat types comprised 17% of the total length of this survey and pools 5%. The pools are relatively shallow, with only three of the fourteen (21%) pools having a maximum residual depth greater than 2 feet. In general, pool enhancement projects are considered when primary pools comprise less than 40% of the length of total stream habitat. In first and second order streams, a primary pool is defined to have a maximum residual depth of at least two feet, occupy at least half the width of the low flow channel, and be as long as the low flow channel width. Installing structures that will increase or deepen pool habitat is recommended for locations where their installation will not be threatened by high stream energy, or where their installation will not conflict with the modification of the numerous log debris accumulations (LDA's) in the stream.

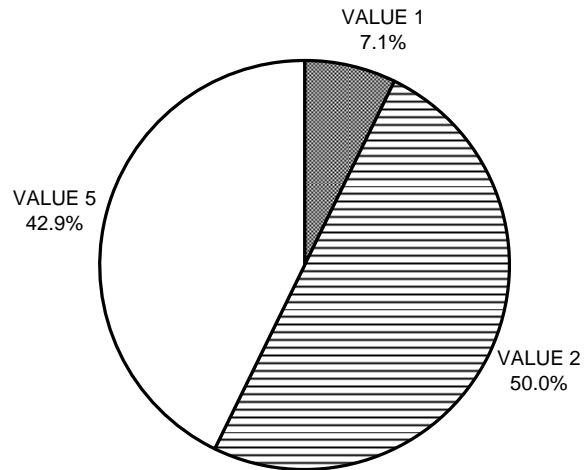
GRAPH 6

The depth of cobble embeddedness was estimated at pool tail-outs. Of the 13 pool tail-outs measured, one had a value of 1 (7.7%); seven had a value of 2 (53.8%); five had a value of 5 (38.5%); (Graph 6). On this scale, a value of 1 indicates the best spawning conditions and a value of 4 the worst. Additionally, a value of 5 was assigned to tail-outs deemed unsuited for spawning due to inappropriate substrate like bedrock, log sills, boulders.

Eight of the 13 pool tail-outs measured had embeddedness ratings of 1 or 2. None of the pool tail-outs had embeddedness ratings of 3 or 4. Five of the pool tail-outs had a rating of 5, which is considered unsuitable for spawning. Cobble embeddedness measured to be 25% or less, a rating of 1, is considered to indicate good quality spawning substrate for salmon and steelhead. Sediment sources in McDonald Creek should be mapped and rated according to their potential sediment yields, and control measures should be taken.

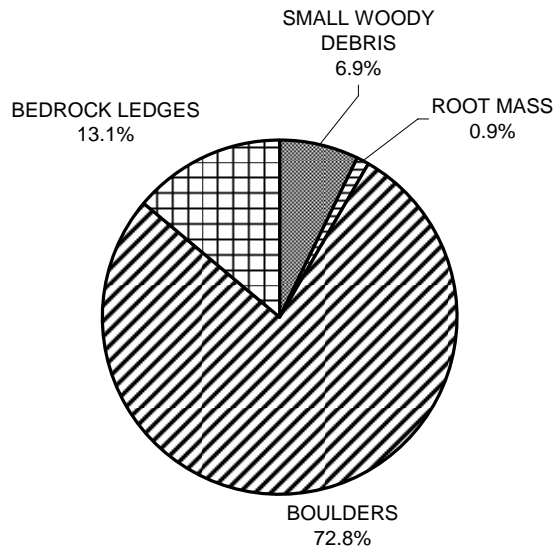
GRAPH 7

Table 5 summarizes mean percent cover by habitat type. Boulders are the dominant cover types in McDonald Creek. Graph 7 describes the pool cover in McDonald Creek. Boulders is the dominant pool cover type followed by bedrock ledges.

The mean shelter rating for pools was 19. The shelter rating in the flatwater habitats was 8. A pool shelter rating of approximately 100 is desirable. The amount of cover that now exists is being provided primarily by Boulders in McDonald Creek. Boulders are the dominant cover type in pools followed by bedrock ledges . Log and root wad cover structures in the pool and flatwater habitats

would enhance both summer and winter salmonid habitat. Log cover structure provides rearing fry with protection from predation, rest from water velocity, and also divides territorial units to reduce density related competition.

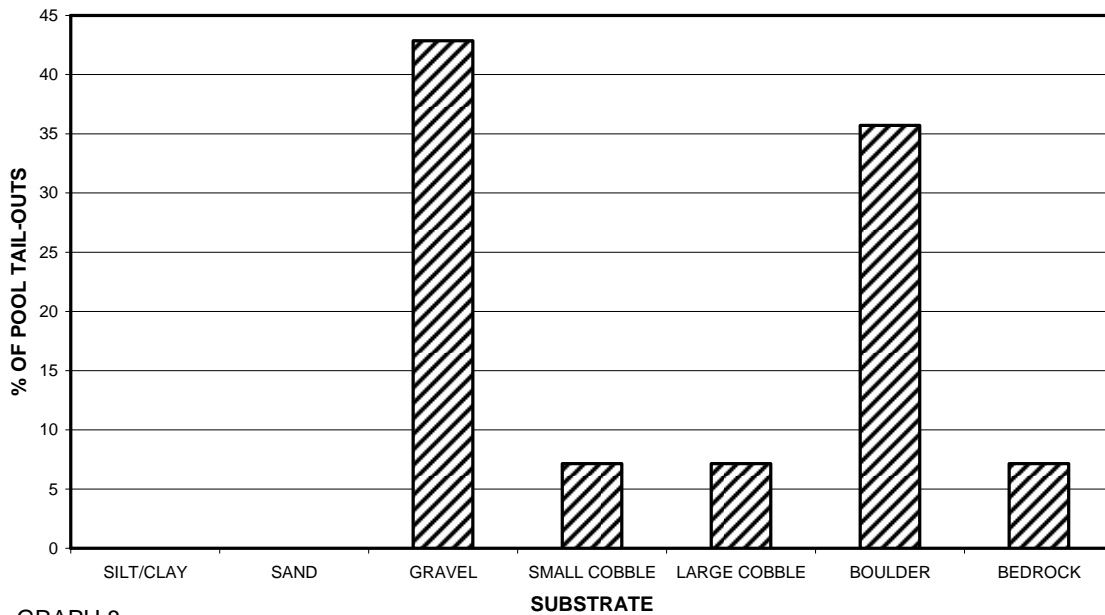
GRAPH 8

Table 6 summarizes the dominant substrate by habitat type. Graph 8 depicts the dominant substrate observed in pool tail-outs. Gravel was observed in 43% of pool tail-outs and boulders were observed in 36% of pool tail-outs.

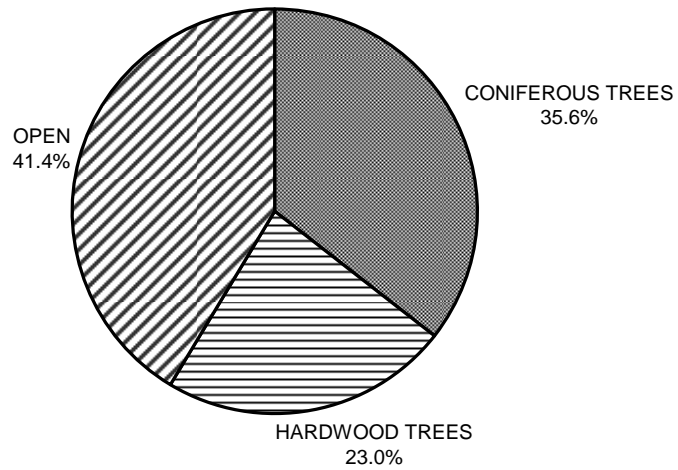
GRAPH 9

The mean percent canopy density for the surveyed length of McDonald Creek was 59%. The mean percentages of hardwood and coniferous trees were 39% and 61%, respectively. Forty-one percent of the canopy was open. Graph 9 describes the mean percent canopy in McDonald Creek.

The mean percent canopy density for the stream was 59%. Reach 1 had a canopy density of 61.5%, Reach 2 had a canopy density of 62.5%, Reach 3 had a canopy density of 37.5%, Reach 4 had a canopy density of 65%, . In general, revegetation projects are considered when canopy density is less than 80%.

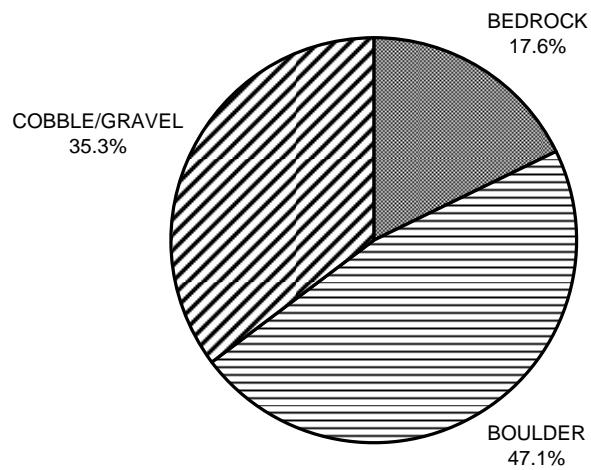
GRAPH 10

For the stream reach surveyed, the mean percent right bank vegetated was 14%. The mean percent left bank vegetated was 18%. The dominant elements composing the structure of the stream banks consisted of 18% bedrock, 47% boulder, 35% cobble/gravel, (Graph 10). Grass and brush were the dominant vegetation type observed in 6% of the units surveyed. Additionally, 21% of the units surveyed had hardwood trees as the dominant vegetation type, and 65% had coniferous trees as the dominant vegetation (Graph 11).

The percentage of right and left bank covered with vegetation was low at 14% and 18%, respectively. In areas of stream bank erosion or where bank vegetation is sparse, planting endemic species of coniferous and hardwood trees, in conjunction with bank stabilization, is recommended.
