CALIFORNIA DEPARTMENT OF FISH AND GAME  
STREAM INVENTORY REPORT

McDowell Creek

*Report Revised April 14, 2006*

*Report Completed 2005*

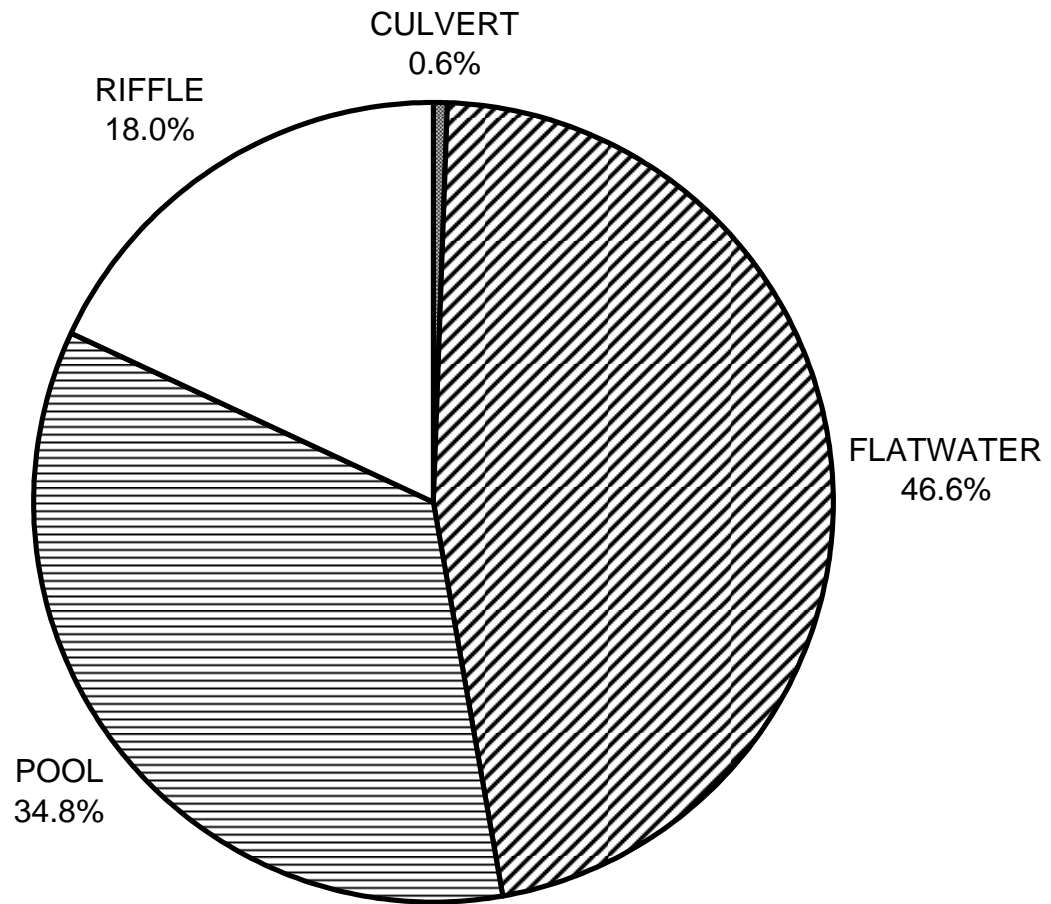
GRAPH 1

Table 1 summarizes the Level II riffle, flatwater, and pool habitat types. Based on frequency of occurrence there were 35% pool units, 47% flatwater units, 18% riffle units, 1% culvert units, (Graph 1). Based on total length of Level II habitat types there were 17% pool units, 70% flatwater units, 12% riffle units, 1% culvert units, (Graph 2).

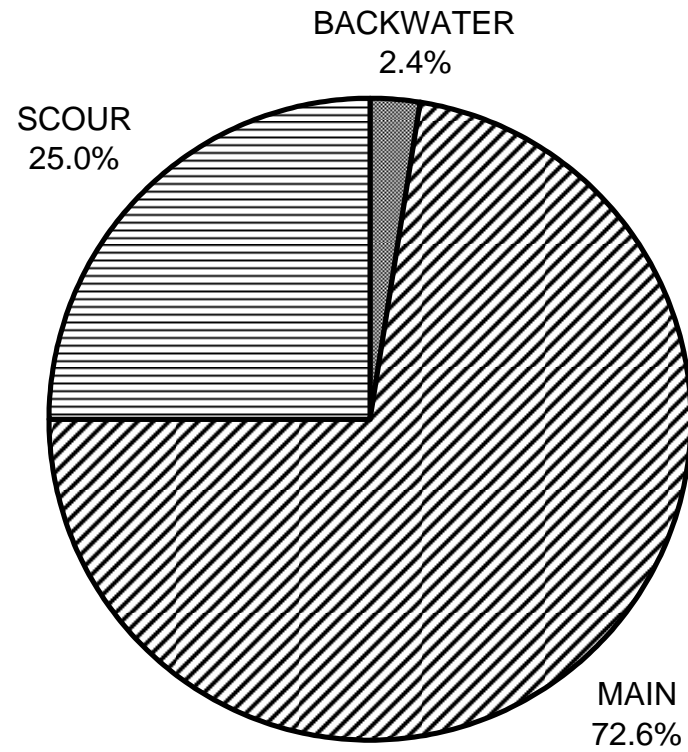
GRAPH 4

A total of 124 pools were identified (Table 3). Main Channel pools were the most frequently encountered, at 73%, and comprised 78% of the total length of all pools (Graph 4).

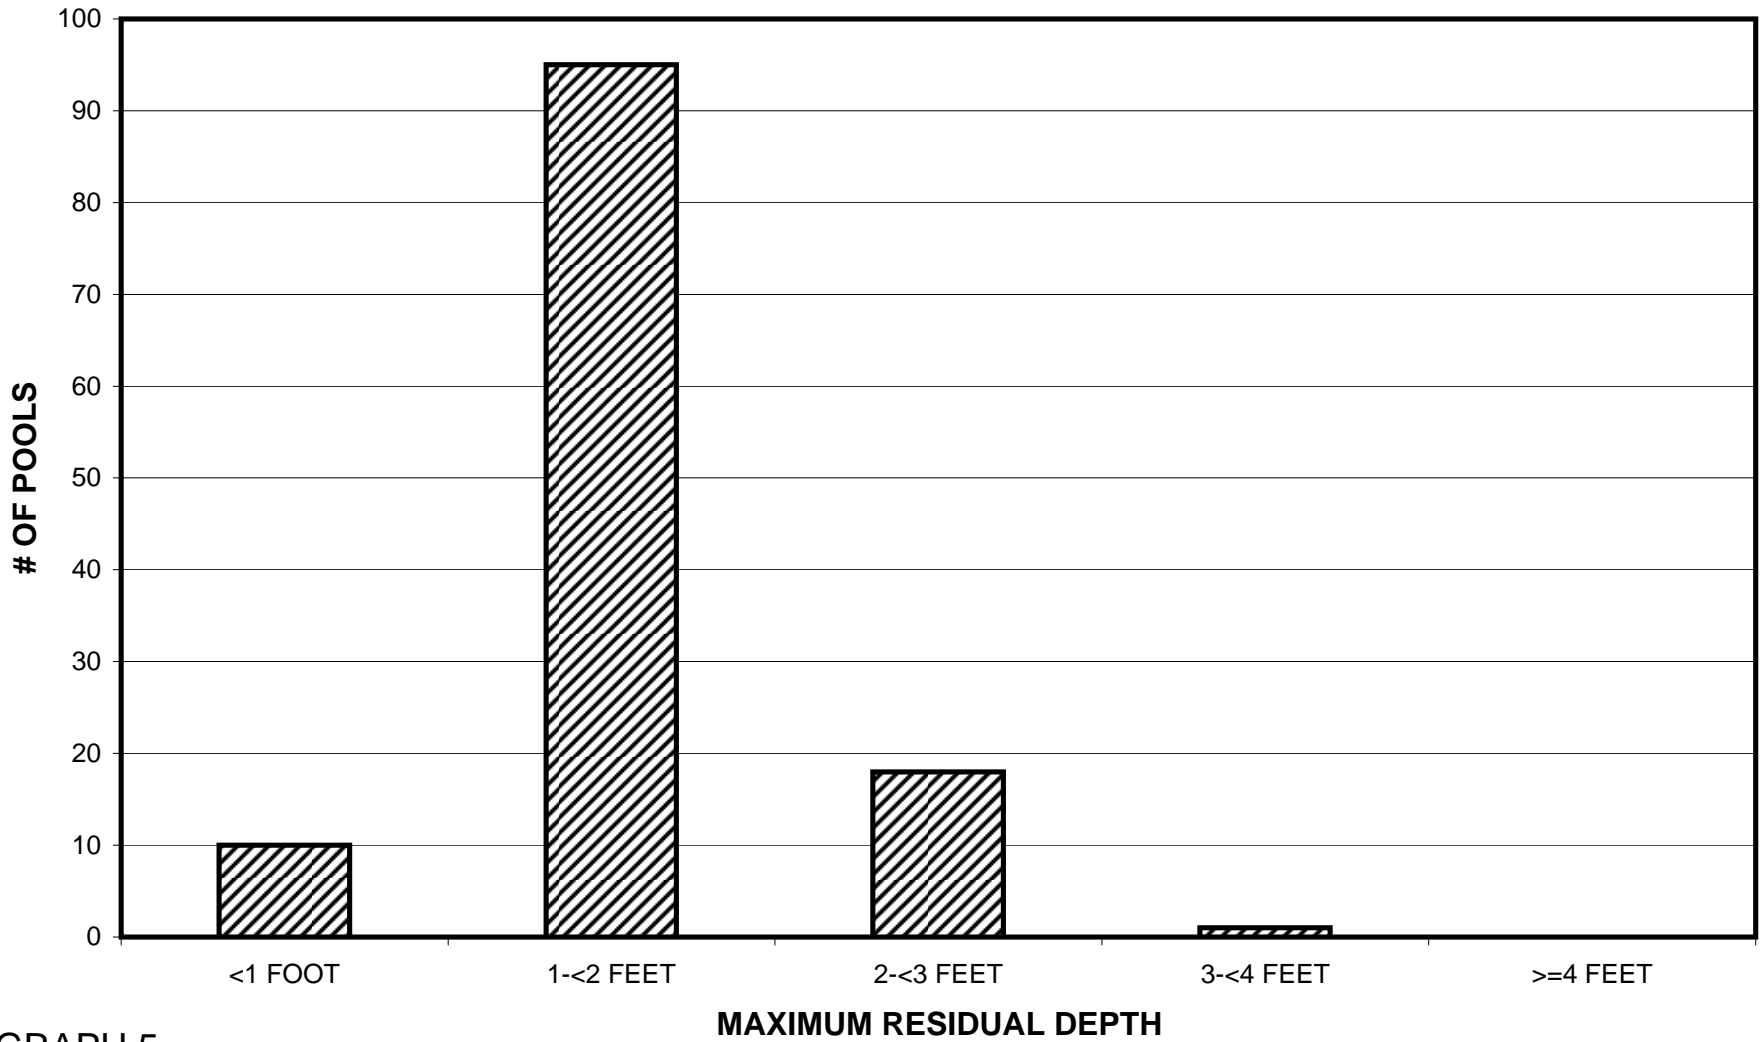
GRAPH 5

Table 4 is a summary of maximum residual pool depths by pool habitat types. Pool quality for salmonids increases with depth. One of the 124 pools (1%) had a residual depth of three feet or greater (Graph 5).

Flatwater habitat types comprised 70% of the total length of this survey, riffles 12%, and pools 17%. The pools are shallow one of the 124 (1%) pools having a maximum residual depth greater than 3 feet. In general, pool enhancement projects are considered when primary pools comprise less than 40% of the length of total stream habitat. In third and fourth order streams, a primary pool is defined to have a maximum residual depth of at least three feet, occupy at least half the width of the low flow channel, and be as long as the low flow channel width. Installing structures that will increase or deepen pool habitat is recommended for locations where their installation will not be threatened by high stream energy, or where their installation will not conflict with the modification of the numerous log debris accumulations (LDA's) in the stream.

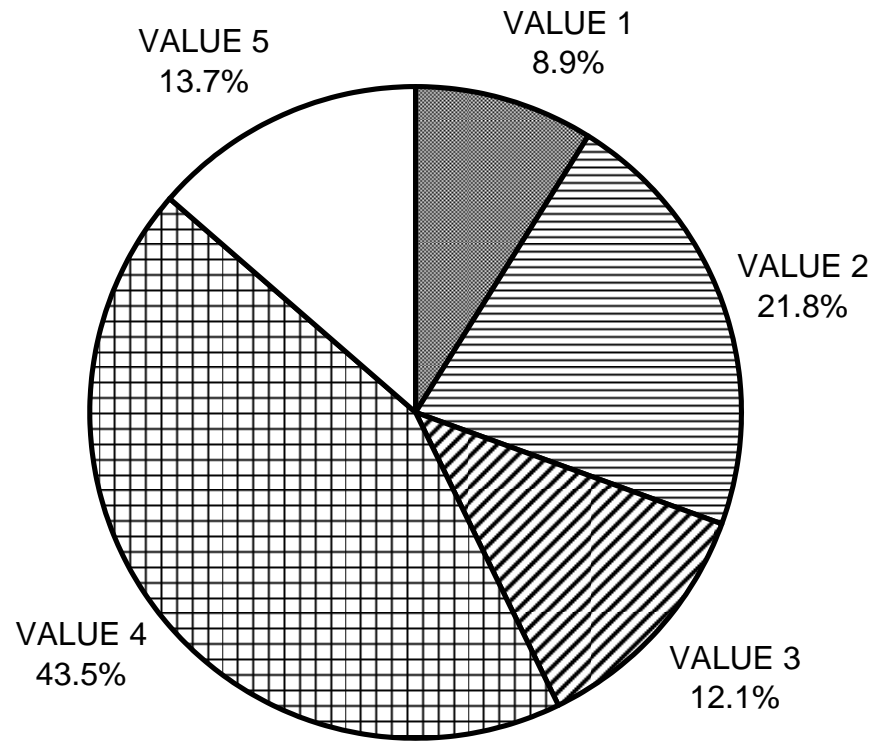
GRAPH 6

The depth of cobble embeddedness was estimated at pool tail-outs. Of the 120 pool tail-outs measured, eleven had a value of 1 (9.2%); twenty-seven had a value of 2 (22.5%); fifteen had a value of 3 (12.5%); fifty-three had a value of 4 (44.2%); fourteen had a value of 5 (11.7%); (Graph 6). On this scale, a value of 1 indicates the best spawning conditions and a value of 4 the worst. Additionally, a value of 5 was assigned to tail-outs deemed unsuited for spawning due to inappropriate substrate like bedrock, log sills, or boulders.

Thirty-eight of the 120 pool tail-outs measured had embeddedness ratings of 1 or 2. Sixty-eight of the pool tail-outs had embeddedness ratings of 3 or 4. Fourteen of the pool tail-outs had a rating of 5, which is considered unsuitable for spawning. Cobble embeddedness measured to be

25% or less, a rating of 1, is considered to indicate good quality spawning substrate for salmon and steelhead. Sediment sources in McDowell Creek should be mapped and rated according to their potential sediment yields, and control measures should be taken.

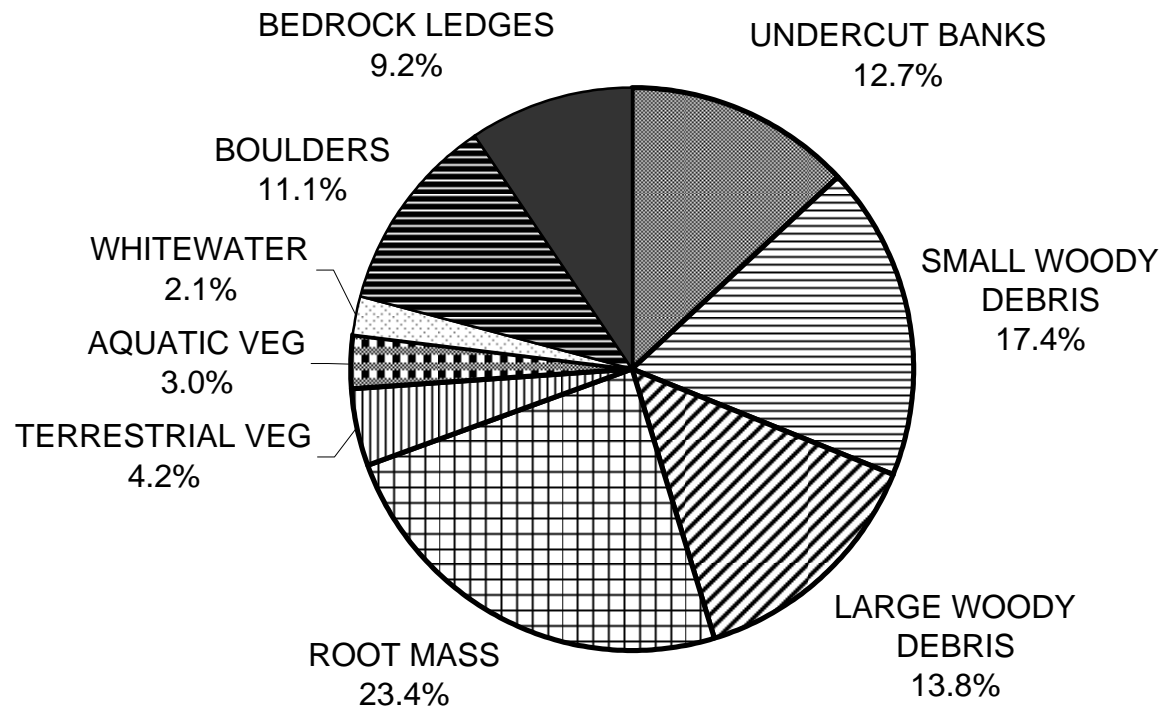
GRAPH 7

Table 5 summarizes mean percent cover by habitat type. Small Woody Debris is the dominant cover type in McDowell Creek. Graph 7 describes the pool cover in McDowell Creek. Root Mass is the dominant pool cover type followed by small woody debris.

The mean shelter rating for pools was 14. The shelter rating in the flatwater habitats was 11. A pool shelter rating of approximately 100 is desirable. The amount of cover that now exists is being provided primarily by Small Woody Debris in McDowell Creek. Root Mass are the dominant cover type in pools followed by small woody debris. Log and root wad cover structures in the pool and flatwater habitats would enhance both summer and winter salmonid habitat. Log cover structure provides rearing fry with protection from predation, rest from water velocity, and also divides territorial units to reduce density related competition.

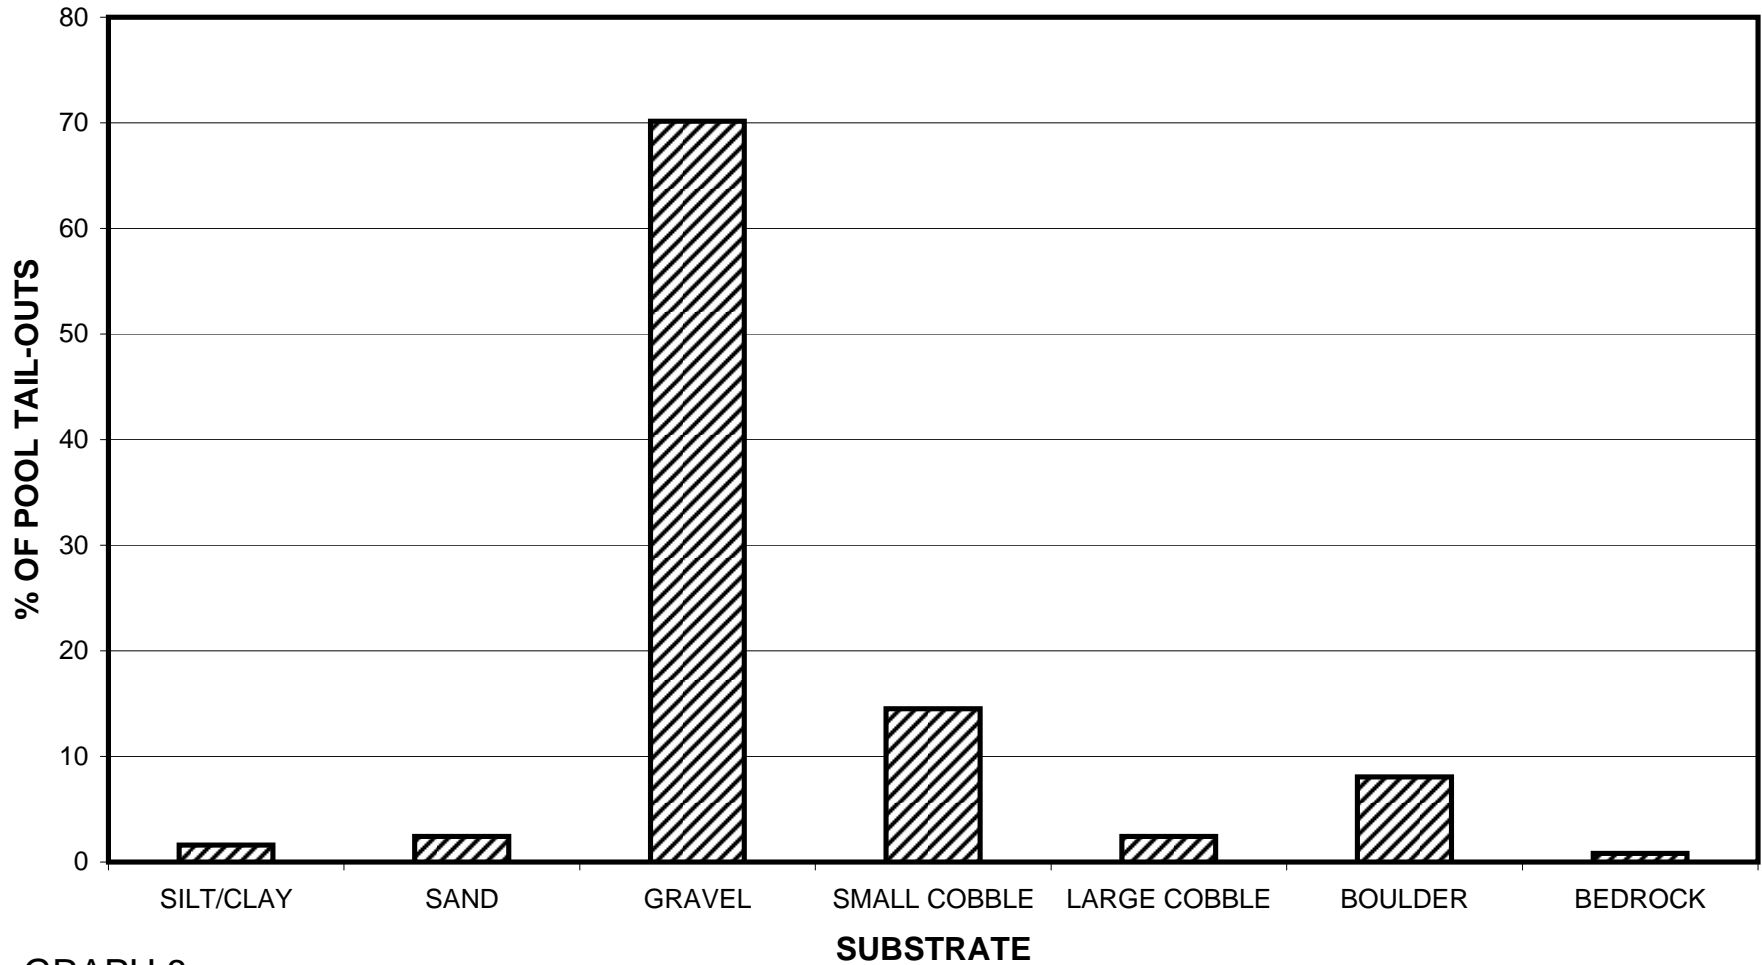
GRAPH 8

Table 6 summarizes the dominant substrate by habitat type. Graph 8 depicts the dominant substrate observed in pool tail-outs. Gravel was observed in 70% of pool tail-outs, and small Cobble observed in 15% of pool tail-outs.

One-hundred five of the 124 pool tail-outs measured had gravel or small cobble as the dominant substrate. This is generally considered good for spawning salmonids.

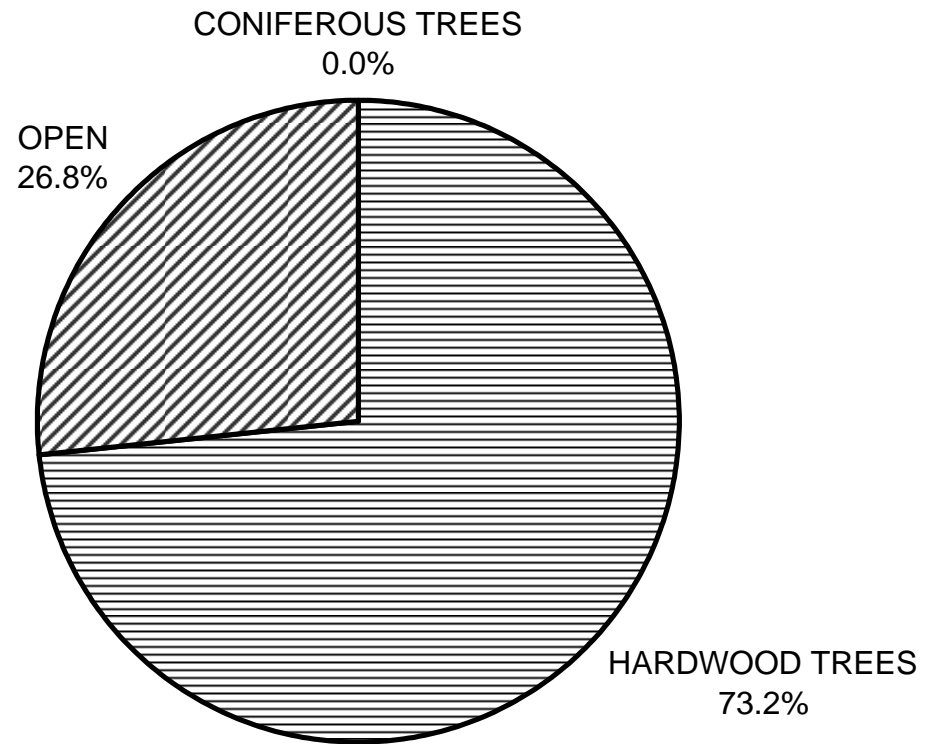
GRAPH 9

The mean percent canopy density for the surveyed length of McDowell Creek was 73%. The mean percentages of hardwood and coniferous trees were 100% and 0%, respectively. Twenty-seven percent of the canopy was open. Graph 9 describes the mean percent canopy in McDowell Creek.

The mean percent canopy density for the stream was 73%. Reach 1 had a canopy density of 82.2%, Reach 2 had a canopy density of 90.6%, Reach 3 had a canopy density of 52.1%, Reach 4 had a canopy density of 77.4%, Reach 5 had a canopy density of 80.9%. In general, revegetation projects are considered when canopy density is less than 80%.

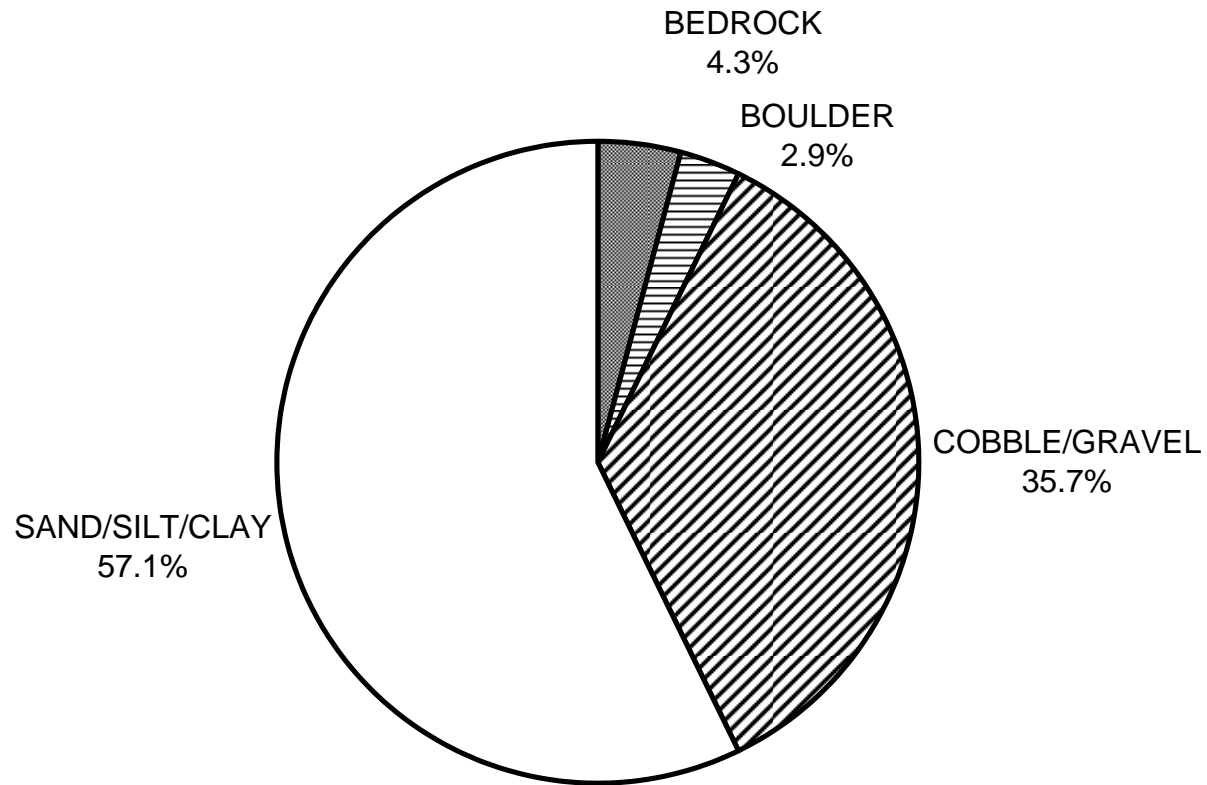
GRAPH 10

For the stream reach surveyed, the mean percent right bank vegetated was 66%. The mean percent left bank vegetated was 64%. The dominant elements composing the structure of the stream banks consisted of 4% bedrock, 3% boulder, 36% cobble/gravel, 57% sand/silt/clay, (Graph 10). Deciduous trees were the dominant vegetation type observed in 59% of the units surveyed. Additionally, there were no coniferous trees as a dominant vegetation type, (Graph 11).

The percentage of right and left bank covered with vegetation was moderate at 66% and 64%, respectively. In areas of stream bank erosion or where bank vegetation is sparse, planting endemic species of coniferous and hardwood trees, in conjunction with bank stabilization, is recommended.
