**CALIFORNIA DEPARTMENT OF FISH AND GAME
STREAM INVENTORY REPORT**

Morrison Creek

Report Revised April 14, 2006

Assessment Completed 2001

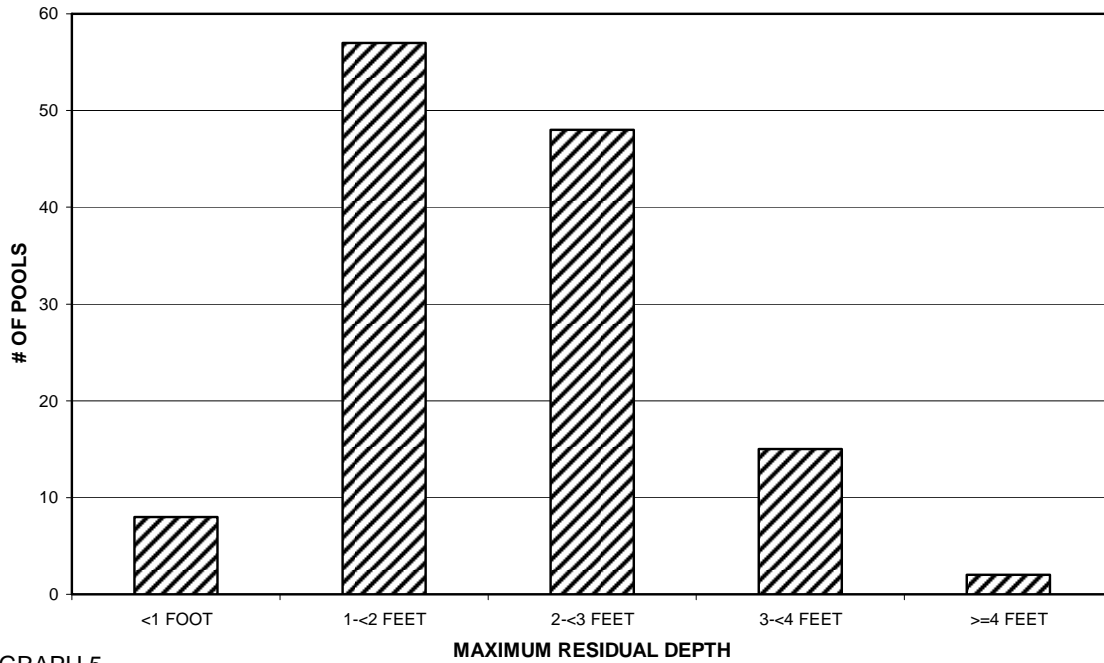
GRAPH 5

Fourteen of the 133 pools (10.5%) had a depth of three feet or greater (Graph 5).

**MORRISON CREEK 2001
MAXIMUM DEPTH IN POOLS**

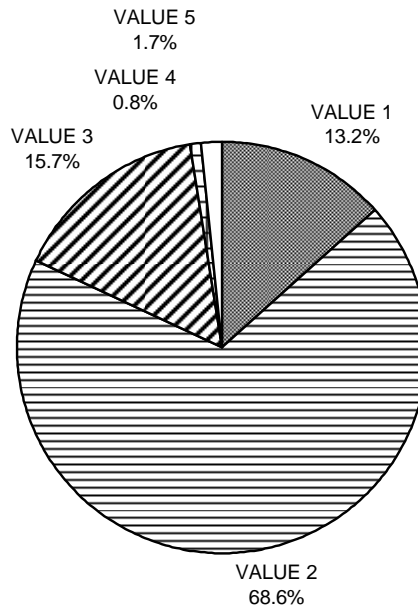
GRAPH 6

The depth of cobble embeddedness was estimated at pool tail-outs. Of the 122 pool tail-outs measured, seventeen had a value of 1 (13%), eighty-three had a value of 2 (68%), nineteen had a value of 3 (16%) and one had a value of 4 (1%). Two of the riffles (2%) rated a 5, which is unsuitable substrate type for spawning. On this scale, a value of one is best for fisheries. Small Cobble was the dominant substrate observed at pool tail-outs. Table 8 describes percent embeddedness by reach.

Sixteen percent of the pool tail-outs measured had embeddedness ratings of either 3 or 4. Only 13% had a rating of 1. Cobble embeddedness measured to be 25% or less (a rating of 1) is considered best for the needs of salmon and steelhead. In a reach comparison, Reach 8 had the poorest rating.

**MORRISON CREEK 2001
PERCENT EMBEDDEDNESS**

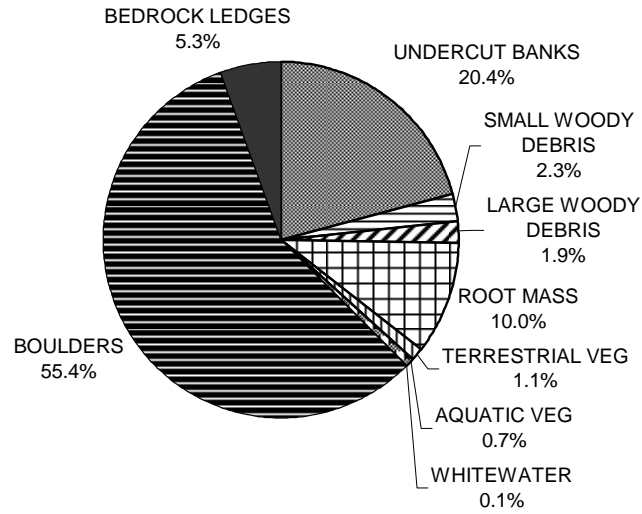
GRAPH 7

Table 5 summarizes fish shelter by habitat type. By percent area, the dominant pool shelter types were Boulders at 55%, Undercut Banks at 20%, Root Mass at 10% and Bedrock at 5%. Graph 7 describes the pool shelter in Morrison Creek.

The mean shelter rating for pools was 13. However, a pool shelter rating of approximately 80 is desirable. The relatively small amount of pool shelter that now exists is being provided primarily by Boulders at 54%, Undercut Banks at 17%, Root Mass at 14% and Bedrock at 5%. Log and root wad cover in the pool and flatwater habitats would improve both summer and winter salmonid habitat. Log cover provides rearing fry with protection from predation, rest from water velocity, and also divides territorial units to reduce density related competition.

**MORRISON CREEK 2001
MEAN PERCENT COVER TYPES IN POOLS**

5. Where feasible, increase woody cover in the pool and flatwater habitat units along the entire stream. Most of the existing shelter is from vegetation and undercut banks. Adding high quality complexity with larger woody cover is desirable. Combination cover/scour structures constructed with boulders and woody debris would be effective in many flatwater and pool locations in the upper reaches. This must be done where the banks are stable or in conjunction with stream bank armor to prevent erosion. In some areas the material is at hand.

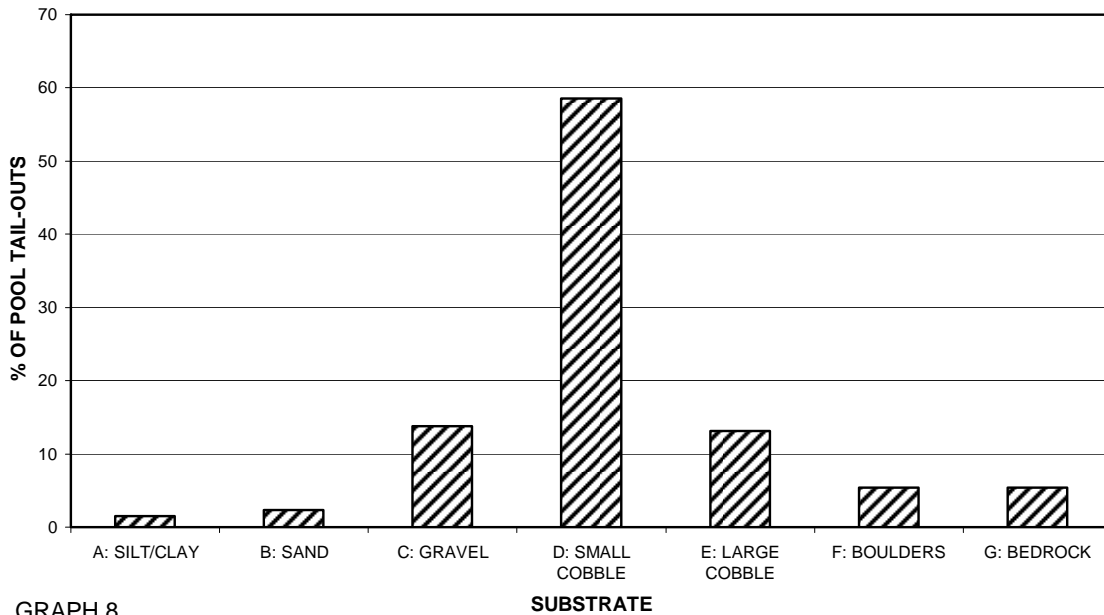
GRAPH 8

Table 6 summarizes the dominant substrate by habitat type. In Low-Gradient Riffles surveyed, the dominant substrate was: Boulders in 49% of the riffles, Small Cobble in 26% of the riffles, Large Cobble in 17% of the riffles, and Bedrock in 6% of the riffles. Of the Pool Tail-outs measured, 59% had Small Cobble as the dominant substrate type, 14% had Gravel as the dominant Substrate, and 13% had Large Cobble as the dominant substrate (Graph 8).

**MORRISON CREEK 2001
SUBSTRATE COMPOSITION IN POOL TAIL-OUTS**

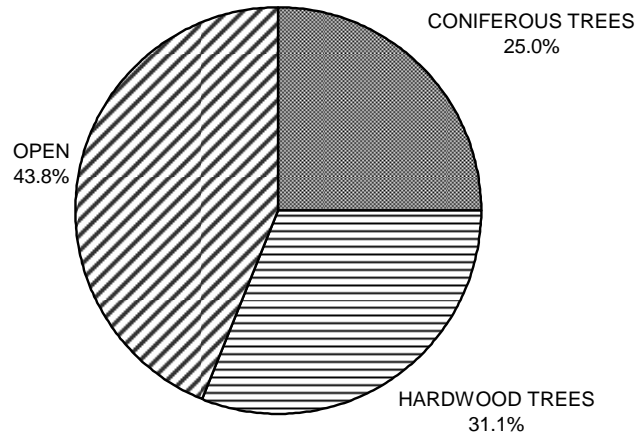
GRAPH 9

The mean percent canopy density for the stream reach surveyed was 56.2%. The mean percentages of deciduous and evergreen trees were 31.1% and 25%, respectively. Graph 9 describes the canopy for the entire survey.

The mean percent canopy for the survey was 53%. This is a low percentage of canopy, since 80 percent is generally considered desirable. Cooler water temperatures are desirable in Morrison Creek. Elevated water temperatures could be reduced by increasing stream canopy. The large trees required for adequate stream canopy would also eventually provide a long term source of large woody debris needed for instream shelter and bank stability.

**MORRISON CREEK 2001
MEAN PERCENT CANOPY**

2. Increase the canopy on Morrison Creek by planting willow, alder, redwood, and Douglas fir along the stream where shade canopy is not at acceptable levels. The reach above the survey section should be assessed for planting and treated as well, since water temperatures throughout are effected from upstream. In many cases, planting will need to be coordinated to follow bank stabilization or upslope erosion control projects.

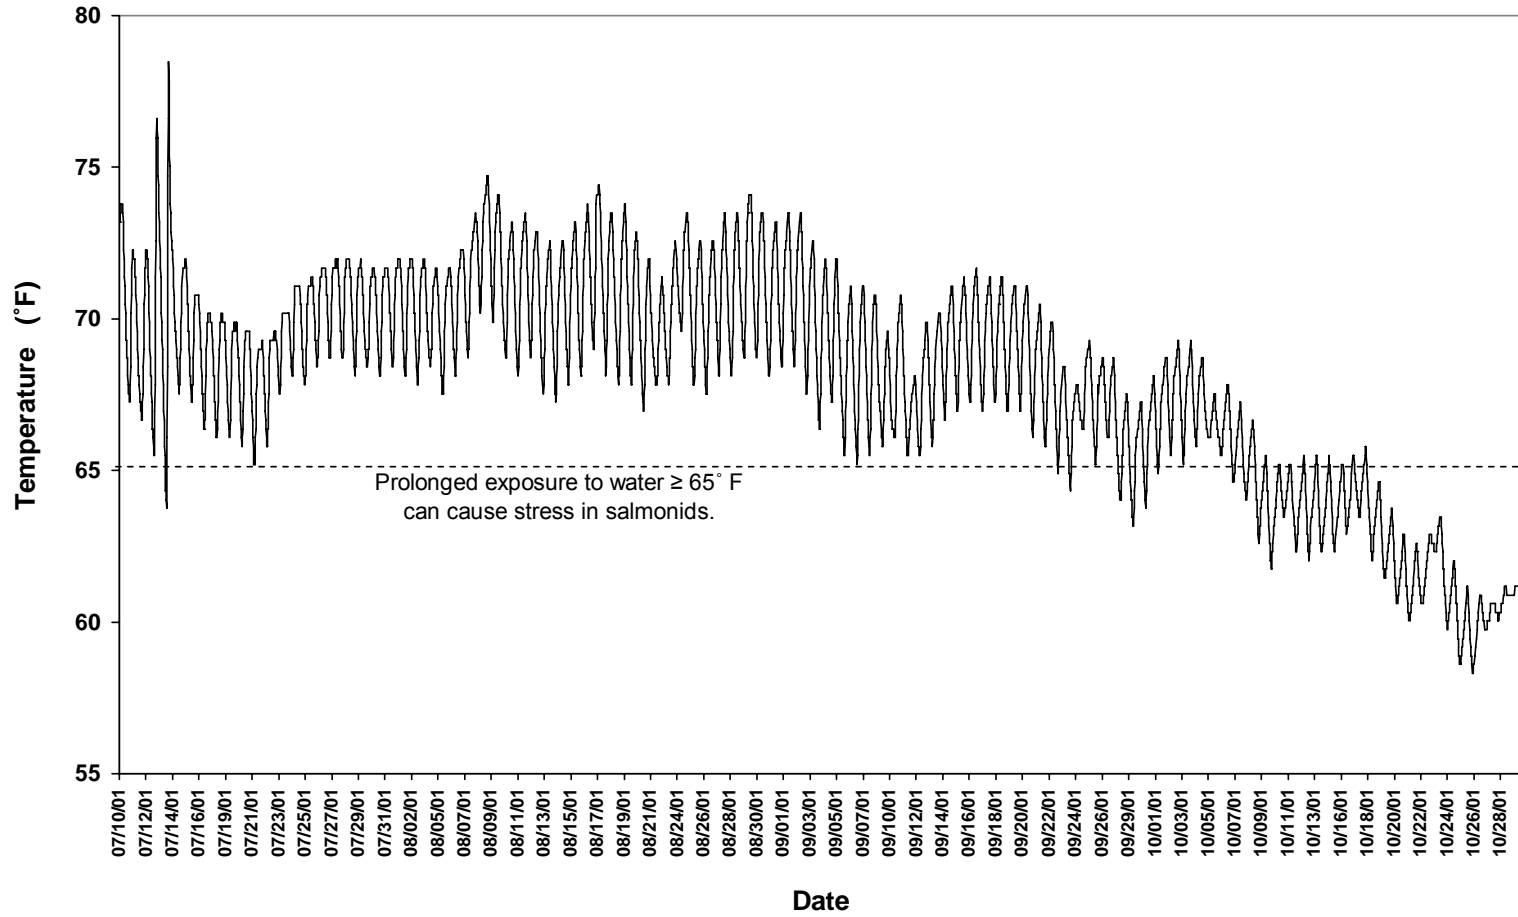
Summer temperatures were also measured using remote temperature recorders placed in pools (see Temperature Summary graphs, Appendix E). A recorder in Reach 1 placed approximately 4600' from the mouth in a left bank pool, logged temperatures every 2 hours from July 10 – October 30, 2001. The highest temperature recorded was 78°F in July and the lowest was 58°F in October. The mean of the daily highs was 71.8°F for the month of July, 73.0°F for August, 70.5°F for September and 65.1°F for October.

The Temperature Summary graph shows that for much of the summer (July through October) the lower watershed exhibited temperatures above the optimal for salmonids.

Morrison Creek Water Temperatures

9. If riparian areas are not improved in Morrison Creek, temperatures should be monitored to determine if they are having a deleterious effect upon juvenile salmonids. To achieve this, biological sampling is also required.
