CALIFORNIA DEPARTMENT OF FISH AND GAME
STREAM INVENTORY REPORT

North Fork Mill Creek
Report Revised April 14, 2006
Report Completed 2005
Assessment Completed 2001

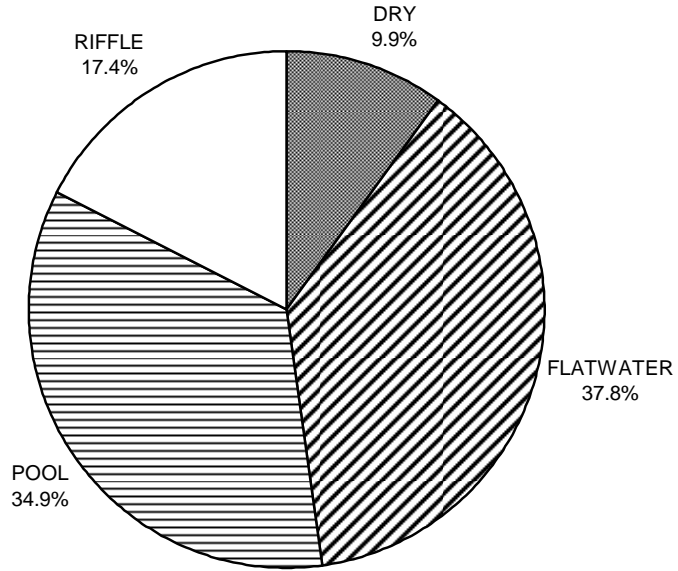
GRAPH 1

Table 1 summarizes the Level II riffle, flatwater, and pool habitat types. Based on total *length* there were 42.6% Dry units, 36.3% Flatwater units, 12.0% Pool units and 9.1% Riffle units (Graph 2). Based on frequency of *occurrence* there were 37.8% Flatwater units, 34.9% Pool units, 17.4% Riffle units and 9.9% Dry units. (Graph 1).

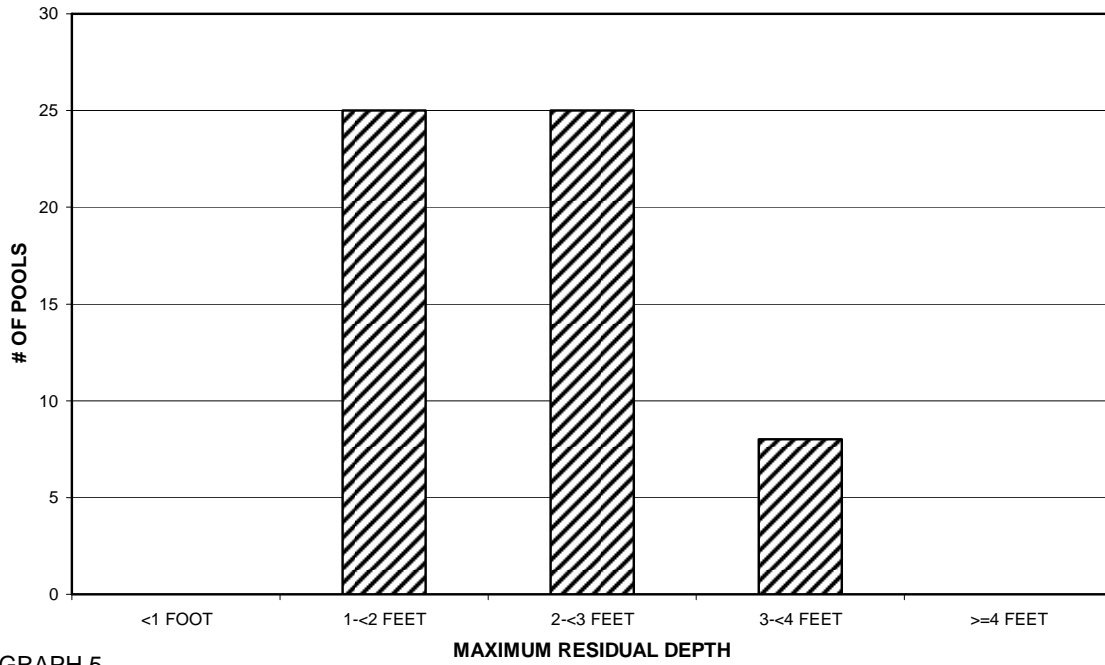
GRAPH 5

Eight of the 58 pools (14%) had a depth of three feet or greater (Graph 5).

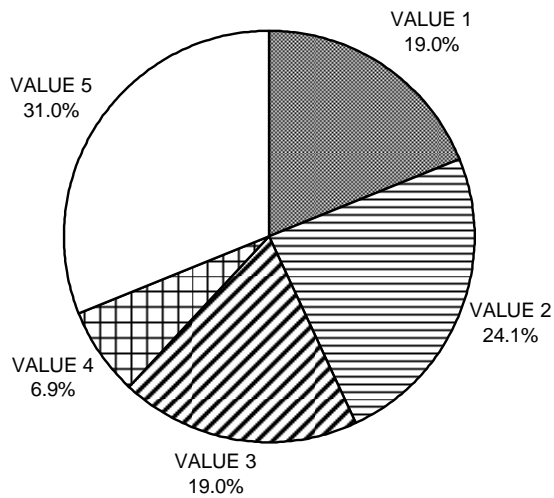
GRAPH 6

Twenty-six percent of the pool tail-outs measured had embeddedness ratings of either 3 or 4. Only 19% had a rating of 1. Cobble embeddedness measured to be 25% or less (a rating of 1) is considered best for the needs of salmon and steelhead.

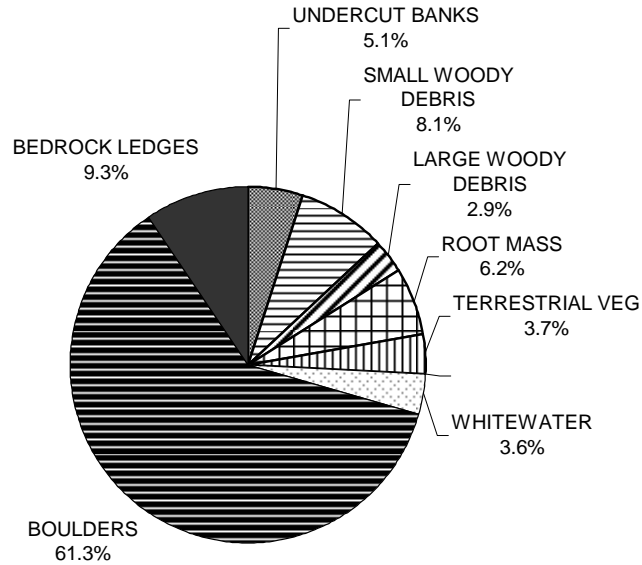
GRAPH 7

Table 5 summarizes fish shelter by habitat type. By percent area, the dominant pool shelter types were Boulders at 50%, Small Wood at 14%, Bedrock at 13%, and White Water at 13%. Graph 7 describes the pool shelter in the North Fork of Mill Creek.

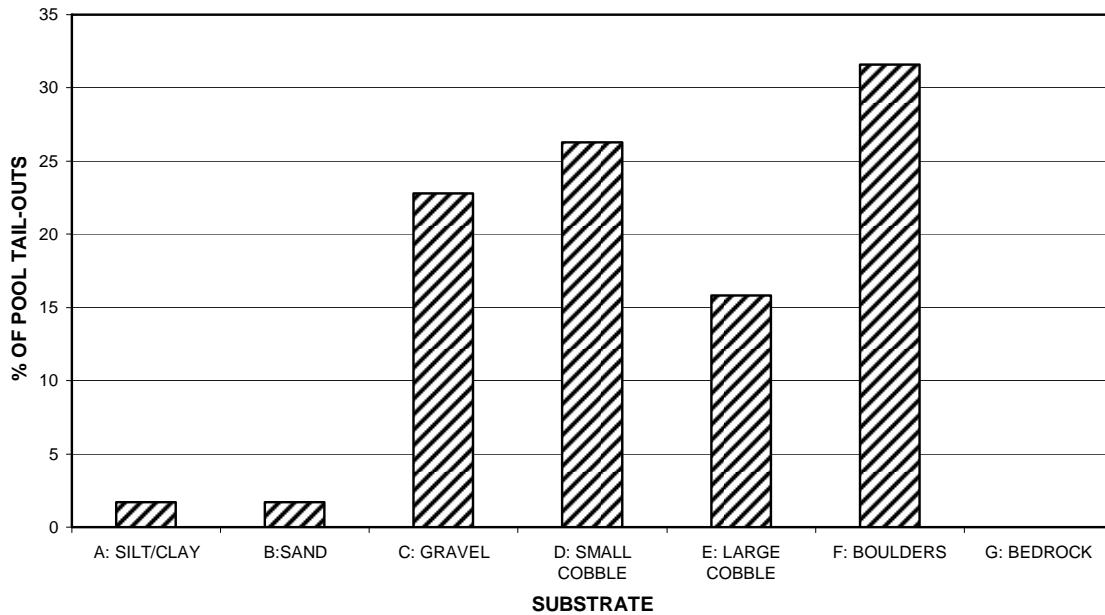
GRAPH 8

Table 6 summarizes the dominant substrate by habitat type. In the 15 Low-Gradient Riffles surveyed, the dominant substrate was Small Cobble in two riffles and Boulders in one riffle. The depth of cobble embeddedness was estimated at pool tail-outs. Of the 58 pool tail-outs measured, eleven had a value of 1 (19%), fourteen had a value of 2 (24%), eleven had a value of 3 (19%) and four had a value of 4 (7%). Eighteen (31%) riffles rated a 5 (Graph 6). Level 5 is unsuitable for spawning. On this scale, a value of 1 is best for fisheries. Boulders and Small Cobble were the dominant substrate observed at pool tail-outs, at 31.6 and 26.3%, respectively (Graph 8).

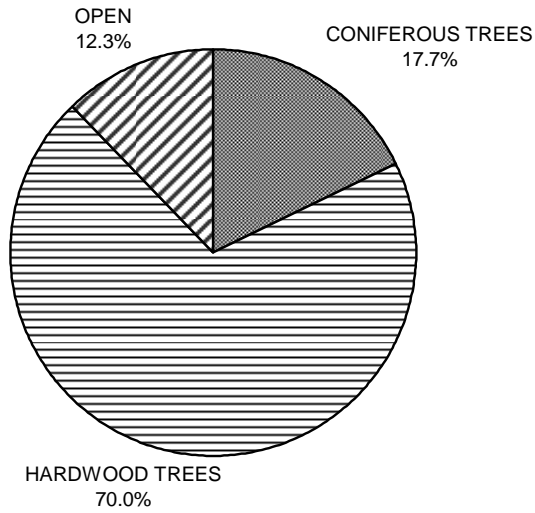
GRAPH 9

The mean percent canopy density for the stream reach surveyed was 75%. The mean percentages of deciduous and evergreen trees were 84% and 16%, respectively. Graph 9 describes the canopy for the entire survey.

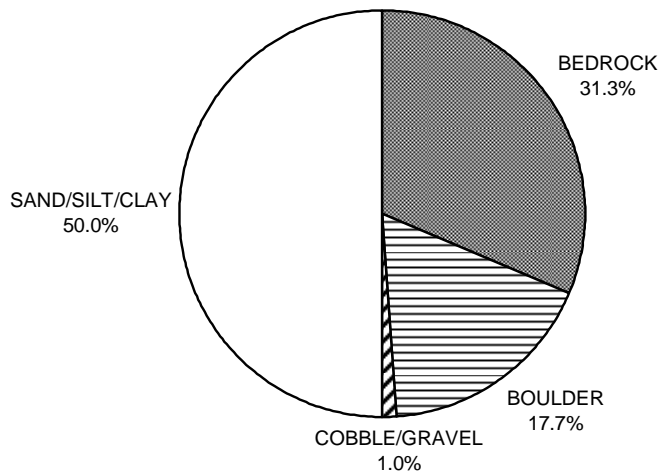
GRAPH 10

For the entire stream reach surveyed, the mean percent right bank vegetated was 80% and the mean percent left bank vegetated was 75%. For the habitat units measured, the dominant vegetation types for the stream banks were: 46% Brush, 30% Deciduous Trees, 16% Bare Soil and 7% Evergreen Trees (Graph 11). The dominant substrate for the stream banks were: 50% Silt, Clay & Sand, 31% Bedrock, 18% Boulder and 1% Cobble & Gravel (Graph 10).

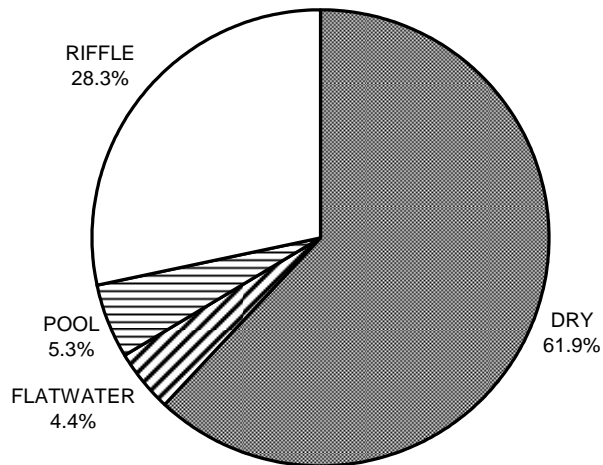
GRAPH 2 Level II habitat types by percent total length

Table 1 summarizes the Level II riffle, flatwater, and pool habitat types. Based on frequency of occurrence there were 29% pool units, 57% riffle units, 7% dry units, 7% flatwater units, (Graph 1). Based on total length of Level II habitat types there were 5% pool units, 28% riffle units, 62% dry units, and 4% flatwater units (Graph 2).

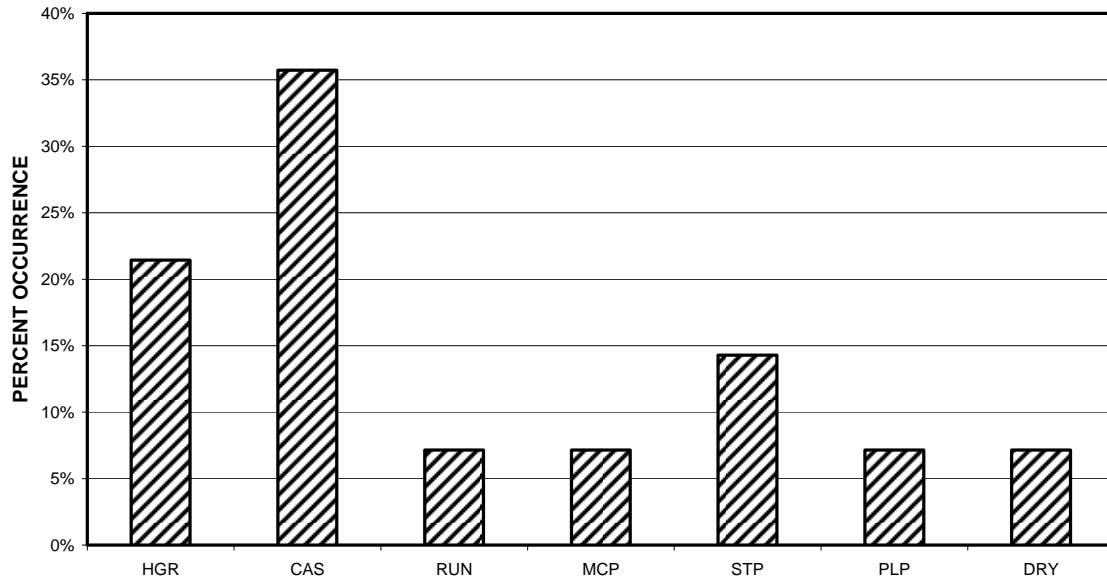
GRAPH 3 Level IV habitat types by percent occurrence **HABITAT TYPE**

Seven Level IV habitat types were identified (Table 2). The most frequent habitat types by percent occurrence were 36% Cascade units, 21% High Gradient Riffle units, and 14% Step Pool units (Graph 3). Based on percent total length, 62% Dry units, 15% Cascade units, and 13% High Gradient Riffle units were found.

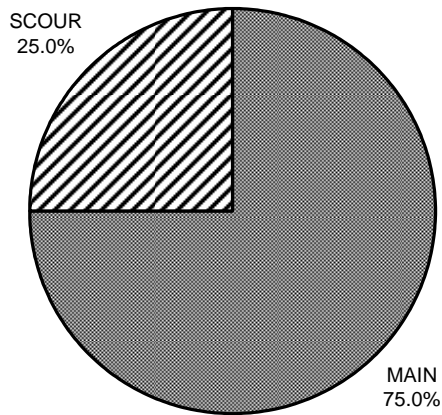
GRAPH 4 Level I pool types by percent occurrence

A total of four pools were identified (Graph 4). Main Channel pools were the most frequently encountered, at 75%, and comprised 81% of the total length of all pools (Table 3).

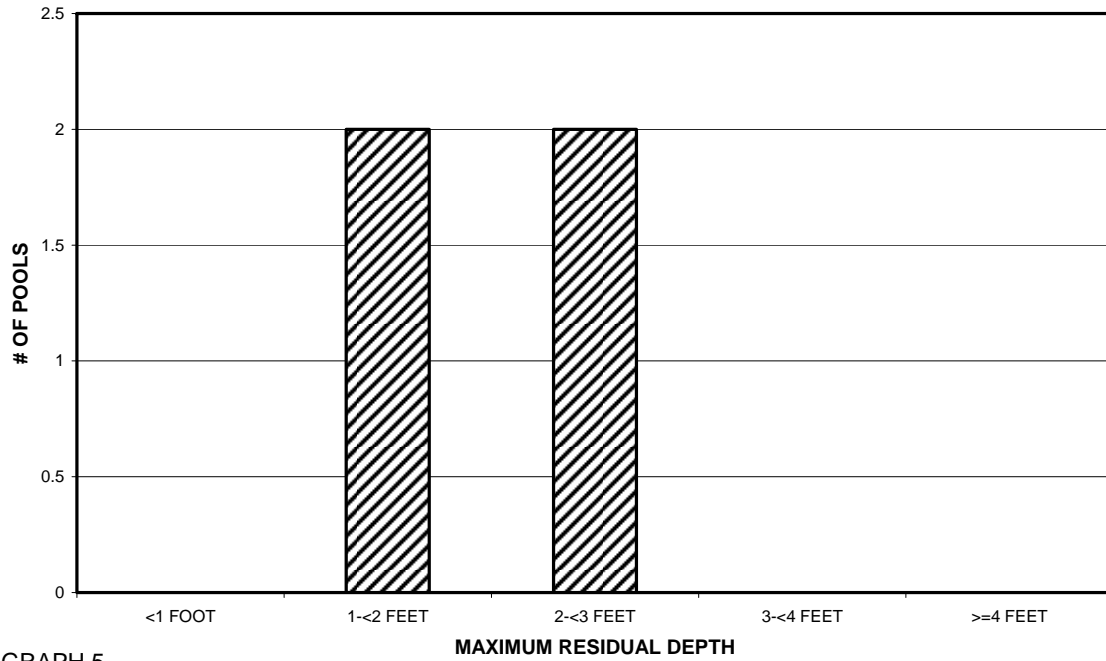
GRAPH 5

Table 4 is a summary of maximum residual pool depths by pool habitat types. Pool quality for salmonids increases with depth. Two of the four pools (50%) had a residual depth of two feet or greater (Graph 5).

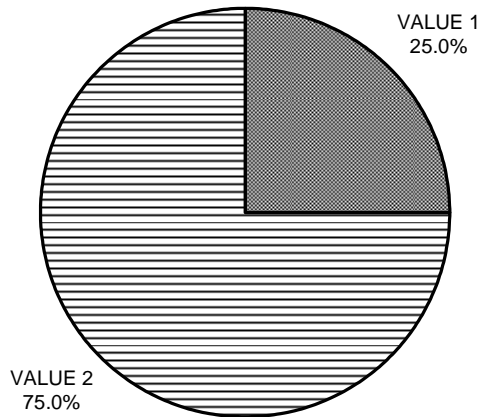
GRAPH 6

The depth of cobble embeddedness was estimated at pool tail-outs. Of the four pool tail-outs measured, one had a value of 1 (25%); three had a value of 2 (75%), (Graph 6). On this scale, a value of 1 indicates the best spawning conditions and a value of 4 the worst. Additionally, a value of 5 was assigned to tail-outs deemed unsuited for spawning due to inappropriate substrate like bedrock, log sills, boulders.

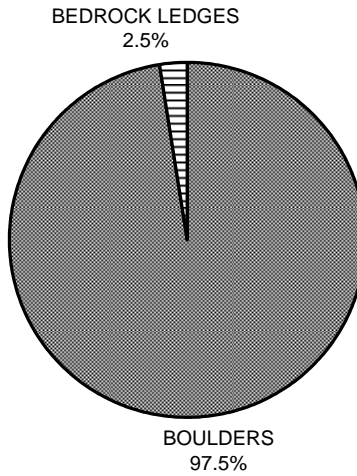
GRAPH 7

Table 5 summarizes mean percent cover by habitat type. Boulders are the dominant cover types in Willow Creek. Graph 7 describes the pool cover in Willow Creek. Boulders are the dominant pool cover type followed by bedrock ledges.

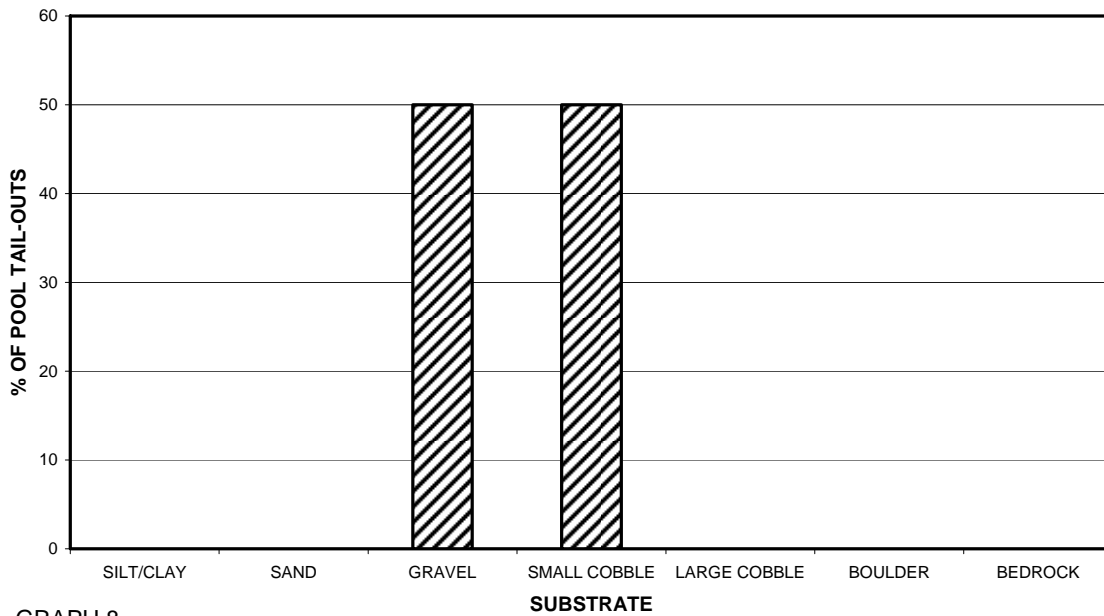
GRAPH 8

Table 6 summarizes the dominant substrate by habitat type. Graph 8 depicts the dominant substrate observed in pool tail-outs. Gravel was observed in 50% of pool tail-outs, and small Cobble observed in 50% of pool tail-outs.

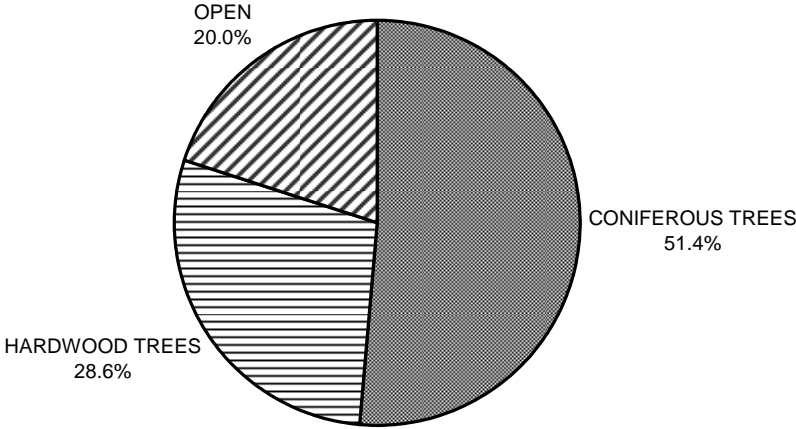
GRAPH 9

The mean percent canopy density for the surveyed length of Willow Creek was 80%. The mean percentages of hardwood and coniferous trees were 36% and 64%, respectively. Twenty percent of the canopy was open. Graph 9 describes the mean percent canopy in Willow Creek.

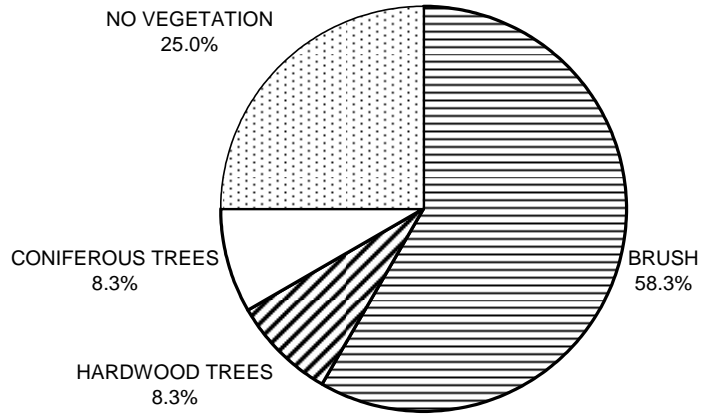
GRAPH 11

For the stream reach surveyed, the mean percent right bank vegetated was 66%. The mean percent left bank vegetated was 83.3%. The dominant elements composing the structure of the stream banks consisted of 42.5% sand/silt/clay, and 25% bedrock (Graph 10). Brush was the dominant vegetation type observed in 58.3% of the units surveyed. Additionally, 8.3% of the units surveyed had hardwood trees as the dominant vegetation type, and 8.3% had coniferous trees as the dominant vegetation (Graph 11).
