**CALIFORNIA DEPARTMENT OF FISH AND GAME
STREAM INVENTORY REPORT**

Pieta Creek

Report Revised April 14, 2006

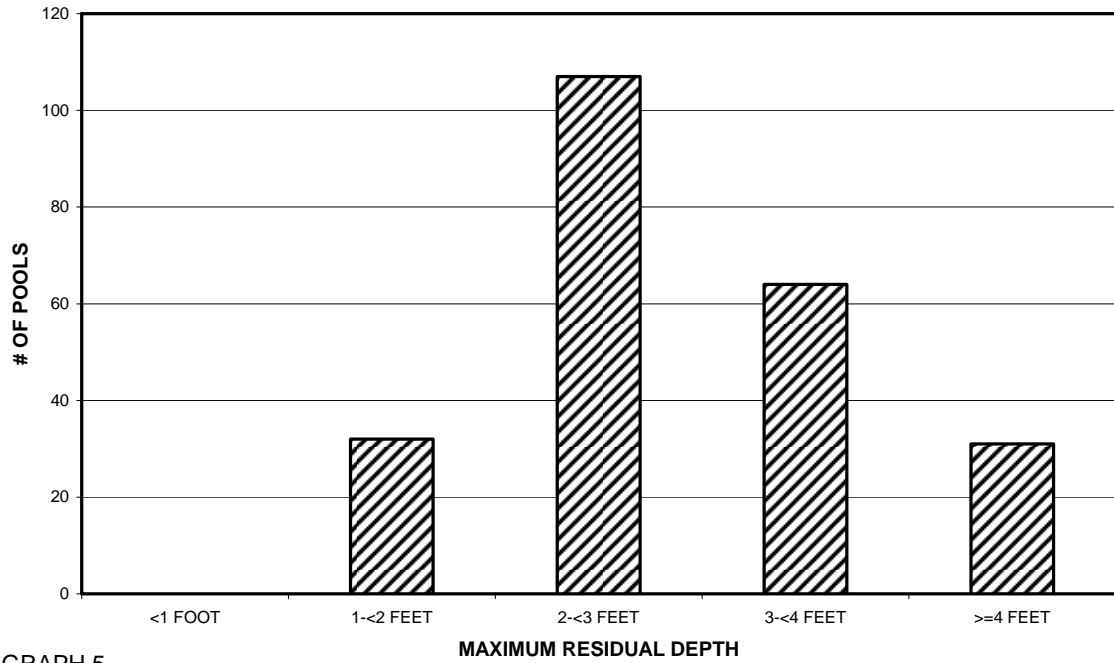
GRAPH 5

Table 4 is a summary of maximum residual pool depths by pool habitat types. Pool quality for salmonids increases with depth. Ninety-five of the 234 pools (41%) had a residual depth of three feet or greater (Graph 5).

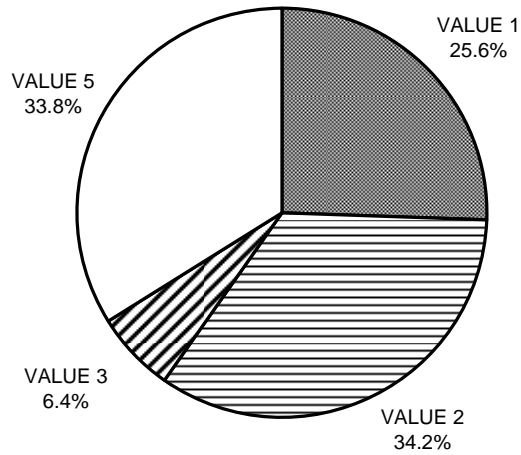
GRAPH 6

The depth of cobble embeddedness was estimated at pool tail-outs. Of the 225 pool tail-outs measured, 57 had a value of 1 (25.3%); 78 had a value of 2 (34.7%); 14 had a value of 3 (6.2%); 76 had a value of 5 (33.8%); (Graph 6). On this scale, a value of 1 indicates the best spawning conditions and a value of 4 the worst. Additionally, a value of 5 was assigned to tail-outs deemed unsuited for spawning due to inappropriate substrate like bedrock, log sills, boulders.

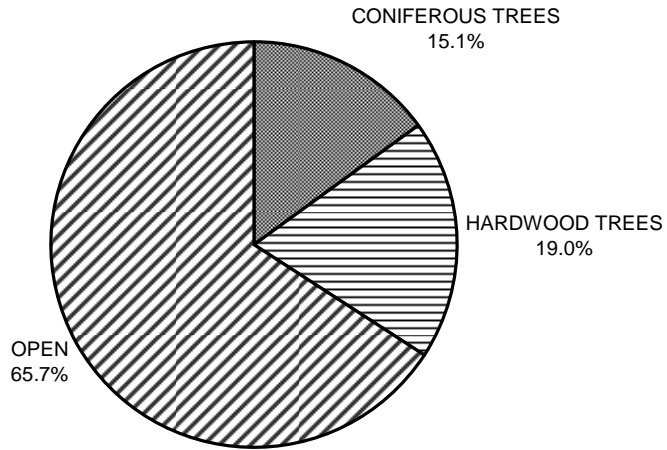
GRAPH 9

The mean percent canopy density for the surveyed length of Pieta Creek was 34%. The mean percentages of hardwood and coniferous trees were 56% and 44%, respectively. Sixty-six percent of the canopy was open. Graph 9 describes the mean percent canopy in Pieta Creek.

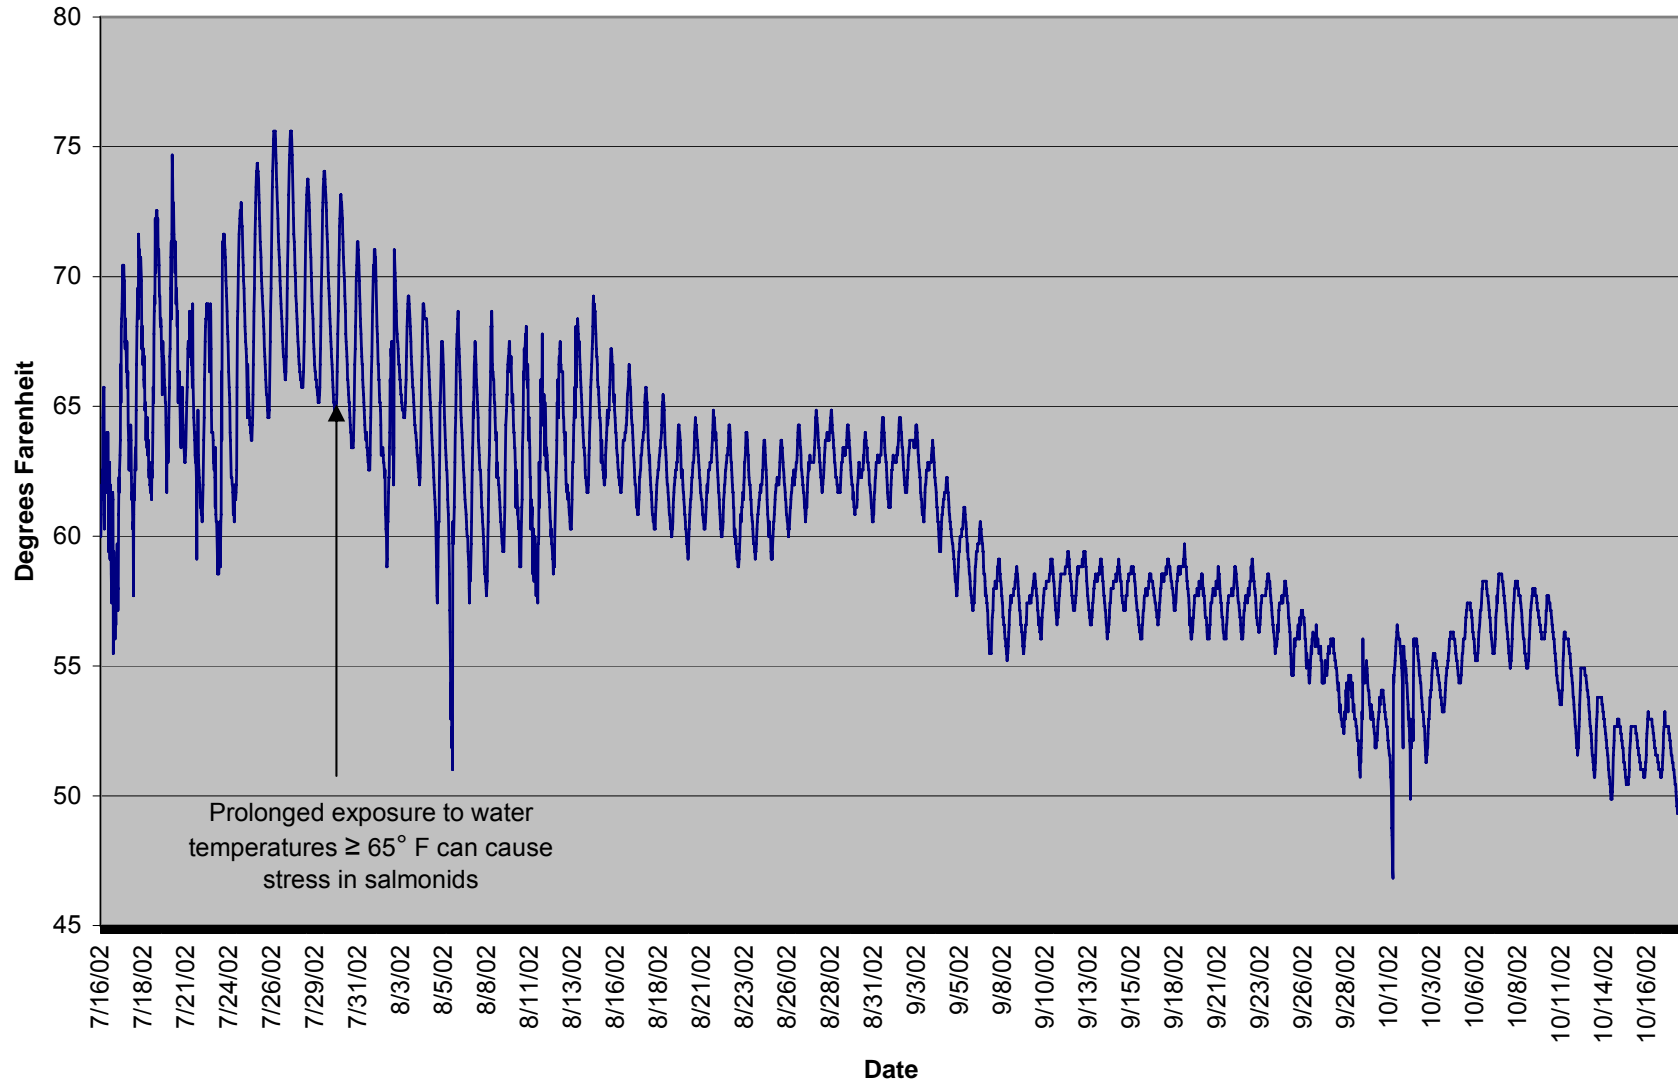
Pieta Creek Water Temperature 2002
(Lower - Reach 4)

Water temperatures ranged from 52°F to 74°F. Air temperatures ranged from 57°F to 90°F. Summer temperatures were also measured using remote temperature recorders placed in pools (see Temperature Summary graphs at end of report). A recorder in Reach 4, approximately 41720' from the mouth, logged temperatures every half hour from 7/15/02 to 8/23/02. The highest temperature recorded was 71.3°F on 7/27/02 and the lowest was 54.4°F on 8/22/02 and 8/23/02. The mean of the daily highs was 70.1°F for the month of July, and 67.7°F for August.

Summer temperatures measured using remote temperature recorders ranged from 54.4°F to 71.3°F for Reach 4 and 46.8°F to 75.6°F for Reach_4. The Temperature Summary graph shows that for much of the summer (July through August) the lower and upper watershed exhibited water temperatures above the optimal for salmonids. It is unknown if this thermal regime is typical. To make any further conclusions, temperatures need to be monitored for a longer period of time in more locations through the critical summer months, and extensive biological sampling should be conducted.

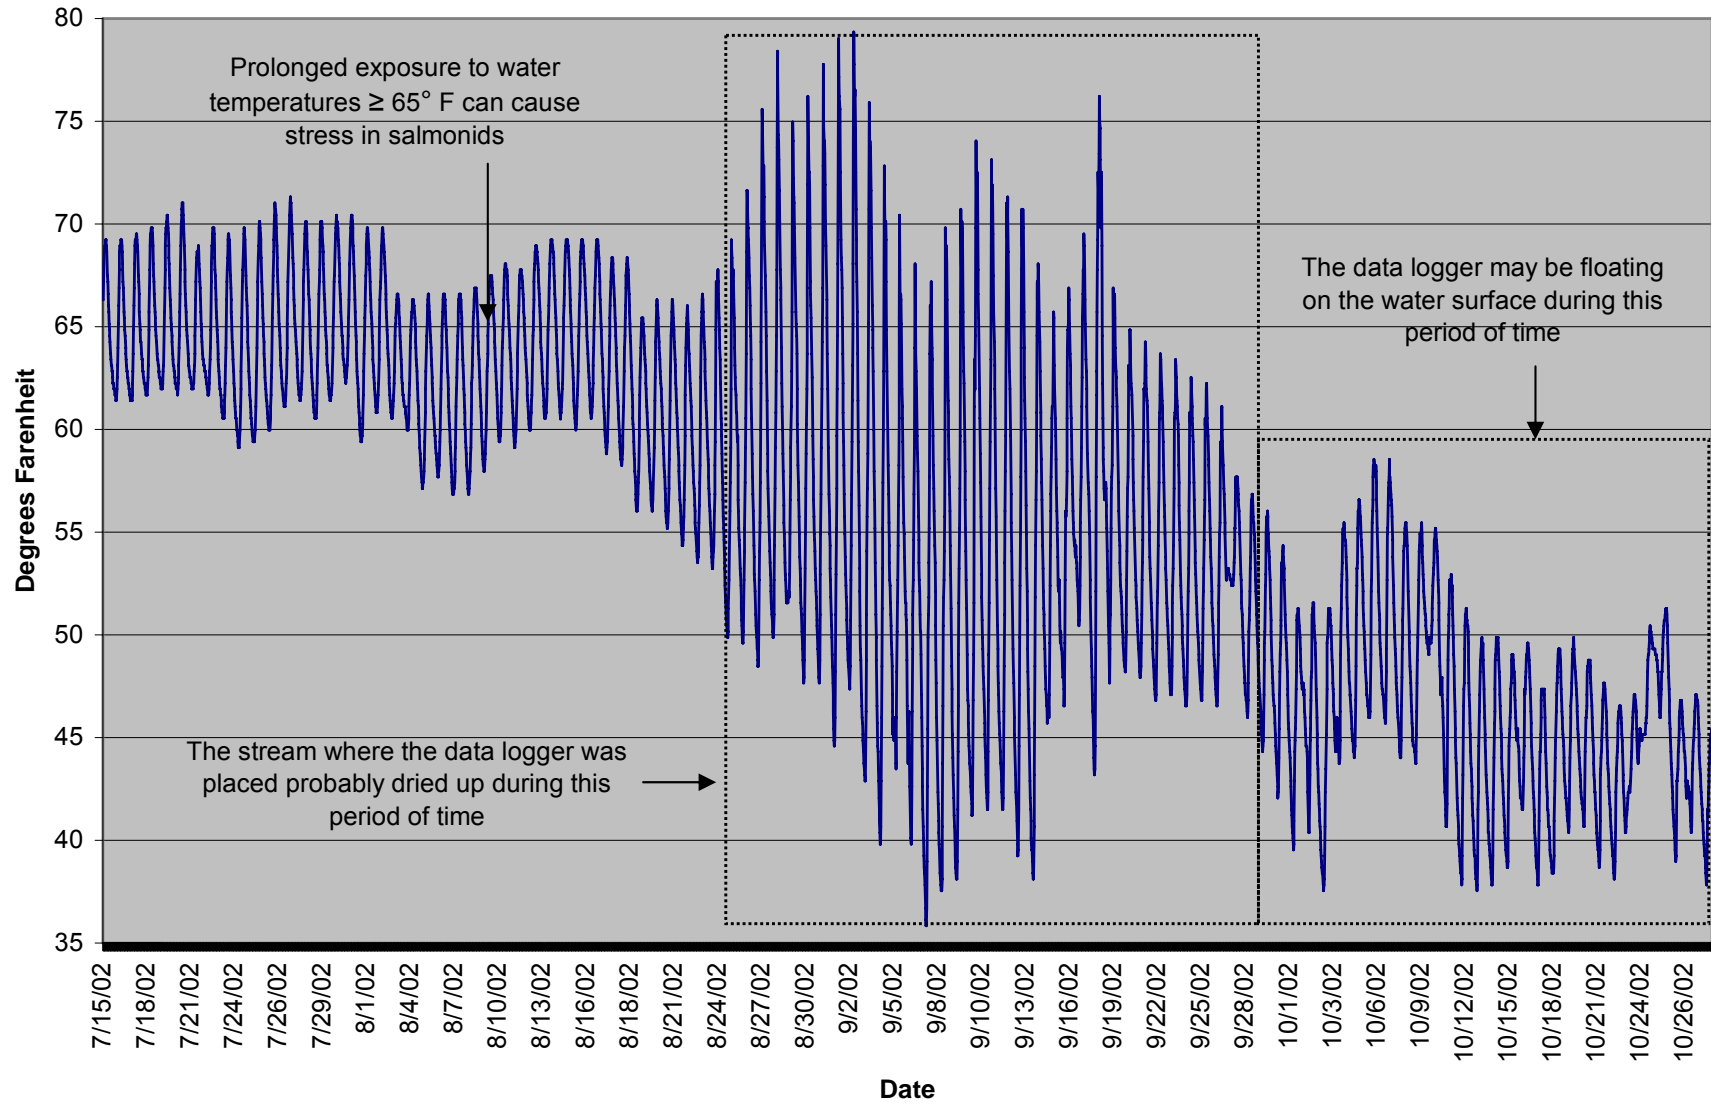
Pieta Creek Water Temperature 2002 (Upper - Reach 8)

Another recorder in an upper reach that was not surveyed logged temperatures from 7/16/02 to 10/18/02. The highest temperature recorded was 75.6°F 7/26/02 and 7/27/02 and the lowest was 46.8°F on 10/1/02. The mean of the daily highs was 72.6°F for the month of July, 66.5°F for August, 59.3°F for September, and 55.9°F for October.
