CALIFORNIA DEPARTMENT OF FISH AND GAME
STREAM INVENTORY REPORT
South Branch Robinson Creek
Report Revised April 14, 2006
Report Completed 2005
Assessment Completed 2001

A stream inventory was conducted during 6/11/2001 to 6/18/2001 on South Branch Robinson Creek. The survey began at the confluence with Robinson Creek and extended upstream 1.5 miles.

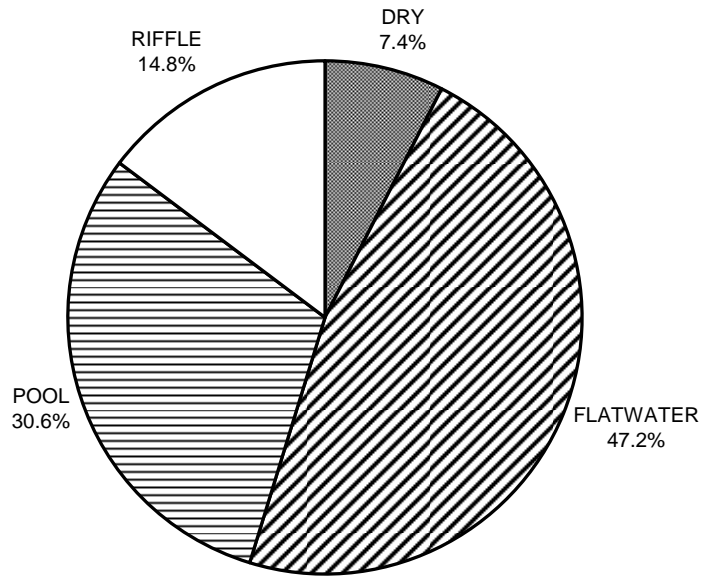
GRAPH 1 Level II habitat types by percent occurrence

Table 1 summarizes the Level II riffle, flatwater, and pool habitat types. Based on frequency of *occurrence* there were 47% flatwater units, 31% pool units, 7% dry units, 15% riffle units, (Graph 1). Based on total *length* of Level II habitat types there were 38% flatwater units, 14% pool units, 40% dry units, 7% riffle units, (Graph 2).

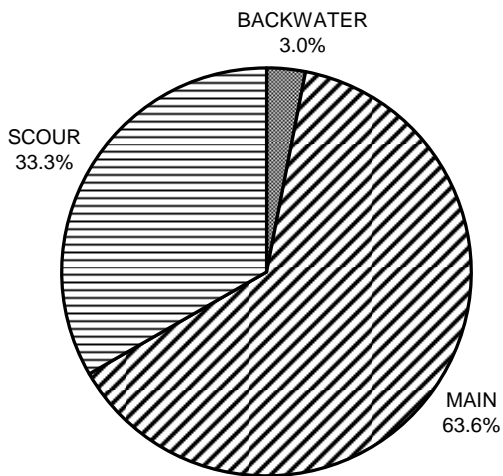
GRAPH 4 Level I pool types by percent occurrence

A total of 33 pools were identified (Table 3). Main Channel pools were the most frequently encountered, at 64%, and comprised 68% of the total length of all pools (Graph 4).

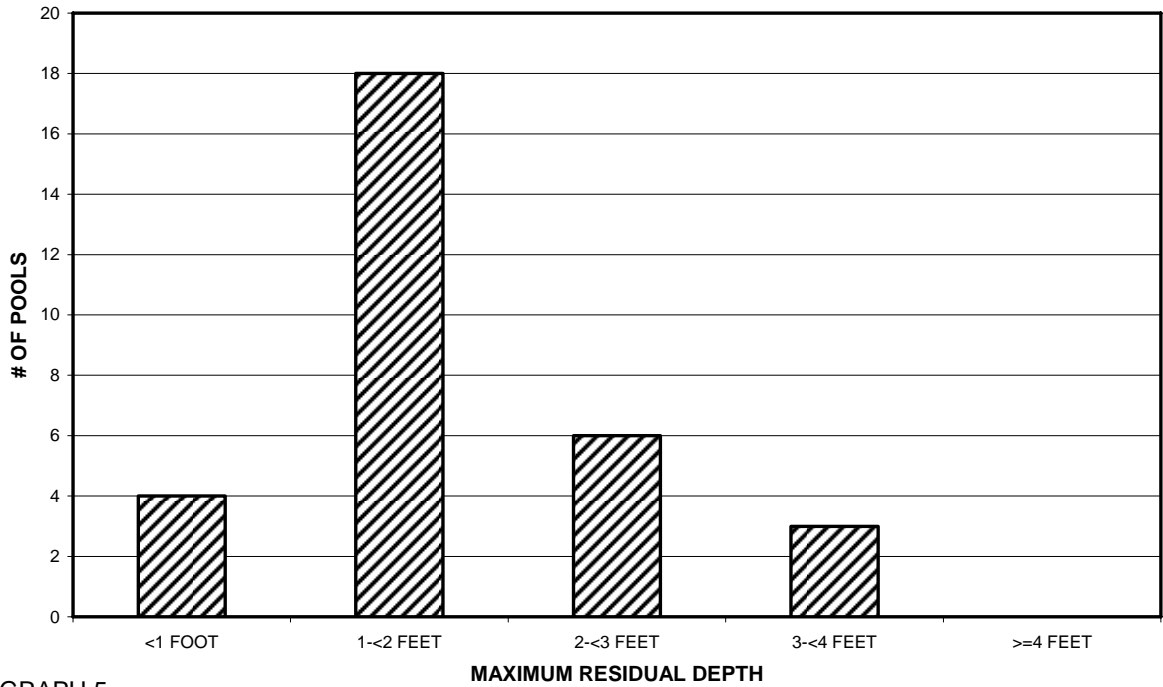
GRAPH 5

Table 4 is a summary of maximum residual pool depths by pool habitat types. Pool quality for salmonids increases with depth. Nine of the 31 pools (29%) had a residual depth of two feet or greater (Graph 5).

Flatwater habitat types comprised 38% of the total length of this survey, riffles 7%, and pools 14%. The pools are relatively shallow/deep, with only nine of the 31 (29%) pools having a maximum residual depth greater than two feet. In general, pool enhancement projects are considered when primary pools comprise

- 2) Where feasible, design and engineer pool enhancement structures to increase the number of pools. This must be done where the banks are stable or in conjunction with stream bank armor to prevent erosion.

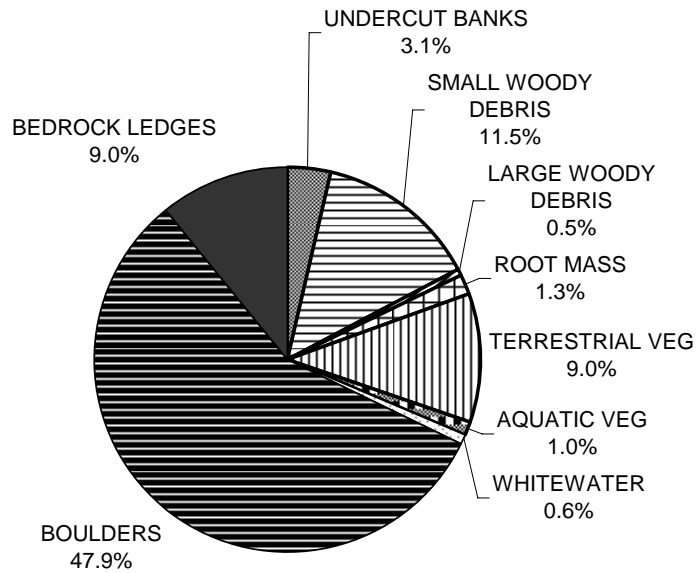
GRAPH 7

Table 5 summarizes mean percent cover by habitat type. Boulders are the dominant cover types in South Branch Robinson Creek. Graph 7 describes the pool cover in South Branch Robinson Creek. Boulders (47%) are the dominant pool cover type followed by small woody debris (12%).

The mean shelter rating for pools was 20. The shelter rating in the flatwater habitats was 4. A pool shelter rating of approximately 100 is desirable. The amount of cover that now exists is being provided primarily by Boulders in South Branch Robinson Creek. Boulders are the dominant cover type in pools followed by small woody debris. Log and root wad cover structures in the pool and flatwater habitats would enhance both summer and winter salmonid habitat. Log cover structure provides rearing fry with protection from predation, rest from water velocity, and also divides territorial units to reduce density related competition.

- 3) Increase woody cover in the pools and flatwater habitat units. Most of the existing cover is from Boulders. Adding high quality complexity with woody cover is desirable.

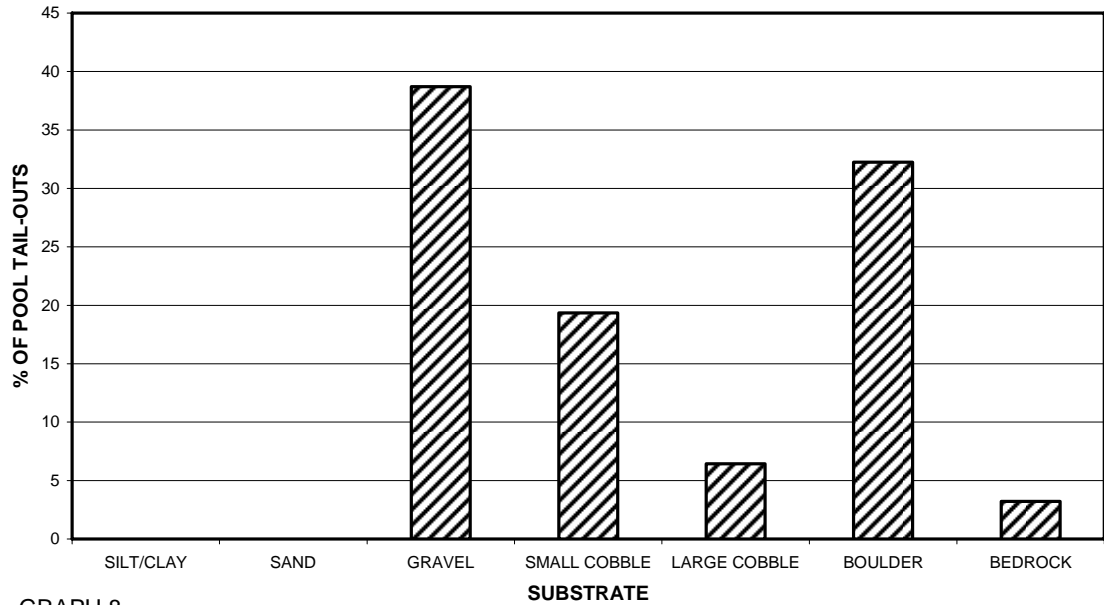
GRAPH 8

Table 6 summarizes the dominant substrate by habitat type. Graph 8 depicts the dominant substrate observed in pool tail-outs. The dominant types of substrate are gravel observed in 39% of pool tail-outs,

and boulders observed in 32% of pool tail-outs.

Eighteen of the 31 pool tail-outs measured had gravel or small cobble as the dominant substrate. This is generally considered good for spawning salmonids.

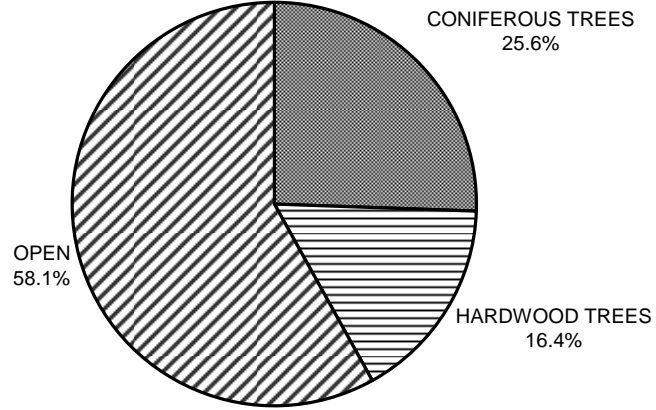
GRAPH 9

The mean percent canopy density for the surveyed length of South Branch Robinson Creek was 42%. The mean percentages of hardwood and coniferous trees were 39% and 61%, respectively. Fifty-eight percent of the canopy was open. Graph 9 describes the mean percent canopy in South Branch Robinson Creek.

The mean percent canopy density for the stream was 42%. Reach 1 had a canopy density of 13.1%, Reach 2 had a canopy density of 36.3%, Reach 3 had a canopy density of 63.5%, Reach 4 had a canopy density of 68.3%. In general, revegetation projects are considered when canopy density is less than 80%.

- 1) Increase the canopy on South Branch Robinson Creek by planting appropriate native vegetation like willow, alder, redwood, and Douglas fir along the stream where shade canopy is not at acceptable levels. The reaches above this survey section should be inventoried and treated as well, since the water flowing here is affected from upstream. In many cases, planting will need to be

coordinated to follow bank stabilization or upslope erosion control projects.

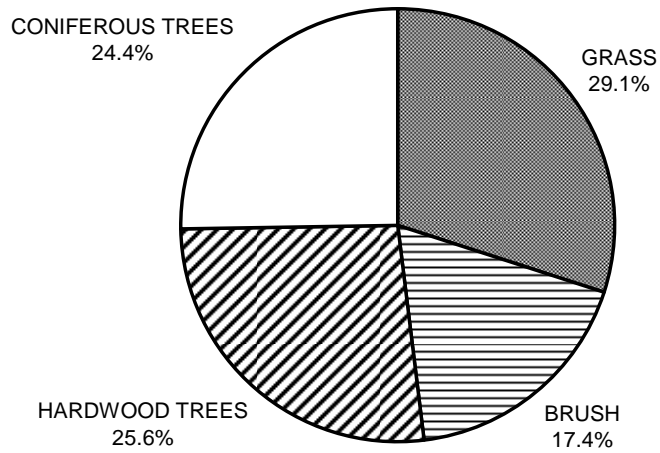
GRAPH 11

For the stream reach surveyed, the mean percent right bank vegetated was 35%. The mean percent left bank vegetated was 36%. The dominant elements composing the structure of the stream banks consisted of 16% bedrock, 33% boulder, 28% cobble/gravel, 21% sand/silt/clay, (Graph 10). Grass was the dominant vegetation type observed in 29% of the units surveyed. Additionally, 25.6% of the units surveyed had hardwood trees as the dominant vegetation type, and 24.4% had coniferous trees as the dominant vegetation (Graph 11).

The percentage of right and left bank covered with vegetation was LOW at 35% and 36%, respectively. In areas of stream bank erosion or where bank vegetation is sparse, planting endemic species of coniferous and hardwood trees, in conjunction with bank stabilization, is recommended.
