**CALIFORNIA DEPARTMENT OF FISH AND GAME
STREAM INVENTORY REPORT**

Sheldon Creek

Report Revised April 14, 2006

Assessment Completed 2002

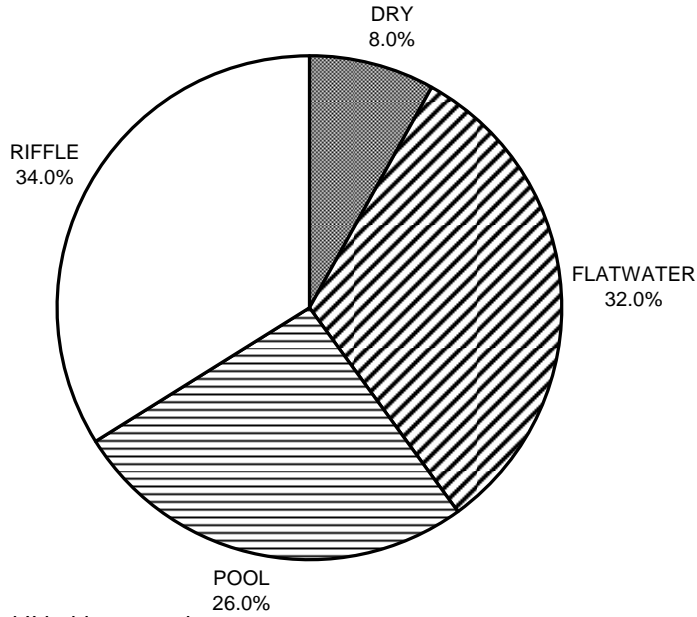
GRAPH 1: Level II habitat types by percent occurrence

Table 1 summarizes the Level II riffle, flatwater, and pool habitat types. Based on frequency of **occurrence** there were 32% flatwater units, 34% riffle units, 26% pool units, 8% dry units, (Graph 1). Based on total **length** of Level II habitat types there were 64% flatwater units, 21% riffle units, 12% pool units, 3% dry units, (Graph 2).

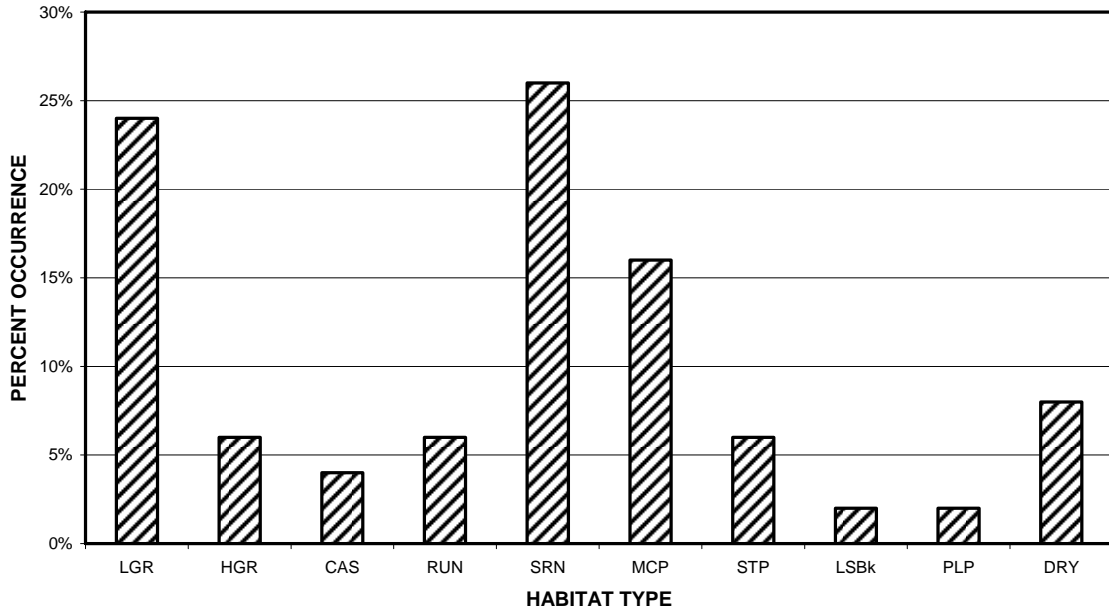
GRAPH 3: Level IV habitat types by percent occurrence

Ten Level IV habitat types were identified (Table 2). The most frequent habitat types by percent **occurrence** were 26% Step Run units, 24% Low Gradient Riffle units, 6% Step Pool units, 16% Mid-Channel Pool units, 6% High Gradient Riffle units, 6% Run units, 8% Dry units, 2% Lateral Scour Pool - Bedrock Formed units, 4% Cascade units, 2% Plunge Pool units, (Graph 3). Based on percent total **length**, 59% Step Run units, 17% Low Gradient Riffle units, 4% Step Pool units, 6% Mid-Channel Pool units, 3% High Gradient Riffle units, 5% Run units, 3% Dry units, 1% Cascade units, 1% Plunge Pool units.

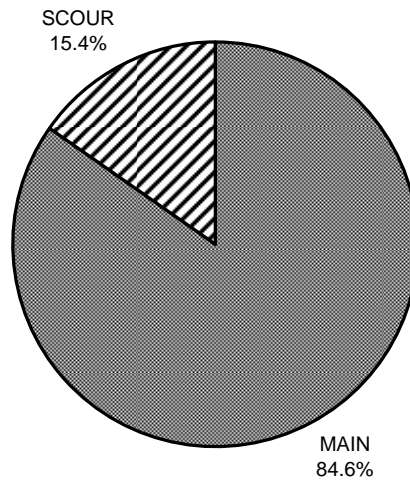
GRAPH 4: Level I pool types by percent occurrence

A total of 12 pools were identified (Table 3). Main Channel pools were the most frequently encountered, at 85%, and comprised 90% of the total length of all pools (Graph 4).

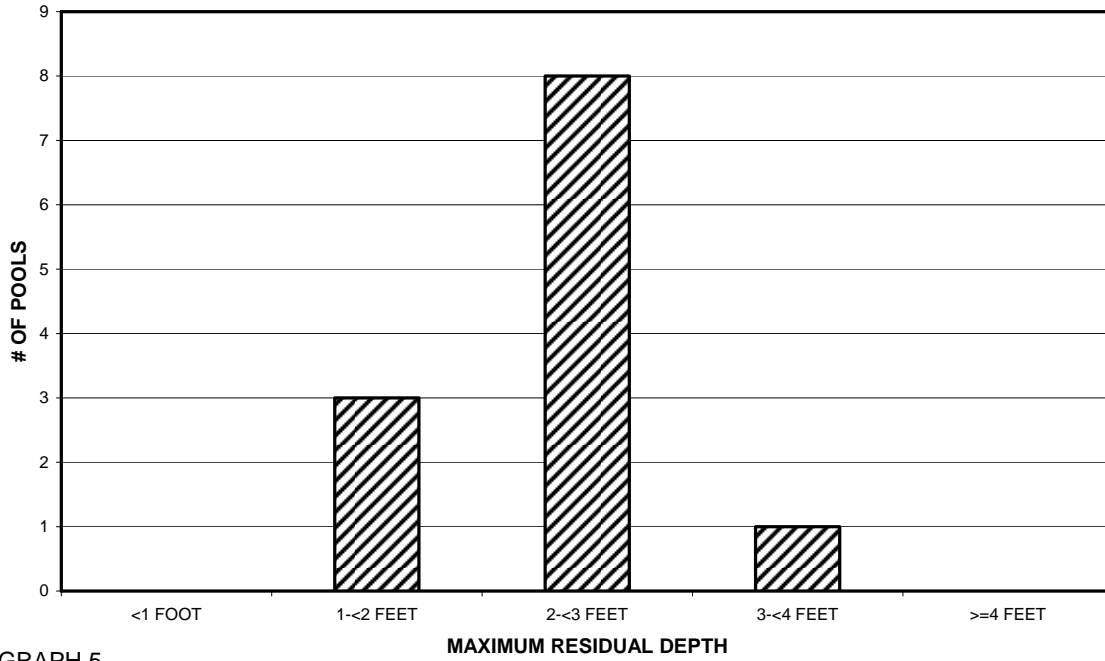
GRAPH 5

Table 4 is a summary of maximum residual pool depths by pool habitat types. Pool quality for salmonids increases with depth. Nine of the twelve pools (75%) had a residual depth of two feet or greater (Graph 5).

Flatwater habitat types comprised 64% of the total length of this survey, riffles 21%, and pools 12%. The pools are relatively deep, with only nine of the twelve (75%) pools having a maximum residual depth greater than 2 feet. In general, pool enhancement projects are considered when primary pools comprise less than 40% of the length of total stream habitat. In first and second order streams, a primary pool is defined to have a maximum residual depth of at least two feet, occupy at least half the width of the low flow channel, and be as long as the low

flow channel width. Installing structures that will increase or deepen pool habitat is recommended for locations where their installation will not be threatened by high stream energy, or where their installation will not conflict with the modification of the numerous log debris accumulations (LDA's) in the stream.

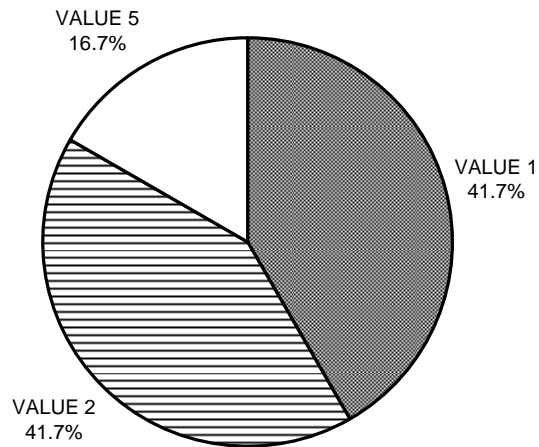
GRAPH 6

The depth of cobble embeddedness was estimated at pool tail-outs. Of the 12 pool tail-outs measured, five had a value of 1 (41.7%); five had a value of 2 (41.7%); two had a value of 5 (16.7%); (Graph 6). On this scale, a value of 1 indicates the best spawning conditions and a value of 4 the worst. Additionally, a value of 5 was assigned to tail-outs deemed unsuited for spawning due to inappropriate substrate like bedrock, log sills, boulders.

Ten of the 12 pool tail-outs measured had embeddedness ratings of 1 or 2. None of the pool tail-outs had embeddedness ratings of 3 or 4. Two of the pool tail-outs had a rating of 5, which is considered unsuitable for spawning. Cobble embeddedness measured to be 25% or less, a rating of 1, is considered to indicate good quality spawning substrate for salmon and steelhead. Sediment sources in Sheldon Creek should be mapped and rated according to their potential sediment yields, and control measures should be taken.

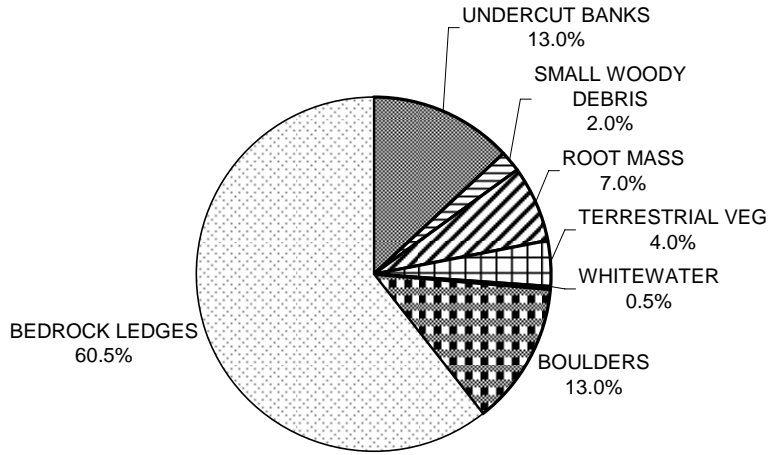
GRAPH 7

Table 5 summarizes mean percent cover by habitat type. Bedrock Ledges are the dominant cover types in Sheldon Creek. Graph 7 describes the pool cover in Sheldon Creek. Bedrock Ledges is the dominant pool cover type followed by boulders.

The mean shelter rating for pools was 32. The shelter rating in the flatwater habitats was 22. A pool shelter rating of approximately 100 is desirable. The amount of cover that now exists is being provided primarily by Bedrock Ledges in Sheldon Creek. Bedrock Ledges are the dominant cover type in pools followed by boulders. Log and root wad cover structures in the pool and flatwater habitats would enhance both summer and winter salmonid habitat. Log cover structure provides rearing fry with protection from predation, rest from water velocity, and also divides territorial units to reduce density related competition.

Where feasible, increase woody cover in the pool and flatwater habitat units along the entire stream. Most of the existing shelter is from vegetation and undercut banks. Adding high quality complexity with larger woody cover is desirable. Combination cover/scour structures constructed with boulders and woody debris would be effective in many flatwater and pool locations in the upper reaches. This must be done where the banks are stable or in conjunction with stream bank armor to prevent erosion. In some areas the material is at hand.

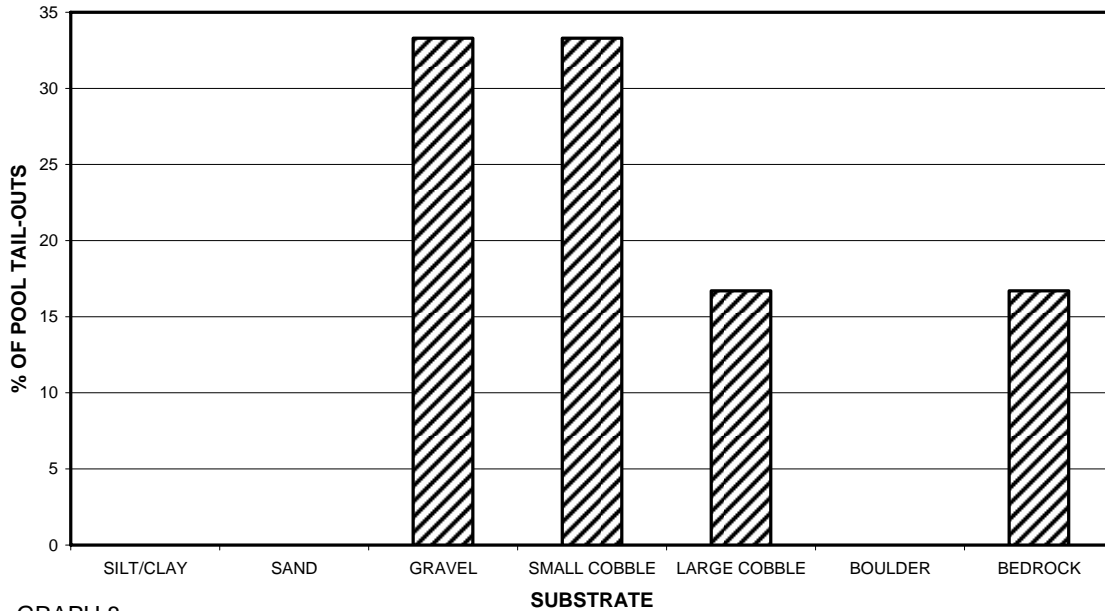
GRAPH 8

Table 6 summarizes the dominant substrate by habitat type. Graph 8 depicts the dominant substrate observed in pool tail-outs.

Eight of the twelve pool tail-outs measured had gravel or small cobble as the dominant substrate. This is generally considered good for spawning salmonids.

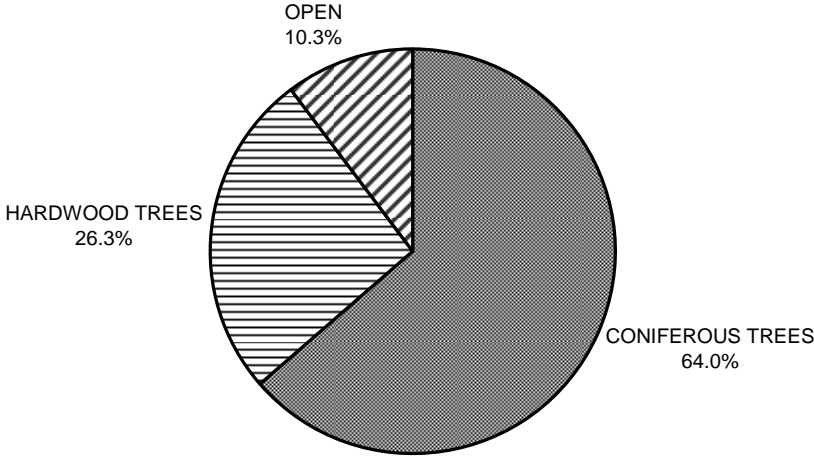
GRAPH 9

The mean percent canopy density for the surveyed length of Sheldon Creek was 90%. The mean percentages of hardwood and coniferous trees were 29% and 71%, respectively. Ten percent of the canopy was open. Graph 9 describes the mean percent canopy in Sheldon Creek.

The mean percent canopy density for the stream was 90%. In general, revegetation projects are considered when canopy density is less than 80%.

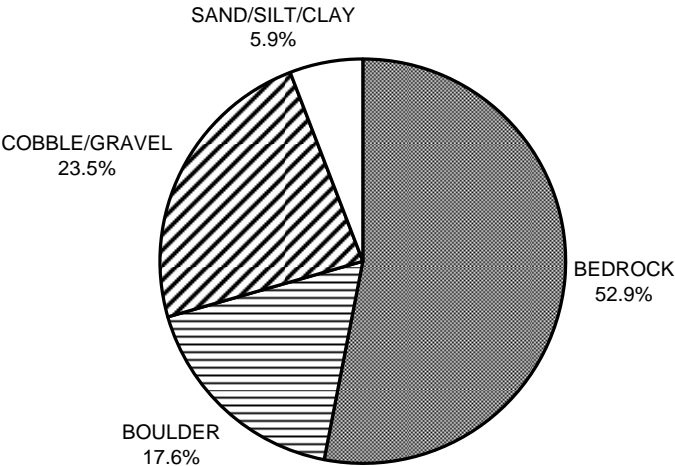
GRAPH 10

For the stream reach surveyed, the mean percent right bank vegetated was 14%. The mean percent left bank vegetated was 30%. The dominant elements composing the structure of the stream banks consisted of 53% bedrock, 18% boulder, 24% cobble/gravel, 6% sand/silt/clay, (Graph 10). Grass was the dominant vegetation type observed in 88% of the units surveyed. Additionally, 3% of the units surveyed had hardwood trees as the dominant vegetation type, and 3% had coniferous trees as the dominant vegetation (Graph 11).

The percentage of right and left bank covered with vegetation was low at 14% and 30%, respectively. In areas of stream bank erosion or where bank vegetation is sparse, planting endemic species of coniferous and hardwood trees, in conjunction with bank stabilization, is recommended.

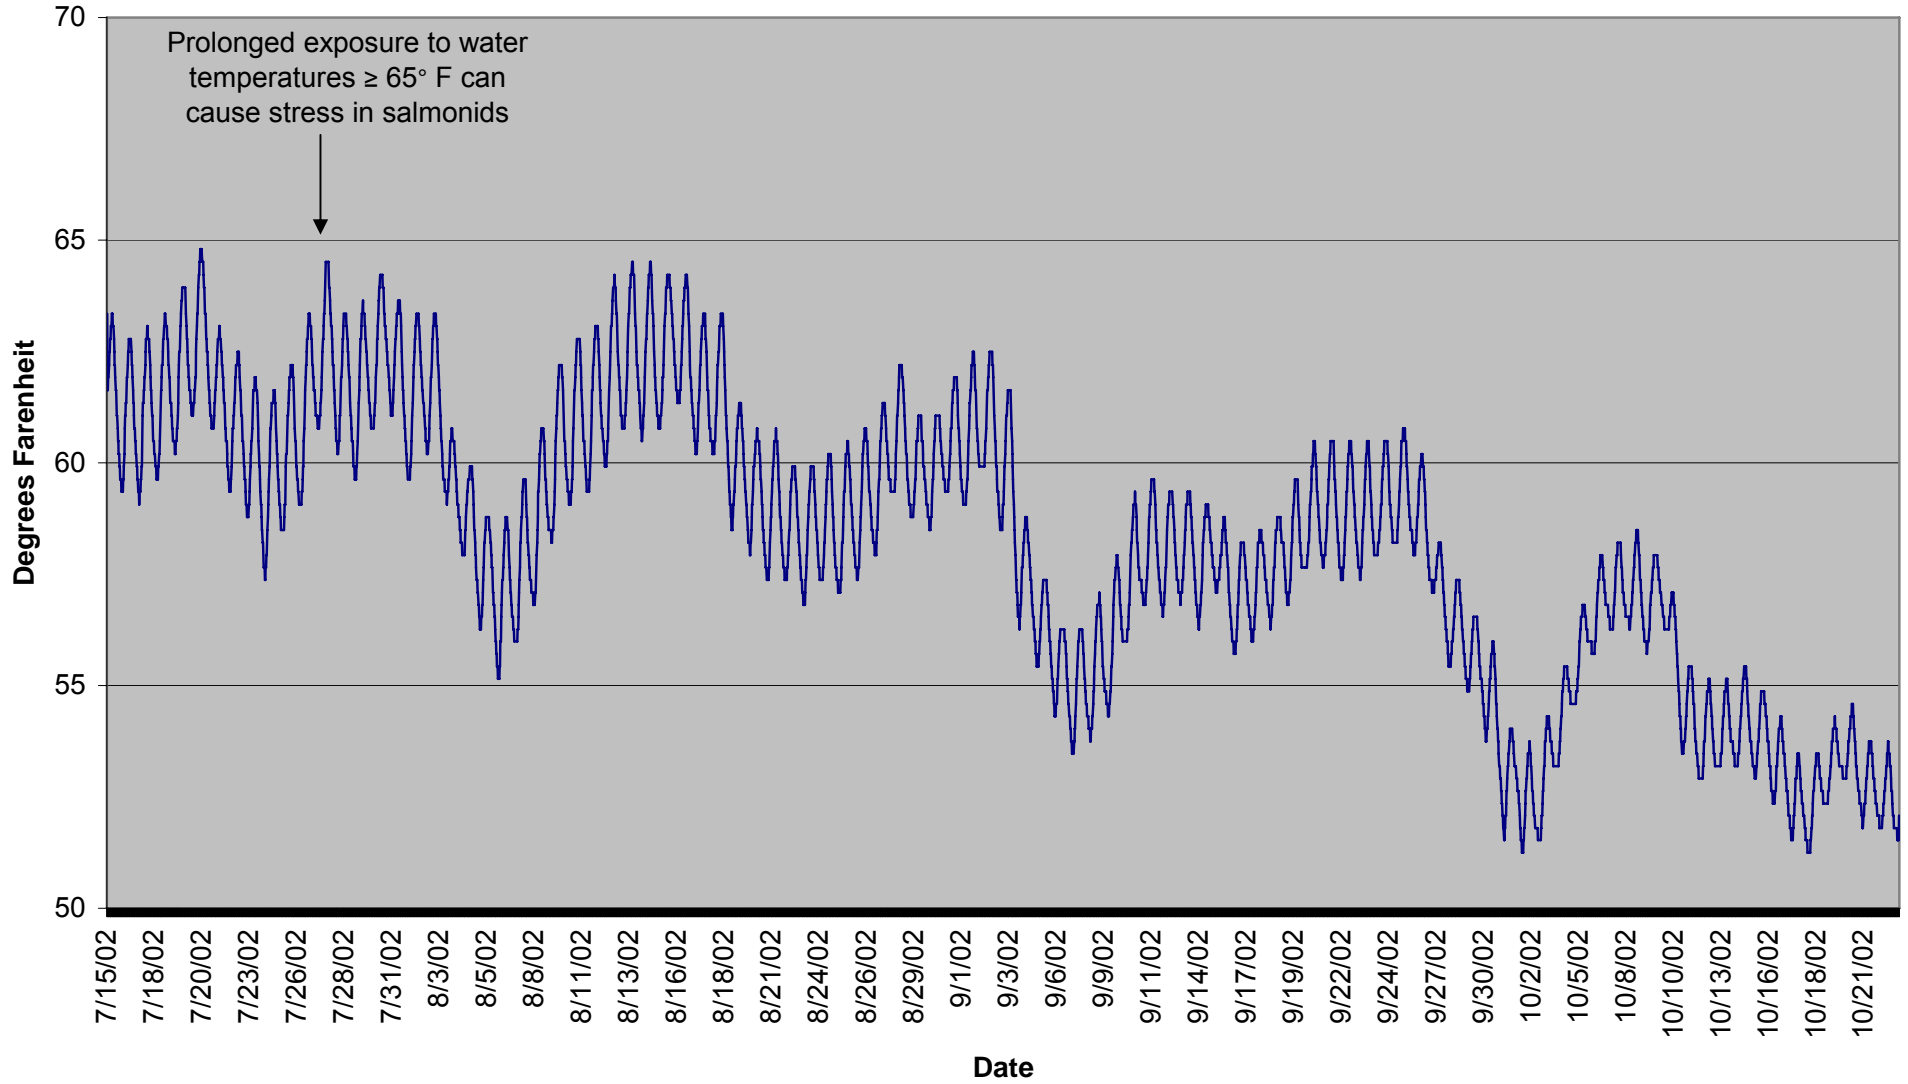
**Unnamed tributary to Sheldon Creek Water Temperature 2002
(Unsurveyed tributary)**

Water temperatures ranged from 48°F to 51°F. Air temperatures ranged from 45°F to 49°F. Summer temperatures were also measured using a remote temperature recorder placed in a pool (see Temperature Summary graphs at end of report). The recorder in a reach upstream of Reach 1 logged temperatures every half hour from 7/15/02 to 10/23/02. The highest temperature recorded was 64.8°F on 7/20/02 and the lowest was 51.3°F on 10/2/02 and 10/18/02. The mean of the daily highs was 63.3°F for the month of July, 61.8°F for August, 59.2°F for September, and 55.4°F for October.

Summer temperatures measured using a remote temperature recorder ranged from 51.3° to 64.8°F. The Temperature Summary graph shows that for much of the summer (July through August) the upper watershed exhibited temperatures at the optimal for salmonids. It is unknown if this thermal regime is typical. To make any further conclusions, temperatures need to be monitored in more locations, for a longer period of time through the critical summer months, and biological sampling could be conducted.
