**CALIFORNIA DEPARTMENT OF FISH AND GAME
STREAM INVENTORY REPORT**

Vasser Creek
Report Revised April 14, 2006
Report Completed 2005
Assessment Completed 2002

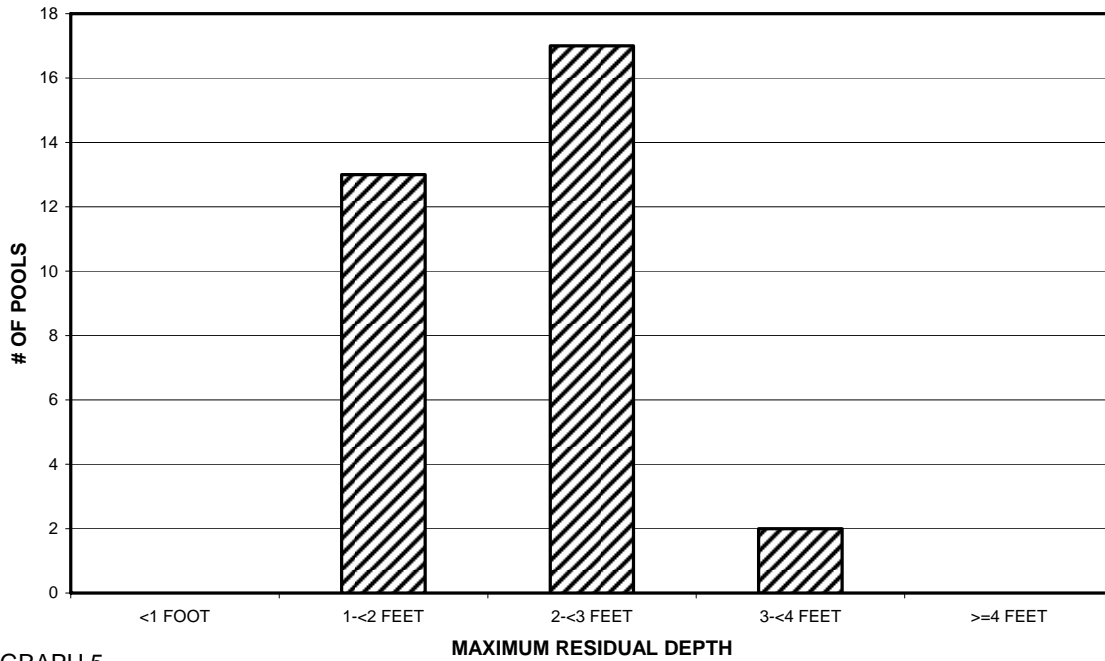
GRAPH 5

Table 4 is a summary of maximum residual pool depths by pool habitat types. Pool quality for salmonids increases with depth. Two of the 32 pools (6%) had a residual depth of three feet or greater (Graph 5).

Flatwater habitat types comprised 81% of the total length of this survey, riffles 10%, and pools 5%. The pools are relatively shallow 2 of the 32 (6%) pools having a maximum residual depth greater than 2 feet. In general, pool enhancement projects are considered when primary pools comprise less than 40% of the length of total stream habitat. In third and fourth order streams, a primary pool is defined to have a maximum residual depth of at least three feet, occupy at least half the width of the low flow channel,

and be as long as the low flow channel width. Installing structures that will increase or deepen pool habitat is recommended for locations where their installation will not be threatened by high stream energy, or where their installation will not conflict with the modification of the numerous log debris accumulations (LDA's) in the stream.

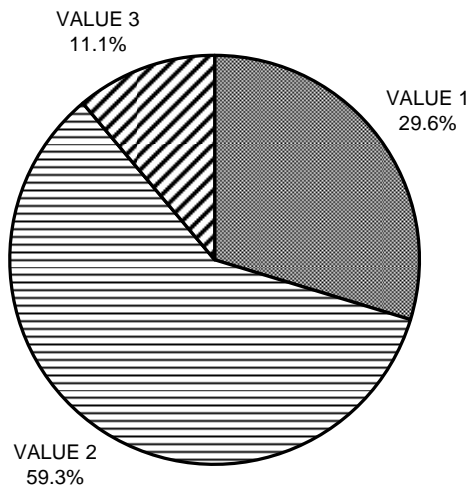
GRAPH 6

The depth of cobble embeddedness was estimated at pool tail-outs. Of the 27 pool tail-outs measured, eight had a value of 1 (29.6%); sixteen had a value of 2 (59.3%); three had a value of 3 (11.1%); (Graph 6). On this scale, a value of 1 indicates the best spawning conditions and a value of 4 the worst. Additionally, a value of 5 was assigned to tail-outs deemed unsuited for spawning due to inappropriate substrate like bedrock, log sills, boulders.

Twenty four of the 27 pool tail-outs measured had embeddedness ratings of 1 or 2. Three of the pool tail-outs had embeddedness ratings of 3 or 4. None of the pool tail-outs had a rating of 5, which is considered unsuitable for spawning. Cobble embeddedness measured to be 25% or less, a rating of 1, is considered to indicate good quality spawning substrate for salmon and steelhead. Sediment sources in Vasser Creek should be mapped and rated according to their potential sediment yields, and control measures should be taken.

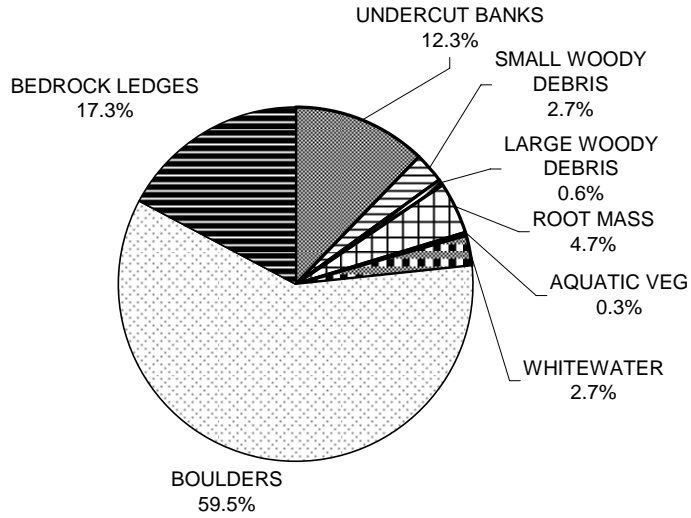
GRAPH 7

Table 5 summarizes mean percent cover by habitat type. Boulders are the dominant cover types in Vasser Creek. Graph 7 describes the pool cover in Vasser Creek. Boulders are the dominant pool cover type followed by bedrock ledges.

The mean shelter rating for pools was 12 . The shelter rating in the flatwater habitats was 4. A pool shelter rating of approximately 100 is desirable. The amount of cover that now exists is being provided primarily by Boulders in Vasser Creek. Boulders are the dominant cover type in pools followed by bedrock ledges . Log and root wad cover structures in the pool and flatwater habitats would enhance both summer and winter salmonid habitat. Log cover structure provides rearing fry with protection from predation, rest from water velocity, and also divides territorial units to reduce density related competition.

- 6) Increase woody cover in the pools and flatwater habitat units. Most of the existing cover is from boulders. Adding high quality complexity with woody cover is desirable.

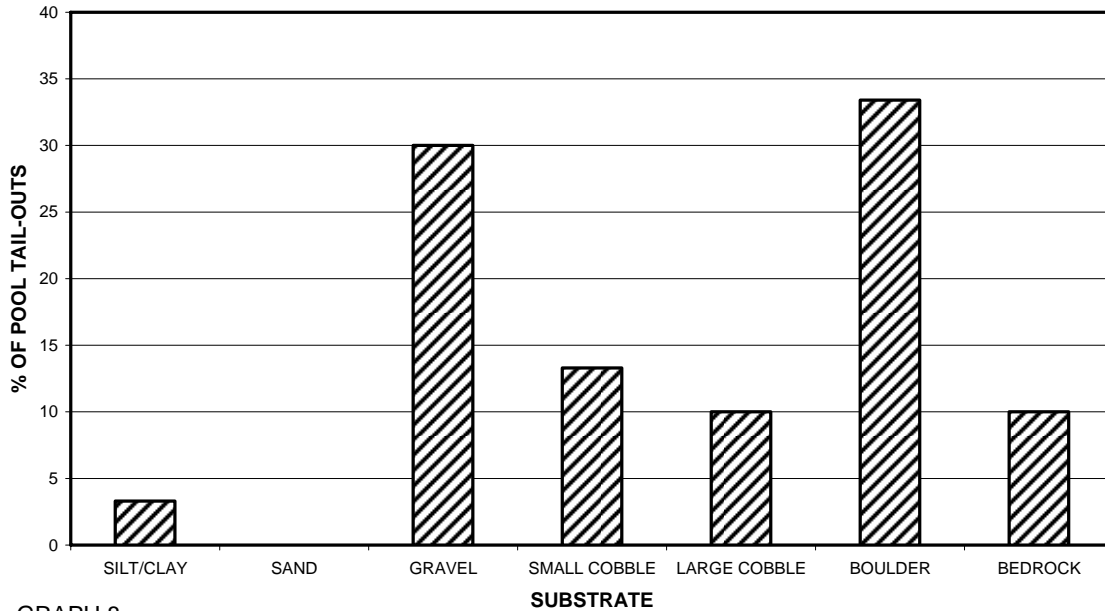
GRAPH 8

Table 6 summarizes the dominant substrate by habitat type. Graph 8 depicts the dominant substrate observed in pool tail-outs. Gravel was observed in 30% of pool tail-outs, and boulders observed in 33% of pool tail-outs.

Seventeen of the 30 pool tail-outs had silt, sand, large cobble, boulders or bedrock as the dominant substrate. This is generally considered unsuitable for spawning salmonids.

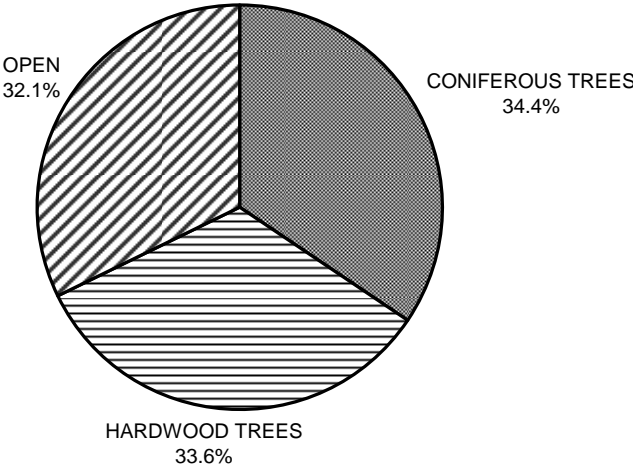
GRAPH 9

The mean percent canopy density for the surveyed length of Vasser Creek was 68%. The mean percentages of hardwood and coniferous trees were 49% and 51%, respectively. Thirty two percent of the canopy was open. Graph 9 describes the mean percent canopy in Vasser Creek.

The mean percent canopy density for the stream was 68%. Reach 1 had a canopy density of 52.9%, Reach 2 had a canopy density of 80.4%, Reach 3 had a canopy density of 81.5%, Reach 4 had a canopy density of 88.8%, . In general, revegetation projects are considered when canopy density is less than 80%.

- 2) Increase the canopy on Vasser Creek by planting willow, alder, redwood, and Douglas fir along the stream where shade canopy is not at acceptable levels. The reaches above this survey section should be inventoried and treated as well, since the water flowing here is affected from upstream. In many cases, planting will need to be coordinated to follow bank stabilization or upslope erosion control projects.

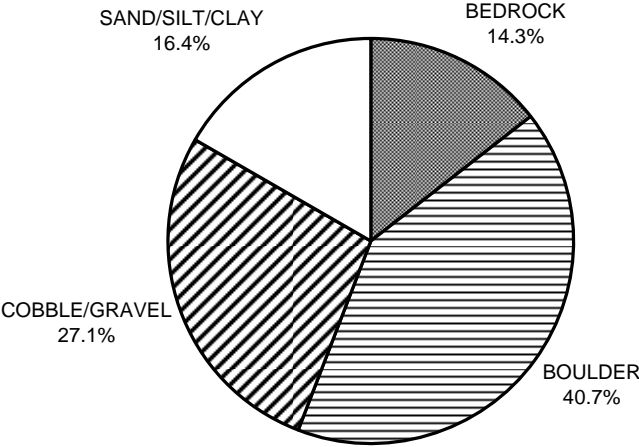
GRAPH 10

For the stream reach surveyed, the mean percent right bank vegetated was 12%. The mean percent left bank vegetated was 14%. The dominant elements composing the structure of the stream banks consisted of 14% bedrock, 41% boulder, 27% cobble/gravel, 16% sand/silt/clay, (Graph 10). (8% grass, 24% brush, 24% deciduous trees, 23% coniferous trees, - Use these numbers to choose 2 dominant types.) Brush was the dominant vegetation type observed in 24% of the units surveyed. Additionally, 24% of the units surveyed had hardwood trees as the dominant vegetation type, and 23% had coniferous trees as the dominant vegetation (Graph 11).

The percentage of right and left bank covered with vegetation was low at 12% and 14%, respectively. In areas of stream bank erosion or where bank vegetation is sparse, planting endemic species of coniferous and hardwood trees, in conjunction with bank stabilization, is recommended.
