# **CALIFORNIA DEPARTMENT OF FISH AND GAME STREAM INVENTORY REPORT**

Grape Creek

*Report Revised April 14, 2006*

*Assessment Completed 1998*

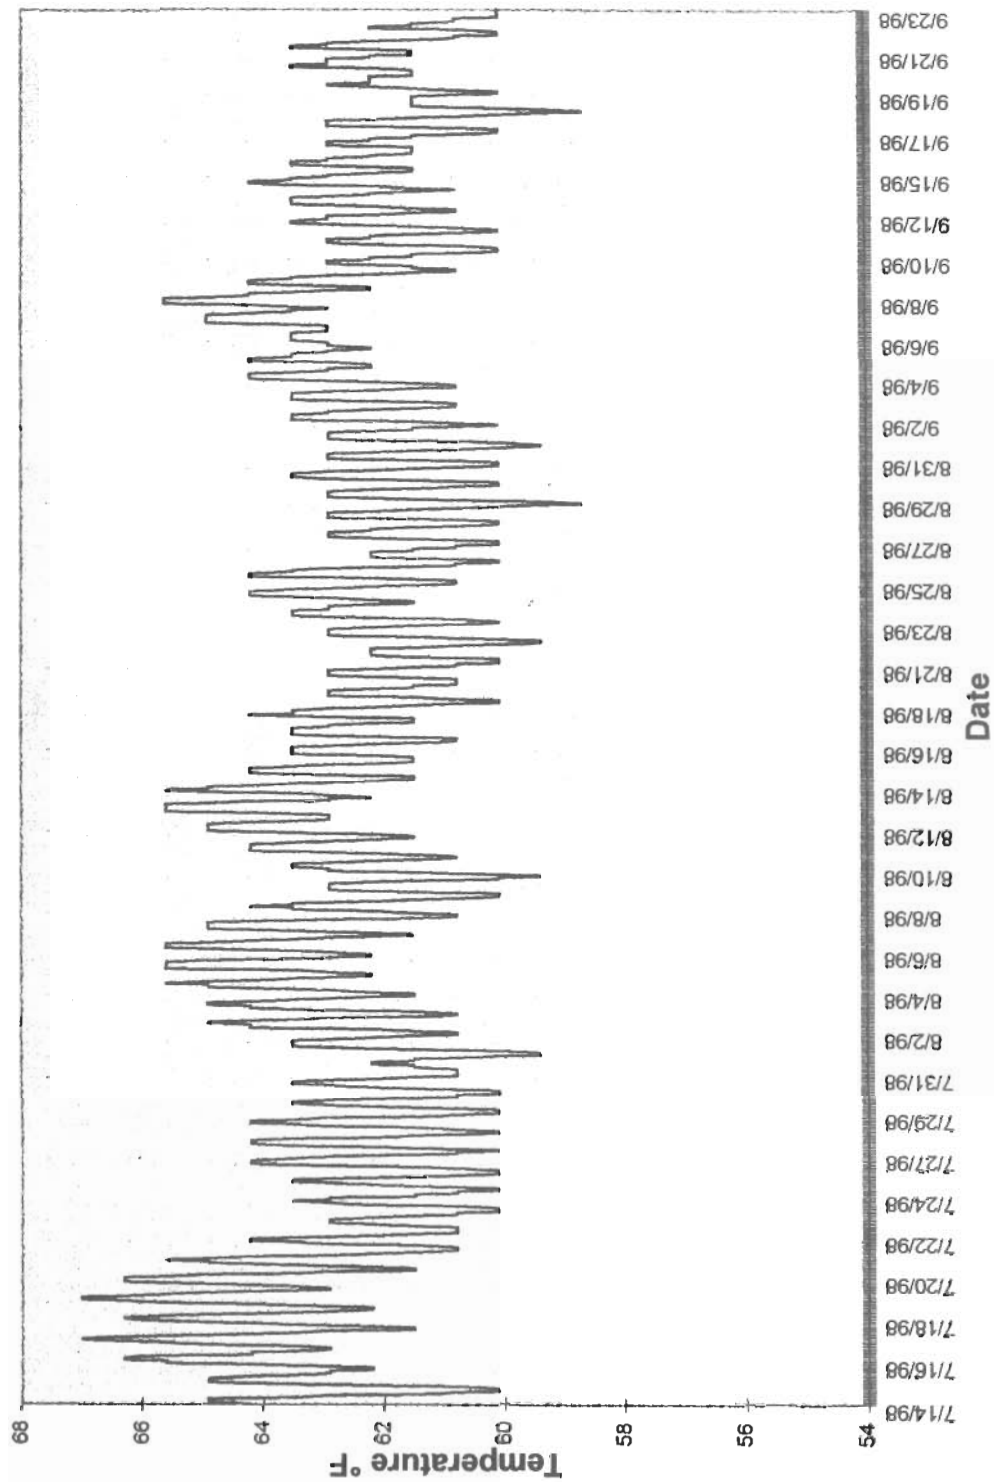
# Grape Creek Water Temperatures

Summer temperatures measured using a remote temperature recorder placed in a pool ranged from 59° to 67°F at 100 feet downstream of Bridge #1 in Reach 1. The Temperature Summary graph shows that for much of the summer (July through August) the lower watershed exhibited temperatures near the optimal for salmonids.

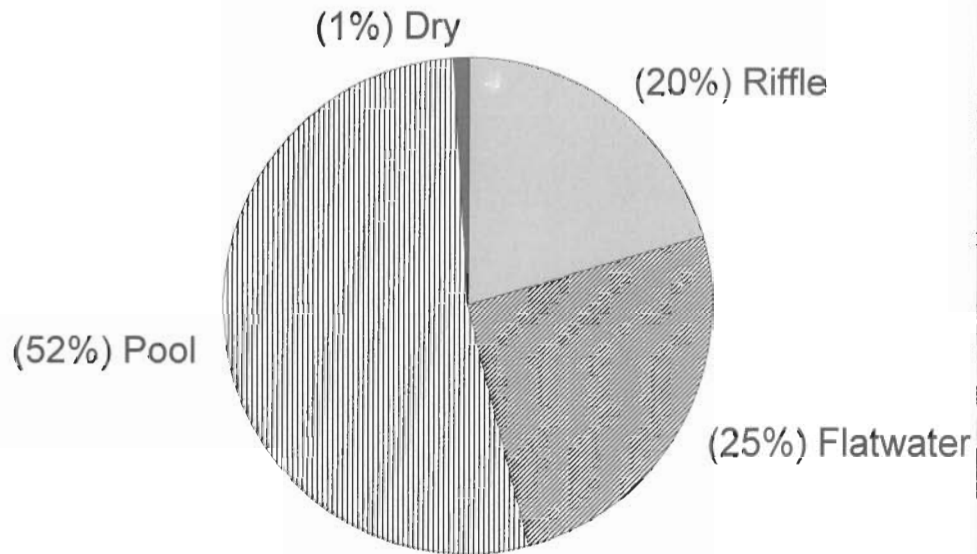
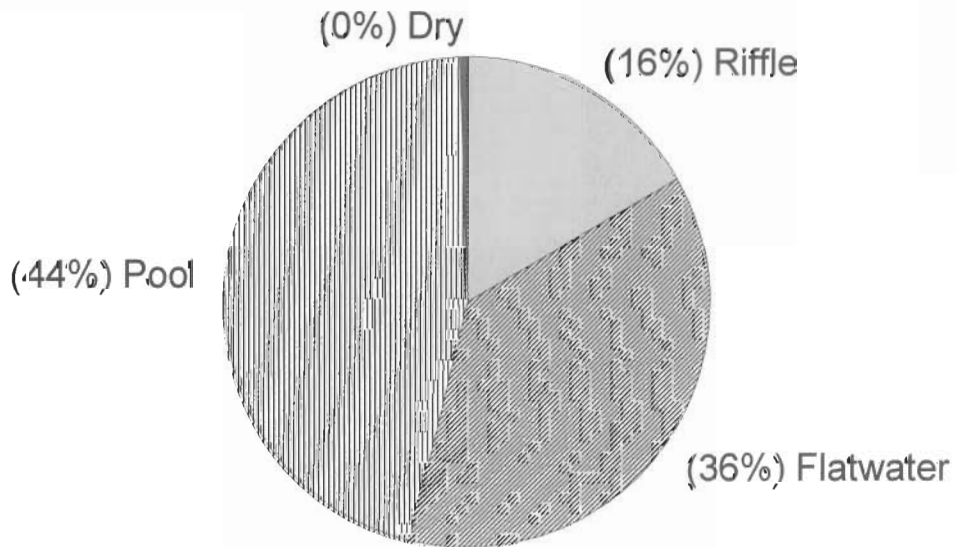
Level II Habitat Types by % Occurrence

Table 1 summarizes the Level II riffle, flatwater, and pool habitat types. Based on frequency of **occurrence** there were 52% pool units, 25% flatwater units, 20% riffle units, and 1% dry streambed units. Based on total **length** there were 44% pool units, 36% flatwater units, 16% riffle units, and 0% dry streambed units (Graph 1).

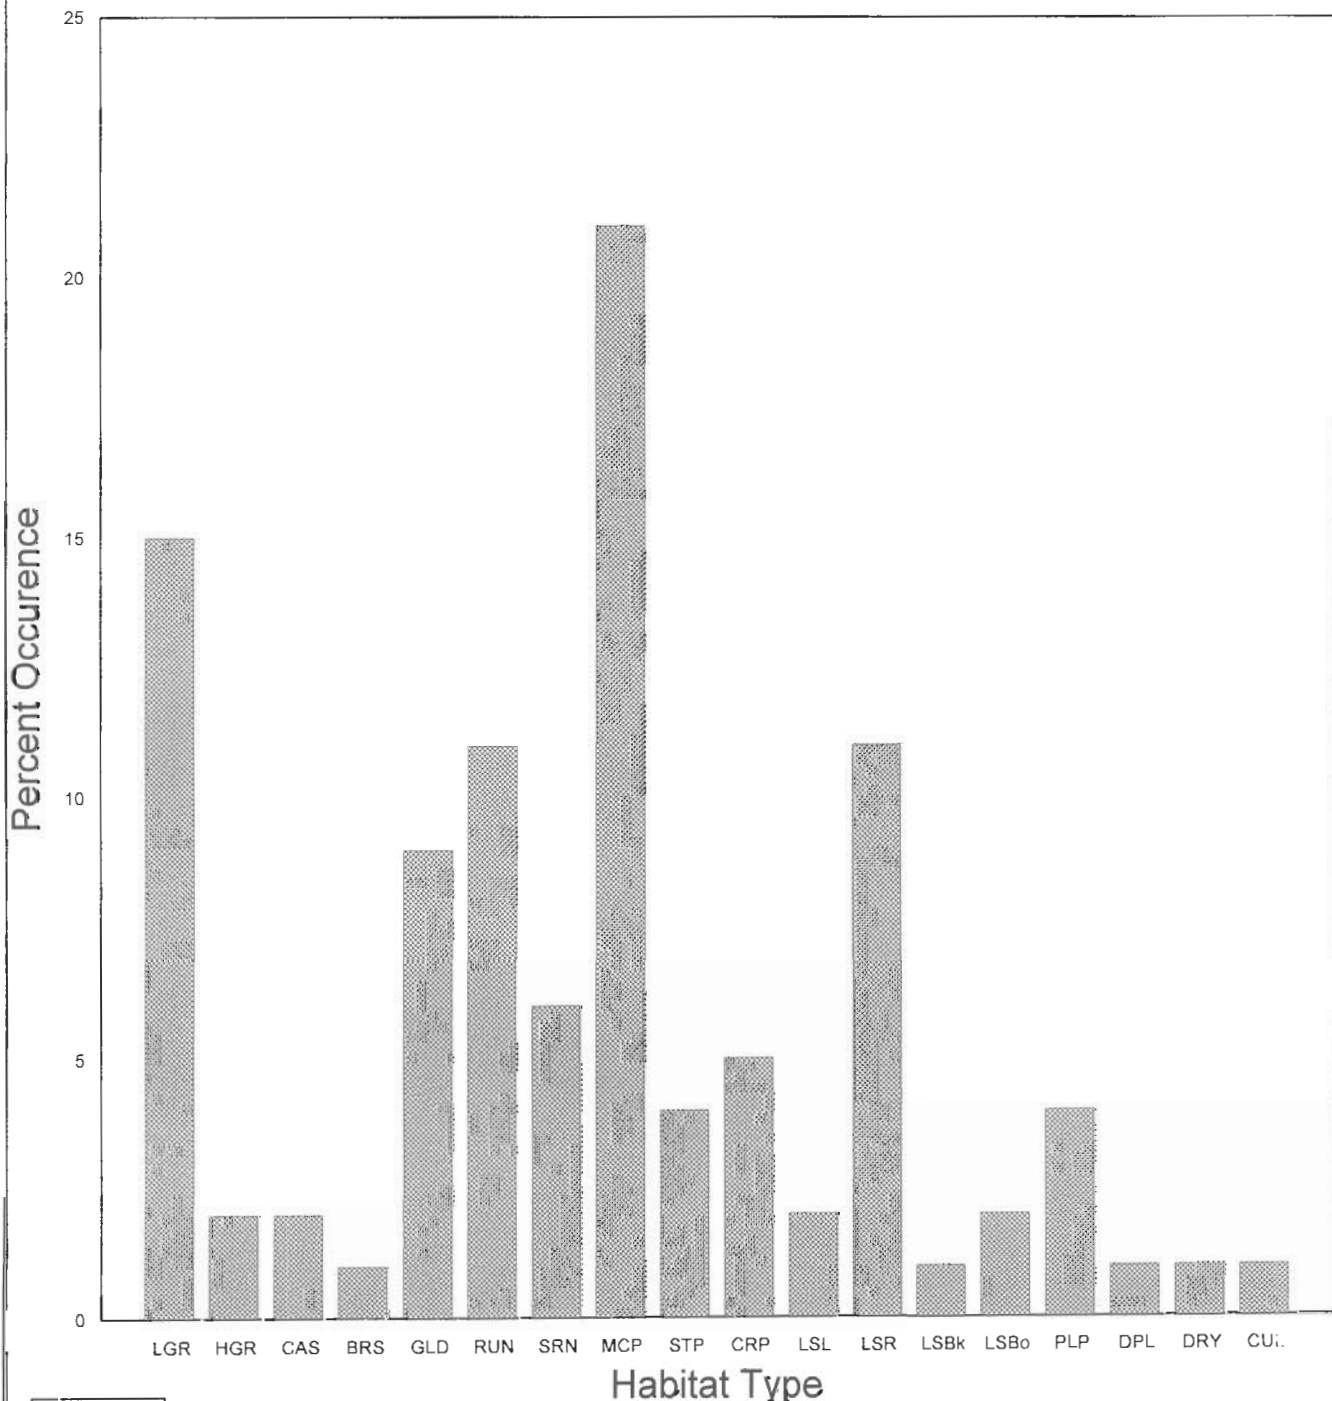
Graph 2

Level IV habitat types were identified. The data is summarized in Table 2. The most frequent habitat types by percent **occurrence** were mid-channel pools at 21%, low gradient riffles 15%, root wad scour pools 11% and runs 11% (Graph 2). By percent total **length**, mid-channel pools made up 15%, runs 13%, glides 11%, and step runs 11%.

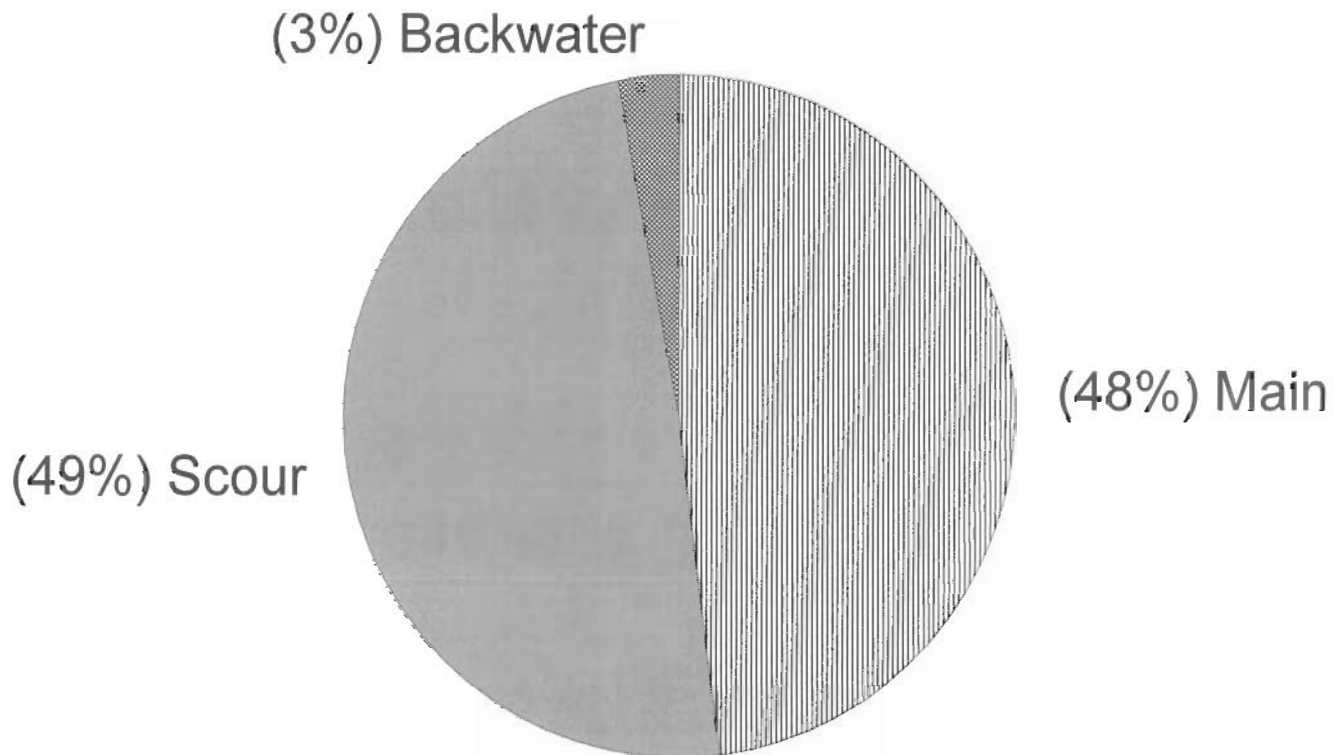
Graph 3

One hundred and eight pools were identified (Table 3). Scour pools were most often encountered at 49%, and comprised 41% of the total length of pools (Graph 3).

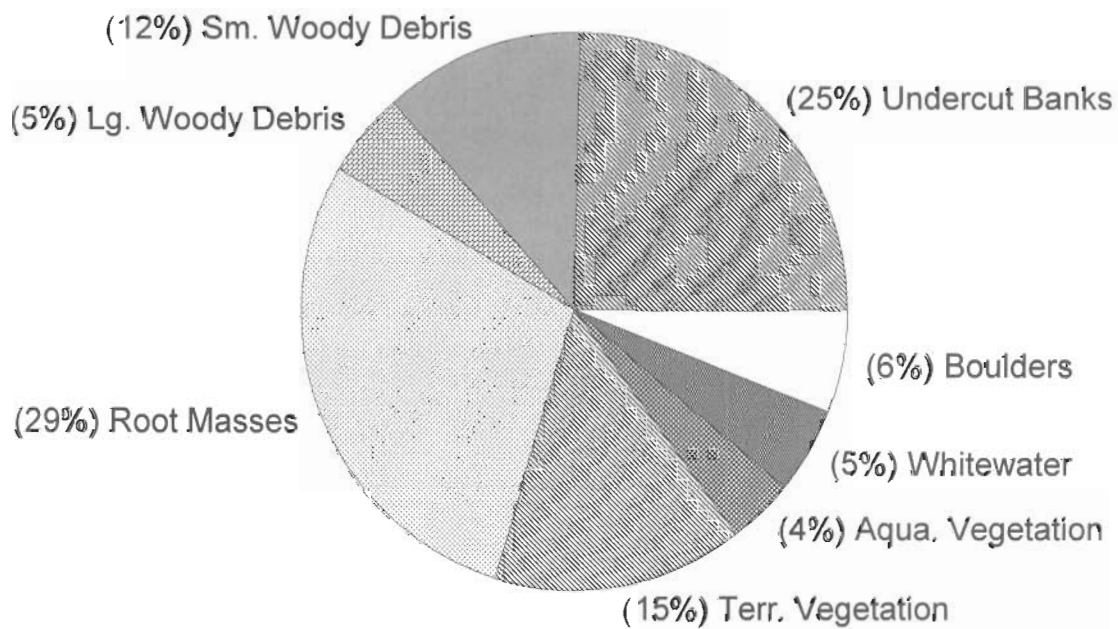
Table 5 summarizes fish shelter by habitat type. By percent area, the dominant pool shelter types were root masses at 29%, undercut banks 25%, terrestrial vegetation 15%, and small woody debris 12%. Graph 5 describes the pool shelter in Grape Creek.

The mean shelter rating for pools was 45. However, a pool shelter rating of approximately 80 is desirable. The relatively small amount of pool shelter that now exists is being provided primarily by root masses (29%), undercut banks (25%), terrestrial vegetation (15%), and small woody debris (12%). Log and root wad cover in the pool and flatwater habitats would improve both summer and winter salmonid habitat. Log cover provides rearing fry with protection from predation, rest from water velocity, and also divides territorial units to reduce density related competition.

- 4) Where feasible, increase woody cover in the pool and flatwater habitat units along the entire stream. Most of the existing >shelter is from vegetation and undercut banks. Adding high quality complexity with larger woody cover is desirable. Combination cover/scour structures constructed with boulders and woody debris would be effective in many flatwater and pool locations in the upper reaches. This must be done where the banks are stable or in conjunction with stream bank armor to prevent erosion (Reaches 1-4). In some areas the material is at hand.

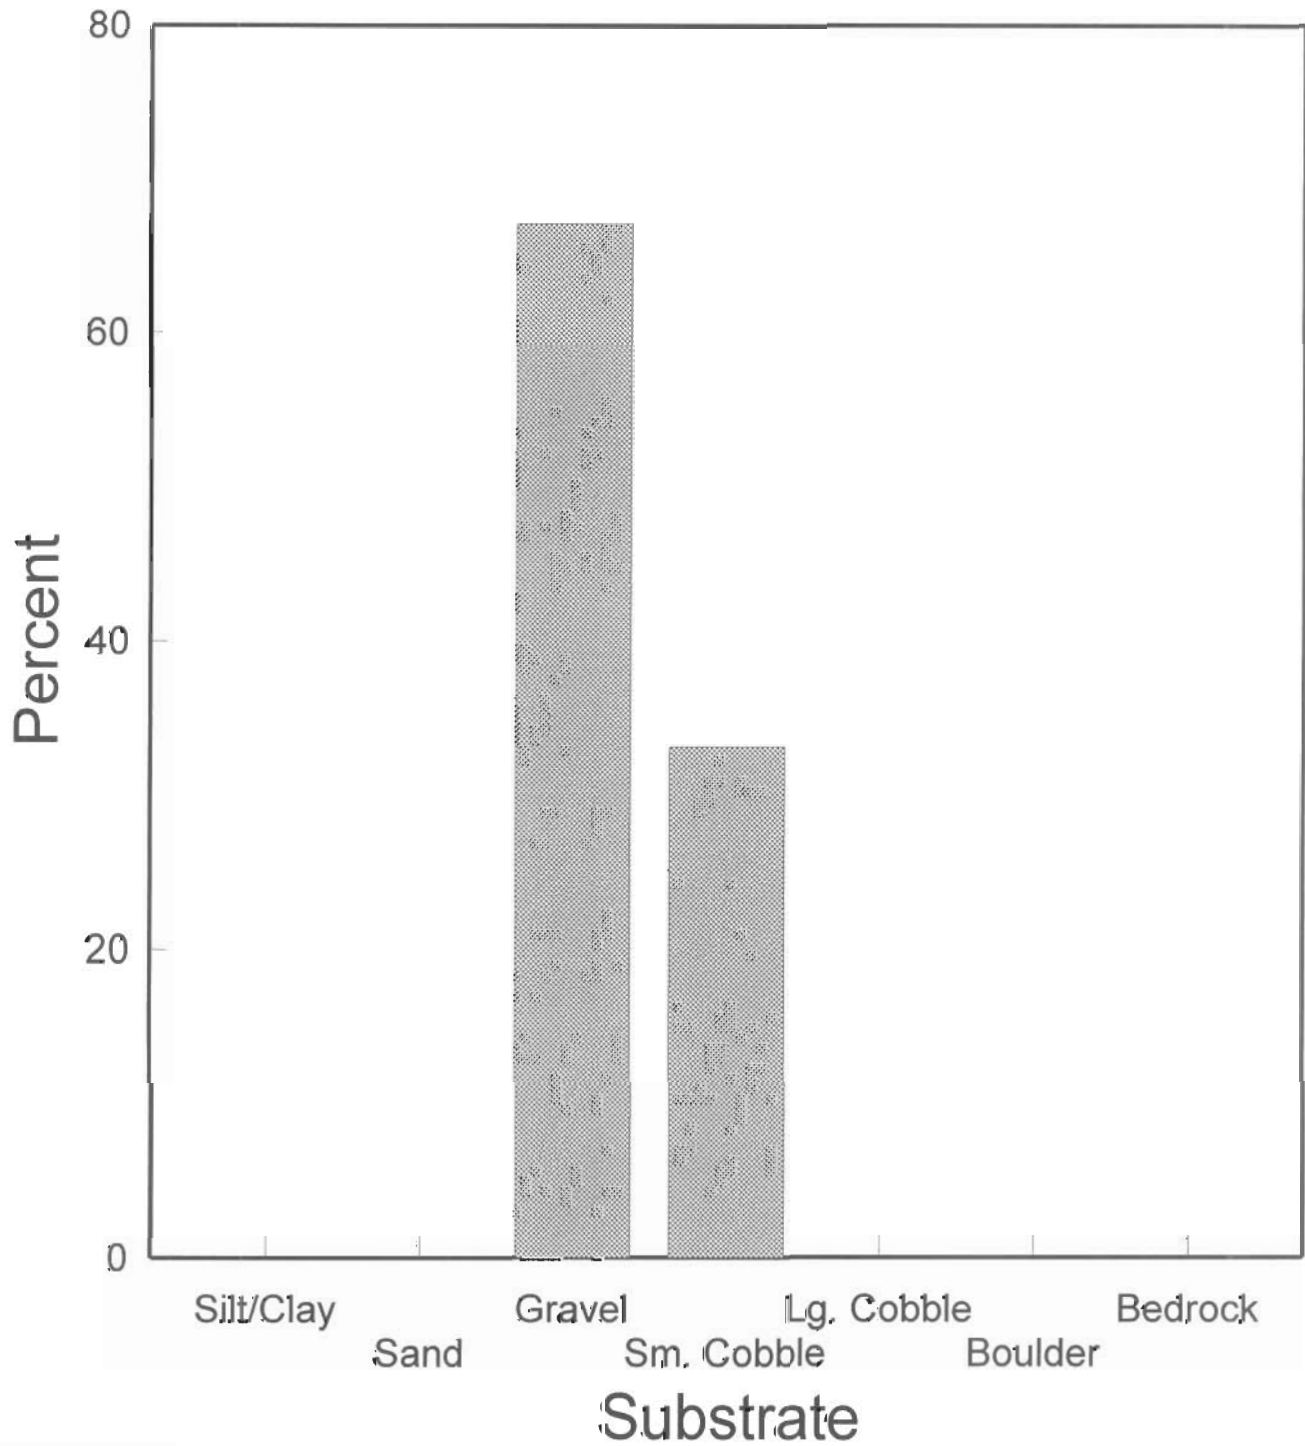
Graph 6

Table 6 summarizes the dominant substrate by habitat type. Gravel was the dominant substrate observed in 4 of the 6 low gradient riffles measured. Small cobble was dominant in two of the low gradient riffles (Graph 6).

All of the six low gradient riffles measured (100%) had either gravel or small cobble as the dominant substrate. This is generally considered good for spawning salmonids.

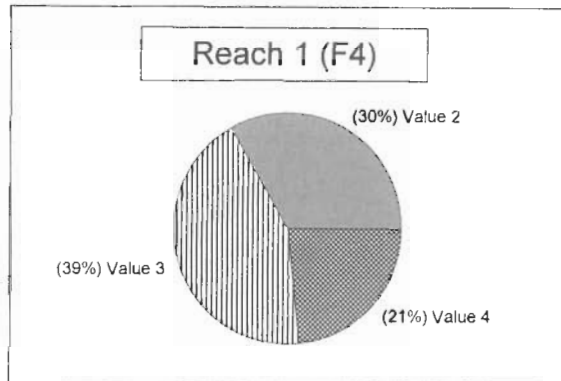
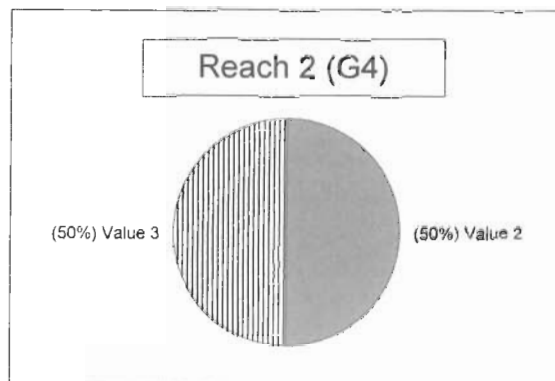
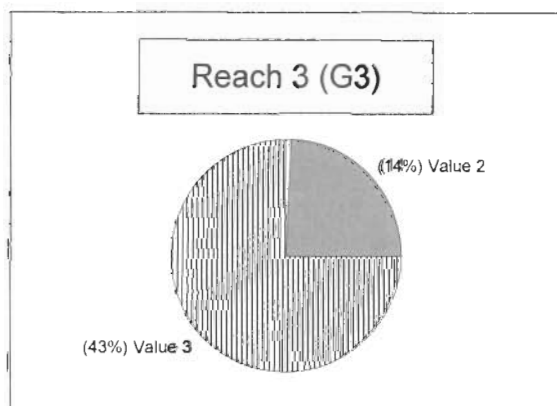
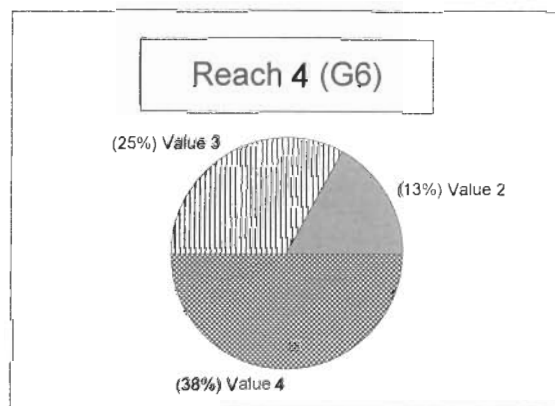
## Percent Cobble Embeddedness by Reach

The depth of cobble embeddedness was estimated at pool tail-outs. Of the 103 pool tail-outs measured, none had a value of 1 (0%); thirty had a value of 2 (29%); forty had a value of 3 (39%); and twenty had a value of 4 (19%). Thirteen (13%) pool tail-outs rated a 5 (unsuitable substrate type for spawning). On this scale, a value of one is best for fisheries. Gravel was the dominant substrate observed at pool tail-outs.

Fifty-eight percent of the pool tail-outs measured had embeddedness ratings of either 3 or 4. None of the pool tail-outs had a rating of 1. Cobble embeddedness measured to be 25% or less, a rating of 1, is considered best for the needs of salmon and steelhead. In a reach comparison, Reaches 1 and 2 had the best ratings and Reaches 3 and 4 had the poorest ratings.

- 1) In Grape Creek, active and potential sediment sources related to the road system need to be mapped, and treated according to their potential for sediment yield to the stream and its tributaries.

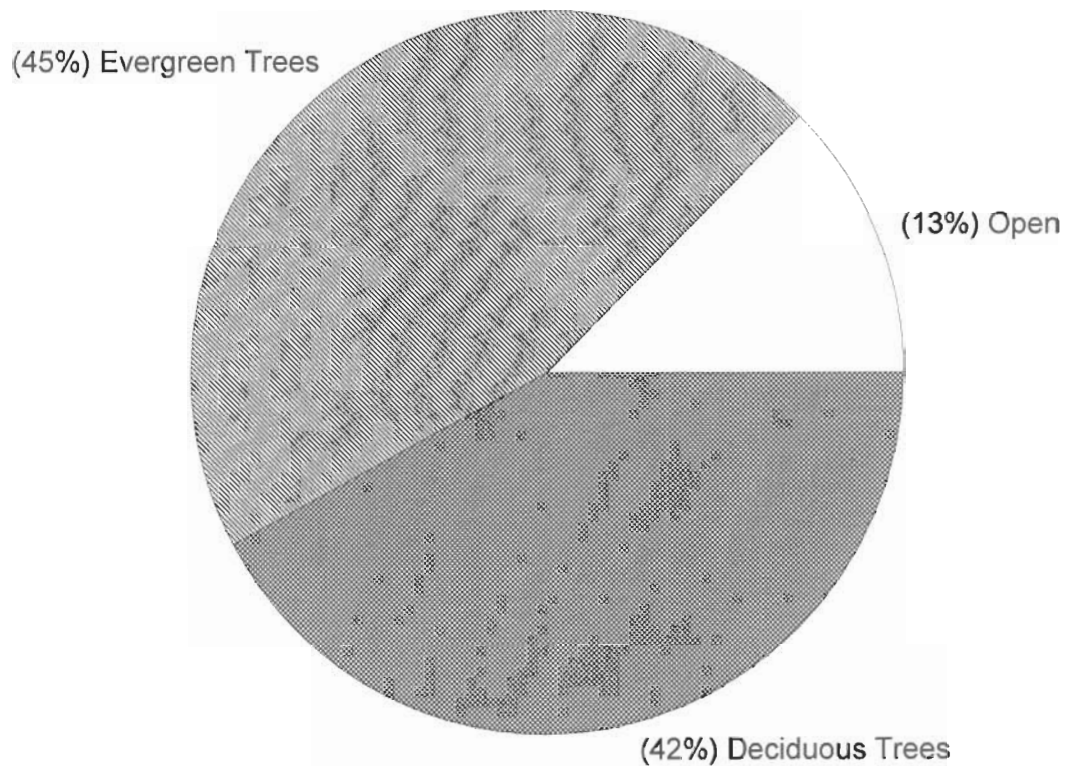
The mean percent canopy density for the stream reach surveyed was 87%. The mean percentages of deciduous and evergreen trees were 48% and 52%, respectively. Graph 8 describes the canopy for the entire survey.

The mean percent canopy for the survey was 87%. This is very good, since 80 percent is generally considered desirable. However, the riparian buffer is thin or nearly absent in areas with agriculture. Vineyard development within the riparian corridor could all lead to less stream canopy and channel incision causing bank erosion and higher water temperatures.

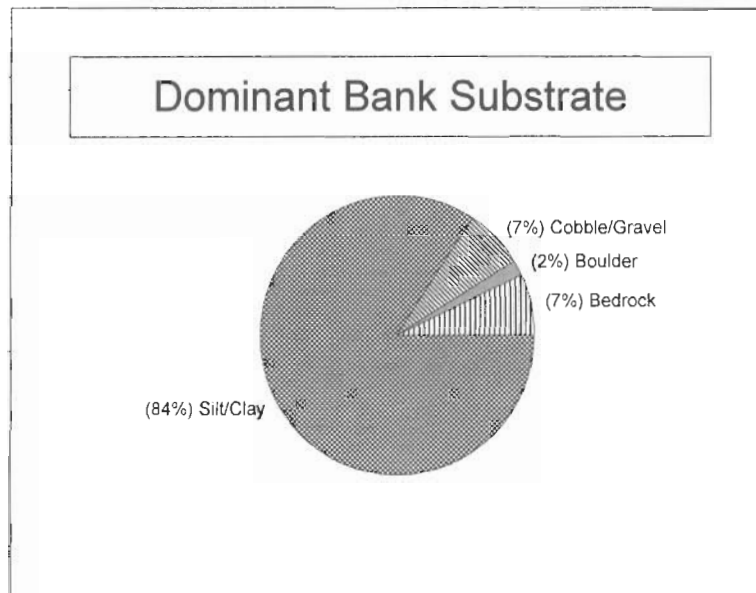
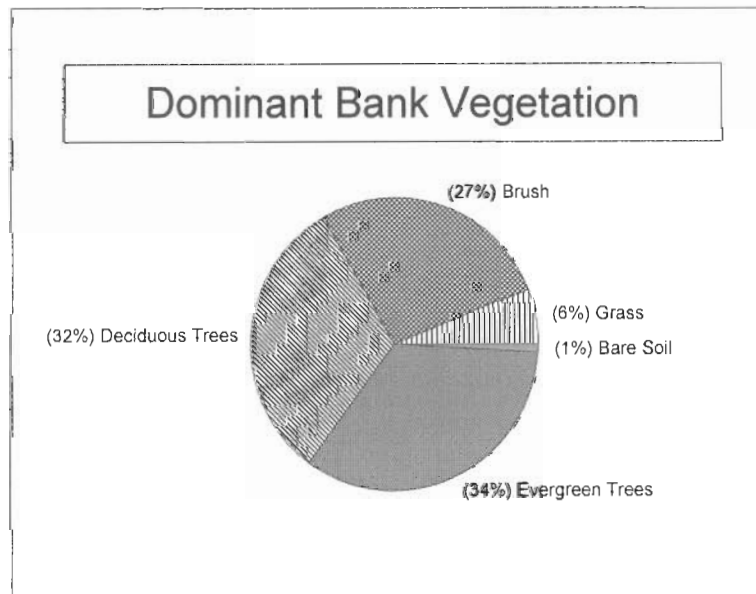
Graph 10

For the entire stream reach surveyed, the mean percent right bank vegetated was 48% and the mean percent left bank vegetated was 56%. For the habitat units measured, the dominant vegetation types for the stream banks were: 34% evergreen trees, 32% deciduous trees, 27% brush, 6% grass and 1% bare soil. The dominant substrate for the stream banks were: 84% silt/clay/sand, 7% bedrock, 7% cobble/gravel and 2% boulder (Graph 10).
