CALIFORNIA DEPARTMENT OF FISH AND GAME  
STREAM INVENTORY REPORT  
**Norton Slough**  
*Report Completed March 20, 2007*  
*Assessment Completed 2006*

## *Norton Slough 2006*

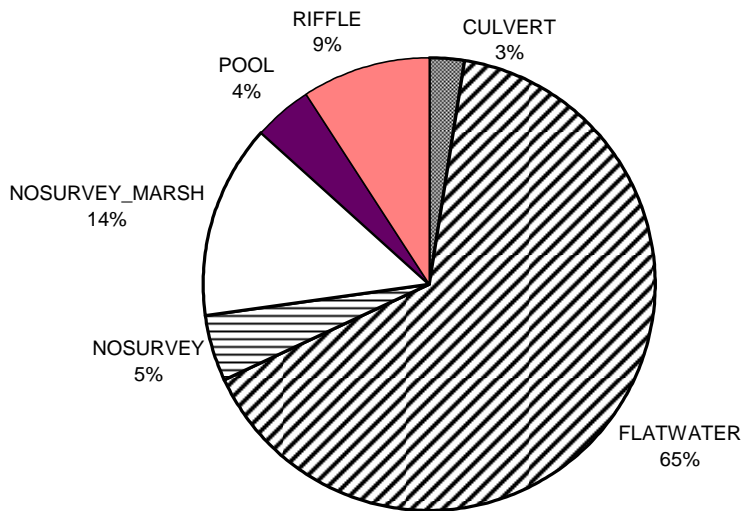
GRAPH 2

Table 1 summarizes the Level II riffle, flatwater, and pool habitat types. Based on frequency of occurrence there were 50% flatwater units, 28% riffle units, 11% pool units, 5% culvert units, 4% nosurvey units, and 2% nosurvey\_marsh units (Graph 1). Based on total length of Level II habitat types there were 65% flatwater units, 9% riffle units, 4% pool units, 3% culvert units, 5% nosurvey units, and 14% nosurvey\_marsh units (Graph 2).

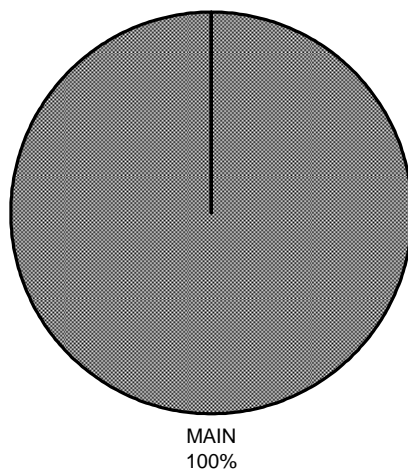
GRAPH 4

A total of 9 pools were identified (Table 3). All pools identified were main channel pools and comprised 100% of the total length of all pools (Graph 4).

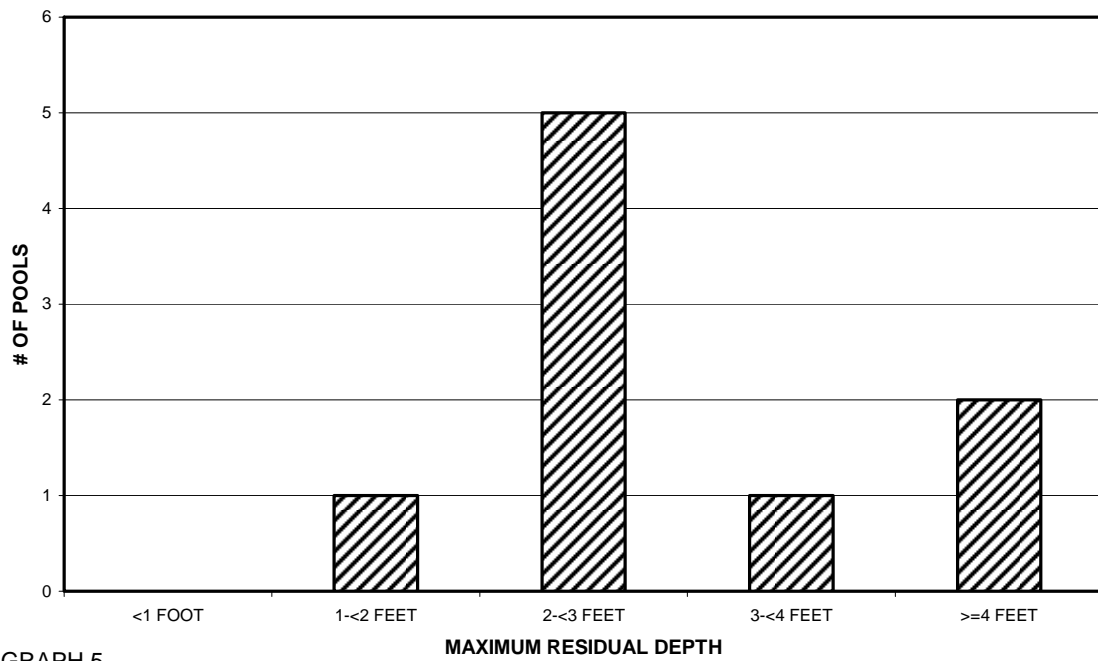
GRAPH 5

Table 4 is a summary of maximum residual pool depths by pool habitat types. Pool quality for salmonids increases with depth. Eight of the 9 pools (89%) had a residual depth of two feet or greater (Graph 5).

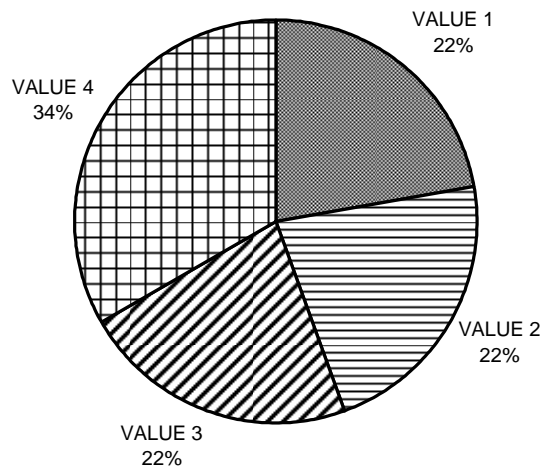
GRAPH 6

The depth of cobble embeddedness was estimated at pool tail-outs. Of the 9 pool tail-outs measured, 2 had a value of 1 (22%); 2 had a value of 2 (22%); 2 had a value of 3 (22%); and 3 had a value of 4 (34%) (Graph 6). On this scale, a value of 1 indicates the best spawning conditions and a value of 4 the worst. Additionally, a value of 5 was assigned to tail-outs deemed

Four of the 9 pool tail-outs measured had embeddedness ratings of 1 or 2 and five of the pool tail-outs had embeddedness ratings of 3 or 4. None of the pool tail-outs had a rating of 5, which is considered unsuitable for spawning. Cobble embeddedness measured to be 25% or less, a rating of 1, is considered to indicate good quality spawning substrate for salmon and steelhead. Sediment sources in Norton Slough should be mapped and rated according to their potential sediment yields, and control measures should be taken.

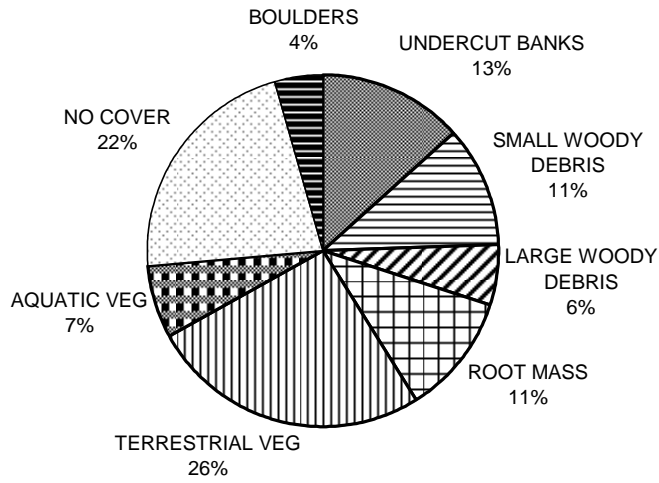
GRAPH 7

Table 5 summarizes mean percent cover by habitat type. Terrestrial Vegetation is the dominant cover types in Norton Slough. Graph 7 describes the pool cover in Norton Slough. Terrestrial Vegetation is the dominant pool cover type followed by undercut banks.

The mean shelter rating for pools was 22. The shelter rating in the flatwater habitats was 50. A pool shelter rating of approximately 100 is desirable. The amount of cover that now exists is being provided primarily by Terrestrial Vegetation in Norton Slough. Terrestrial Vegetation is the dominant cover type in pools followed by undercut banks. Log and root wad cover structures in the pool and flatwater habitats would enhance both summer and winter salmonid habitat. Log cover structure provides rearing fry with protection from predation, rest from water velocity, and also divides territorial units to reduce density related competition.

4. Increase woody cover in the pools and flatwater habitat units. Most of the existing cover in the pools is from Terrestrial Vegetation. Adding high quality complexity with woody cover in the pools is desirable.

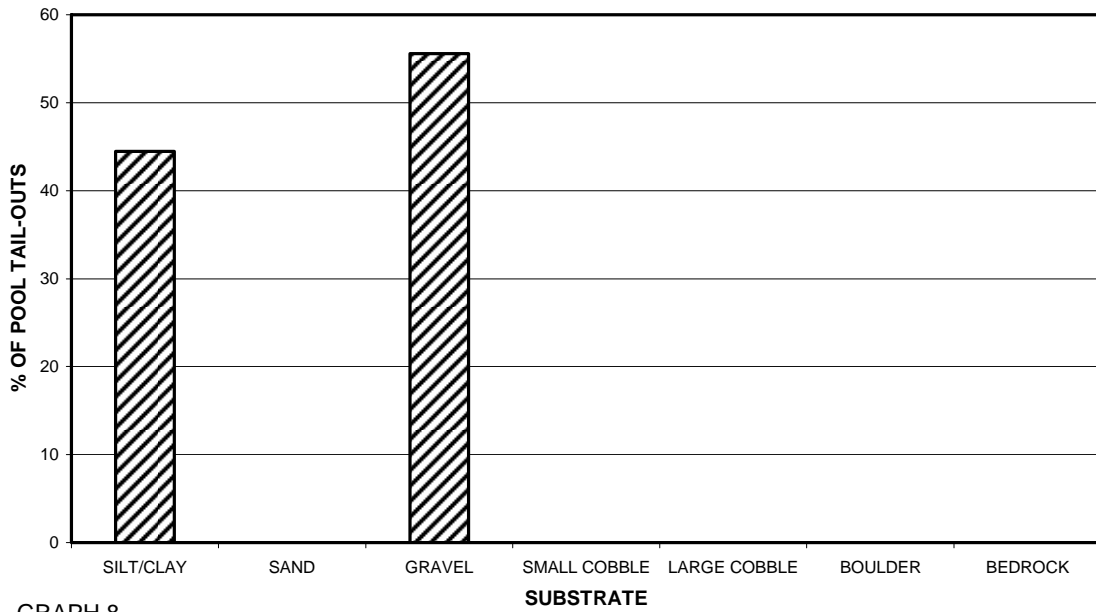
GRAPH 8

Table 6 summarizes the dominant substrate by habitat type. Graph 8 depicts the dominant substrate observed in pool tail-outs. A silt/clay substrate type was observed in 44% of pool tail-outs, and gravel substrate was observed in 56%.

Five of the 9 pool tail-outs measured had gravel or small cobble as the dominant substrate. This is generally considered good for spawning salmonids. The other 4 of the 9 pool tail-outs had silt or sand as the dominant substrate, which is generally considered unsuitable for spawning salmonids.

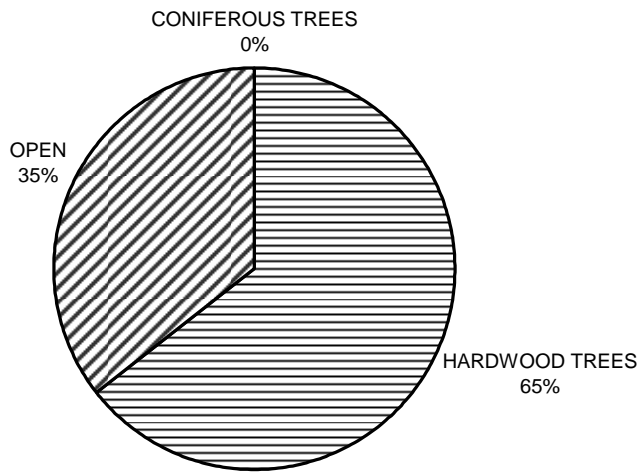
GRAPH 9

The mean percent canopy density for the surveyed length of Norton Slough was 65%. The mean percentages of hardwood and coniferous trees were 100% and 0%, respectively. Thirty-five percent of the canopy was open. Graph 9 describes the mean percent canopy in Norton Slough.

The mean percent canopy density for the stream was 65%. In general, revegetation projects are considered when canopy density is less than 80%.

5. Increase the canopy on Norton Slough by planting appropriate native vegetation like willow, alder, redwood, and Douglas fir along the stream where shade canopy is not at acceptable levels. The reaches above this survey section should be inventoried and treated as well, since the water flowing here is affected from upstream. In many cases, planting will need to be coordinated to follow bank stabilization or upslope erosion control projects.

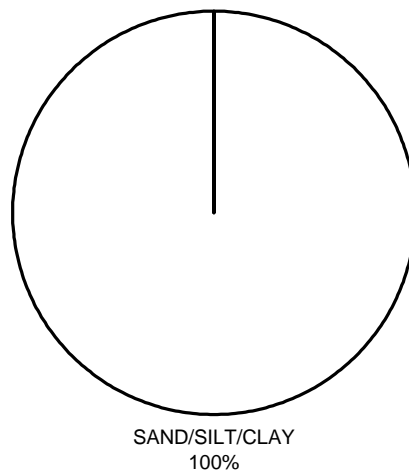
GRAPH 10

For the stream reach surveyed, the mean percent right bank vegetated was 85%. The mean percent left bank vegetated was 88%. The dominant elements composing the structure of the stream banks consisted of 100% sand/silt/clay (Graph 10). Brush was the dominant vegetation type observed in 55% of the units surveyed. Additionally, 45% of the units surveyed had hardwood trees as the dominant vegetation type (Graph 11).

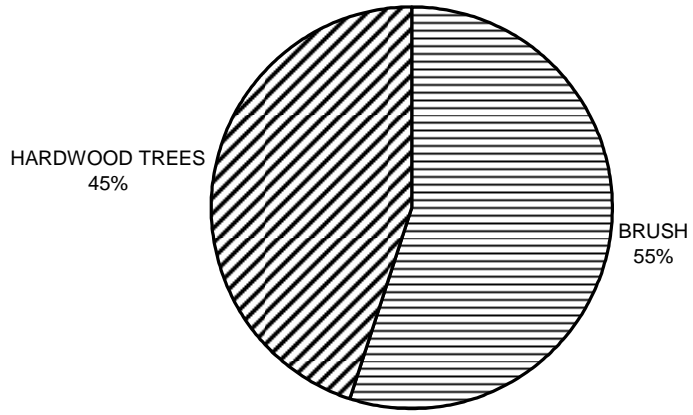
GRAPH 11

The percentage of right and left bank covered with vegetation was relatively high at 85% and 88%, respectively. In areas of stream bank erosion or where bank vegetation is sparse, planting endemic species of coniferous and hardwood trees, in conjunction with bank stabilization, is recommended.
