STREAM INVENTORY REPORT

Puma Creek

A stream inventory was conducted during 7/24/2006 and 7/25/2006 on Puma Creek. The survey began at the confluence with Telegraph Creek and extended upstream 0.8 miles.

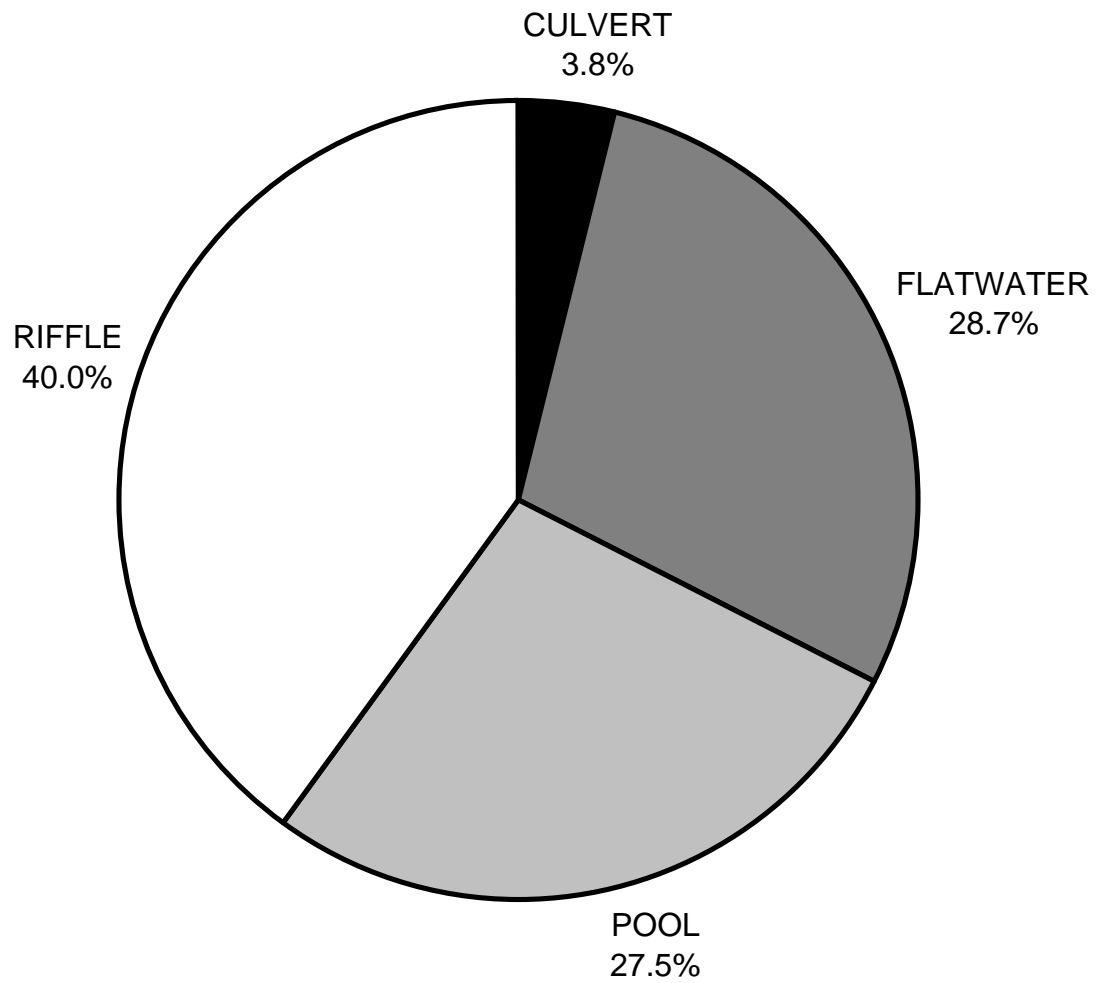
GRAPH 1

Table 1 summarizes the Level II riffle, flatwater, and pool habitat types. Based on frequency of occurrence there were 40% riffle units, 27.5% pool units, 28.8% flatwater units, and 3.8% culvert units (Graph 1). Based on total length of Level II habitat types there were 48.2% riffle units, 39.2% flatwater units, 6% pool units, and 6.6% culvert units (Graph 2).

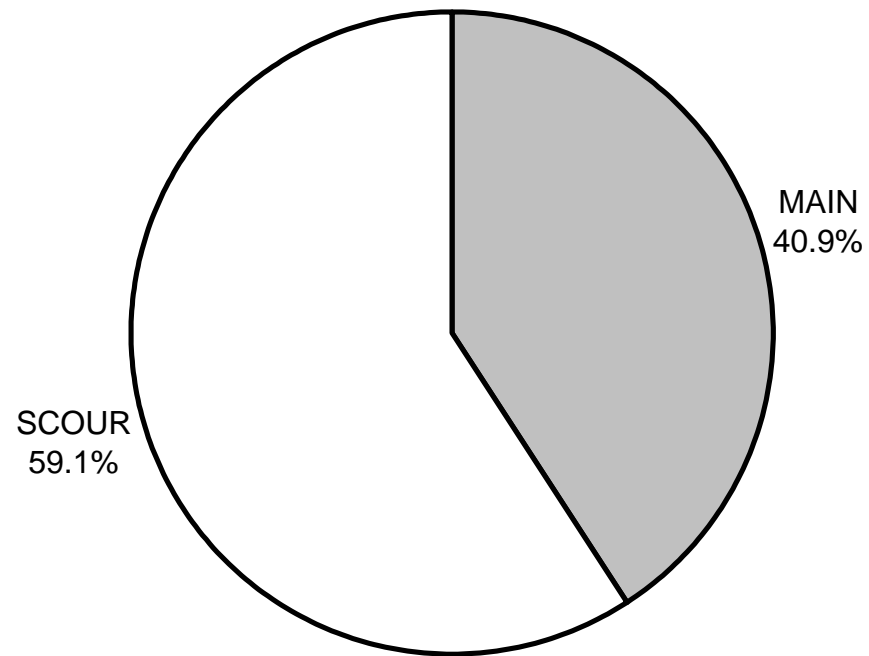
GRAPH 4

A total of 22 pools were identified (Table 3). Scour pools were the most frequently encountered, at 59% (Graph 4), and comprised 57% of the total length of all pools (Table 3).

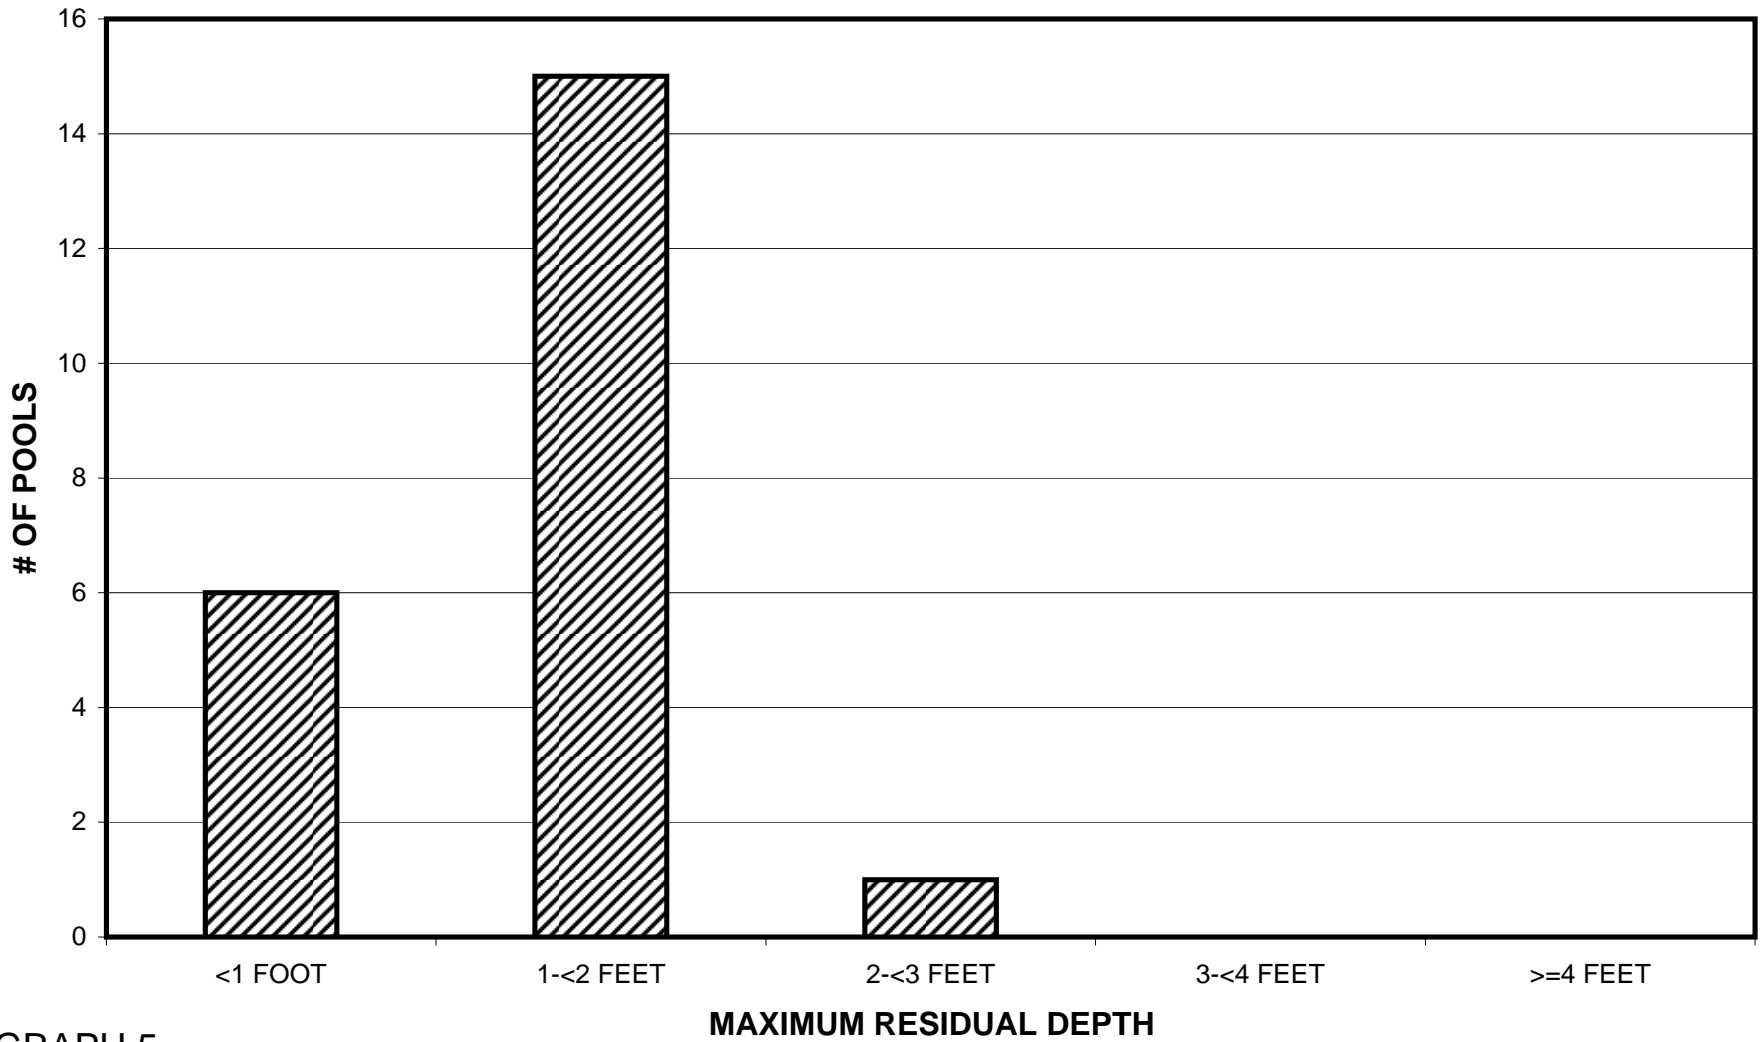
GRAPH 5

Table 4 is a summary of maximum residual pool depths by pool habitat types. Pool quality for salmonids increases with depth. One of the 22 pools (5%) had a residual depth of two feet or greater (Graph 5).

Flatwater habitat types comprised 39% of the total length of this survey, riffles 48%, and pools 6%. The pools are relatively shallow, with only 1 of the 22 (4.5%) pools having a maximum

residual depth greater than 2 feet. In general, pool enhancement projects are considered when primary pools comprise less than 40% of the length of total stream habitat. In first and second order streams, a primary pool is defined to have a maximum residual depth of at least two feet, occupy at least half the width of the low flow channel, and be as long as the low flow channel width. Installing structures that will increase or deepen pool habitat is not recommended for Puma Creek due to the channel type not being suitable for fish habitat improvements structures.

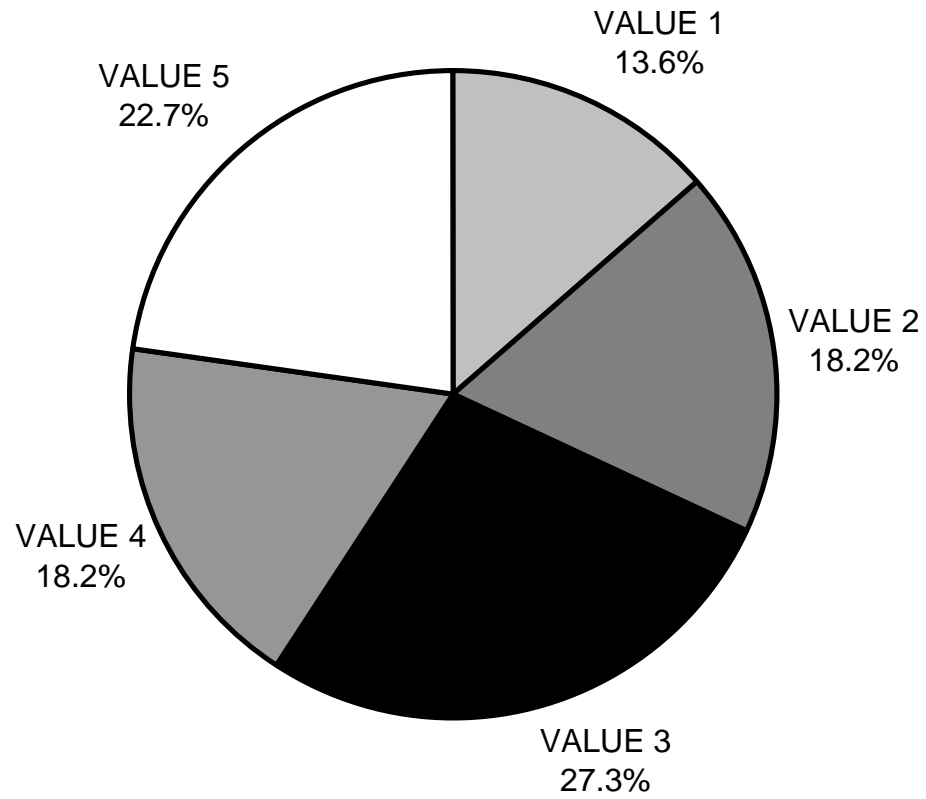
GRAPH 6

The depth of cobble embeddedness was estimated at pool tail-outs. Of the 22 pool tail-outs measured, 3 had a value of 1 (13.6%); 4 had a value of 2 (18.2%); 6 had a value of 3 (27.3%); 4 had a value of 4 (18.2%); and 5 had a value of 5 (22.7%); (Graph 6). On this scale, a value of 1 indicates the best spawning conditions and a value of 4 the worst. Additionally, a value of 5 was assigned to tail-outs deemed unsuited for spawning due to inappropriate substrate such as bedrock, log sills, boulders, or other considerations.

Seven of the 22 pool tail-outs measured had embeddedness ratings of 1 or 2. Ten of the pool tail-outs had embeddedness ratings of 3 or 4. Five of the pool tail-outs had a rating of 5, which is considered unsuitable for spawning. Cobble embeddedness measured to be 25% or less, a rating of 1, is considered to indicate good quality spawning substrate for salmon and steelhead. Sediment sources in Puma Creek should be mapped and rated according to their potential sediment yields, and control measures should be taken.

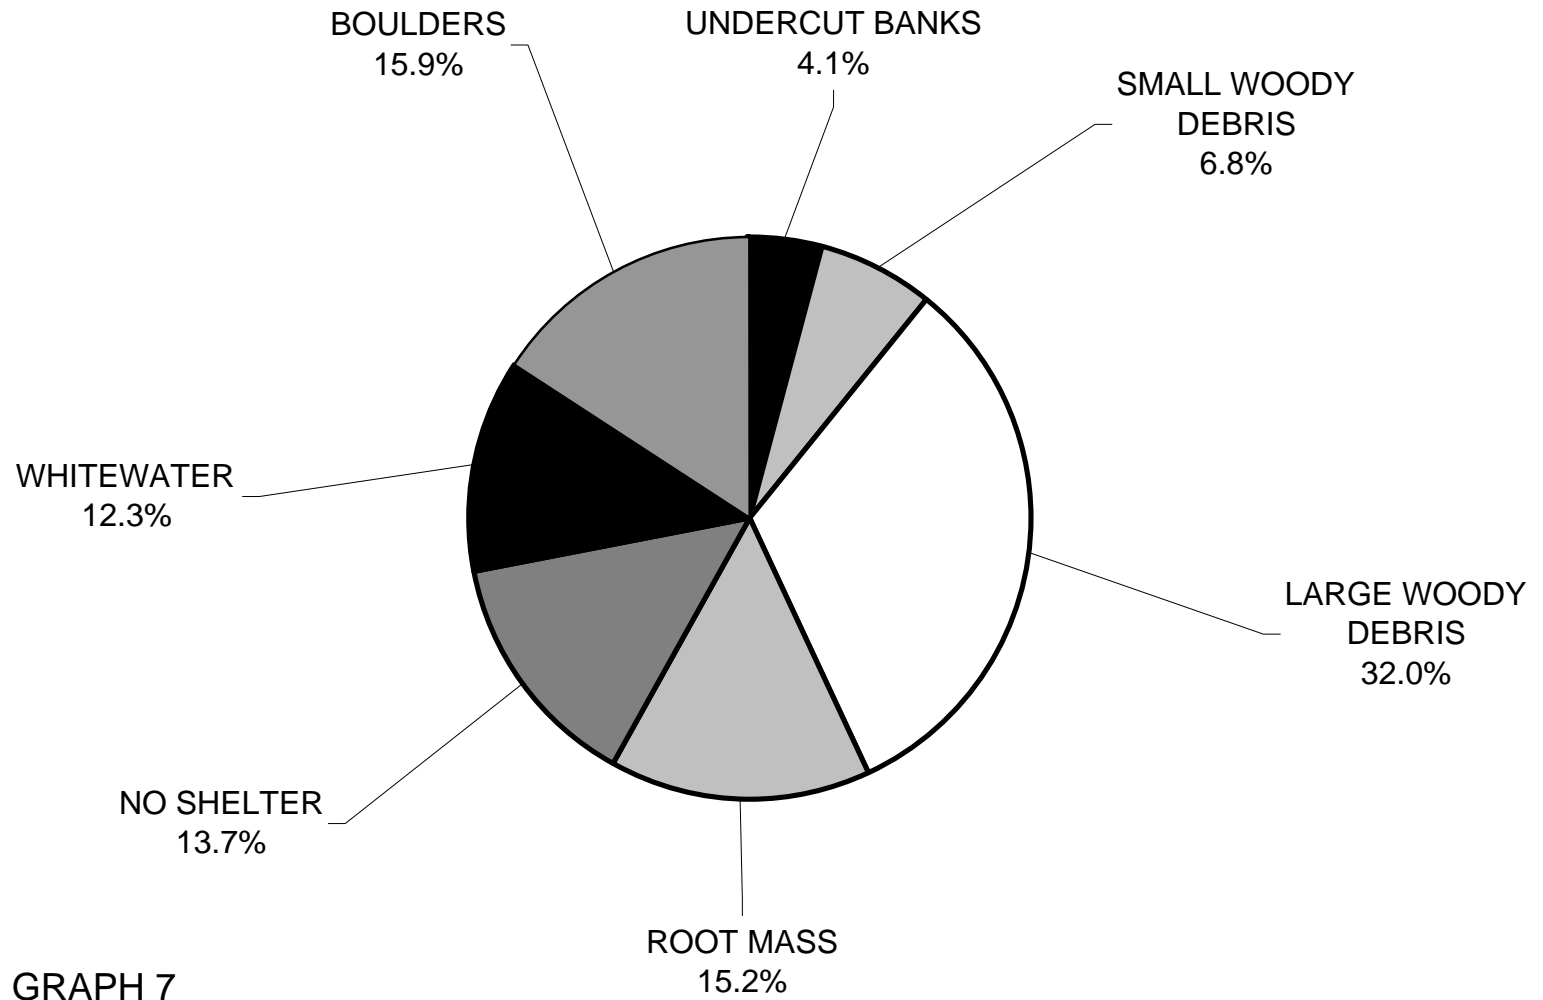
GRAPH 7

Table 5 summarizes mean percent cover by habitat type. Large woody debris is the dominant cover types in Puma Creek. Graph 7 describes the pool cover in Puma Creek. Large woody debris is the dominant pool cover type followed by boulders.

The mean shelter rating for pools was 37. The shelter rating in the flatwater habitats was 8. A pool shelter rating of approximately 100 is desirable. The amount of cover that now exists is being provided primarily by large woody debris in Puma Creek. Large woody debris is the dominant cover type in pools followed by boulders. Log and root wad cover structures in the pool and flatwater habitats would enhance both summer and winter salmonid habitat. Log cover structure provides rearing fry with protection from predation, rest from water velocity, and also divides territorial units to reduce density related competition.

- 4) Increase woody cover in the pools and flatwater habitat units. Most of the existing cover in the pools is from large woody debris. Adding high quality complexity with woody cover in the pools is desirable.
- 5) Inventory and map sources of stream bank erosion and prioritize them according to present and potential sediment yield. Identified sites should then be treated to reduce the amount of fine sediments entering the stream.

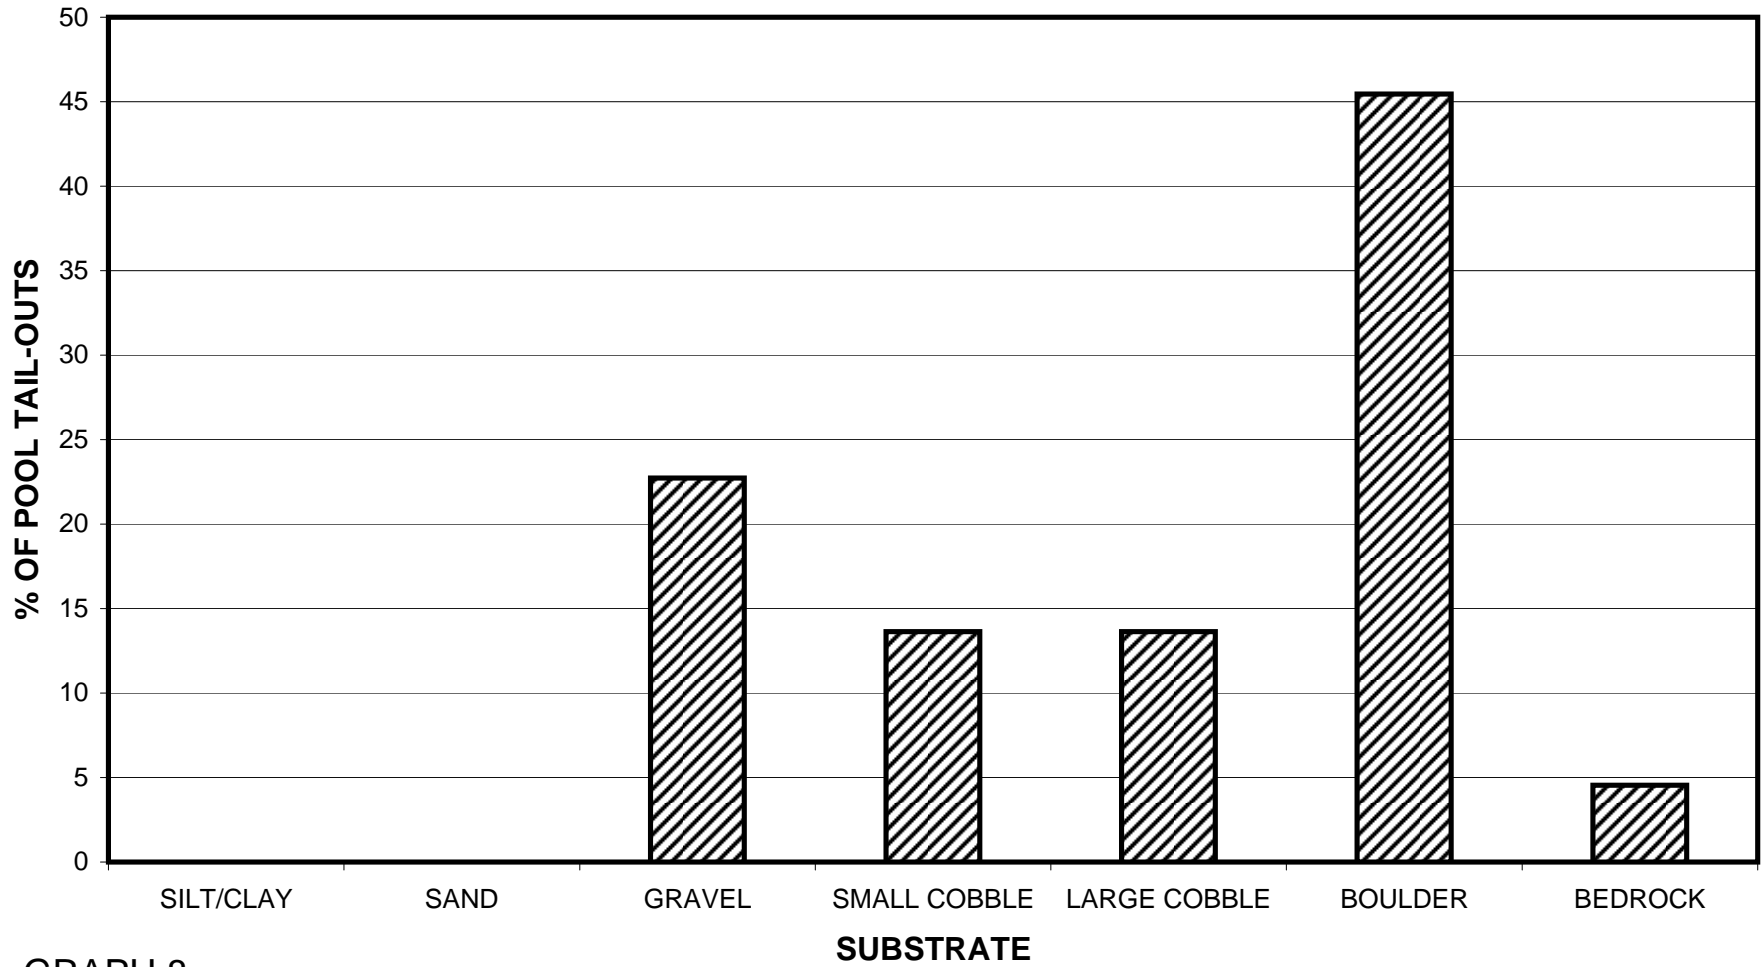
GRAPH 8

Table 6 summarizes the dominant substrate by habitat type. Graph 8 depicts the dominant substrate observed in pool tail-outs. Boulders are the dominant substrate type, observed in 45% of pool tail-outs, followed by gravel, observed in 23% of pool tail-outs.

Fourteen of the 22 pool tail-outs had either silt, sand, large cobble, boulders or bedrock as the dominant substrate. These substrates are generally considered unsuitable for spawning salmonids.

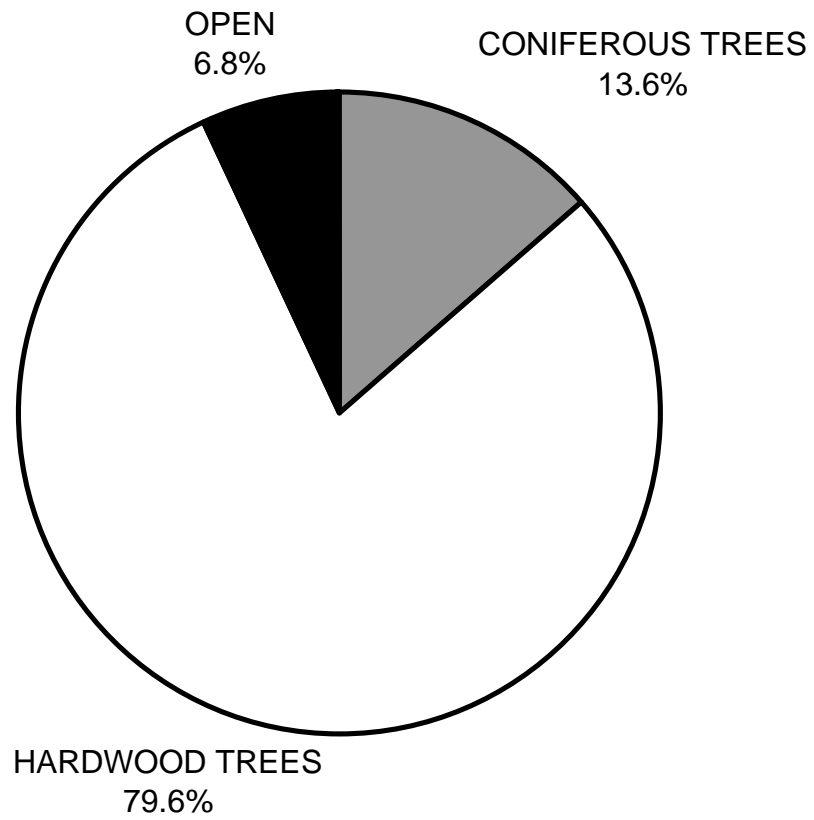
GRAPH 9

The mean percent canopy density for the surveyed length of Puma Creek was 93%. Seven percent of the canopy was open. Of the canopy present, the mean percentages of hardwood and coniferous trees were 85% and 15%, respectively. Graph 9 describes the mean percent canopy in Puma Creek.

The mean percent canopy density for the stream was 93%. In general, revegetation projects are considered when canopy density is less than 80%. The percentage of right and left bank covered with vegetation was 93% and 94%, respectively. In areas of stream bank erosion planting endemic species of coniferous and hardwood trees is recommended.

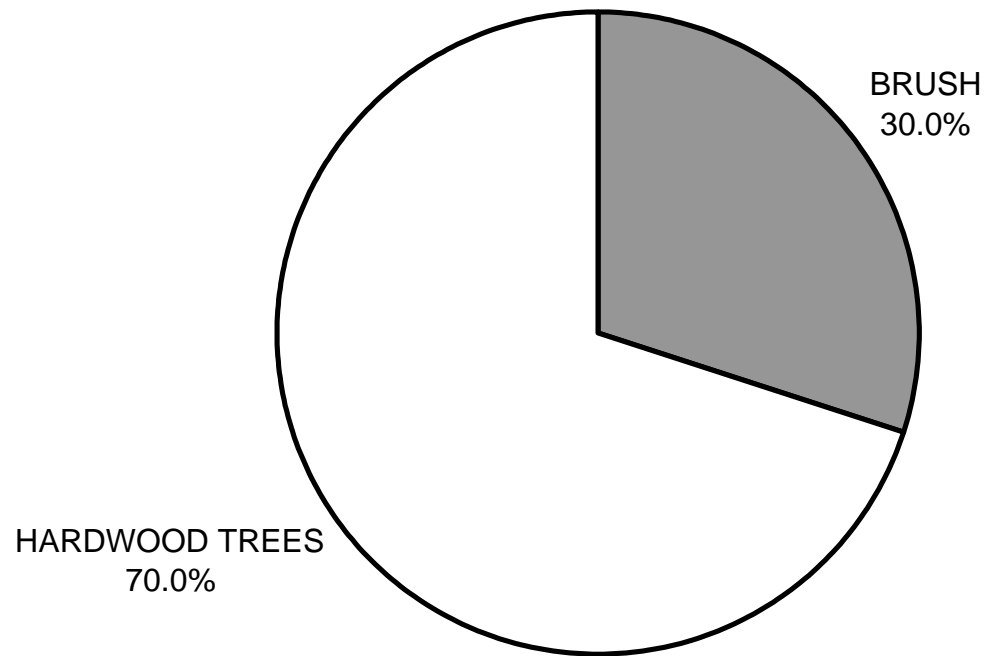
GRAPH 11

For the stream reach surveyed, the mean percent right bank vegetated was 93%. The mean percent left bank vegetated was 94%. The dominant elements composing the structure of the stream banks consisted of 78% sand/silt/clay, 8% cobble/gravel, 12% bedrock and 2% boulder (Graph 10). Hardwood trees were the dominant vegetation type observed in 70% of the units surveyed. The remaining 30% of the units surveyed had brush as the dominant vegetation type (Graph 11).
