**California Department of Fish and Wildlife
Santa Cruz County
Big Basin Coastal Watersheds
Stream Habitat Assessment Report**

Mill Creek

Surveyed 2010

STREAM INVENTORY REPORT

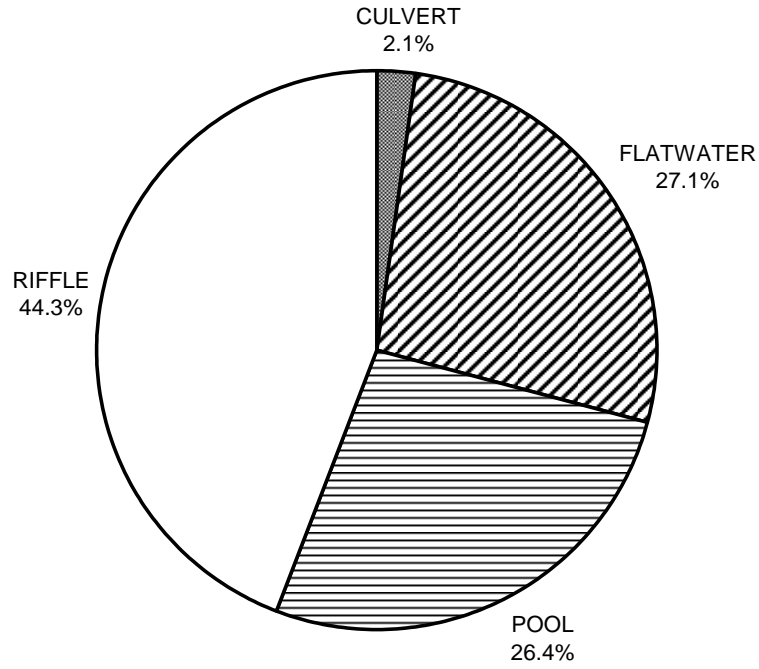
GRAPH 1

Table 1 summarizes the Level II riffle, flatwater, and pool habitat types. Based on frequency of occurrence there were 27% flatwater units, 44% riffle units, 26% pool units, and 2% culvert units (Graph 1). Based on total length of Level II habitat types there were 28% flatwater units, 58% riffle units, 13% pool units, and 1% culvert units (Graph 2).

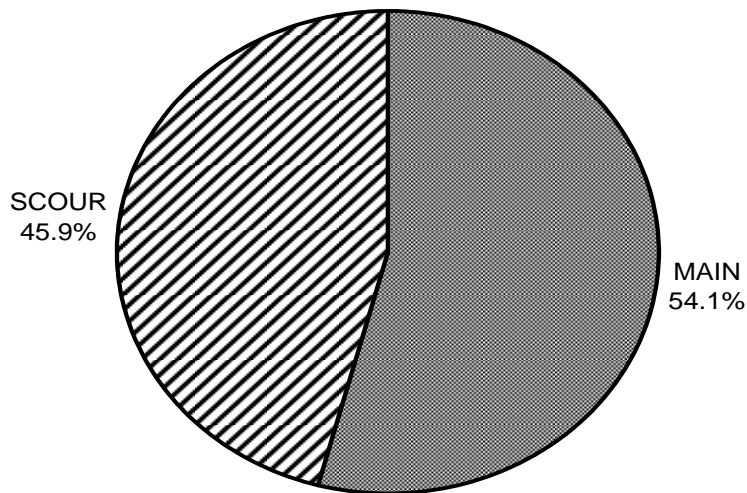
GRAPH 4

A total of 37 pools were identified (Table 3). Main Channel pools were the most frequently encountered, at 54%, and comprised 65% of the total length of all pools (Graph 4).

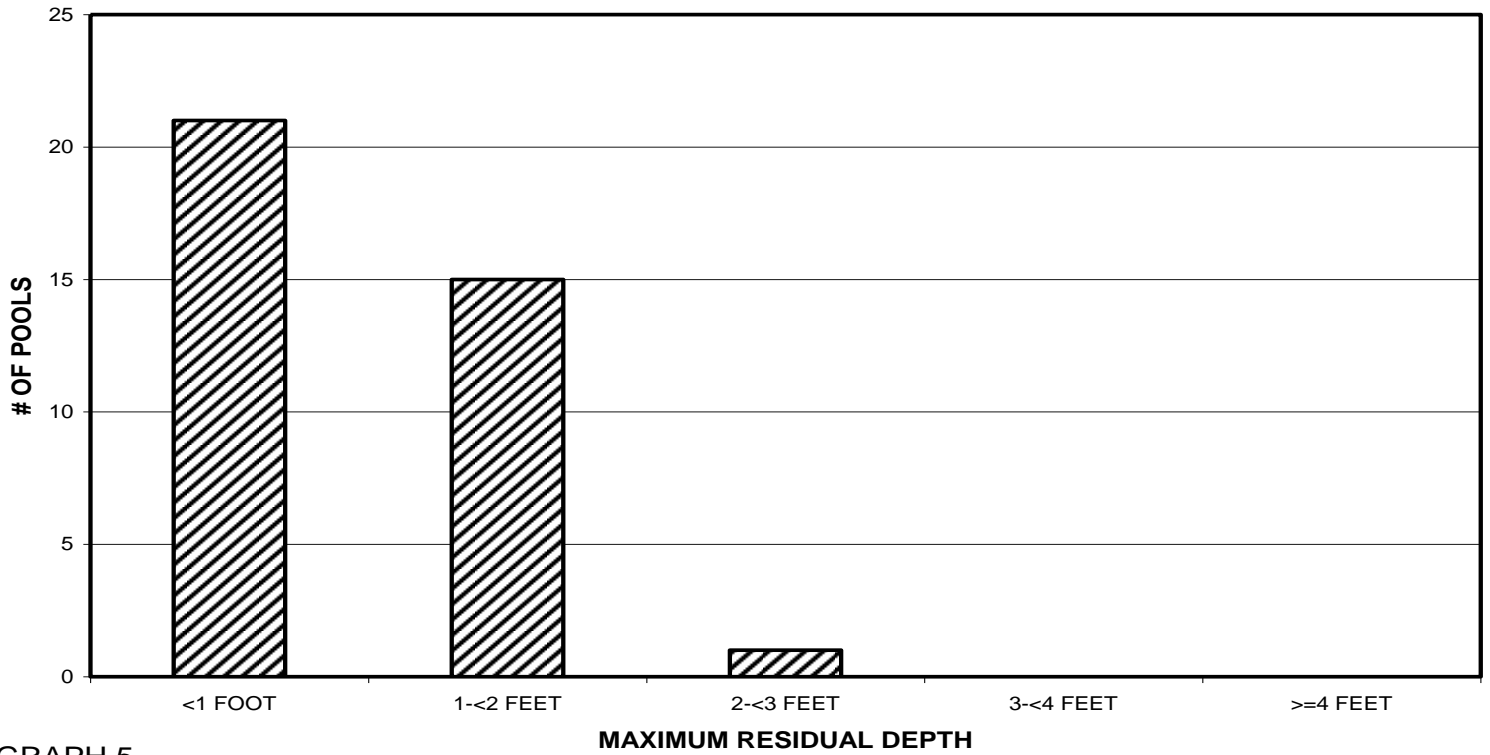
GRAPH 5

Table 4 is a summary of maximum residual pool depths by pool habitat types. Pool quality for salmonids increases with depth. One of the 37 pools (3%) had a residual depth of two feet or greater (Graph 5).

Flatwater habitat types comprised 28% of the total length of this survey, riffles 58%, and pools 13%. The pools are relatively shallow, with only 1 of the 37 (3%) pools having a maximum residual depth greater than 2 feet. In general, pool enhancement projects are considered when primary pools comprise less than 40% of the length of total stream habitat. In first and second order streams, a primary pool is defined to have a maximum residual depth of at least two feet, occupy at least half the width of the low flow channel, and be as long as the low flow channel width. Installing structures that will increase or deepen pool habitat is recommended for locations where their installation will not be threatened by high stream energy, or where their installation will not conflict with the modification of the numerous log debris accumulations (LDA's) in the stream.

- 1) Where feasible, design and engineer pool enhancement structures to increase the number of pools. This must be done where the banks are stable or in conjunction with stream bank armor to prevent erosion.

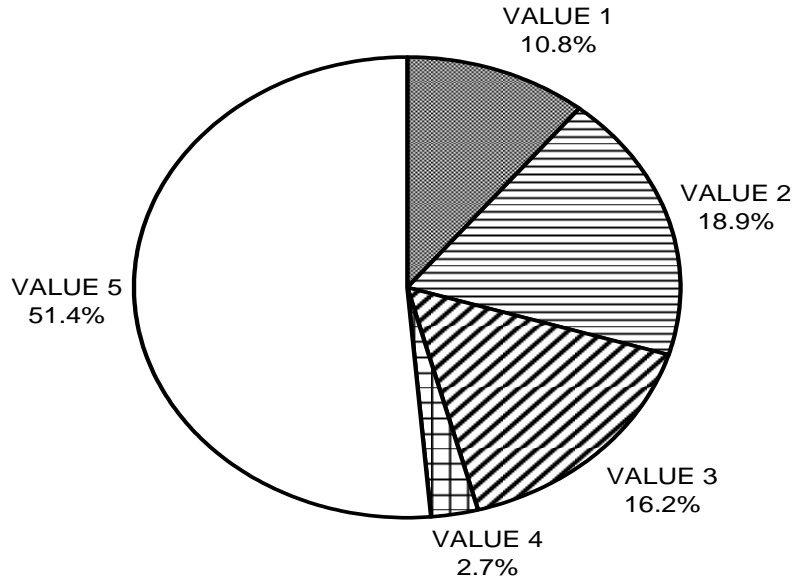
GRAPH 6

The depth of cobble embeddedness was estimated at pool tail-outs. Of the 37 pool tail-outs measured, 4 had a value of 1 (10.8%); 7 had a value of 2 (18.9%); 6 had a value of 3 (16.2%); 1 had a value of 4 (2.7%); 19 had a value of 5 (51.4%); (Graph 6). On this scale, a value of 1 indicates the best spawning conditions and a value of 4 the worst. Additionally, a value of 5 was assigned to tail-outs deemed unsuited for spawning due to inappropriate substrate such as bedrock, log sills, boulders, or other considerations.

Eleven of the 37 pool tail-outs measured had embeddedness ratings of 1 or 2. Seven of the pool tail-outs had embeddedness ratings of 3 or 4. Nineteen of the pool tail-outs had a rating of 5, which is considered unsuitable for spawning. Cobble embeddedness measured to be 25% or less, a rating of 1, is considered to indicate good quality spawning substrate for salmon and steelhead. Sediment sources in Mill Creek should be mapped and rated according to their potential sediment yields, and control measures should be taken.

- 3) Inventory and map sources of stream bank erosion and prioritize them according to present and potential sediment yield. Reach 2, in particular, was identified as a section of concern. Identified sites should then be treated to reduce the amount of fine sediments entering the stream. Active and potential sediment sources related to the road system need to be identified, mapped, and treated according to their potential for sediment yield to the stream and its tributaries.

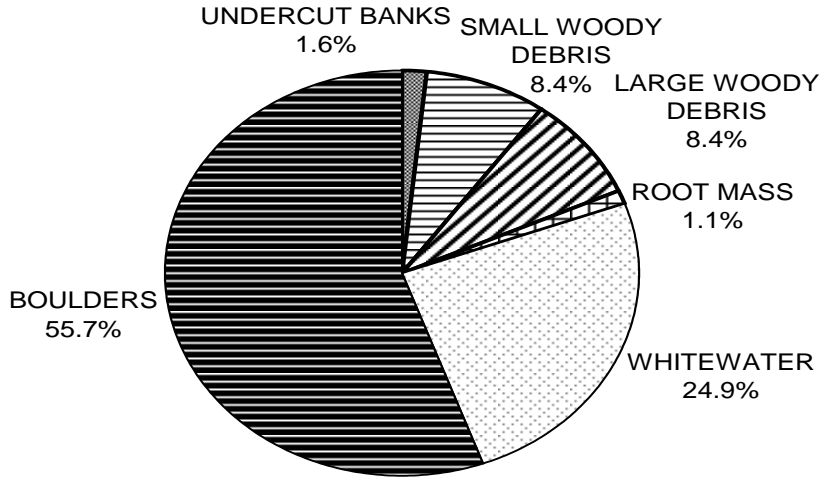
GRAPH 7

Table 5 summarizes mean percent cover by habitat type. Boulders are the dominant cover types in Mill Creek. Graph 7 describes the pool cover in Mill Creek. Boulders are the dominant pool cover type followed by whitewater.

The mean shelter rating for pools was 22. The shelter rating in the flatwater habitats was 11. A pool shelter rating of approximately 100 is desirable. The amount of cover that now exists is being provided primarily by Boulders in Mill Creek. Boulders are the dominant cover type in pools followed by whitewater. Log and root wad cover structures in the pool and flatwater habitats would enhance both summer and winter salmonid habitat. Log cover structure provides rearing fry with protection from predation, rest from water velocity, and also divides territorial units to reduce density related competition.

- 2) Increase woody cover in the pools and flatwater habitat units. Most of the existing cover in the pools is from boulders. Adding high quality complexity with woody cover in the pools is desirable.

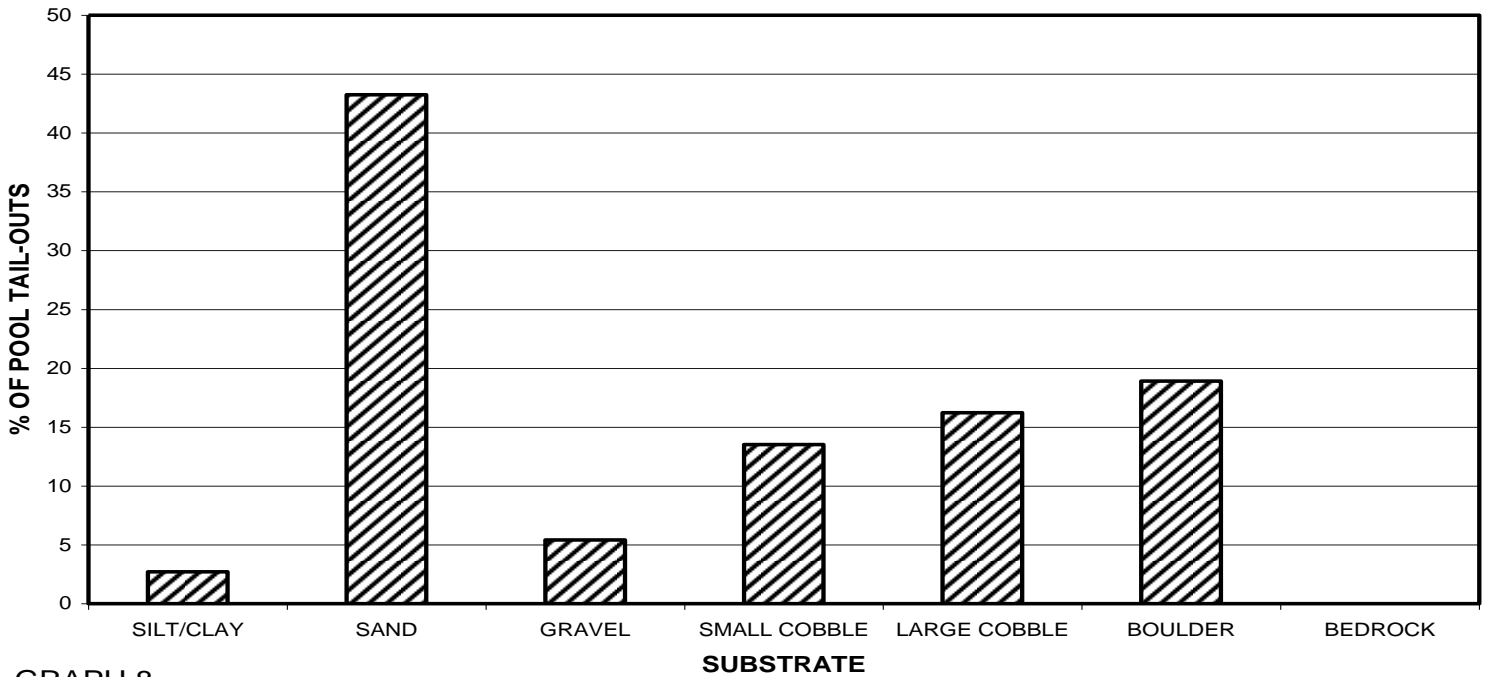
GRAPH 8

Table 6 summarizes the dominant substrate by habitat type. Graph 8 depicts the dominant substrate observed in pool tail-outs, sand observed in 43% of pool tail-outs and boulders observed in 19% of pool tail-outs.

Thirty of the 37 pool tail-outs had silt, sand, large cobble, boulders or bedrock as the dominant substrate. This is generally considered unsuitable for spawning salmonids.

- 4) Suitable size spawning substrate on Mill Creek is limited to relatively few reaches. Projects should be designed at suitable sites to trap and sort spawning gravel.

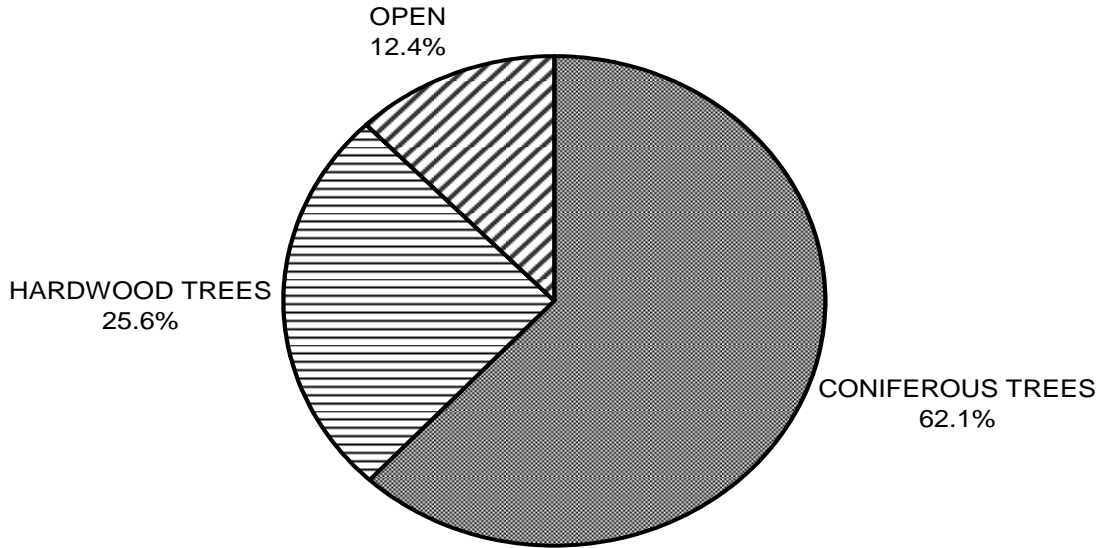
GRAPH 9

The mean percent canopy density for the surveyed length of Mill Creek was 88%. The mean percentages of hardwood and coniferous trees were 29% and 71%, respectively. Twelve percent of the canopy was open. Graph 9 describes the mean percent canopy in Mill Creek.

The mean percent canopy density for the stream was 88%. Reach 1 had a canopy density of 88.9% and Reach 2 had a canopy density of 86.9%. In general, revegetation projects are considered when canopy density is less than 80%.

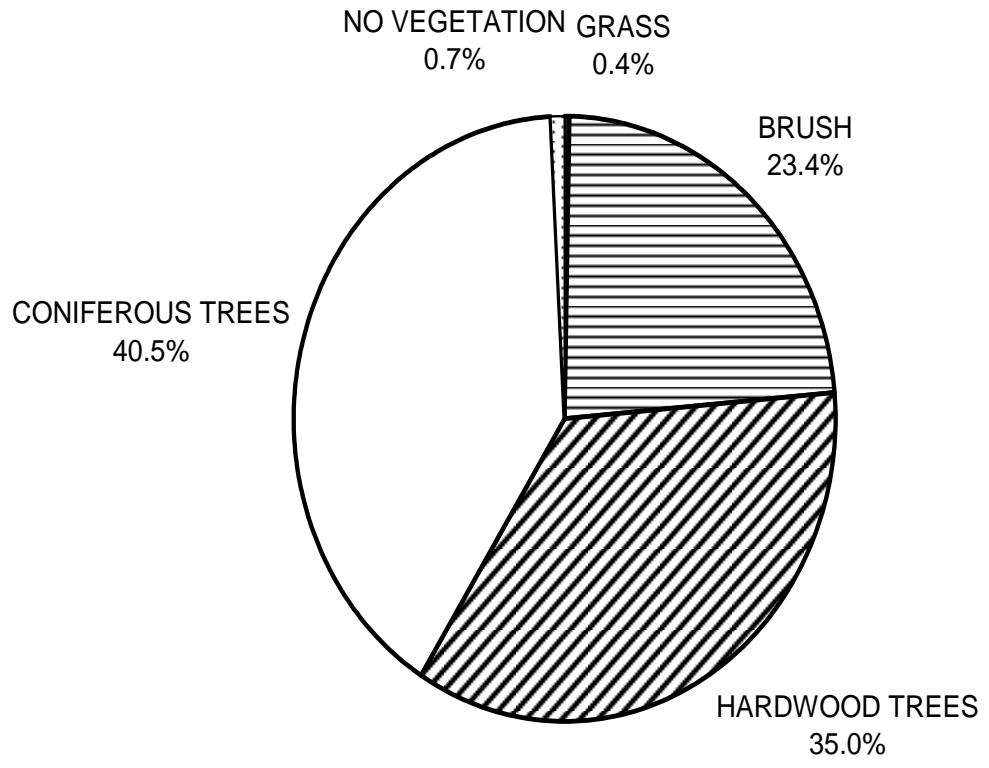
GRAPH 11

For the stream reach surveyed, the mean percent right bank vegetated was 63%. The mean percent left bank vegetated was 60%. The dominant elements composing the structure of the stream banks consisted of 3% bedrock, 34% boulder, 22% cobble/gravel, and 41% sand/silt/clay (Graph 10). Coniferous trees were the dominant vegetation type observed in 40.5% of the units surveyed. Additionally, 35.0% of the units surveyed had hardwood trees as the dominant vegetation type, 23.4% had brush as the dominant vegetation and 0.4% had grass as the dominant vegetation (Graph 11).

The percentage of right and left bank covered with vegetation was at 63% and 60%, respectively. In areas of stream bank erosion or where bank vegetation is sparse, planting endemic species of coniferous and hardwood trees, in conjunction with bank stabilization, is recommended.
