**California Department of Fish and Wildlife
Santa Cruz County
Big Basin Coastal Watershed
Stream Habitat Assessment Reports**

Molino Creek

Surveyed 2010

STREAM INVENTORY REPORT

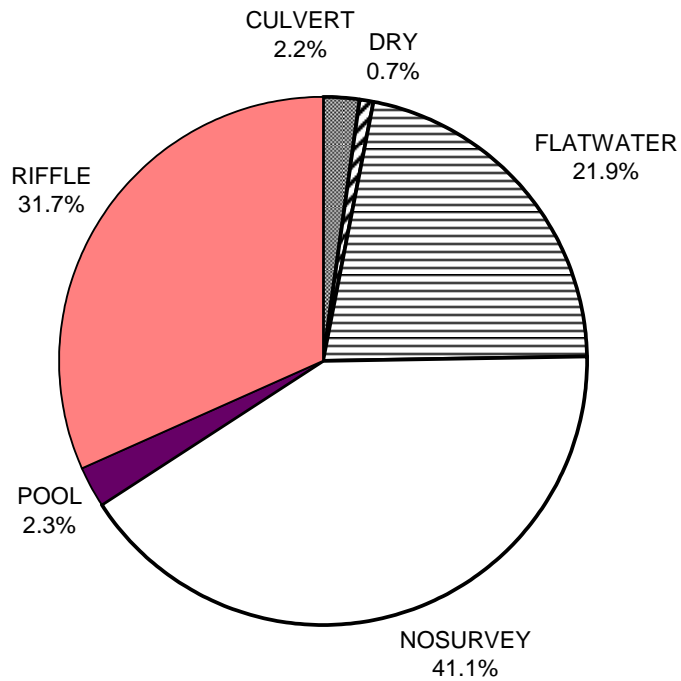
GRAPH 2

Table 1 summarizes the Level II riffle, flatwater, and pool habitat types. Based on frequency of occurrence there were 1% nosurvey units, 2% culvert units, 39% flatwater units, 41% riffle units, 14% pool units, 2% dry units, (Graph 1). Based on total length of Level II habitat types there were 41% nosurvey units, 2% culvert units, 22% flatwater units, 32% riffle units, 2% pool units,

1% dry units, (Graph 2).

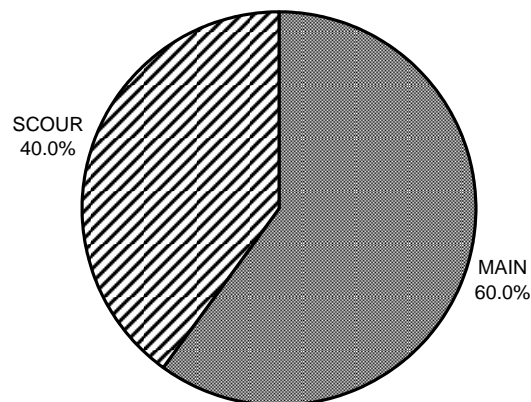
GRAPH 4

A total of 25 pools were identified (Table 3). Main Channel pools were the most frequently encountered, at 60%, and comprised 52% of the total length of all pools (Graph 4).

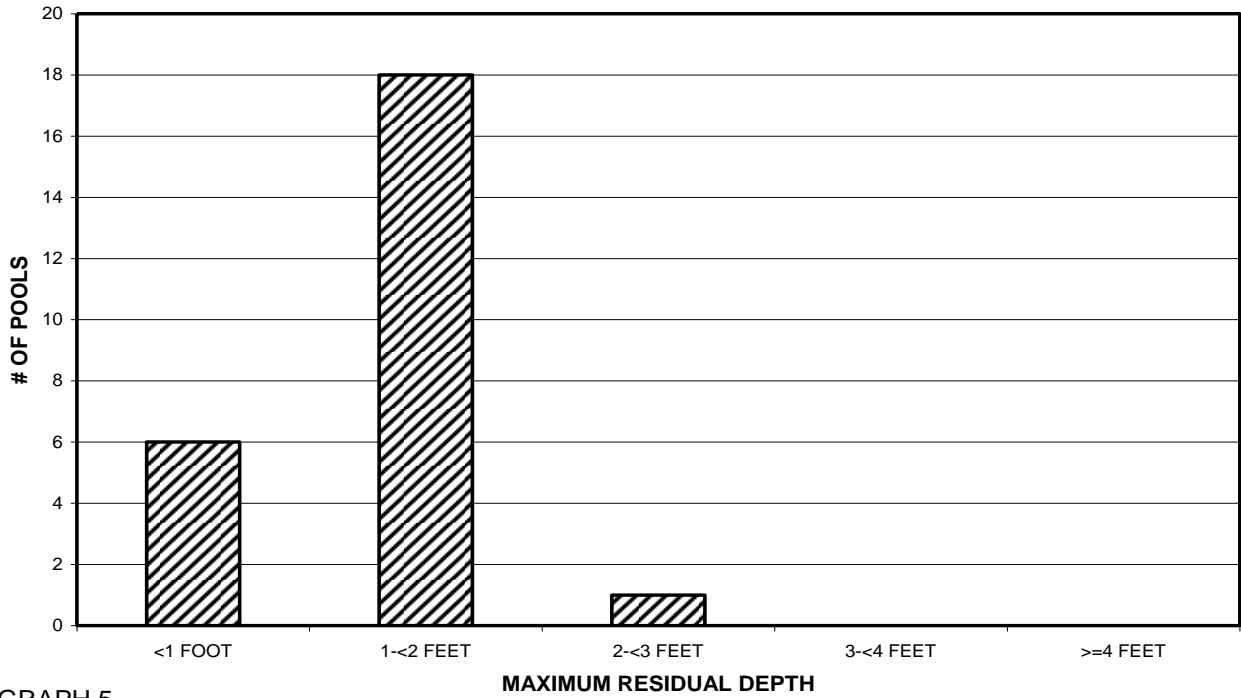
GRAPH 5

Table 4 is a summary of maximum residual pool depths by pool habitat types. Pool quality for salmonids increases with depth. One of the 25 pools (4%) had a residual depth of two feet or greater (Graph 5).

Flatwater habitat types comprised 21.9% of the total length of this survey, riffles 31.7%, and pools 2.3%. The pools are relatively shallow, with only 1 of the 25 (4%) pools having a maximum residual depth greater than 2 feet. In general, pool enhancement projects are considered when primary pools comprise less than 40% of the length of total stream habitat. In

- 1) Where feasible, design and engineer pool enhancement structures to increase the number of pools. This must be done where the banks are stable or in conjunction with stream bank armor to prevent erosion.

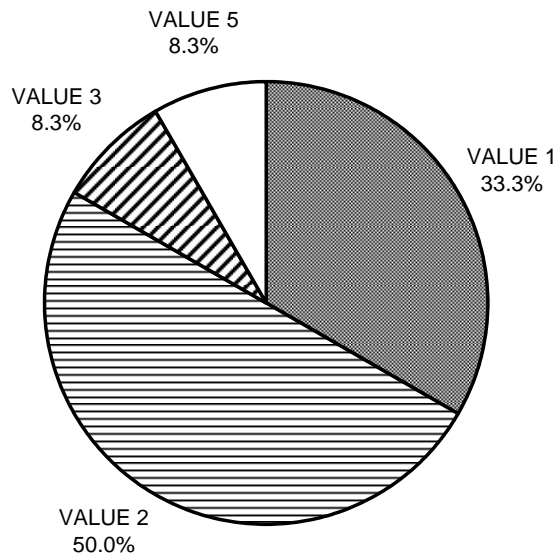
GRAPH 6

The depth of cobble embeddedness was estimated at pool tail-outs. Of the 24 pool tail-outs measured, 8 had a value of 1 (33.3%); 12 had a value of 2 (50%); 2 had a value of 3 (8.3%); 2 had a value of 5 (8.3%) (Graph 6). On this scale, a value of 1 indicates the best spawning conditions and a value of 4 the worst. Additionally, a value of 5 was assigned to tail-outs deemed unsuited for spawning due to inappropriate substrate such as bedrock, log sills, boulders, or other considerations.

Twenty of the 24 pool tail-outs measured had embeddedness ratings of 1 or 2. Two of the pool tail-outs had embeddedness ratings of 3 or 4. Two of the pool tail-outs had a rating of 5, which is considered unsuitable for spawning. Cobble embeddedness measured to be 25% or less, a rating of 1, is considered to indicate good quality spawning substrate for salmon and steelhead. Sediment sources in Molino Creek should be mapped and rated according to their potential sediment yields, and control measures should be taken.

- 5) Inventory and map sources of stream bank erosion and prioritize them according to present and potential sediment yield. Identified sites should then be treated to reduce the amount of fine sediments entering the stream. Active and potential sediment sources related to the road system need to be identified, mapped, and treated according to their potential for sediment yield to the stream and its tributaries.

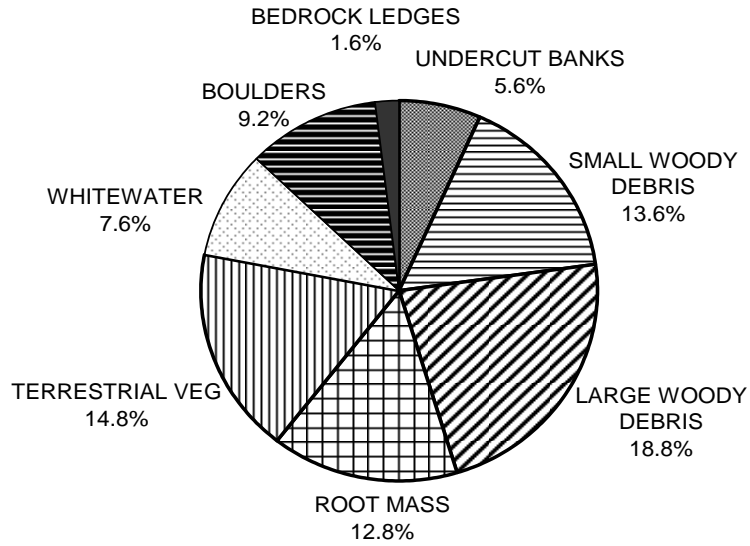
GRAPH 7

Table 5 summarizes mean percent cover by habitat type. Terrestrial Vegetation is the dominant cover types in Molino Creek. Graph 7 describes the pool cover in Molino Creek. Large Woody Debris is the dominant pool cover type followed by terrestrial vegetation.

The mean shelter rating for pools was 21. The shelter rating in the flatwater habitats was 15. A pool shelter rating of approximately 100 is desirable. The amount of cover that now exists is being provided primarily by Terrestrial Vegetation in Molino Creek. Large Woody Debris is the dominant cover type in pools followed by terrestrial vegetation. Log and root wad cover structures in the pool and flatwater habitats would enhance both summer and winter salmonid habitat. Log cover structure provides rearing fry with protection from predation, rest from water velocity, and also divides territorial units to reduce density related competition.

- 2) Increase woody cover in the pools and flatwater habitat units. Most of the existing cover in the pools is from Terrestrial Vegetation. Adding high quality complexity with woody cover in the pools is desirable.

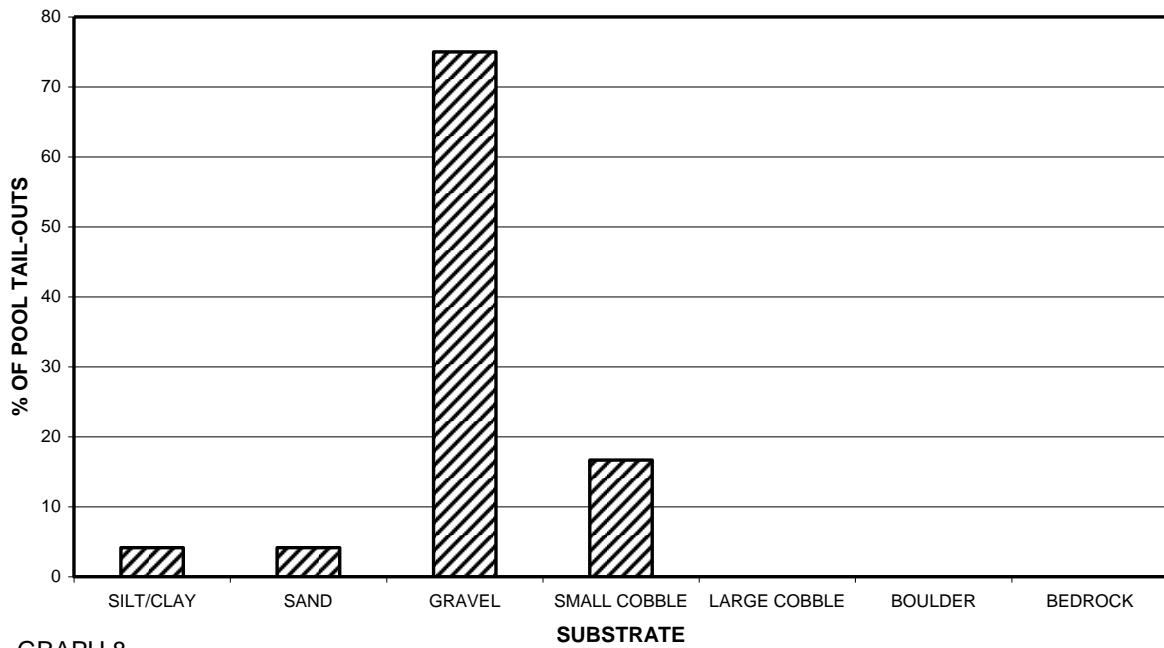
GRAPH 8

Table 6 summarizes the dominant substrate by habitat type. Graph 8 depicts the dominant substrate observed in pool tail-outs. Gravel observed in 75% of pool tail-outs, small Cobble observed in 17% of pool tail-outs.

Twenty two of the 24 pool tail-outs measured had gravel or small cobble as the dominant substrate. This is generally considered good for spawning salmonids.

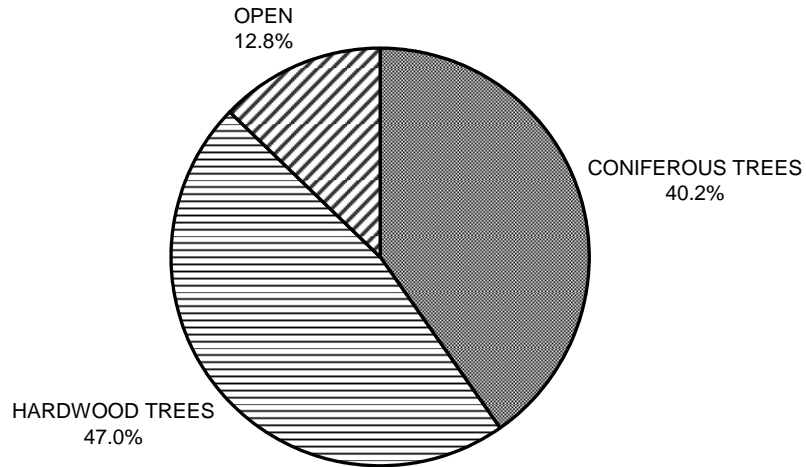
GRAPH 9

The mean percent canopy density for the surveyed length of Molino Creek was 87%. The mean percentages of hardwood and coniferous trees were 54% and 46%, respectively. Thirteen percent of the canopy was open. Graph 9 describes the mean percent canopy in Molino Creek.

The mean percent canopy density for the stream was 87%. Reach 2 had a canopy density of 80.1%, Reach 3 had a canopy density of 85.3%, and Reach 5 had a canopy density of 93.4%. In general, revegetation projects are considered when canopy density is less than 80%.

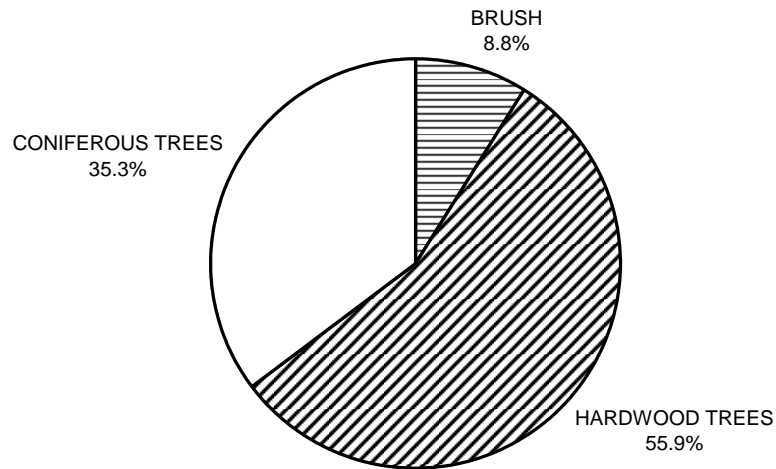
GRAPH 11

For the stream reach surveyed, the mean percent right bank vegetated was 76%. The mean percent left bank vegetated was 78%. The dominant elements composing the structure of the stream banks consisted of 4% bedrock, 0% boulder, 3% cobble/gravel, 92% sand/silt/clay, (Graph 10). Hardwood trees were the dominant vegetation type observed in 55.9% of the units surveyed. Additionally, 35.3% of the units surveyed had coniferous trees as the dominant vegetation type, and 8.8% had brush as the dominant vegetation (Graph 11).

The percentage of right and left bank covered with vegetation was moderate at 76% and 78%, respectively. In areas of stream bank erosion or where bank vegetation is sparse, planting endemic species of coniferous and hardwood trees, in conjunction with bank stabilization, is recommended.
