**California Department of Fish and Wildlife**  
**Santa Cruz County**  
**Big Basin Coastal Watershed**  
**Stream Habitat Assessment Reports**

# **San Vicente Creek**

*Surveyed 2010*

# STREAM INVENTORY REPORT

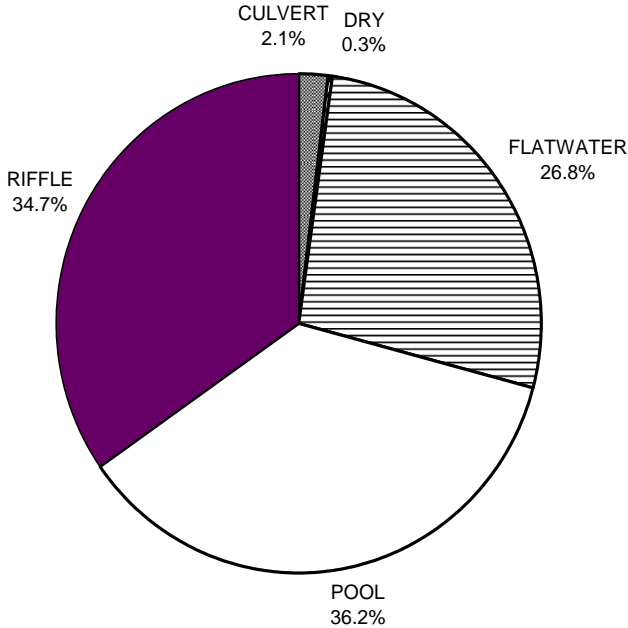
GRAPH 1

Table 1 summarizes the Level II riffle, flatwater, and pool habitat types. Based on frequency of occurrence there were 36% pool units, 35% riffle units, 27% flatwater units, 2% culvert units, and 0% dry units (Graph 1). Based on total length of Level II habitat types, there were 37% riffle units, 32% flatwater units, 28% pool units, 3% culvert units, and 0% dry units (Graph 2).

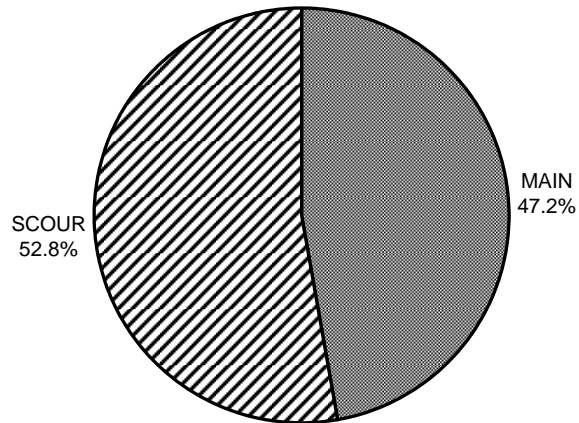
GRAPH 4

A total of 123 pools were identified (Table 3). Scour pools were the most frequently encountered at 53% (Graph 4), and comprised 51% of the total length of all pools (Table 3).

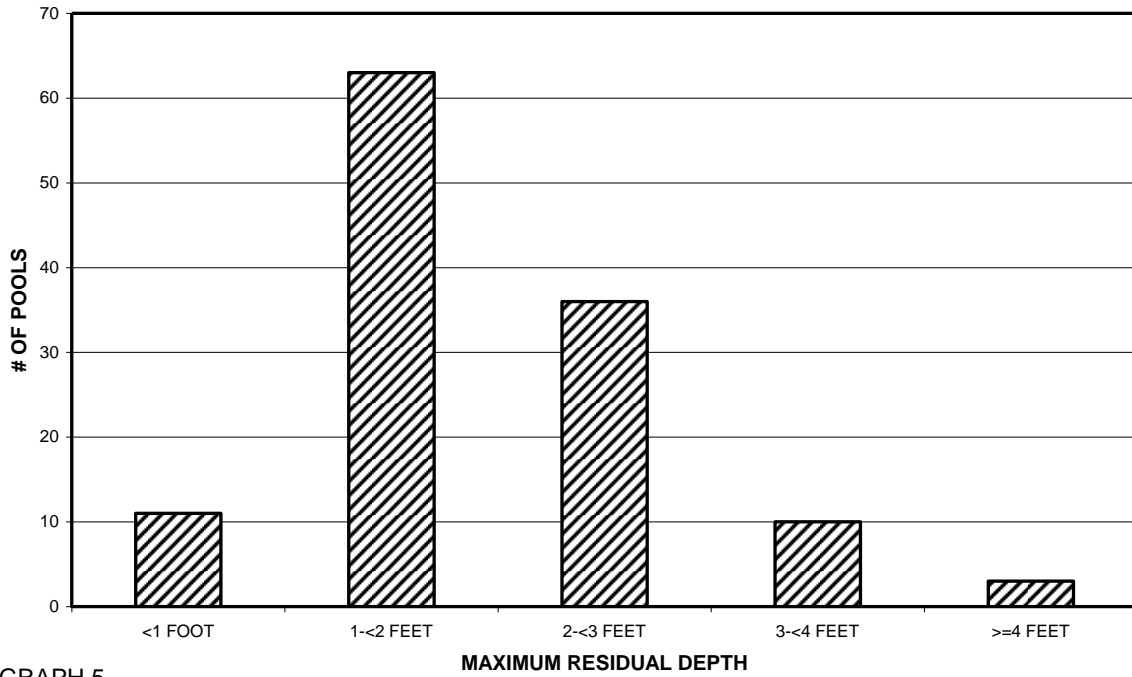
GRAPH 5

Table 4 is a summary of maximum residual pool depths by pool habitat types. Pool quality for salmonids increases with depth. Thirteen of the 123 pools (11%) had a residual depth of three feet or greater (Graph 5).

Flatwater habitat types comprised 32% of the total length of this survey, riffles 37%, and pools 28%. The pools are relatively shallow, with 13 of the 123 (11%) pools having a maximum residual depth greater than three feet. In general, pool enhancement projects are considered when primary pools comprise less than 40% of the length of total stream habitat. In first and second order streams, a primary pool is defined to have a maximum residual depth of at least three feet, occupy at least half the width of the low flow channel, and be as long as the low flow channel width. Installing structures that will increase or deepen pool habitat is recommended for locations where their installation will not be threatened by high stream energy, or where their installation will not conflict with the modification of the numerous log debris accumulations (LDA's) in the stream.

- 1) Increase woody cover in the pools and flatwater habitat units. Most of the existing cover in the pools is from terrestrial vegetation. Adding high quality complexity with woody cover in the pools is desirable.

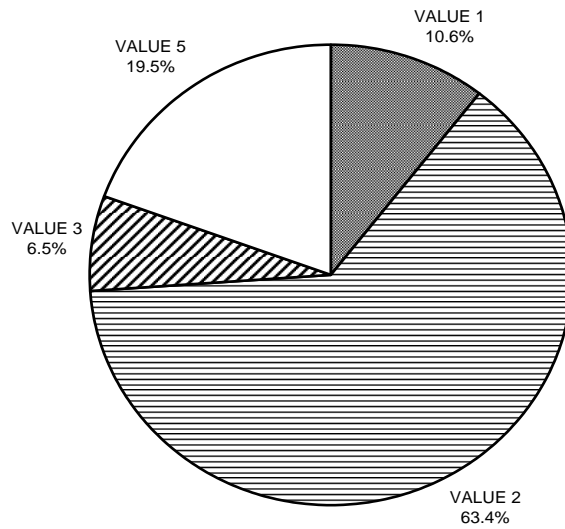
GRAPH 6

The depth of cobble embeddedness was estimated at pool tail-outs. Of the 123 pool tail-outs measured, 13 had a value of 1 (11%), 78 had a value of 2 (63%), 8 had a value of 3 (7%), 24 had a value of 5 (20%) (Graph 6). On this scale, a value of 1 indicates the best spawning conditions and a value of 4 the worst. Additionally, a value of 5 was assigned to tail-outs deemed unsuited for spawning due to inappropriate substrate such as bedrock, log sills, boulders, or other considerations.

Ninety-one of the 123 pool tail-outs measured had embeddedness ratings of 1 or 2. Eight of the pool tail-outs had embeddedness ratings of 3 or 4. Twenty-four of the pool tail-outs had a rating of 5, which is considered unsuitable for spawning. Cobble embeddedness measured to be 25% or less, a rating of 1, is considered to indicate good quality spawning substrate for salmon and steelhead. Sediment sources in San Vicente Creek should be mapped and rated according to their potential sediment yields, and control measures should be taken.

- 3) Inventory and map sources of stream bank erosion particularly in Reach 5, and prioritize them according to present and potential sediment yield. Identified sites should then be treated to reduce the amount of fine sediments entering the stream. Active and potential sediment sources related to the road system need to be identified, mapped, and treated according to their potential for sediment yield to the stream and its tributaries.

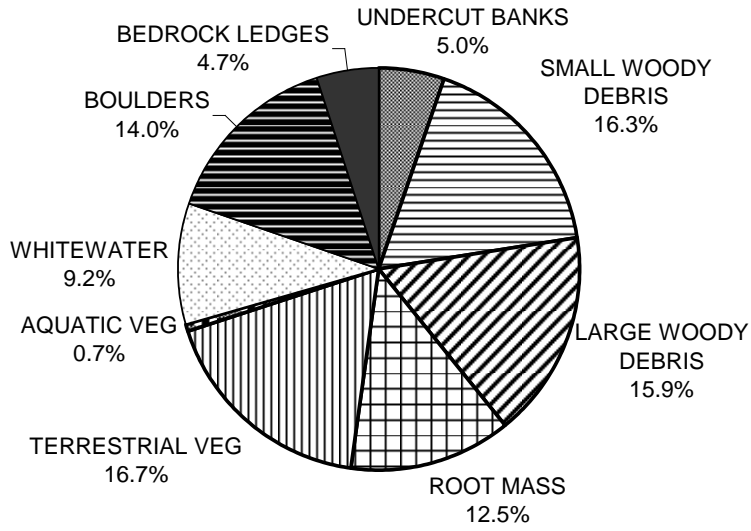
GRAPH 7

Table 5 summarizes mean percent cover by habitat type. Boulders are the dominant cover type in San Vicente Creek. Graph 7 describes the pool cover in San Vicente Creek. Terrestrial vegetation is the dominant pool cover type, followed by small woody debris.

The mean shelter rating for pools is 35. The shelter rating in the flatwater habitats is 9. A pool shelter rating of approximately 100 is desirable. The amount of cover that now exists is being provided primarily by boulders in San Vicente Creek. Terrestrial vegetation is the dominant cover type in pools, followed by small woody debris. Log and root wad cover structures in the pool and flatwater habitats would enhance both summer and winter salmonid habitat. Log cover structure provides rearing fry with protection from predation, rest from water velocity, and also divides territorial units to reduce density related competition.

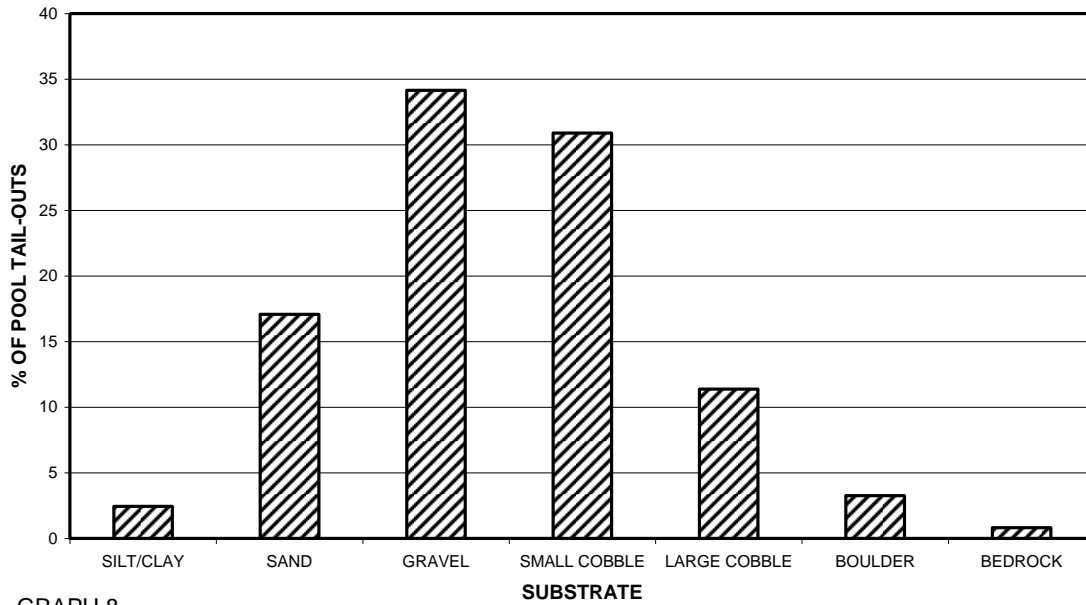
GRAPH 8

Table 6 summarizes the dominant substrate by habitat type. Graph 8 depicts the dominant substrate observed in pool tail-outs. Gravel substrate was observed in 34% of pool tail-outs; and small cobble substrate was observed in 31% of pool tail-outs.

Eighty of the 123 pool tail-outs measured had gravel and small cobble as the dominant substrate. This is generally considered good for spawning salmonids.

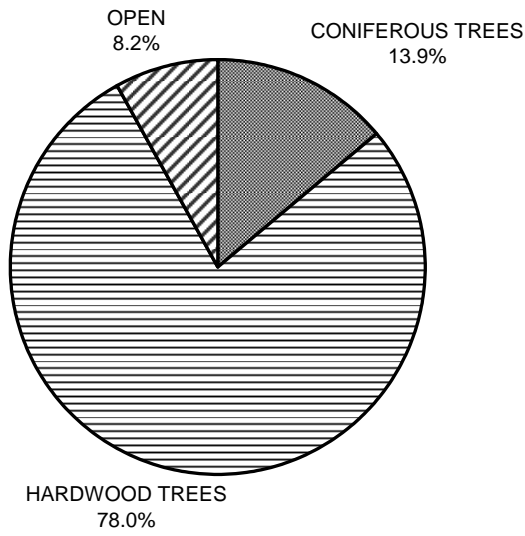
GRAPH 9

respectively. Eight percent of the canopy was open. Graph 9 describes the mean percent canopy in San Vicente Creek.

The mean percent canopy density for the stream was 92%. Reach 1 had a canopy density of 90.8%, Reach 2 had a canopy density of 93.5%, Reach 3 had a canopy density of 91.4%, Reach 4 had a canopy density of 91.8%, and Reach 5 had a canopy density of 94%. In general, revegetation projects are considered when canopy density is less than 80%.

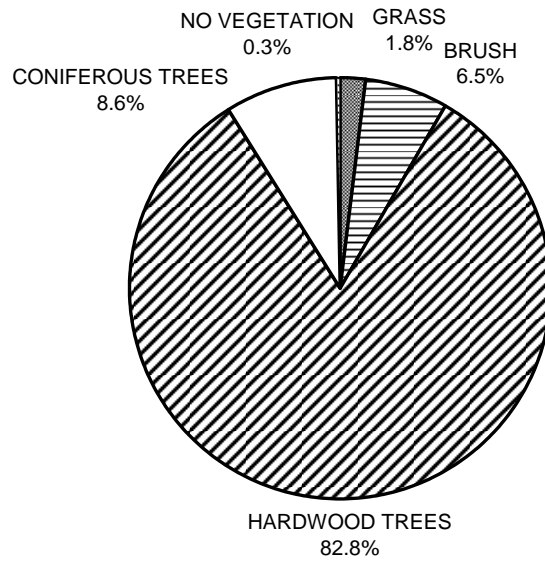
GRAPH 11

For the stream reach surveyed, the mean percent right bank vegetated was 77%. The mean percent left bank vegetated was 80% (Table 7). The dominant elements composing the structure of the stream banks consisted of 65% sand/silt/clay, 22% cobble/gravel, 9% bedrock, 4% boulder (Graph 10). Deciduous trees were the dominant vegetation type observed in 83% of the units surveyed. Additionally, 9% of the units surveyed had coniferous trees as the dominant vegetation type, and 6% had brush as the dominant vegetation type (Graph 11).

The percentage of right and left bank covered with vegetation was 77% and 80%, respectively. In areas of stream bank erosion or where bank vegetation is sparse, planting endemic species of coniferous and hardwood trees, in conjunction with bank stabilization, is recommended.
