**MARIA YGNACIO
STREAM INVENTORY REPORT
FEBRUARY, 2010**

MAY 2011

STREAM INVENTORY REPORT

MARIA YGNACIO CREEK

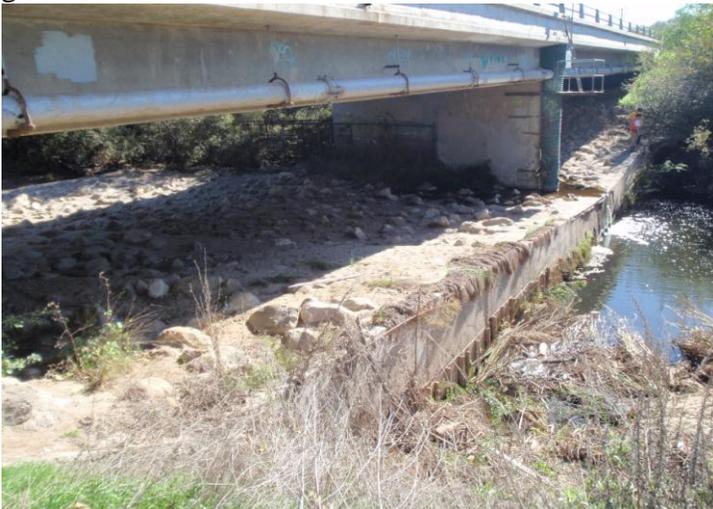
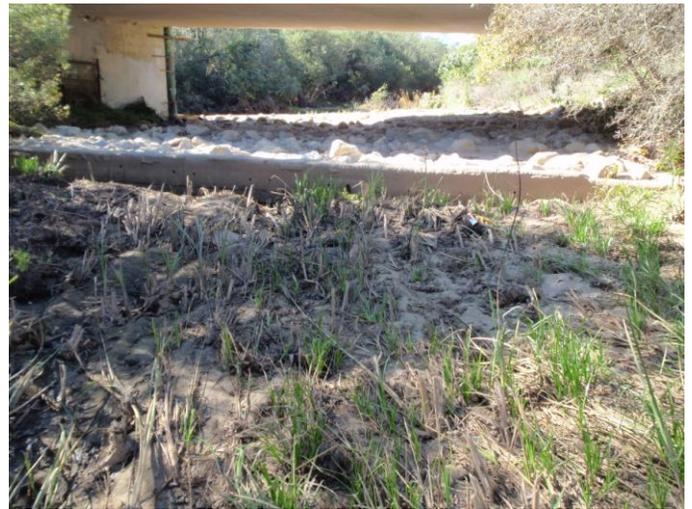
Description: Maria Ygnacio's confluence with Atascadero occurs at the Patterson Bridge where the two creeks converge at the drop off directly downstream of the bridge structure. At the time of the survey, the structure measured 132 ft across the stream channel and 71 ft from the middle division on the Maria Ygnacio side. There was a 3.7 ft plunge from the lip of the drop off to the surface of the pool with pool depth beneath the drop off measuring 6.3 ft. The structure is 76.5 ft long through the stream channel on the Maria Ygnacio side and composed of concrete boulder riprap. Due to velocity breaks, this structure would be passable for steelhead with good flow conditions.

MY Patterson Bridge, Maria Ygnacio/Atascadero, RB

MY Patterson Bridge, Maria Ygnacio, looking DS

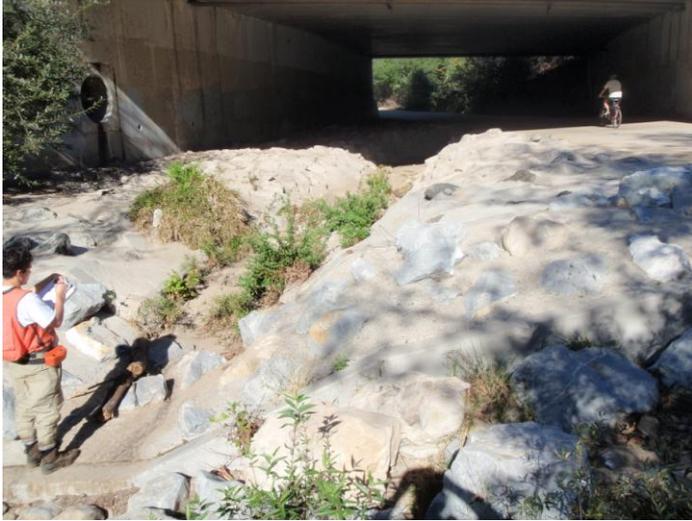
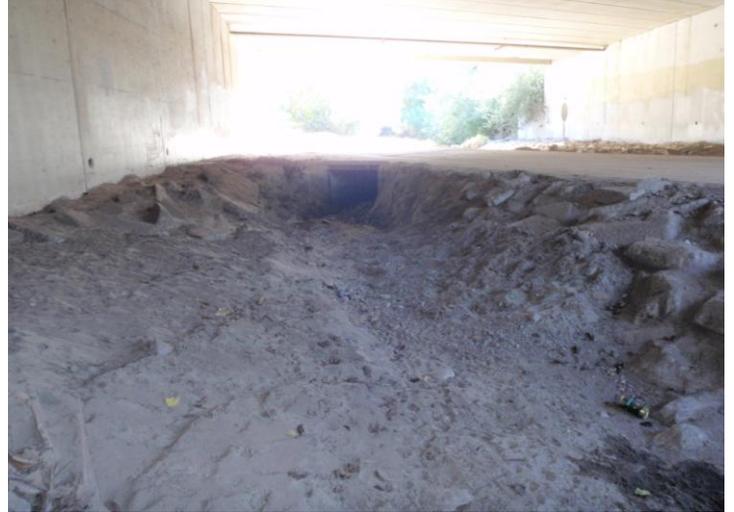
and 76 ft from the end of the apron to the footpath box culvert. The entire length, including the apron, is 147 ft from the upstream edge of the bridge structure. The bridge itself is 115 ft long and 54 ft wide. The footpath box culvert is 30 ft long, 4 ft tall, and 5.5 ft wide, and contains a smoothed concrete bottom. This structure imposes a moderate degree of difficulty to swim into the channel, and a high degree of difficulty to pass through box culvert due to the lack of velocity breaks.

MY Hollister Bridge, looking US

MY Beneath Hollister Bridge, looking DS

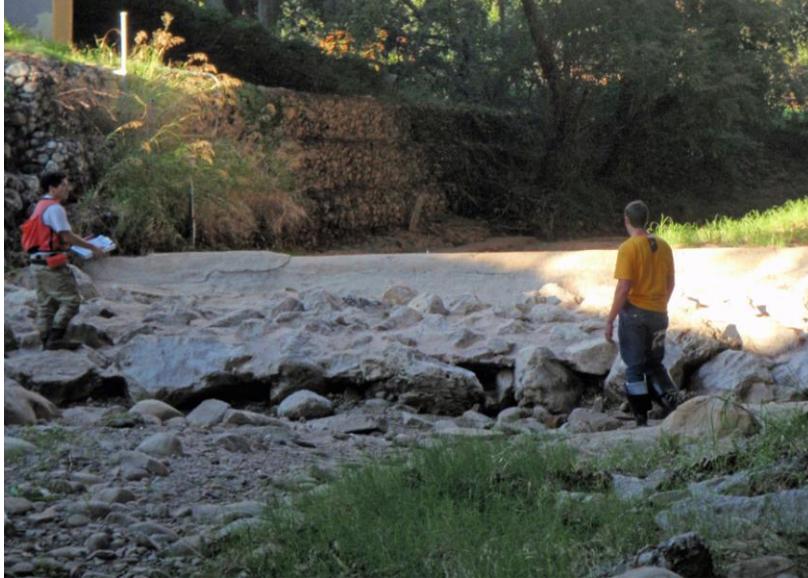
MY University Ave Bridge Grade Control Structure

Description: Just downstream of the University bridge, there was a riprap concrete apron constructed through the stream channel. The apron was 21 ft lengthwise through the channel and 38 ft across with a 1.5 ft average lip height and a negligible pool beneath the plunge. The structure would be passable with adequate flow.

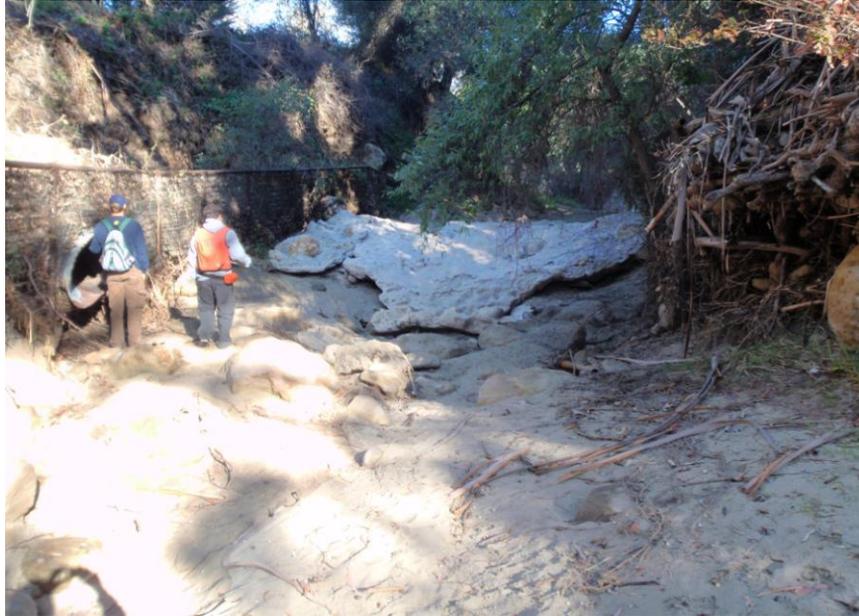
MY Concrete Grade Control Structure 2

Description: The structure was 17ft long, 25 ft wide across the stream, with 2.6 ft deep scour beneath the lip and a slope of approximately 15 degrees. The structure should be passable with a moderate degree of difficulty during good flow conditions.

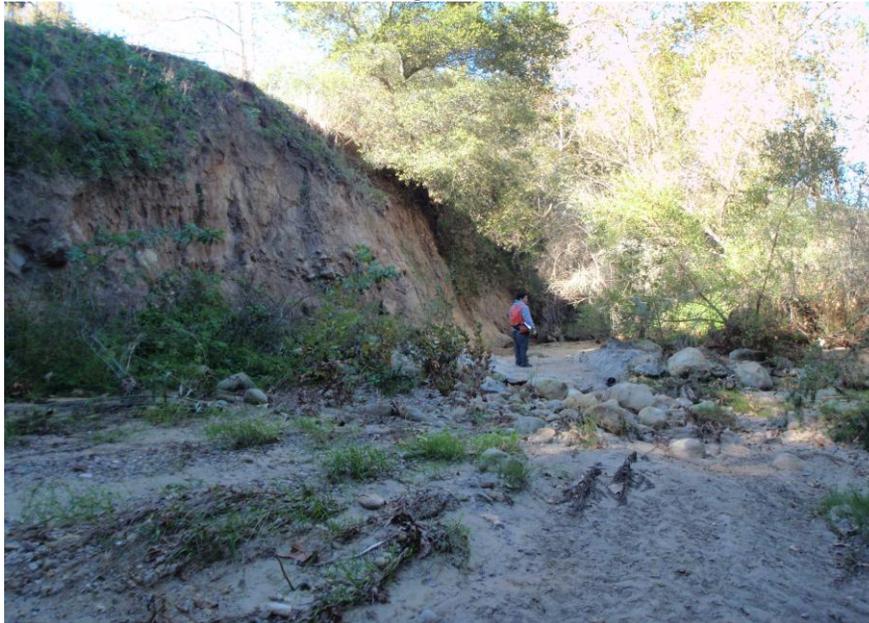
MY Concrete Grade Control Structure 3, looking US

Description: This structure was broken in the middle and would present negligible migration difficulties. It spanned 48 ft across the stream channel and, at its longest, it was 10 ft.

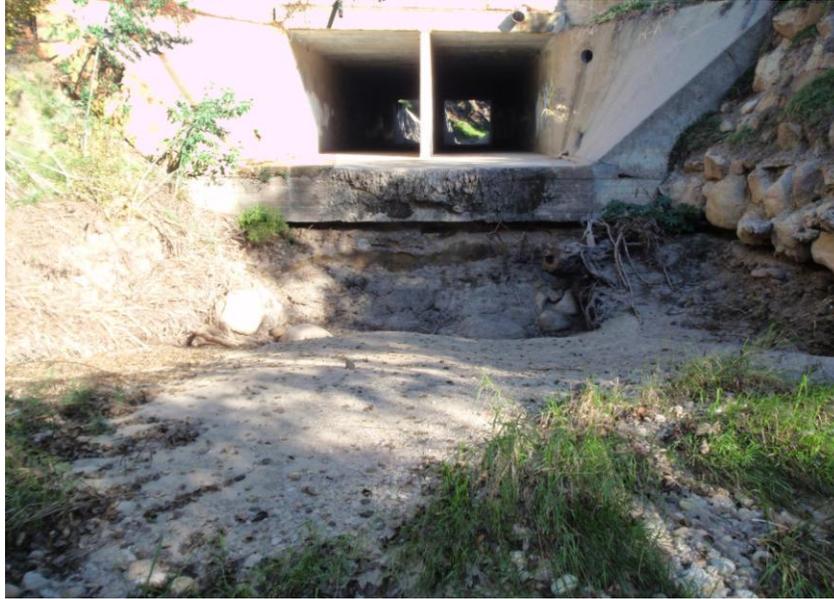
MY Cathedral Oaks Bridge, looking US

Description: The Cathedral Oaks bridge was comprised of a concrete bifurcated box culvert, 186 ft long with each tunnel measuring 12 ft wide. The outlet apron was 24 ft wide at the lip, and 21 ft long with sloped concrete wing walls. The curved inlet apron was 45 ft long w/ sloped inlet wing walls and narrows to 3.8 ft at the base. The plunge was 10 ft max deep from the downstream lip to the creek bed. With adequate pool depth, the jump would be passable; however, migration through the culvert would be difficult due to the flat surface, the lack of velocity breaks, and the narrow inlet. Overall, migration of steelhead through the culvert would be challenging.

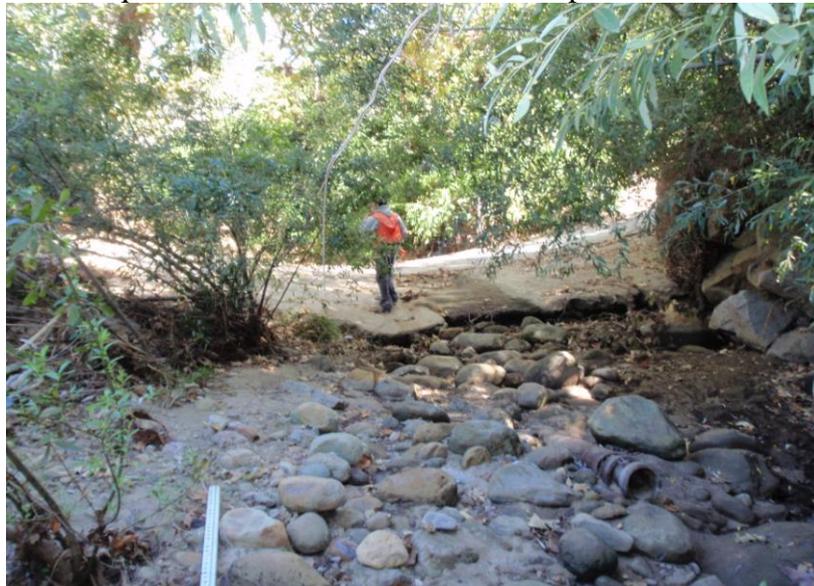
MY Valba Street Arizona Crossing, looking US

Descriptions: Valba street contained an instream concrete Arizona Crossing. The structure spanned the entire length of the stream channel, and included an outlet apron that was 13 ft long while the whole stream length of the structure was 25 ft. With adequate flow, this structure should be passable.

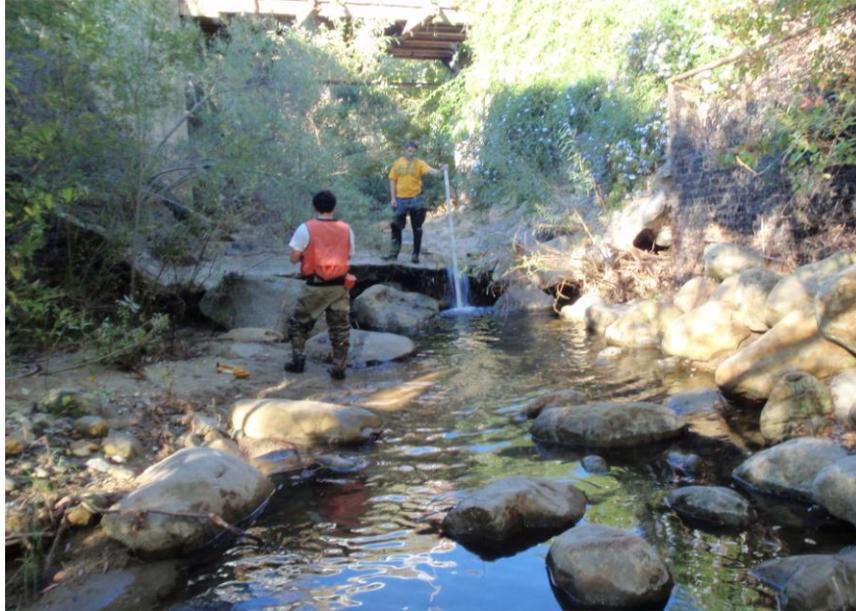
MY Concrete Grade Control Structure 4

Description: This grade control structure spanned the channel beneath a footbridge and involved a concrete apron and inlet wing walls. The structure was 25.5 ft wide with a 19ft apron and 35 ft of total length. Beneath the downstream plunge, the pool had a depth of 1.8 ft with a 2.2 ft jump onto the apron. With appropriate flow, this structure would be passable to steelhead; however, due to the lack of velocity breaks the structure would only be passable during ideal flows.

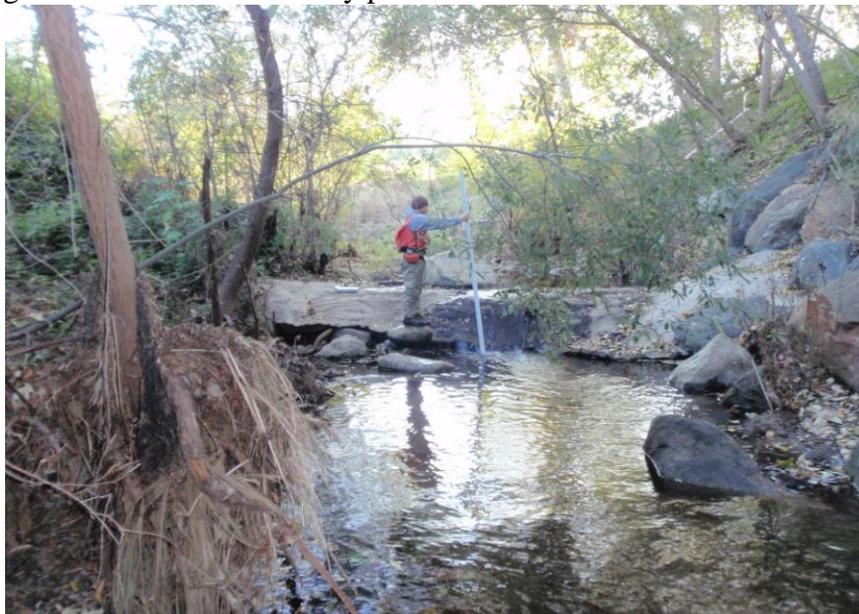
MY Concrete Grade Control Structure 5

Description: This concrete gradient structure was 25 ft wide and 6.5 ft long with a 1 ft. pool depth beneath the plunge and a jump height of 2.5 ft. It would easily passable with sufficient flow.

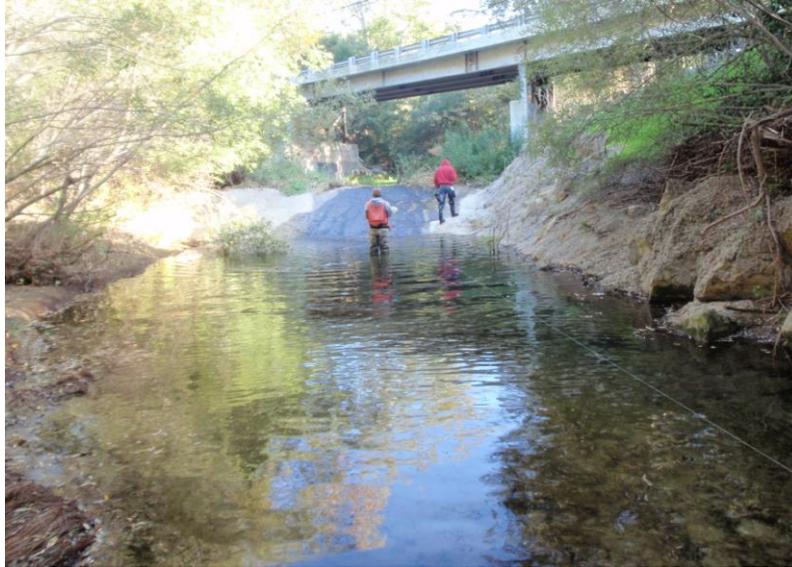
MY San Marcos Bridge, looking US

Description: Downstream of the natural bottom San Marcos bridge was an outlet concrete apron that was 42 ft wide and 46 ft long. Its length extended into a pool with 21ft of concrete outside of the pool with a slope of approximately 15 degrees and a height of 3.5 ft. At the time of the survey, the wetted width was 12ft with a depth of 0.1 ft. The max depth of the downstream pool was 2.5 ft. The structure would be difficult to migrate past for steelhead due to its slope, width, and lack of velocity breaks. During seasons of extremely high flow, it may be possible for steelhead to migrate past this barrier. Beneath the bridge, the natural bottom stream channel width was ~28 ft with boulder erosion control on the RB and 2 concrete suspensions.

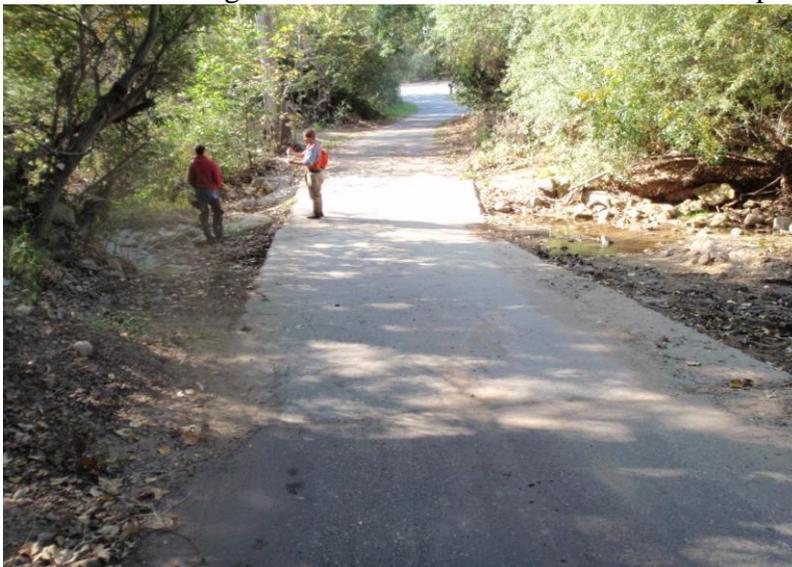
MY Arizona Crossing 1, LB looking US

Description: This concrete Arizona crossing spanned the entire stream channel and was 12 ft long. There was a pipe running beneath the structure allowing for water flow. This structure would be passable with suitable flow.

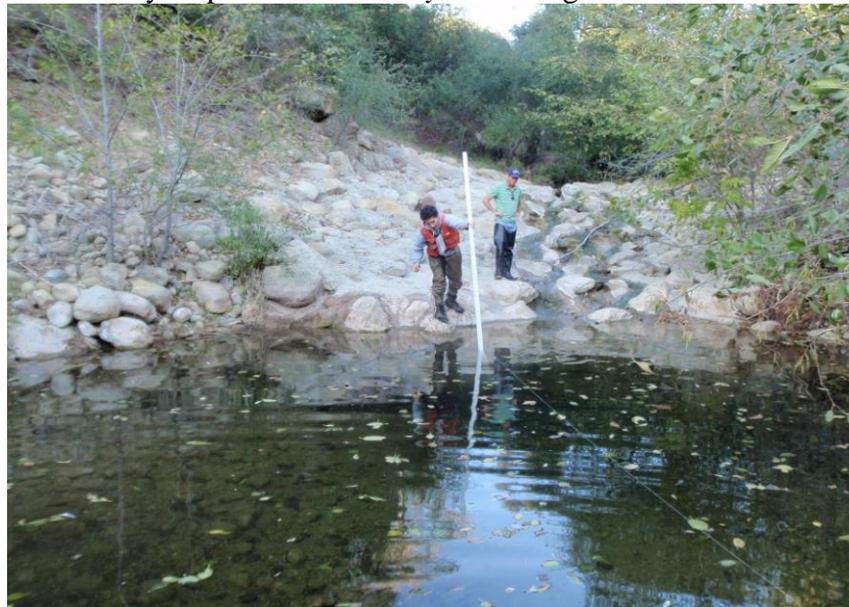
MY Grade Control 8

Description: This boulder, riprap gradient structure was constructed above the debris basin to provide an inlet into the debris basin. The structure was approximately 8 ft high, 41 ft long, and had a slope of approximately 12 degrees. The height and steepness of the structure appear to prevent all upstream migration for steelhead; however, with suitable flow it may be possible for *O. mykiss* to migrate over this barrier.

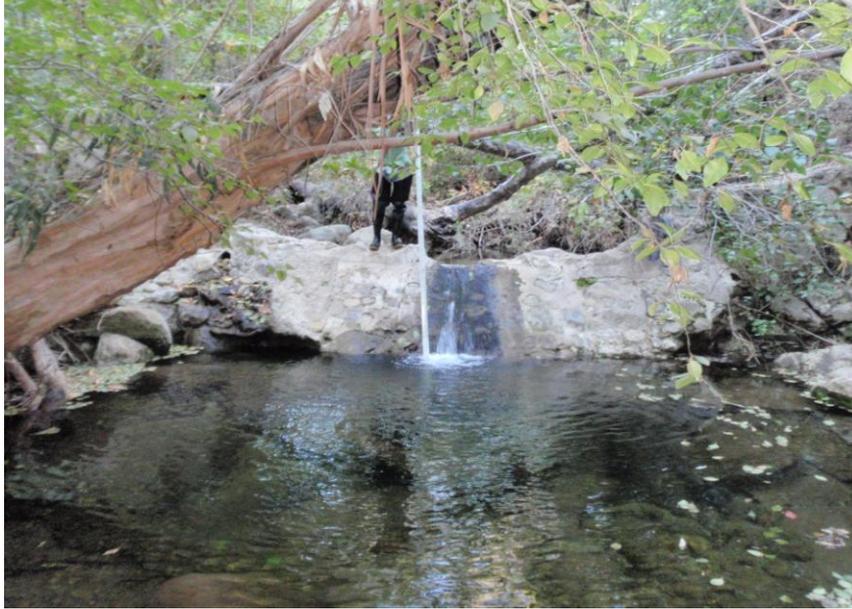
MY Grade Control 9

Description: This concrete dam structure was 18 ft wide with a 3.4 ft jump from a 4 ft deep section of pool beneath the plunge (max depth in the pool was 5.8 ft). Sufficient depth in the downstream pool should be enough to allow passage with a low to moderate degree of difficulty during most flow conditions.

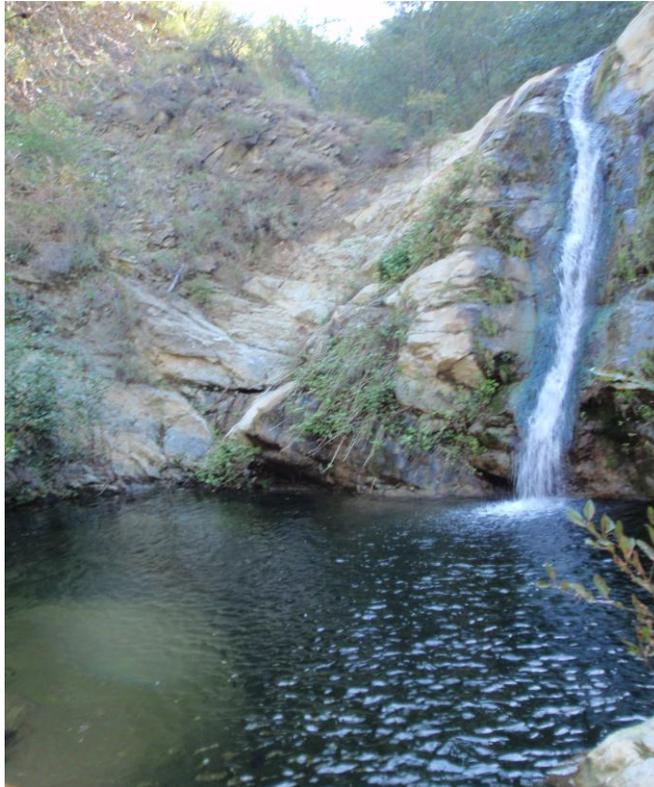
MY Anadromy Barrier Waterfall

Description: This natural waterfall was approximately 40ft. The height of the waterfall prevents migration during all flow conditions, thus making this the natural anadromy barrier for steelhead in Maria Ygnacio.

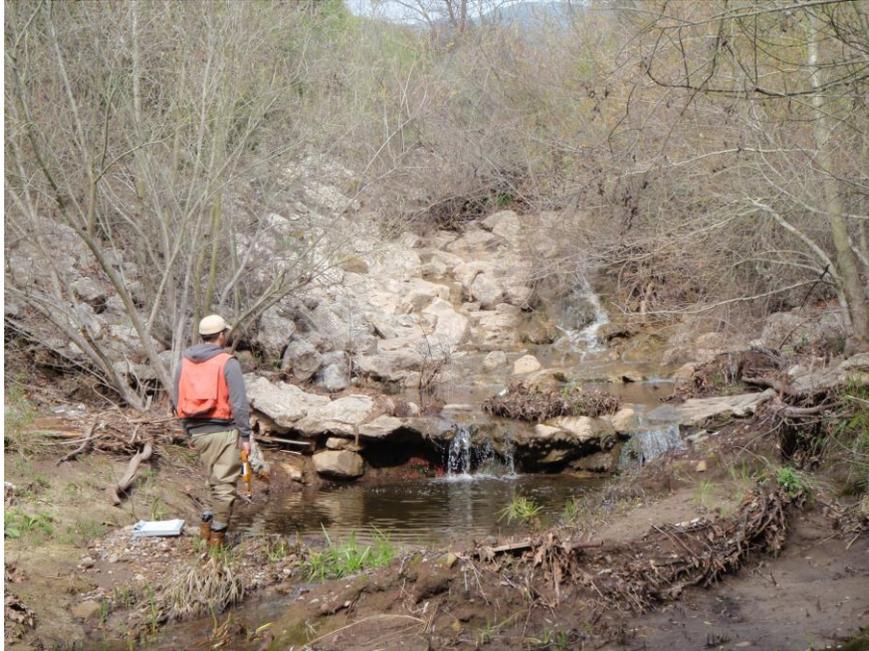
MYEF Grade Control 3

Description: This grade control structure contained two sections: a 31 ft riprap embankment and a small concrete outlet apron separated by 15 ft of shallow pool that had been silted in. The concrete outlet apron was approximately 5 ft in length and created a 2 ft plunge followed by a downstream pool with a depth of 2 ft beneath the apron (max pool depth = 2.4 ft). The riprap bank was 31 ft long and 9.2 ft high, indicating a slope of approximately 17 degrees. The lack of flow and steepness and length of the bank would make it extremely difficult for steelhead to migrate past this structure.

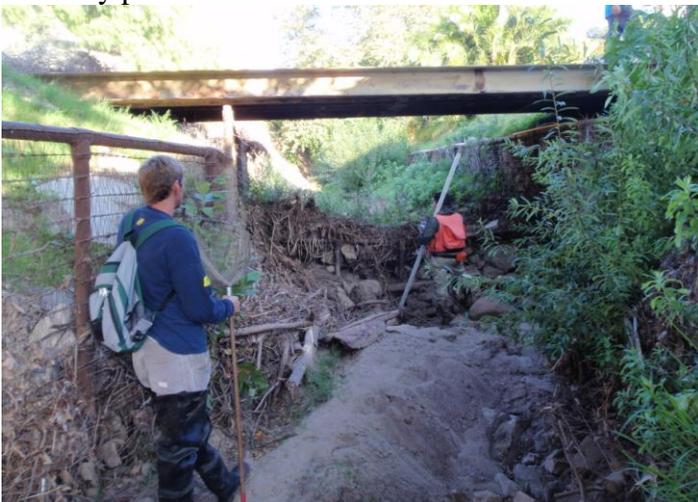
Metal Pipe Check Structure

Description: Beneath a footbridge inside the nursery, there was a metal pipe check structure that stood 4 ft tall with debris entrapped behind it and negligible downstream scour. The lack of scour pool would make migration difficult unless a sufficient pool was formed to jump past the pipe structure. There was another metal pipe check structure approximately 50 ft downstream from the footbridge pipe check structure; however, this barrier would be easily passable with sufficient flow.

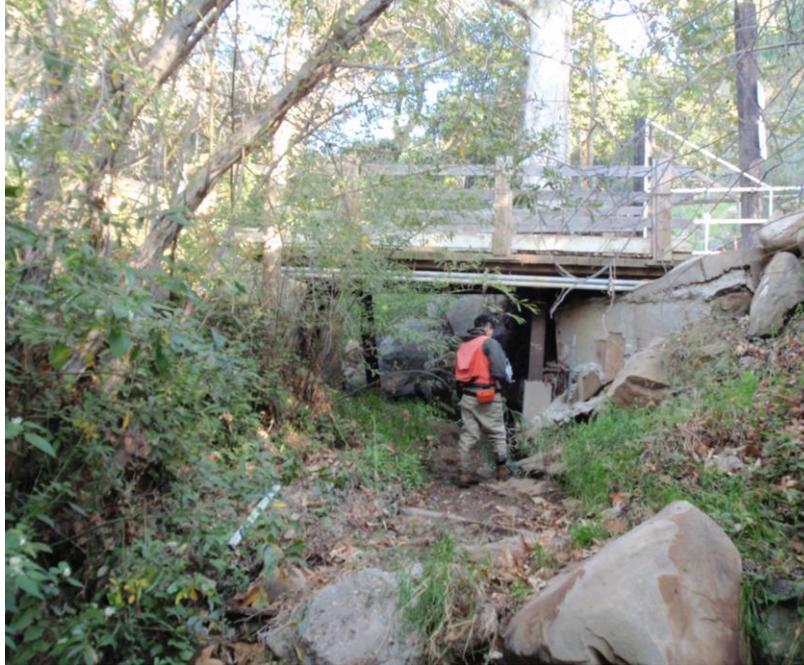
MYEF Footbridge, looking US

Description: There was a second bridge observed in the nursery. This bridge contained a natural bottom; however, there was considerable erosion observed underneath the left bank buttress. This structure would not pose a threat to steelhead migration.

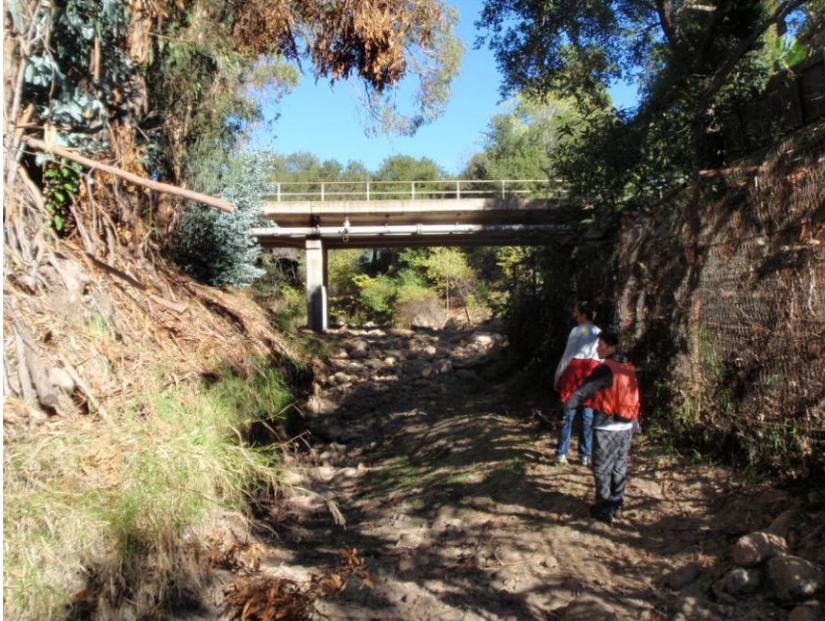
Vala Footbridge, looking US

Description: The natural bottom footbridge between Vala and Turnpike would be passable under all conditions. On the downstream right bank, there was considerable erosion beneath a stand of eucalyptus.

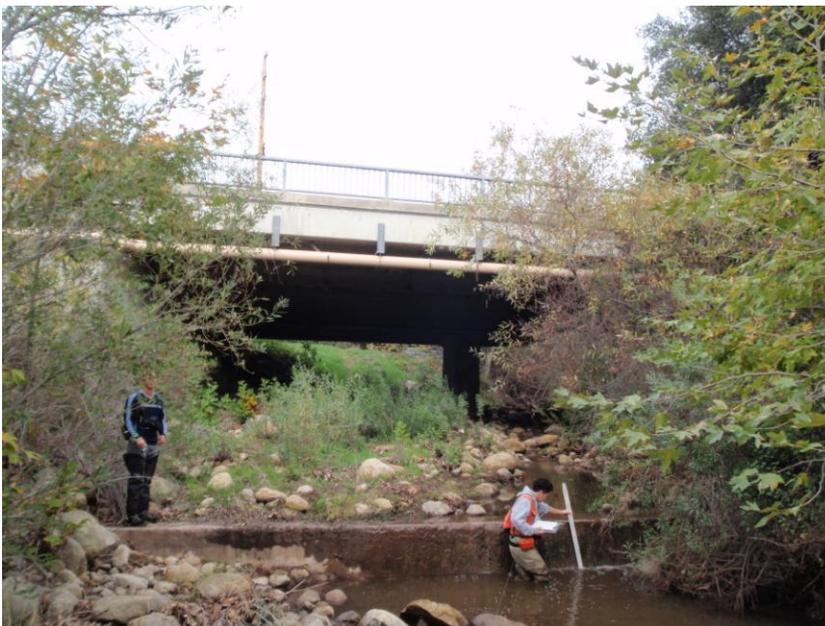
Description: The Cathedral Oaks bridge was a natural bottom bridge with a downstream concrete lip. The concrete lip was 26 ft wide across the stream, 2 ft long and 2 ft with a 1.2 ft water depth beneath the lip. At the time of the survey, the wetted width was 19 ft. Beneath the bridge there was one middle buttress but the rest of the stream bed was natural.

Concrete lip DS of Cathedral Oaks bridge

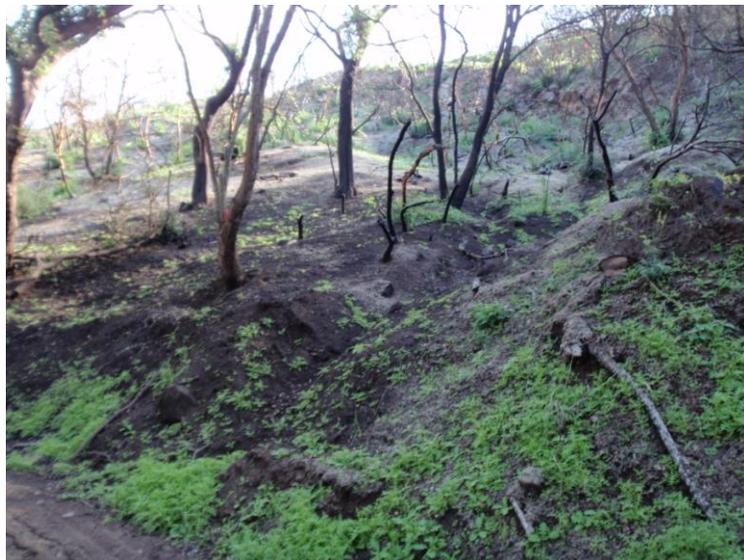
The Jesusita Fire was a wildfire that began on May 5, 2009 and burned 8,733 acres, including portions of the Maria Ygnacio watershed (see Map 4). Just downstream of the San Marcos Pass bridge and approximately 2.76 miles up from the San Antonio-Maria Ygnacio confluence, the San Antonio Creek survey moved upstream through areas within the Jesusita Fire burn perimeter. Closer to the perimeter, the San Antonio riparian corridor remained intact and only the upper hillsides were burned. As the survey moved further upstream, the impacts of the burn were observed closer to the stream channel with the riparian corridor burned on both banks in same sections. The most extensive burned areas were observed on the mainstem close to the anadromy barrier, and throughout majority of the East Fork San Antonio where the hillsides were almost entirely denuded as a result of the fire including vegetation on the stream banks directly beside the stream (see Picture 1).

Picture 1: Burned hillside in the East Fork San Antonio

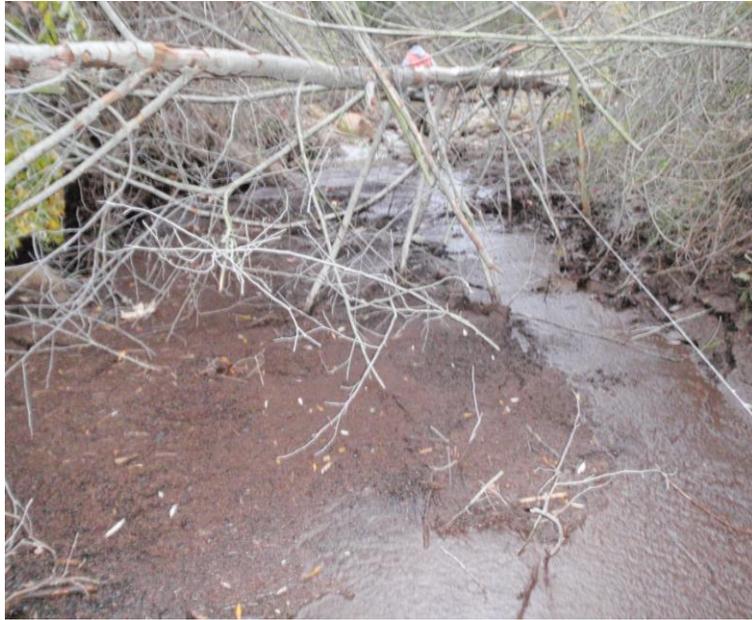
In addition to the burned bank vegetation, a considerable amount of deposited sand and silt sediment was observed through both the Maria Ygnacio and San Antonio watersheds. It should be noted that for both the B5 channel types for the East Fork Maria Ygnacio and Reach 1 of Maria Ygnacio Creek, there was a considerable amount of sand, which could have been deposited in the lower reaches due to loosened bank sediment and ash from the Jesusita Fire. Beneath the sand deposition, the dominant substrate was boulder. It's possible that following significant storm events with suitable flushing flows, the sand deposit will be flushed downstream and the dominant channel substrate would return to boulder and the channel types would transition for B5 to B2.

Picture 2: Instream topsoil on pool surface

deposition filled habitat units that normally would have been pools (see Picture 3). Sand and silt deposited in the stream as a result of the Jesusita Fire should be flushed out after future storm events most likely reverting the dominant substrates to pre-fire conditions. The banks of San Antonio Creek and the East Fork San Antonio were also denuded by the burn with entire hillsides burned in some areas and sections of erosion. In the East Fork San Antonio towards the end of the survey, the use of hydromulch was observed on the hillsides to prevent erosion. With time, there should be a natural recruitment of native vegetation that will repopulate the riparian corridor, revitalizing the canopy and bank vegetation.

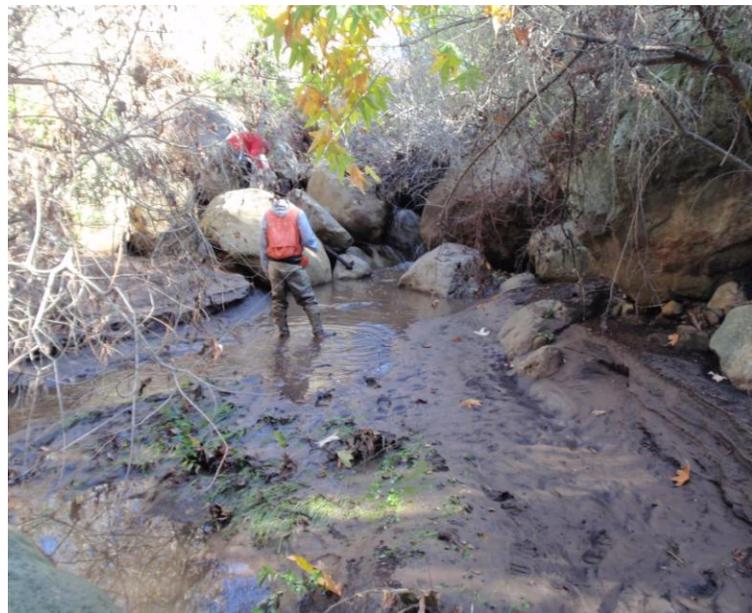
Picture 3: Silt & sand filled pool
