**California Department of Fish and Wildlife
Marin County
Marin Coastal Watershed
Stream Habitat Assessment Report**

Easkoot Creek

Surveyed 2010

STREAM INVENTORY REPORT

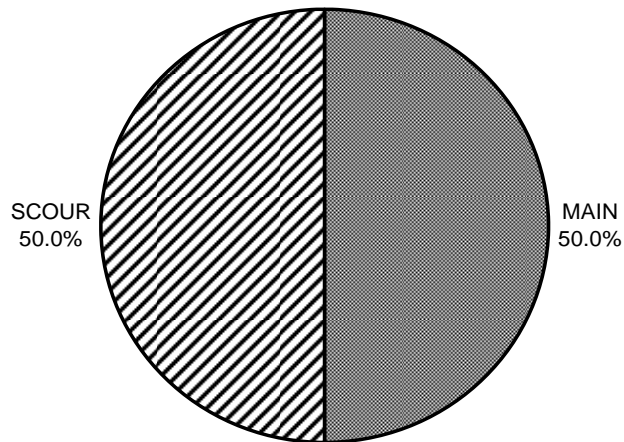
GRAPH 4

A total of 8 pools were identified (Table 3). Main Channel and scour pools were evenly encountered at 50% each. The Main Channel was comprised of 58% and scours was comprised of 42% of the total length of all pools (Graph 4).

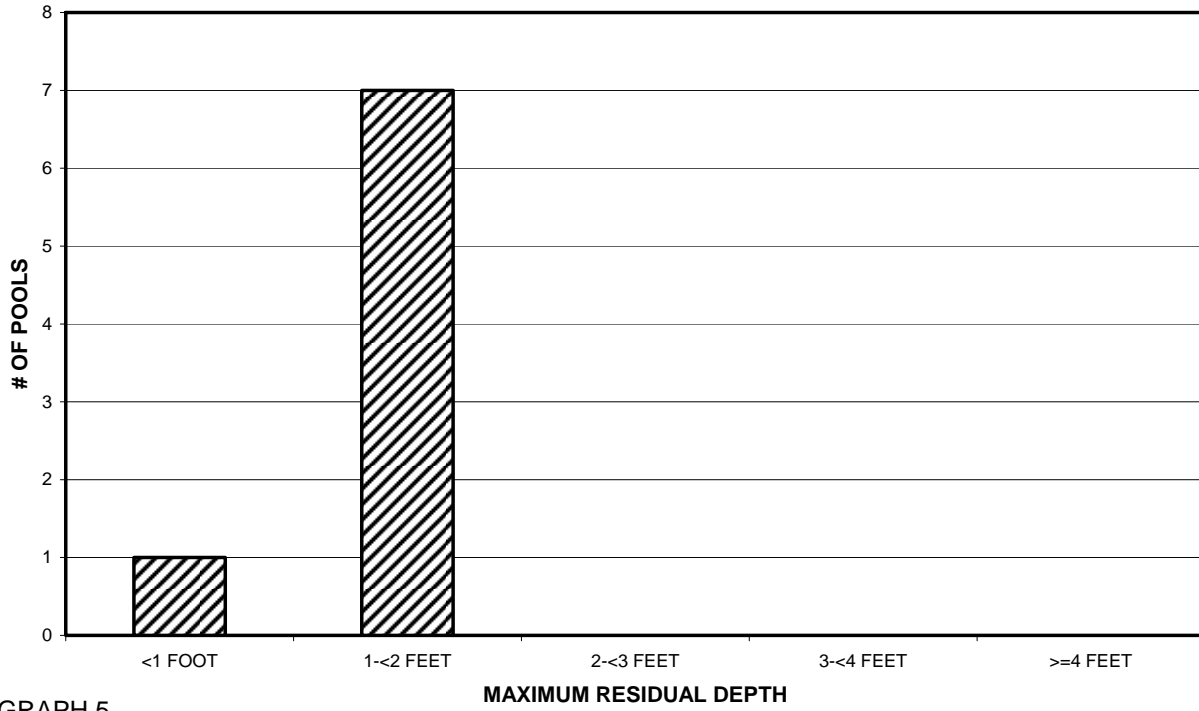
GRAPH 5

Table 4 is a summary of maximum residual pool depths by pool habitat types. Pool quality for salmonids increases with depth. Zero of the 8 pools (0%) had a residual depth of two feet or greater (Graph 5).

- 1) Where feasible, design and engineer pool enhancement structures to increase the number of pools. This must be done where the banks are stable or in conjunction with stream bank armor to prevent erosion.

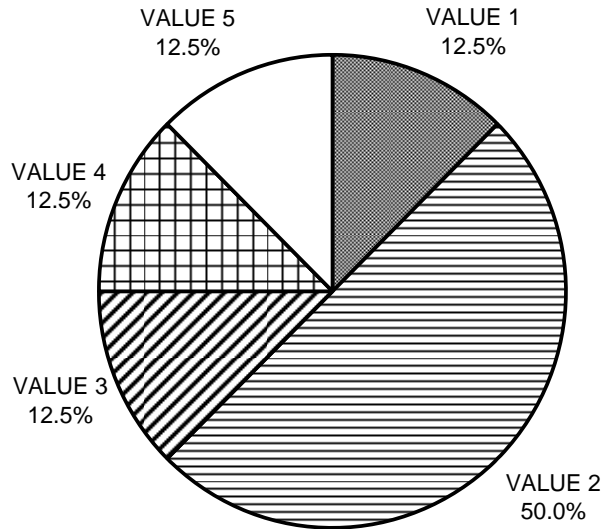
GRAPH 6

The depth of cobble embeddedness was estimated at pool tail-outs. Of the 8 pool tail-outs measured, 1 had a value of 1 (12.5%); 4 had a value of 2 (50%); 1 had a value of 3 (12.5%); 1 had a value of 4 (12.5%); and, 1 had a value of 5 (12.5%) (Graph 6). On this scale, a value of 1 indicates the best spawning conditions and a value of 4 the worst. Additionally, a value of 5 was assigned to tail-outs deemed unsuited for spawning due to inappropriate substrate such as bedrock, log sills, boulders, or other considerations.

Five of the 8 pool tail-outs measured had embeddedness ratings of 1 or 2. Two of the pool tail-outs had embeddedness ratings of 3 or 4. One of the pool tail-outs had a rating of 5, which is considered unsuitable for spawning. Cobble embeddedness measured to be 25% or less, a rating of 1, is considered to indicate good quality spawning substrate for salmon and steelhead. Sediment sources in Easkoot Creek should be mapped and rated according to their potential sediment yields, and control measures should be taken.

- 5) Inventory and map sources of stream bank erosion and prioritize them according to present and potential sediment yield. Identified sites should then be treated to reduce the amount of fine sediments entering the stream. Active and potential sediment sources related to the road system need to be identified, mapped, and treated according to their potential for sediment yield to the stream and its tributaries.

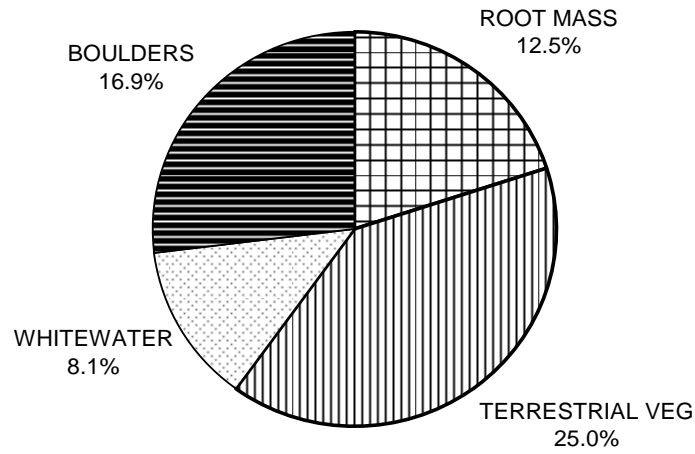
GRAPH 7

Table 5 summarizes mean percent cover by habitat type. Terrestrial Vegetation is the dominant cover types in Easkoot Creek. Graph 7 describes the pool cover in Easkoot Creek. Terrestrial Vegetation is the dominant pool cover type followed by boulders.

- 2) Increase woody cover in the pools and flatwater habitat units. Most of the existing cover in the pools is from Terrestrial Vegetation. Adding high quality complexity with woody cover in the pools is desirable.

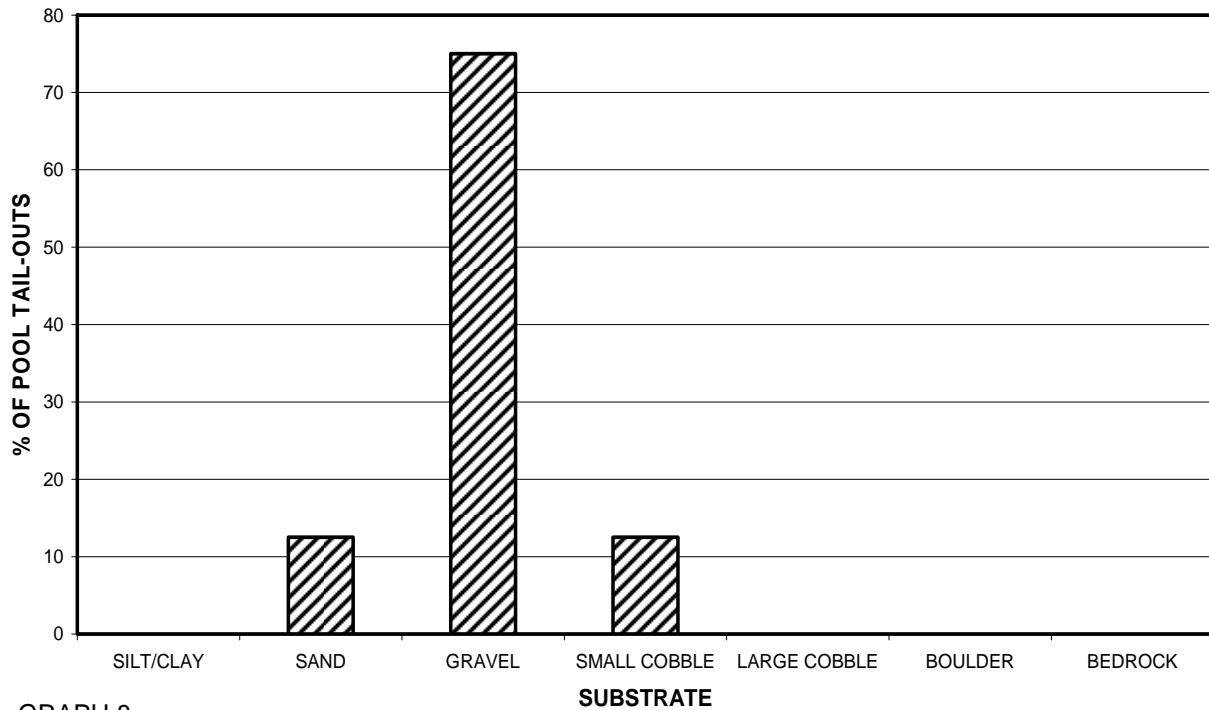
GRAPH 8

Table 6 summarizes the dominant substrate by habitat type. Graph 8 depicts the dominant substrate observed in pool tail-outs which were sand and small Cobble observed in 13%, each, of pool tail-outs, and gravel observed in 75% of pool tail-outs.

Seven of the 8 pool tail-outs measured had gravel or small cobble as the dominant substrate. This is generally considered good for spawning salmonids.

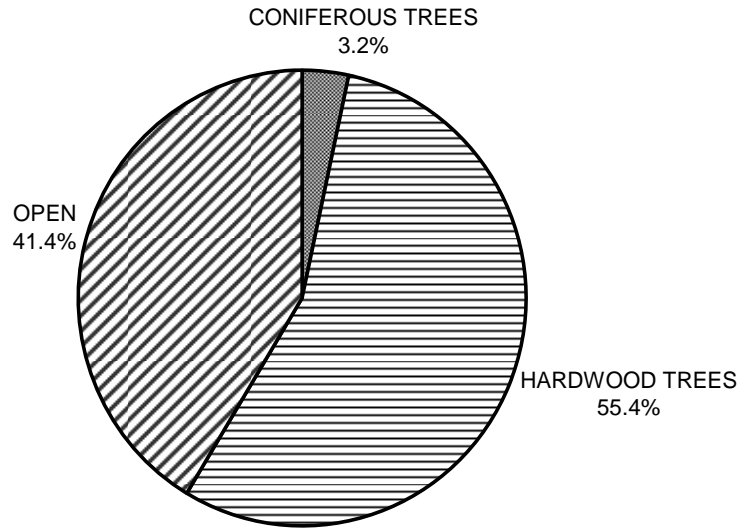
GRAPH 9

The mean percent canopy density for the surveyed length of Easkoot Creek was 59%. The mean percentages of hardwood and coniferous trees were 95% and 5%, respectively. Forty-one percent of the canopy was open. Graph 9 describes the mean percent canopy in Easkoot Creek.

The mean percent canopy density for the stream was 59%. Reach 2 had a canopy density of 50.4% and Reach 3 had a canopy density of 70.8%. In general, revegetation projects are considered when canopy density is less than 80%.

- 3) Increase the canopy throughout Easkoot Creek by planting appropriate native vegetation like willow, alder, redwood, and Douglas fir along the stream where shade canopy is not at acceptable levels. The reaches above this survey section should be inventoried and treated as well, since the water flowing here is affected from upstream. In many cases, planting will need to be coordinated to follow bank stabilization or upslope erosion control projects.

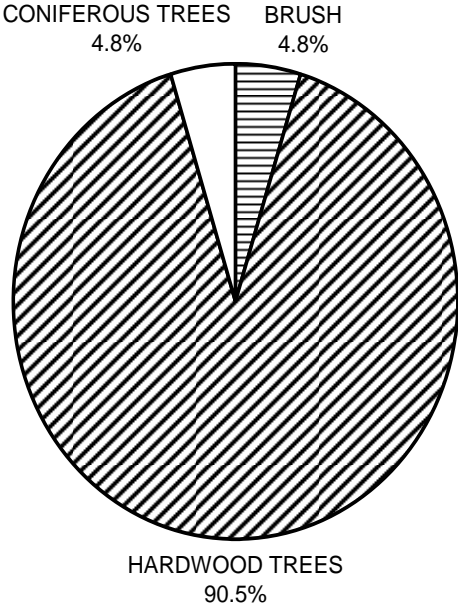
GRAPH 11

For the stream reach surveyed, the mean percent right bank vegetated was 68%. The mean percent left bank vegetated was 67%. The dominant elements composing the structure of the stream banks consisted of 10% bedrock, 10% boulder, 17% cobble/gravel, and 64% sand/silt/clay (Graph 10). Hardwood trees were the dominant vegetation type observed in 90.5% of the units surveyed. Additionally, 4.8% of the units surveyed had coniferous trees as the dominant vegetation type, and 4.8% had brush as the dominant vegetation (Graph 11).

The percentage of right and left bank covered with vegetation was 68% and 67%, respectively. In areas of stream bank erosion or where bank vegetation is sparse, planting endemic species of coniferous and hardwood trees, in conjunction with bank stabilization, is recommended.
