**California Department of Fish and Game  
Marin Coastal Watershed  
Stream Habitat Assessment Reports  
Green Gulch**

## STREAM INVENTORY REPORT

*Surveyed Summer 2008*

### Green Gulch

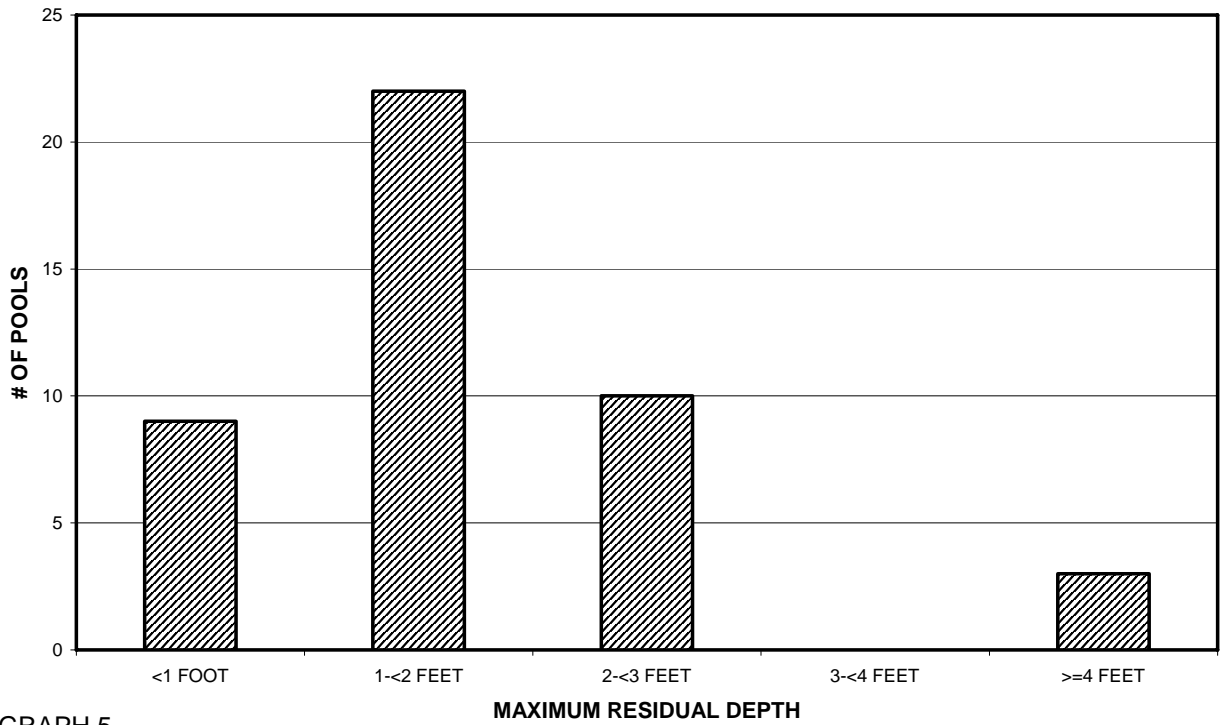
GRAPH 5

Table 4 is a summary of maximum residual pool depths by pool habitat types. Pool quality for salmonids increases with depth. Thirteen of the 44 pools (30%) had a residual depth of two feet or greater (Graph 5).

- 6) Where feasible, design and engineer pool enhancement structures to increase the number of pools. This must be done where the banks are stable or in conjunction with stream bank armor to prevent erosion.

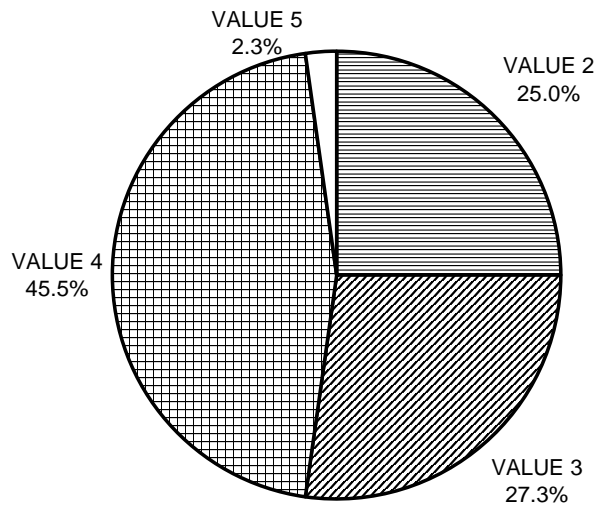
GRAPH 6

The depth of cobble embeddedness was estimated at pool tail-outs. Of the 44 pool tail-outs measured, 11 had a value of 2 (25%); 12 had a value of 3 (27.3%); 20 had a value of 4 (45.5%); and 1 had a value of 5 (2.3%) (Graph 6). On this scale, a value of 1 indicates the best spawning conditions and a value of 4 the worst. Additionally, a value of 5 was assigned to tail-outs deemed unsuited for spawning due to inappropriate substrate such as bedrock, log sills, boulders, or other considerations.

Eleven of the 44 pool tail-outs measured had embeddedness ratings of 1 or 2. Thirty two of the pool tail-outs had embeddedness ratings of 3 or 4. One of the pool tail-outs had a rating of 5, which is considered unsuitable for spawning. Cobble embeddedness measured to be 25% or less, a rating of 1, is considered to indicate good quality spawning substrate for salmon and steelhead. Sediment sources in Green Gulch should be mapped and rated according to their potential sediment yields, and control measures should be taken.

- 4) Active and potential sediment sources related to the road system need to be identified, mapped, and treated according to their potential for sediment yield to the stream and its tributaries.

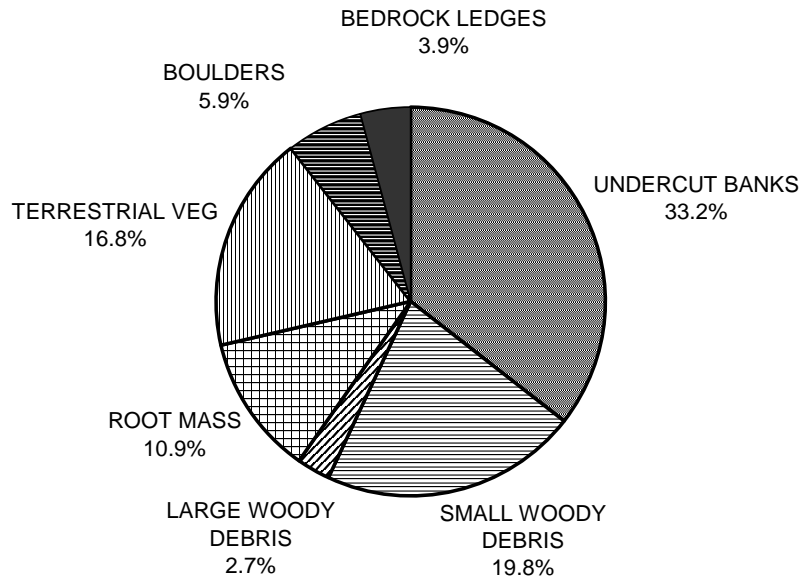
GRAPH 7

Table 5 summarizes mean percent cover by habitat type. Undercut Banks are the dominant cover type in Green Gulch. Graph 7 describes the pool cover in Green Gulch. Undercut banks are the dominant pool cover type followed by small woody debris.

The mean shelter rating for pools was 11. The shelter rating in the flatwater habitats was 20. A pool shelter rating of approximately 100 is desirable. The amount of cover that now exists is being provided primarily by Undercut Banks in Green Gulch. Undercut Banks are the dominant cover type in pools followed by small woody debris. Log and root wad cover structures in the pool and flatwater habitats would enhance both summer and winter salmonid habitat. Log cover structure provides rearing fry with protection from predation, rest from water velocity, and also divides territorial units to reduce density related competition.

- 3) Increase woody cover in the pools and flatwater habitat units. Most of the existing cover in the pools is from undercut banks. Adding high quality complexity with woody cover in the pools is desirable.

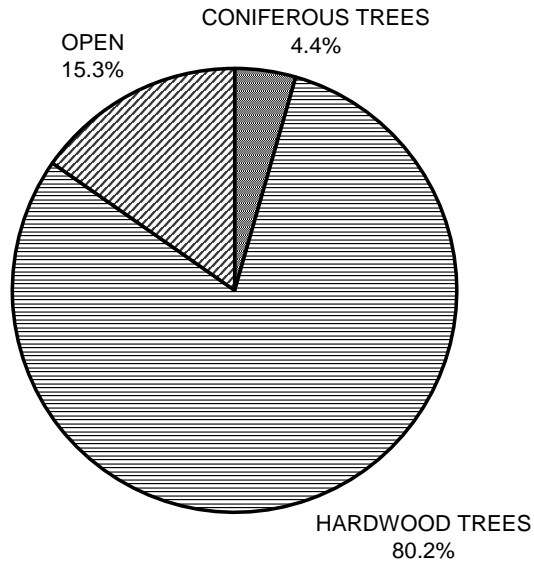
GRAPH 9

The mean percent canopy density for the surveyed length of Green Gulch was 85%. The mean percentages of hardwood and coniferous trees were 95% and 5%, respectively. Fifteen percent of the canopy was open. Graph 9 describes the mean percent canopy in Green Gulch.

89%, Reach 4 had a canopy density of 87%, Reach 6 had a canopy density of 27%, Reach 8 had a canopy density of 68%, Reach 10 had a canopy density of 20%, Reach 12 had a canopy density of 90%. In general, revegetation projects are considered when canopy density is less than 80%.

- 5) Increase the canopy on Green Gulch by planting appropriate native vegetation like willow, alder, redwood, and Douglas fir along the stream where shade canopy is not at acceptable levels. The riparian zone is thin in some areas and should be increased where appropriate. The reaches above this survey section should be inventoried and treated as well, since the water flowing here is affected from upstream. In many cases, planting will need to be coordinated to follow bank stabilization or upslope erosion control projects. There are also sections where the stream is being impacted from horses
