**California Department of Fish and Game**  
**Petaluma River Watershed**  
**Stream Habitat Assessment Reports**  
**Adobe Creek**  
*Surveyed 2007*

# STREAM INVENTORY REPORT

## Adobe Creek

*Survey conducted summer 2007*

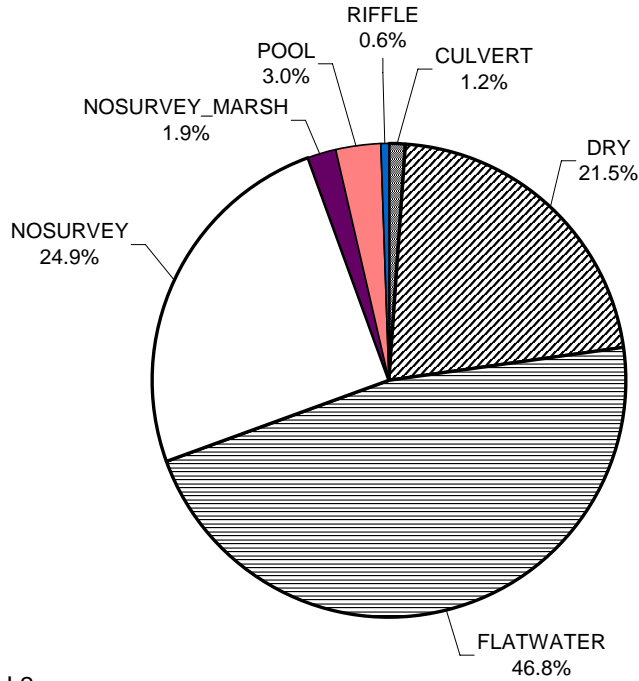
GRAPH 2

Table 1 summarizes the Level II riffle, flatwater, and pool habitat types. Based on frequency of occurrence there were approximately 2% nosurvey units, 9% culvert units, 1% no survey due to marsh units, 8% dry units, 54% flatwater units, 2% riffle units and 25% pool units (Graph 1). Based on total length of Level II habitat types there were 25% nosurvey units, 1% culvert units, 2% nosurvey\_marsh units, 22% dry units, 47% flatwater units, 1% riffle units and 3% pool units (Graph 2).

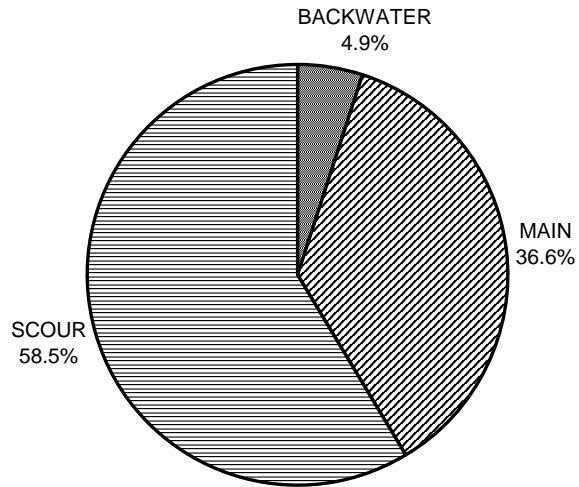
GRAPH 4

A total of 41 pools were identified (Table 3). Scour pools were the most frequently encountered, at 59%, and comprised 49% of the total length of all pools (Graph 4).

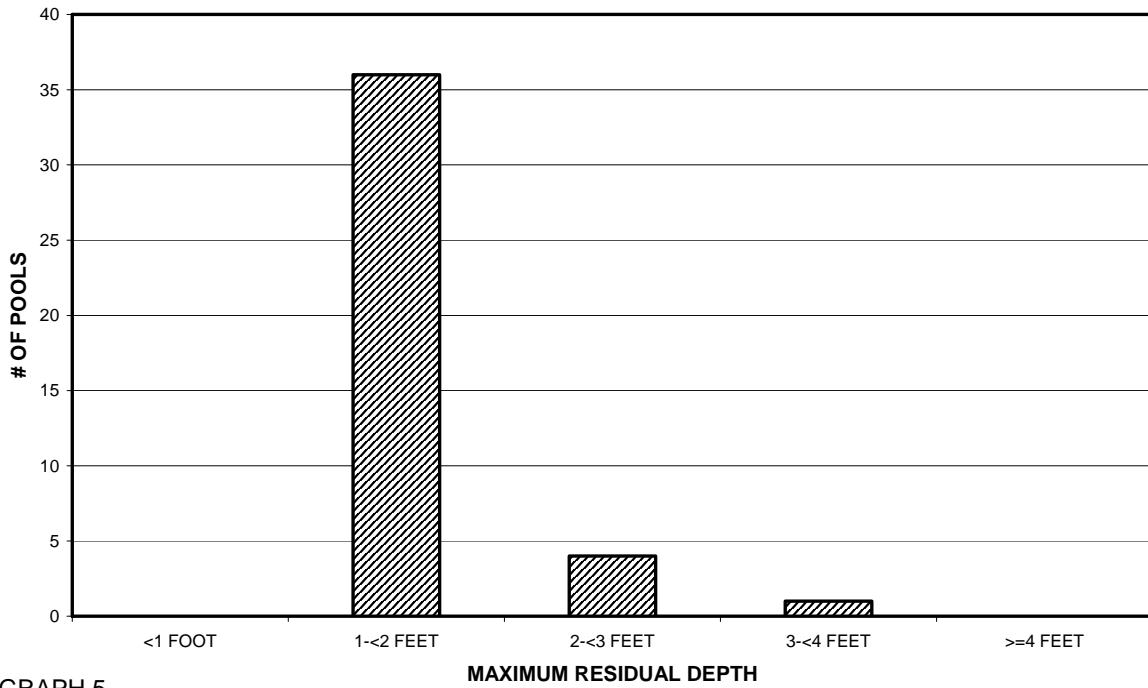
GRAPH 5

Table 4 is a summary of maximum residual pool depths by pool habitat types. Pool quality for salmonids increases with depth. Five of the 41 pools (12%) had a residual depth of two feet or greater (Graph 5).

Flatwater habitat types comprised 47% of the total length of this survey, riffles 1%, and pools 3%. The pools are relatively shallow, with only 5 of the 41 (12%) pools having a maximum residual depth greater than 2 feet. In general, pool enhancement projects are considered when primary pools comprise less than 40% of the length of total stream habitat. In first and second order streams, a primary pool is defined to have a maximum residual depth of at least two feet, occupy at least half the width of the low flow channel, and be as long as the low flow channel width. Installing structures that will increase or deepen pool habitat is recommended for locations where their installation will not be threatened by high stream energy, or where their installation will not conflict with the modification of the numerous log debris accumulations (LDA's) in the stream.

- 8) Where feasible, design and engineer pool enhancement structures to increase the number of pools. This must be done where the banks are stable or in conjunction with stream bank armor to prevent erosion.

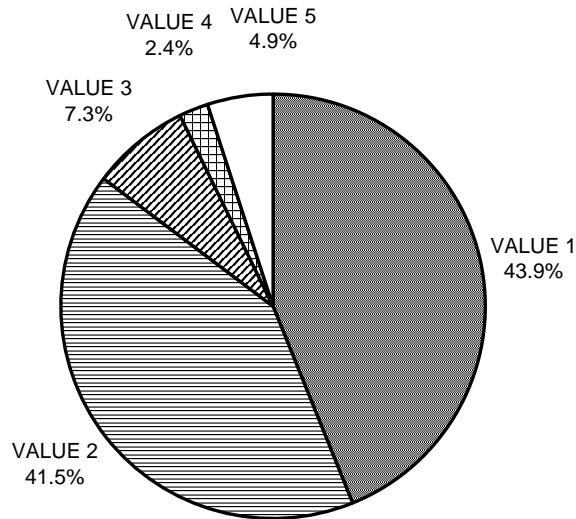
GRAPH 6

The depth of cobble embeddedness was estimated at pool tail-outs. Of the 41 pool tail-outs measured, 18 had a value of 1 (43.9%); 17 had a value of 2 (41.5%); 3 had a value of 3 (7.3%); 1 had a value of 4 (2.4%); and 2 had a value of 5 (4.9%) (Graph 6). On this scale, a value of 1 indicates the best spawning conditions and a value of 4 the worst. Additionally, a value of 5 was assigned to tail-outs deemed unsuited for spawning due to inappropriate substrate such as bedrock, log sills, boulders, or other considerations.

Thirty-five of the 41 pool tail-outs measured had embeddedness ratings of 1 or 2. Four of the pool tail-outs had embeddedness ratings of 3 or 4. Two of the pool tail-outs had a rating of 5, which is considered unsuitable for spawning. Cobble embeddedness measured to be 25% or less,

- 4) Inventory and map sources of stream bank erosion and prioritize them according to present and potential sediment yield. Identified sites should then be treated to reduce the amount of fine sediments entering the stream.

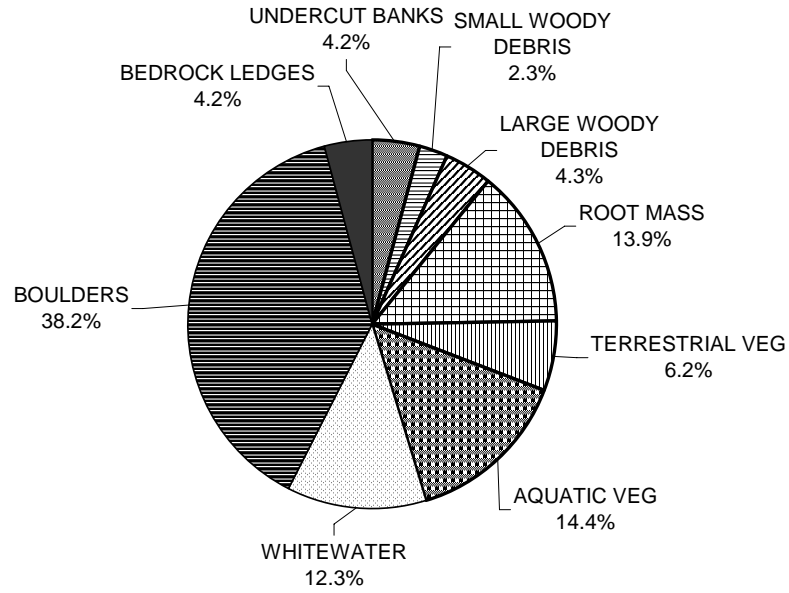
GRAPH 7

Table 5 summarizes mean percent cover by habitat type. Boulders are the dominant cover types in Adobe Creek. Graph 7 describes the pool cover in Adobe Creek. Boulders are the dominant pool cover type followed by aquatic vegetation.

The mean shelter rating for pools was 23. The shelter rating in the flatwater habitats was 7. A pool shelter rating of approximately 100 is desirable. The amount of cover that now exists is being provided primarily by Boulders in Adobe Creek. Boulders are the dominant cover type in pools followed by aquatic vegetation. Log and root wad cover structures in the pool and flatwater habitats would enhance both summer and winter salmonid habitat. Log cover structure provides rearing fry with protection from predation, rest from water velocity, and also divides territorial units to reduce density related competition.

- 7) Increase woody cover in the pools and flatwater habitat units. Most of the existing cover in the pools is from Boulders. Adding high quality complexity with woody cover in the pools is desirable.

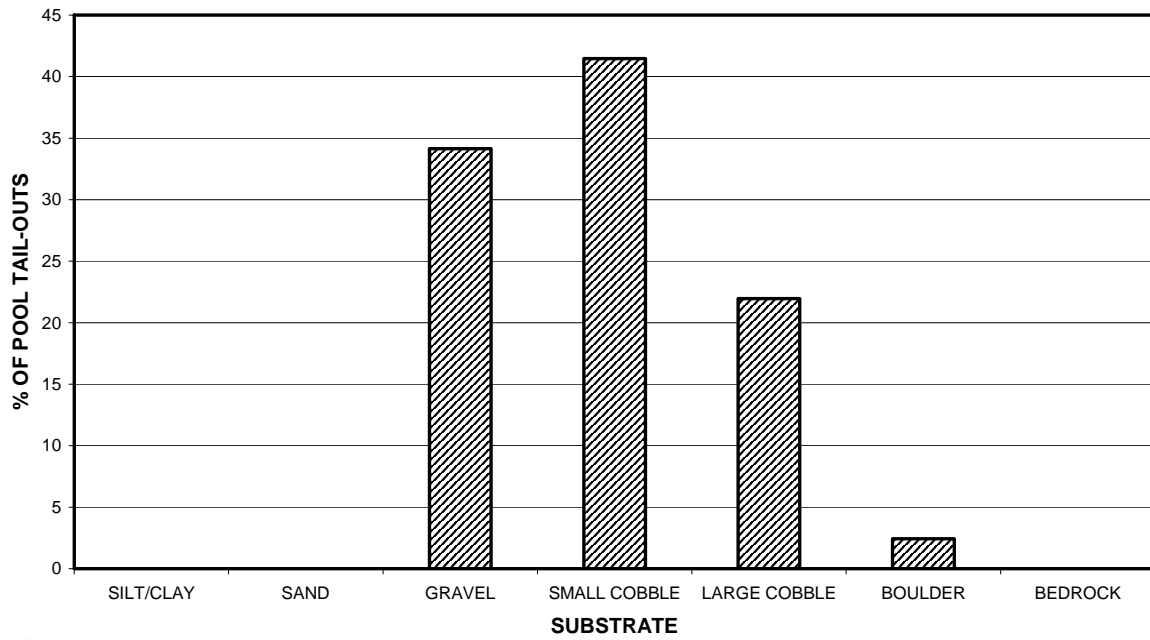
GRAPH 8

Table 6 summarizes the dominant substrate by habitat type. Graph 8 depicts the dominant substrate observed in pool tail-outs. Gravel was observed in 34% of pool tail-outs and small Cobble observed in 41% of pool tail-outs.

Thirty-one of the 41 pool tail-outs measured had gravel or small cobble as the dominant substrate. This is generally considered good for spawning salmonids.

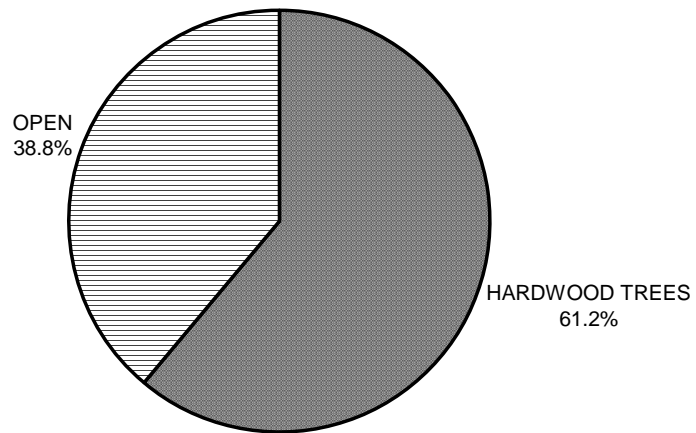
GRAPH 9

The mean percent canopy density for the surveyed length of Adobe Creek was 61%. The mean percentages of hardwood and coniferous trees were 100% and 0%, respectively. Thirty-nine percent of the canopy was open. Graph 9 describes the mean percent canopy in Adobe Creek.

The mean percent canopy density for the stream was 61%. Reach 1 was not measured for canopy density, Reach 2 had a canopy density of 64%, Reach 3 had a canopy density of 63%, Reach 4 had a canopy density of 33% and Reach 6 had a canopy density of 60%. In general, revegetation projects are considered when canopy density is less than 80%.

- 5) Increase the canopy on Adobe Creek by planting appropriate native vegetation like willow, alder, redwood, and Douglas fir along the stream where shade canopy is not at acceptable levels. The reaches above this survey section should be inventoried and treated as well, since the water flowing here is affected from upstream. In many cases, planting will need to be coordinated to follow bank stabilization or upslope erosion control projects.

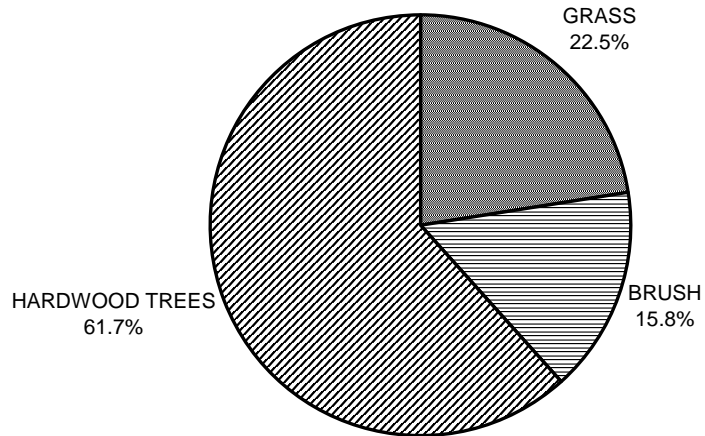
GRAPH 11

For the stream reach surveyed, the mean percent right bank vegetated was 70%. The mean percent left bank vegetated was 69%. The dominant elements composing the structure of the stream banks consisted of 1% bedrock, 10% boulder, 11% cobble/gravel and 78% sand/silt/clay (Graph 10). Deciduous trees were the dominant vegetation type observed in 62% of the units surveyed. Additionally, 22% of the units surveyed had grass as the dominant vegetation type, and 16% had brush as the dominant vegetation (Graph 11).
