**California Department of Fish and Game**  
**Petaluma River Watershed**  
**Stream Habitat Assessment Reports**  
**East Washington Creek**

### **East Washington Creek**

*Surveyed Summer 2007*

*Report Completed March 2008*

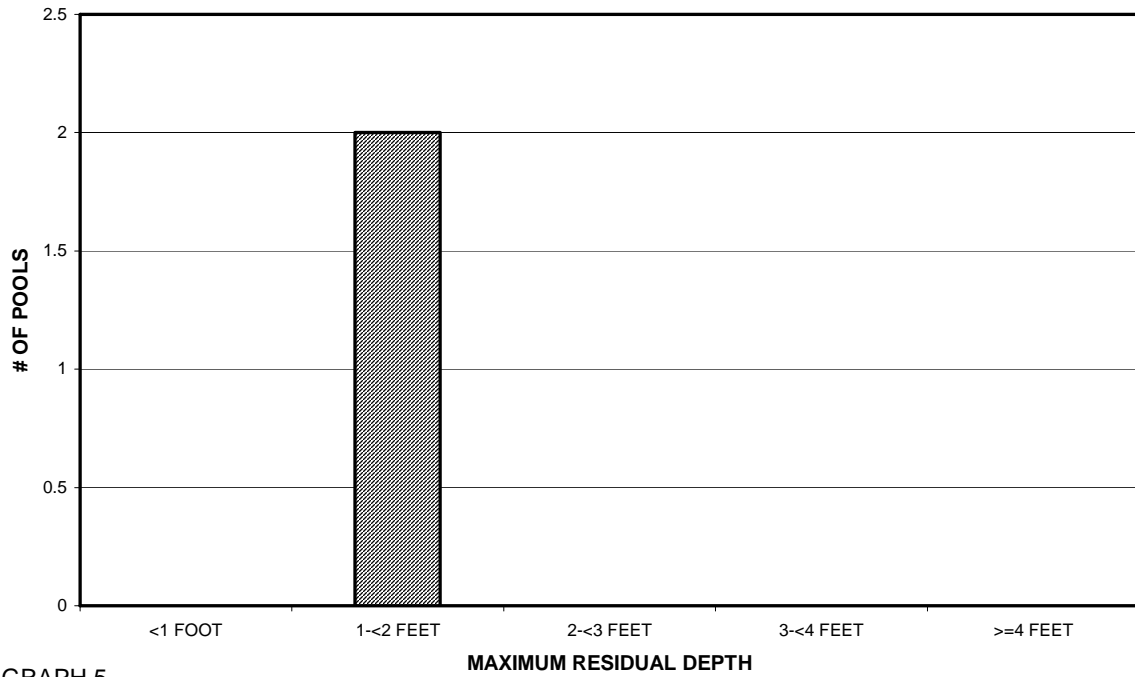
GRAPH 5

Table 4 is a summary of maximum residual pool depths by pool habitat types. Pool quality for salmonids increases with depth. None of the 2 pools had a residual depth of two feet or greater (Graph 5).

Flatwater habitat types comprised 15% of the total length of this survey, pools 0.4%, and there were no riffles recorded. The pools are relatively shallow, with none of the 2 pools having a maximum residual depth greater than 2 feet. In general, pool enhancement projects are considered when primary pools comprise less than 40% of the length of total stream habitat. In first and second order streams, a primary pool is defined to have a maximum residual depth of at least two feet, occupy at least half the width of the low flow channel, and be as long as the low flow channel width. Installing structures that will increase or deepen pool habitat is recommended for locations where their installation will not be threatened by high stream energy, or where their installation will not conflict with the modification of the numerous log debris accumulations (LDA's) in the stream.

- 5) Where feasible, design and engineer pool enhancement structures to increase the number of pools. This must be done where the banks are stable or in conjunction with stream bank armor to prevent erosion.

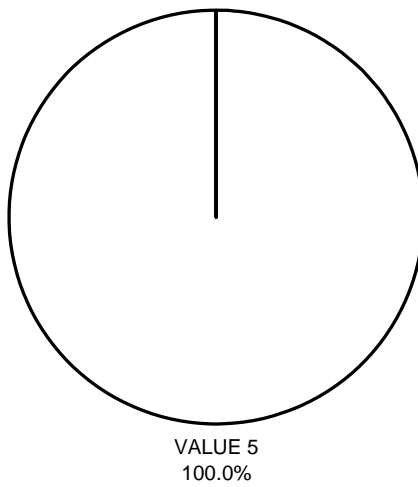
GRAPH 6

The depth of cobble embeddedness was estimated at pool tail-outs. Of the 2 pool tail-outs measured, 2 had a value of 5 (100%) (Graph 6). On this scale, a value of 1 indicates the best spawning conditions and a value of 4 the worst. Additionally, a value of 5 was assigned to tail-outs deemed unsuited for spawning due to inappropriate substrate such as bedrock, log sills, boulders, or other considerations.

None of the 2 pool tail-outs measured had embeddedness ratings of 1 or 2. None of the pool tail-outs had embeddedness ratings of 3 or 4. Two of the pool tail-outs had a rating of 5, which is considered unsuitable for spawning. Cobble embeddedness measured to be 25% or less, a rating of 1, is considered to indicate good quality spawning substrate for salmon and steelhead. Sediment sources in East Washington Creek should be mapped and rated according to their potential sediment yields, and control measures should be taken.

- 2) Inventory and map sources of stream bank erosion and prioritize them according to present and potential sediment yield. Identified sites should then be treated to reduce the amount of fine sediments entering the stream.

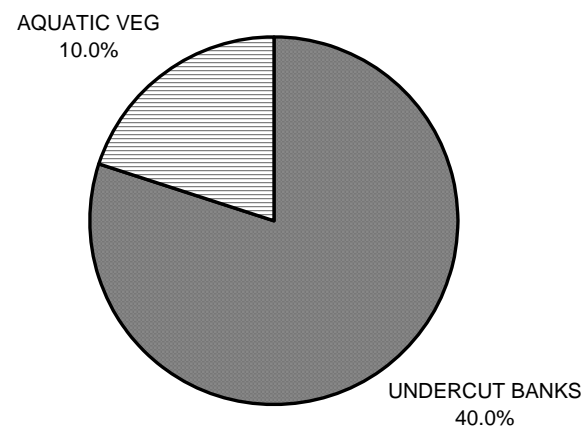
GRAPH 7

dominant cover types in East Washington Creek. Graph 7 describes the pool cover in East Washington Creek. Undercut Banks are the dominant pool cover type followed by aquatic vegetation.

A pool shelter rating of approximately 100 is desirable. The amount of cover that now exists is being provided primarily by Aquatic Vegetation in East Washington Creek. Undercut Banks are the dominant cover type in pools followed by aquatic vegetation. Log and root wad cover structures in the pool and flatwater habitats would enhance both summer and winter salmonid habitat. Log cover structure provides rearing fry with protection from predation, rest from water velocity, and also divides territorial units to reduce density related competition.

- 7) Increase woody cover in the pools and flatwater habitat units. Most of the existing cover in the pools is from Undercut Banks. Adding high quality complexity with woody cover in the pools is desirable.

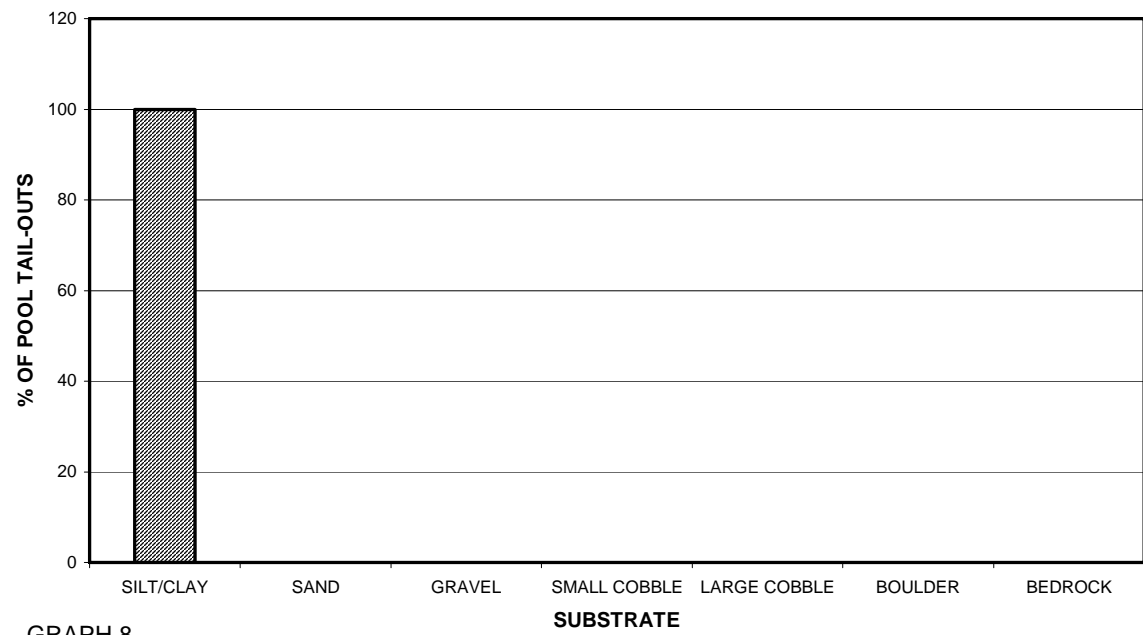
GRAPH 8

Table 6 summarizes the dominant substrate by habitat type. Graph 8 depicts the dominant substrate observed in pool tail-outs. A silt/clay substrate type was observed in 100% of pool tail-outs.

Two of the 2 pool tail-outs had silt, sand, large cobble, boulders or bedrock as the dominant substrate. This is generally considered unsuitable for spawning salmonids.

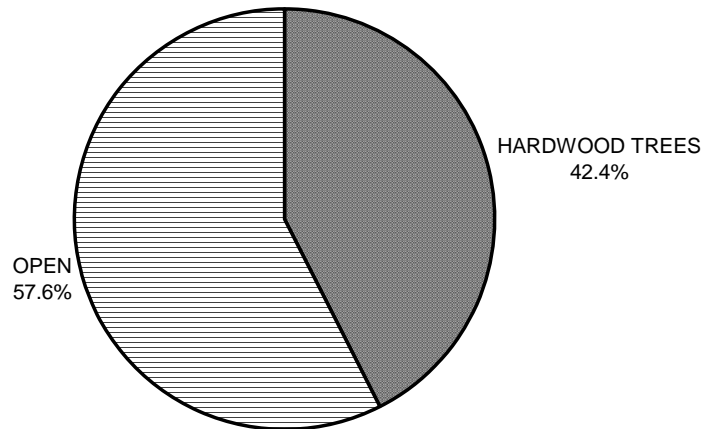
GRAPH 9

The mean percent canopy density for the surveyed length of East Washington Creek was 42%. The mean percentages of hardwood and coniferous trees were 100% and 0%, respectively. Fifty-eight percent of the canopy was open. Graph 9 describes the mean percent canopy in East Washington Creek.

The mean percent canopy density for the stream was 42%. Reach 1 had a canopy density of 13.6%, Reach 3 had a canopy density of 71.2%. In general, revegetation projects are considered when canopy density is less than 80%.

- 3) Increase the canopy on East Washington Creek by planting appropriate native vegetation like willow, alder, redwood, and Douglas fir along the stream where shade canopy is not at acceptable levels. The reaches above this survey section should be inventoried and treated as well, since the water flowing here is affected

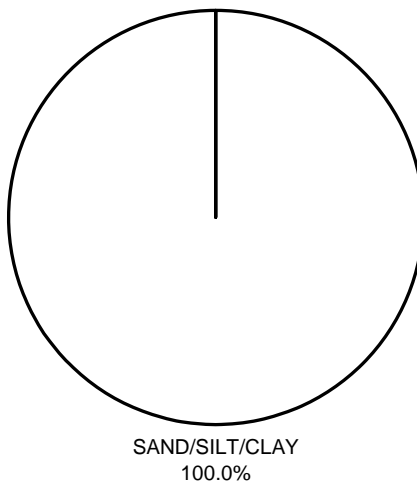
GRAPH 10

For the stream reach surveyed, the mean percent right bank vegetated was 24%. The mean percent left bank vegetated was 26%. The dominant elements composing the structure of the stream banks consisted of 100% sand/silt/clay (Graph 10). Deciduous trees were the dominant vegetation type observed in 60% of the units surveyed. Additionally, 30% of the units surveyed had grass as the dominant vegetation type, and 10% had brush as the dominant vegetation (Graph 11).

The percentage of right and left bank covered with vegetation was low at 24% and 26%, respectively. In areas of stream bank erosion or where bank vegetation is sparse, planting endemic species of coniferous and hardwood trees, in conjunction with bank stabilization, is recommended.
