California Department of Fish and Game
Petaluma River Watershed
Stream Habitat Assessment Reports

STREAM INVENTORY REPORT

Ellis Creek

Surveyed Summer 2007

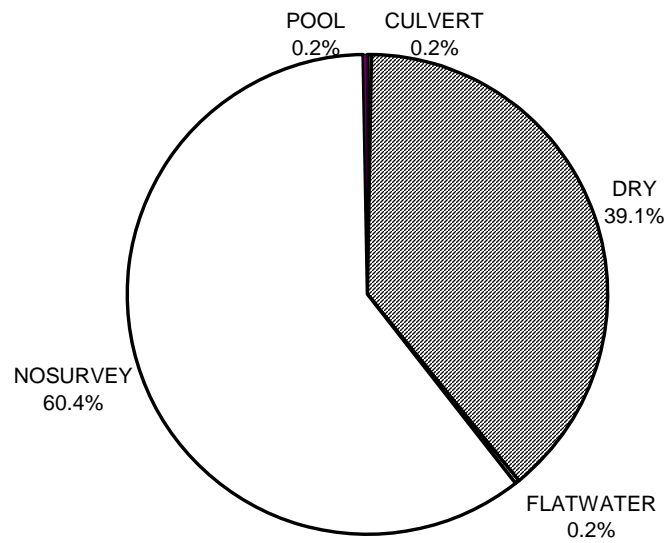
GRAPH 2

Table 1 summarizes the Level II riffle, flatwater, and pool habitat types. Based on frequency of occurrence there were 27% nosurvey units, 36% dry units, 9% flatwater units, 18% pool units and 9% culvert units (Graph 1). Based on total length of Level II habitat types there were 60% nosurvey units, 39% dry units, 0.2% flatwater units, 0.2% pool units and 0.2% culvert units (Graph 2).

**Ellis Creek 2007
HABITAT TYPES BY PERCENT TOTAL LENGTH**

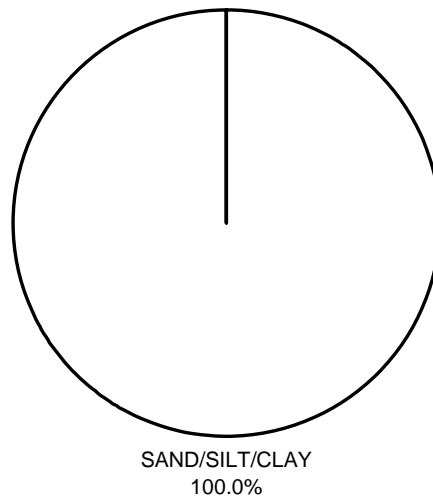
GRAPH 10

For the stream reach surveyed, the mean percent right bank vegetated was 38%. The mean percent left bank vegetated was 47%. The dominant elements composing the structure of the stream banks consisted of 100% sand/silt/clay (Graph 10).

The percentage of right and left bank covered with vegetation was low at 38% and 47%, respectively. In areas of stream bank erosion or where bank vegetation is sparse, planting endemic species of coniferous and hardwood trees, in conjunction with bank stabilization, is recommended.

**Ellis Creek 2007
DOMINANT BANK COMPOSITION IN SURVEY REACH**

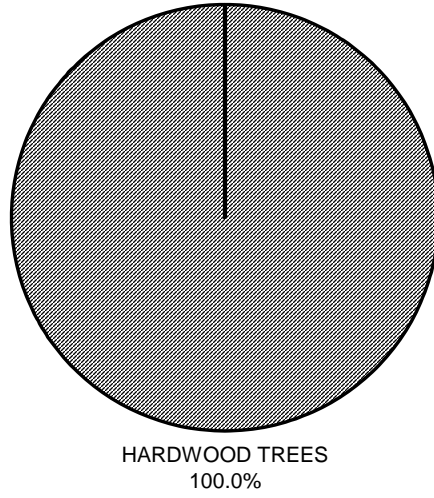
GRAPH 11

**Ellis Creek 2007
DOMINANT BANK VEGETATION IN SURVEY REACH**
