California Department of Fish and Game
Petaluma River Watershed
Stream Habitat Assessment Reports
Lichau Creek
Surveyed 2007

STREAM INVENTORY REPORT

Lichau Creek

Survey conducted summer 2007

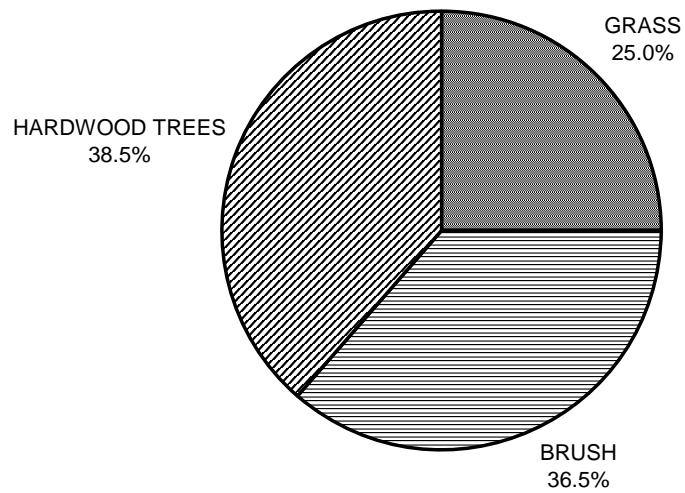
GRAPH 11

For the stream reach surveyed, the mean percent right bank vegetated was 69%. The mean percent left bank vegetated was 73%. The dominant elements composing the structure of the stream banks consisted of 3% bedrock, 4% boulder, 8% cobble/gravel, and 85% sand/silt/clay (Graph 10). Deciduous was the dominant vegetation type observed in 38% of the units surveyed. Additionally, 36% of the units surveyed had brush as the dominant vegetation type, and 25% had grass as the dominant vegetation (Graph 11).

The percentage of right and left bank covered with vegetation was moderate, 69% and 73%, respectively. In areas of stream bank erosion or where bank vegetation is sparse, planting endemic species of coniferous and hardwood trees, in conjunction with bank stabilization, is recommended.

**LICHAU CREEK 2007
DOMINANT BANK VEGETATION IN SURVEY REACH**
