California Department of Fish and Game
Petaluma River Watershed
Stream Habitat Assessment Reports
Lynch Creek
Surveyed 2007

STREAM INVENTORY REPORT

Lynch Creek

Surveyed Summer 2007

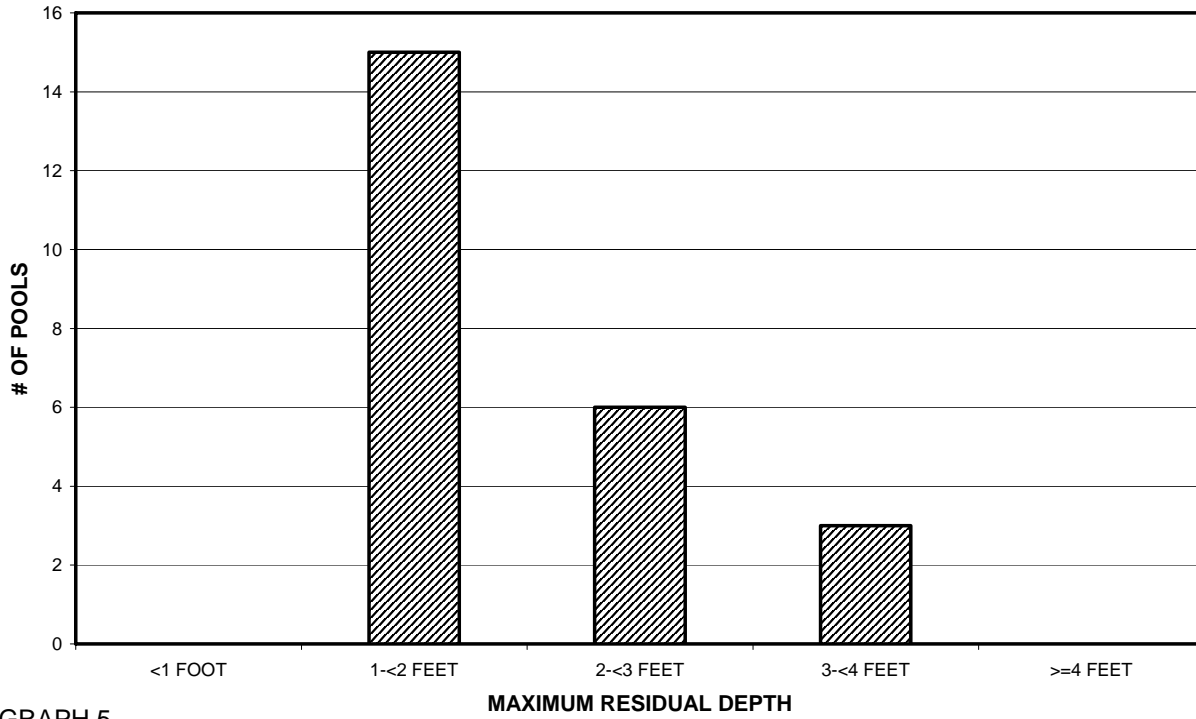
GRAPH 5

Table 4 is a summary of maximum residual pool depths by pool habitat types. Pool quality for salmonids increases with depth. Nine of the 24 pools (38%) had a residual depth of two feet or greater (Graph 5).

Flatwater habitat types comprised 16% of the total length of this survey, riffles 4%, and pools 1%. The pools are relatively shallow, with only 9 of the 24 (38%) pools having a maximum residual depth greater than 2 feet. In general, pool enhancement projects are considered when primary pools comprise less than 40% of the length of total stream habitat. In first and second order streams, a primary pool is defined to have a maximum residual depth of at least two feet, occupy at least half the width of the low flow channel, and be as long as the low flow channel width. Installing structures that will increase or deepen pool habitat is recommended for locations where their installation will not be threatened by high stream energy, or where their installation will not conflict with the modification of the numerous log debris accumulations (LDA's) in the stream.

- 4) Where feasible, design and engineer pool enhancement structures to increase the number of pools in Lynch Creek and the 2 unnamed tributaries to Lynch Creek surveyed. This must be done where the banks are stable or in conjunction with stream bank armor to prevent erosion.

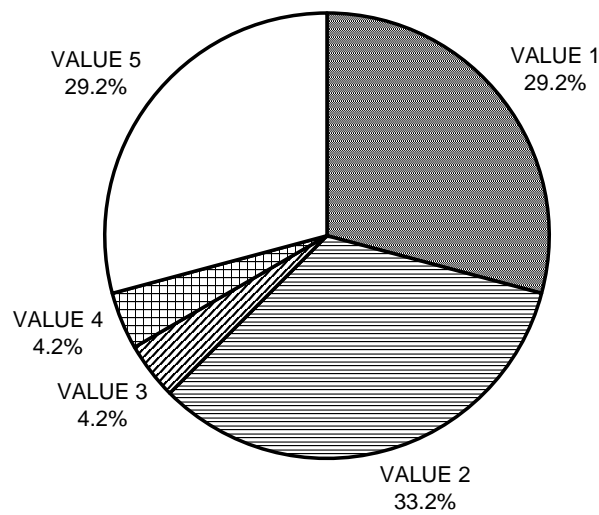
GRAPH 6

The depth of cobble embeddedness was estimated at pool tail-outs. Of the 24 pool tail-outs measured and shown in Graph 6, 7 had a value of 1 (29.2%); 8 had a value of 2 (33.3%); 1 had a value of 3 (4.2%); 1 had a value of 4 (4.2%); and 7 had a value of 5 (29.2%). On this scale, a value of 1 indicates the best spawning conditions and a value of 4 the worst. Additionally, a value of 5 was assigned to tail-outs deemed unsuited for spawning due to inappropriate substrate such as bedrock, log sills, boulders, or other considerations.

Fifteen of the 24 pool tail-outs measured had embeddedness ratings of 1 or 2. Two of the pool tail-outs had embeddedness ratings of 3 or 4. Seven of the pool tail-outs had a rating of 5, which is considered unsuitable for spawning. Cobble embeddedness measured to be 25% or less, a rating of 1, is considered to indicate good quality spawning substrate for salmon and steelhead. Sediment sources in Lynch Creek should be mapped and rated according to their potential sediment yields, and control measures should be taken.

- 7) Inventory and map sources of stream bank erosion and prioritize them according to present and potential sediment yield. Identified sites should then be treated to reduce the amount of fine sediments entering the stream.

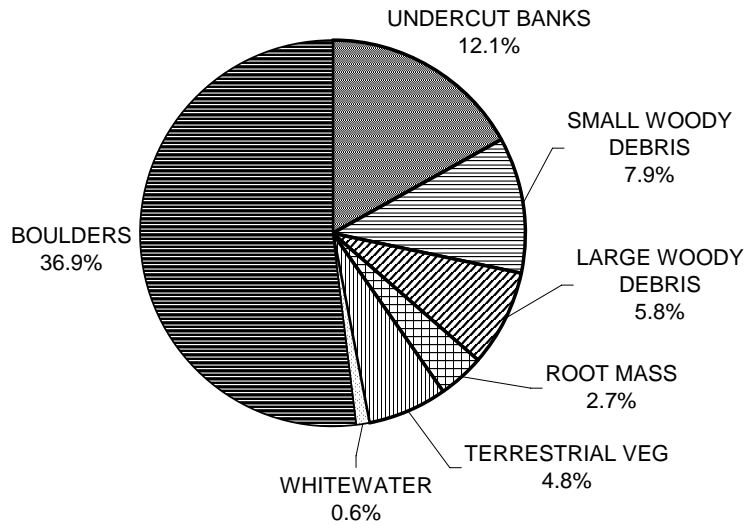
GRAPH 7

Table 5 summarizes mean percent cover by habitat type. Boulders are the dominant cover type in Lynch Creek. Graph 7 describes the pool cover in Lynch Creek. Boulders are the dominant pool cover type followed by undercut banks.

The mean shelter rating for pools was 18. The shelter rating in the flatwater habitats was 8. A pool shelter rating of approximately 100 is desirable. The amount of cover that now exists is being provided primarily by boulders in Lynch Creek. Boulders are the dominant cover type in pools followed by undercut banks. Log and root wad cover structures in the pool and flatwater habitats would enhance both summer and winter salmonid habitat. Log cover structure provides rearing fry with protection from predation, rest from water velocity, and also divides territorial units to reduce density related competition.

- 3) Increase woody cover in the pools and flatwater habitat units. Most of the existing cover in the pools is from boulders. Adding high quality complexity with woody cover in the pools is desirable.

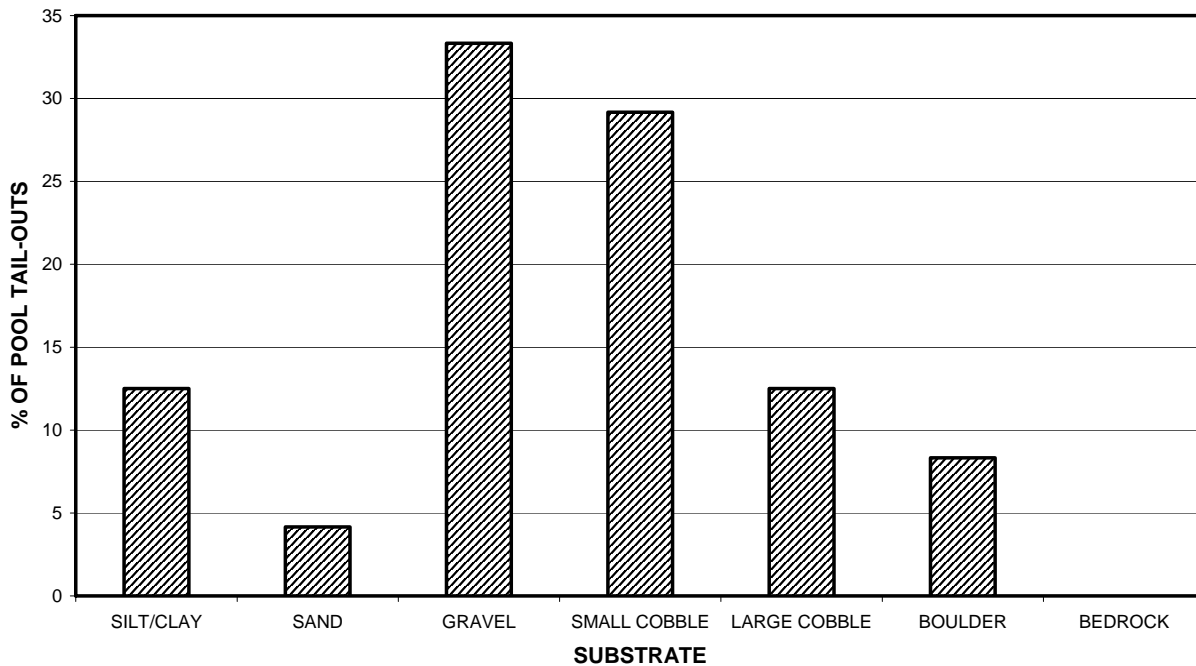
GRAPH 8

Table 6 summarizes the dominant substrate by habitat type. Graph 8 depicts the dominant substrate observed in pool tail-outs. A gravel substrate type was observed in 33% of pool tail-outs while small cobble was observed in 29% of pool tail-outs.

Fifteen of the 24 pool tail-outs measured had gravel or small cobble as the dominant substrate. This is generally considered good for spawning salmonids.

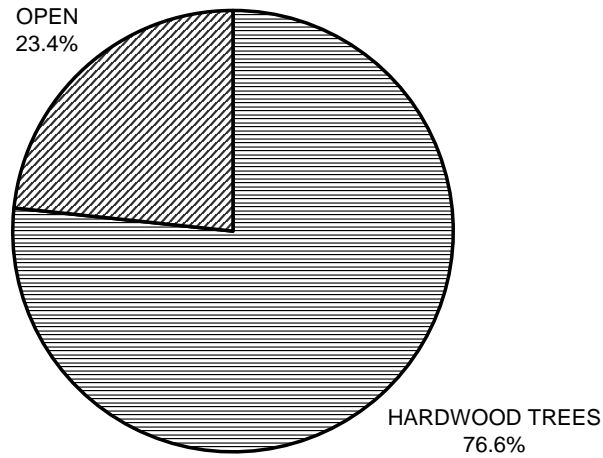
GRAPH 9

The mean percent canopy density for the surveyed length of Lynch Creek was 77%. The mean percentages of hardwood and coniferous trees were 100% and 0%, respectively. Twenty-three percent of the canopy was open. Graph 9 describes the mean percent canopy in Lynch Creek.

The mean percent canopy density for the stream was 77%. Reach 1 had a canopy density of 70%, Reach 2 had a canopy density of 75%, Reach 3 had a canopy density of 86%, Reach 5 had a canopy density of 84%, and Reach 6 had a canopy density of 75%. In general, revegetation projects are considered when canopy density is less than 80%.

- 6) Increase the canopy on Lynch Creek by planting appropriate native vegetation like willow, alder, redwood, and Douglas fir along the stream where shade canopy is not at acceptable levels. The reaches above this survey section should be inventoried and treated as well, since the water flowing here is affected from upstream. In many cases, planting will need to be coordinated to follow bank stabilization or upslope erosion

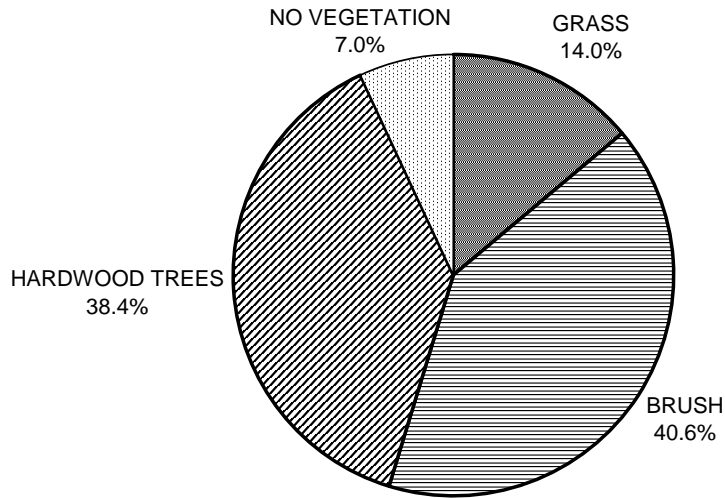
GRAPH 11

For the stream reach surveyed, the mean percent right bank vegetated was 52%. The mean percent left bank vegetated was also 52%. The dominant elements composing the structure of the stream banks consisted of 83% sand/silt/clay, 10% bedrock, 5% cobble/gravel, and 2% boulder (Graph 10). Brush was the dominant vegetation type observed in 41% of the units surveyed. Additionally, 38% of the units surveyed had hardwood trees as the dominant vegetation type, and 14% had grass as the dominant vegetation (Graph 11).

The percentage of right and left bank covered with vegetation was moderate at 52% on each side. In areas of stream bank erosion or where bank vegetation is sparse, planting endemic species of coniferous and hardwood trees, in conjunction with bank stabilization, is recommended.
