California Department of Fish and Game
Petaluma River Watershed
Stream Habitat Assessment Reports
San Antonio Creek
Surveyed 2007

STREAM INVENTORY REPORT

San Antonio Creek

Surveyed: Summer 2007

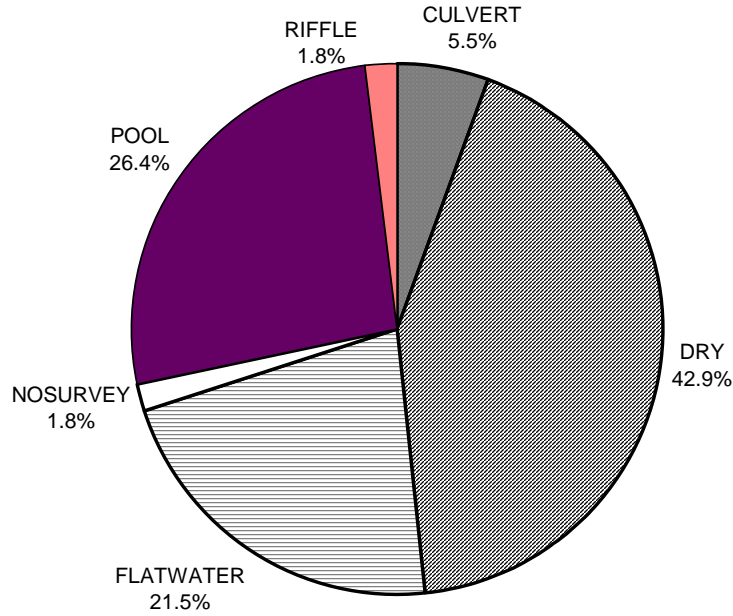
GRAPH 1

Table 1 summarizes the Level II riffle, flatwater, and pool habitat types. Based on frequency of occurrence there were 43% dry units, 26% pool units, 6% culvert units, 21% flatwater units, 2% nosurvey units and 2% riffle units (Graph 1). Based on total length of Level II habitat types there were 50% dry units, 40% nosurvey units, 5% flatwater units, 4% pool units, 1% culvert units, and less than 1% riffle units (Graph 2).

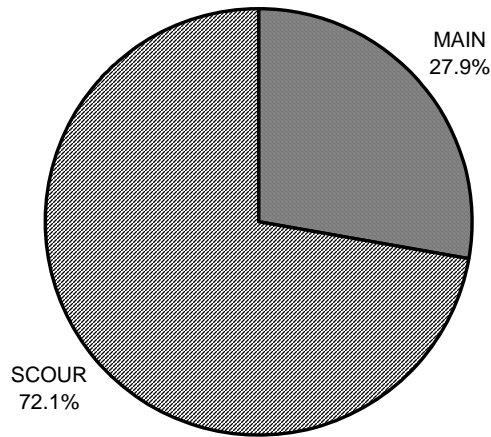
GRAPH 4

A total of 43 pools were identified (Table 3). Scour pools were the most frequently encountered, at 72%, and comprised 70% of the total length of all pools (Graph 4).

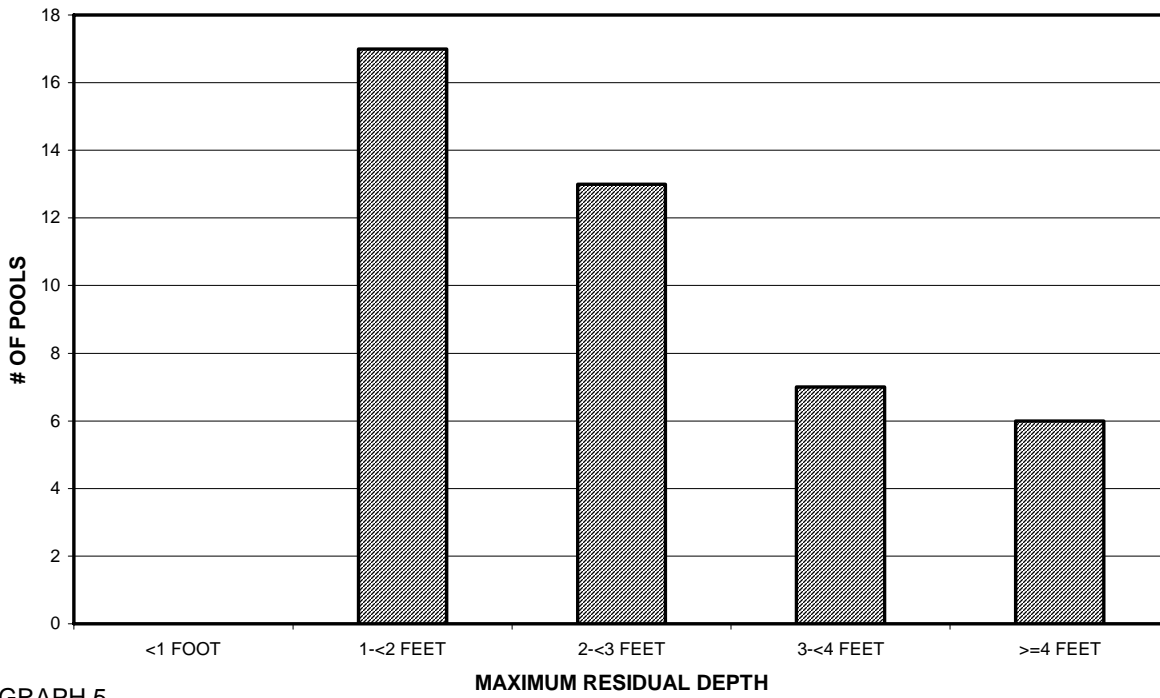
GRAPH 5

Table 4 is a summary of maximum residual pool depths by pool habitat types. Pool quality for salmonids increases with depth. Twenty six of the 43 pools (60%) had a residual depth of two feet or greater (Graph 5). Thirteen of the 43 pools (30%) had a residual depth of three feet or greater (Graph 5).

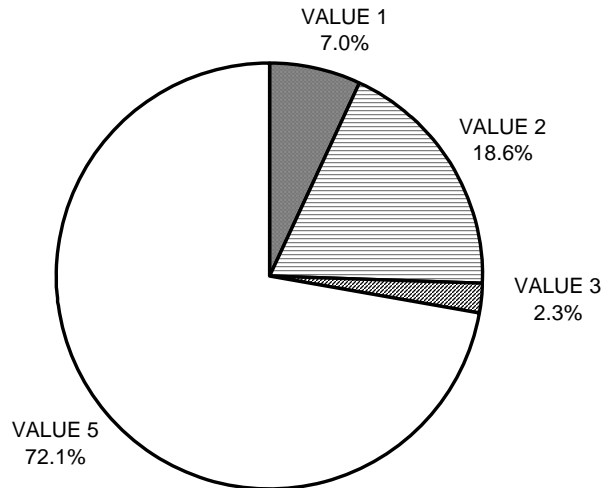
GRAPH 6

The depth of cobble embeddedness was estimated at pool tail-outs. Of the 43 pool tail-outs measured, 3 had a value of 1 (7%); 8 had a value of 2 (18.6%); 1 had a value of 3 (2.3%); and 31 had a value of 5 (72.1%) (Graph 6). On this scale, a value of 1 indicates the best spawning conditions and a value of 4 the worst. Additionally, a value of 5 was assigned to tail-outs deemed unsuited for spawning due to inappropriate substrate such as bedrock, log sills, boulders, or other considerations.

Eleven of the 43 pool tail-outs measured had embeddedness ratings of 1 or 2. One of the pool tail-outs had embeddedness ratings of 3 or 4. Thirty-one of the pool tail-outs had a rating of 5, which is considered unsuitable for spawning. Cobble embeddedness measured to be 25% or less, a rating of 1, is considered to indicate good quality spawning substrate for salmon and steelhead. Sediment sources in San Antonio Creek should be mapped and rated according to their potential sediment yields, and control measures should be taken.

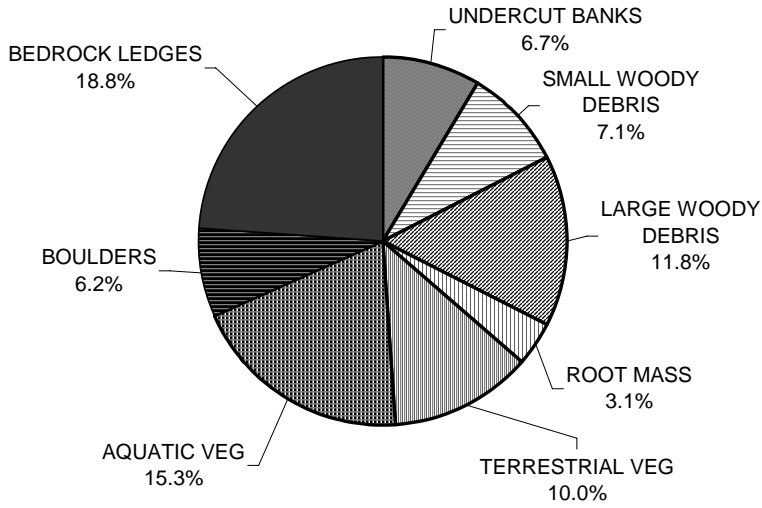
GRAPH 7

Table 5 summarizes mean percent cover by habitat type. Bedrock Ledges are the dominant cover types in San Antonio Creek. Graph 7 describes the pool cover in San Antonio Creek. Bedrock Ledges are the dominant pool cover type followed by aquatic vegetation.

The mean shelter rating for pools was 14. The shelter rating in the flatwater habitats was 3. A pool shelter rating of approximately 100 is desirable. The amount of cover that now exists is being provided primarily by Bedrock Ledges in San Antonio Creek. Bedrock Ledges are the dominant cover type in pools followed by aquatic vegetation. Log and root wad cover structures in the pool and flatwater habitats would enhance both summer and winter salmonid habitat. Log cover structure provides rearing fry with protection from predation, rest from water velocity, and also divides territorial units to reduce density related competition.

- 4) Increase woody cover in the pools and flatwater habitat units. Most of the existing cover in the pools is from Bedrock Ledges. Adding high quality complexity with woody cover in the pools is desirable.

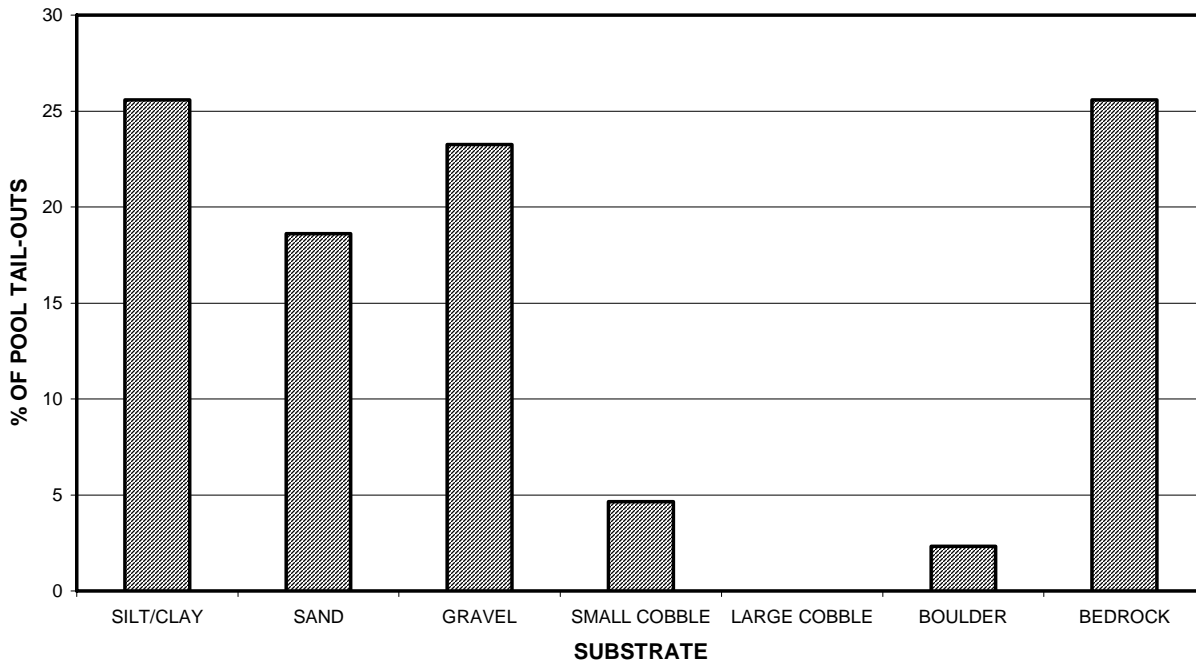
GRAPH 8

Table 6 summarizes the dominant substrate by habitat type. Graph 8 depicts the dominant substrate observed in pool tail-outs. A silt/clay substrate type was observed in 26% of pool tail-outs and bedrock was observed in 26% of pool tail-outs.

Thirty-one of the 43 pool tail-outs had silt, sand, large cobble, boulders or bedrock as the dominant substrate. This is generally considered unsuitable for spawning salmonids.

- 8) Suitable size spawning substrate on San Antonio Creek is limited to relatively few reaches. Projects should be designed at suitable sites to trap and sort spawning gravel.

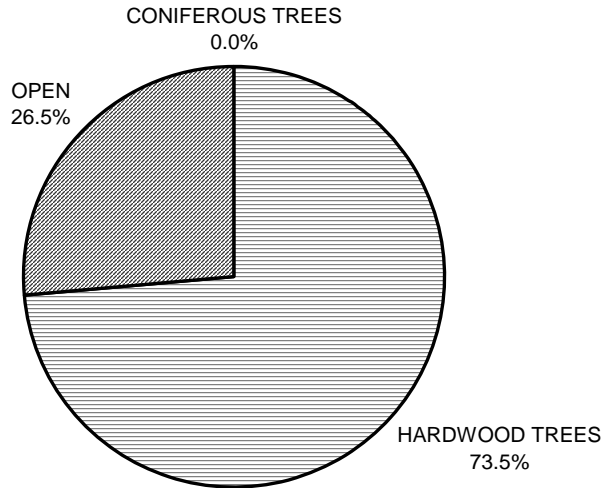
GRAPH 9

The mean percent canopy density for the surveyed length of San Antonio Creek was 74%. The mean percentages of hardwood and coniferous trees were 100% and 0%, respectively. Twenty six percent of the canopy was open. Graph 9 describes the mean percent canopy in San Antonio Creek.

The mean percent canopy density for the stream was 74%. Reach 1 had a canopy density of 48%, Reach 3 had a canopy density of 81%, Reach 5 had a canopy density of 38%, Reach 7 had a canopy density of 85% and Reach 8 had a canopy density of 90%. In general, revegetation projects are considered when canopy density is less than 80%.

- 6) Increase the canopy on San Antonio Creek especially in reaches 1 and 5 by planting appropriate native vegetation like willow, alder, redwood, and Douglas fir along the stream where shade canopy is not at acceptable levels. The reaches above this survey section should be inventoried and treated as well, since the water flowing here is affected from upstream. In many cases, planting will need to be coordinated to follow bank stabilization or upslope erosion control projects.

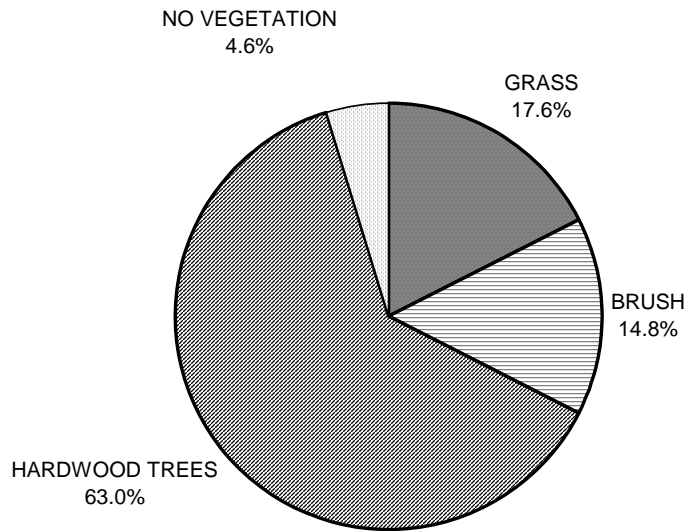
GRAPH 11

For the stream reach surveyed, the mean percent right bank vegetated was 48%. The mean percent left bank vegetated was 54%. The dominant elements composing the structure of the stream banks consisted of 16% bedrock, 3% cobble/gravel and 81% sand/silt/clay (Graph 10). Deciduous trees were the dominant vegetation type observed in 63% of the units surveyed. Additionally, 18% of the units surveyed had grass as the dominant vegetation type, and 15% had brush as the dominant vegetation (Graph 11).

The percentage of right and left bank covered with vegetation was moderate at 48% and 54%, respectively. In areas of stream bank erosion or where bank vegetation is sparse, planting endemic species of coniferous and hardwood trees, in conjunction with bank stabilization, is recommended.
