**California Department of Fish and Game**  
**Petaluma River Watershed**  
**Stream Habitat Assessment Reports**  
**Washington Creek**  
*Surveyed 2007*

## STREAM INVENTORY REPORT

**Washington Creek**  
*Surveyed Summer 2007*  
*Report Completed March 2008*

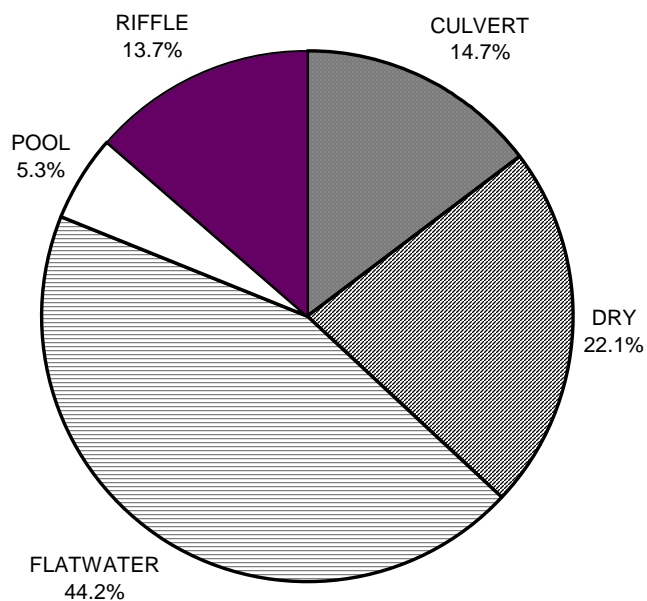
GRAPH 1

Table 1 summarizes the Level II riffle, flatwater, and pool habitat types. Based on frequency of occurrence there were 44% flatwater units, 5% pool units, 14% riffle units, 15% culvert units, 22% dry units, (Graph 1). Based on total length of Level II habitat types there were 29% flatwater units, 1% pool units, 4% riffle units, 4% culvert units, 62% dry units (Graph 2).

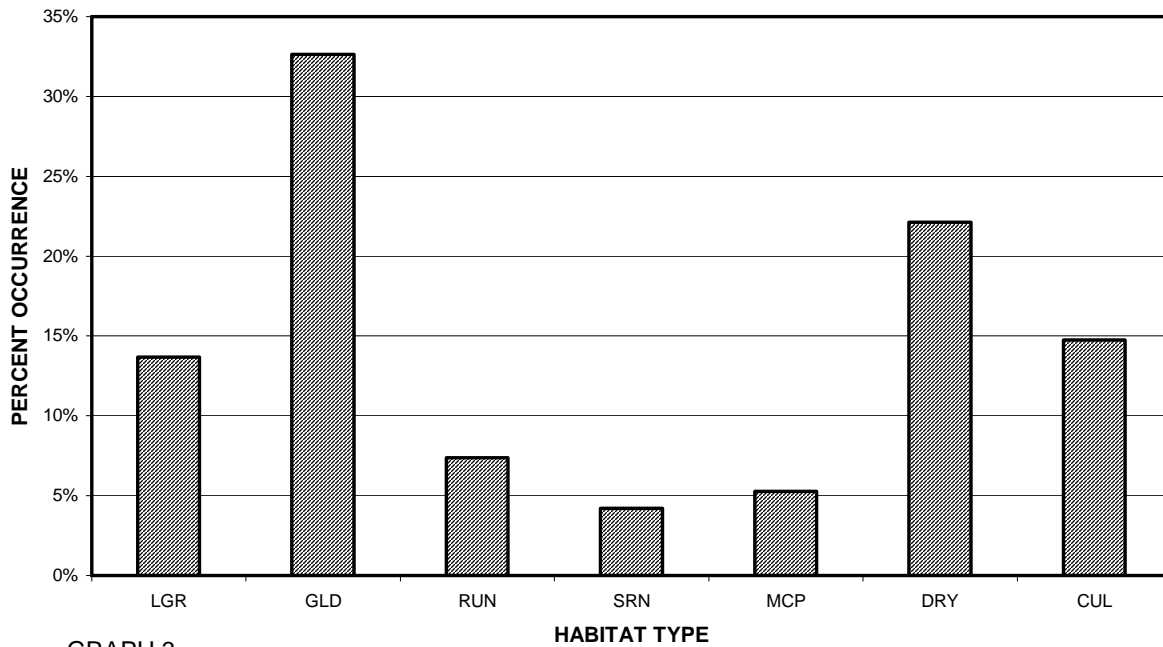
GRAPH 3

Six Level IV habitat types were identified (Table 2). The most frequent habitat types by percent occurrence were 33% Glide units, 15% Culvert units and 22% Dry units (Graph 3). The most frequent habitat types based on percent total length were 62% Dry units, 24% Glide units and 4% Low Gradient Riffle units.

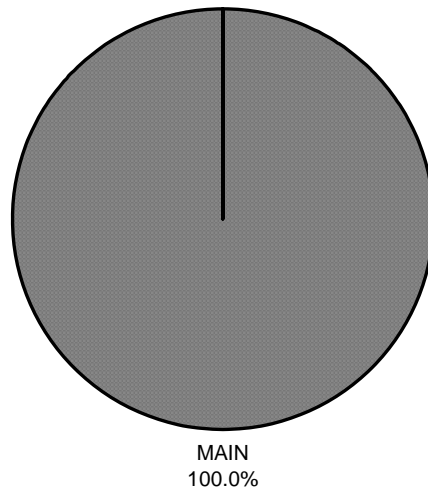
GRAPH 4

A total of 5 pools were identified (Table 3). Main Channel pools were the most frequently encountered, at 100%, and comprised 100% of the total length of all pools (Graph 4).

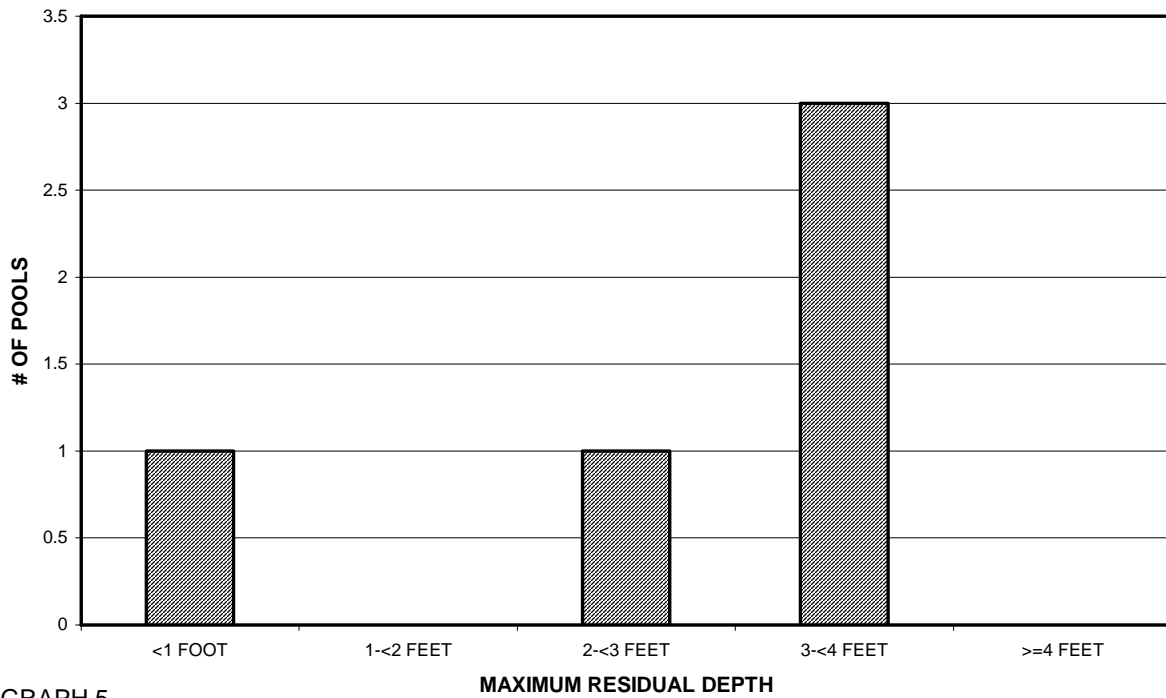
GRAPH 5

Table 4 is a summary of maximum residual pool depths by pool habitat types. Pool quality for salmonids increases with depth. Four of the 5 pools (80%) had a residual depth of two feet or greater (Graph 5).

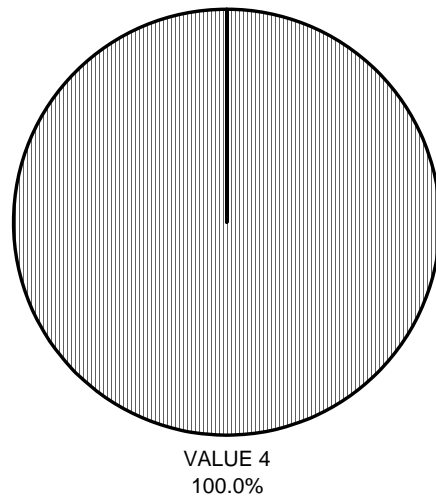
GRAPH 6

The depth of cobble embeddedness was estimated at pool tail-outs. Of the 5 pool tail-outs measured, all 5 had a value of 4 (100%) (Graph 6). On this scale, a value of 1 indicates the best spawning conditions and a value of 4 the worst. Additionally, a value of 5 was assigned to tail-outs deemed unsuited for spawning due to inappropriate substrate such as bedrock, log sills, boulders, or other considerations.

None of the 5 pool tail-outs measured had embeddedness ratings of 1 or 2. Five of the pool tail-outs had embeddedness ratings of 3 or 4. None of the pool tail-outs had a rating of 5, which is considered unsuitable for spawning. Cobble embeddedness measured to be 25% or less, a rating of 1, is considered to indicate good quality spawning substrate for salmon and steelhead. Sediment sources in Washington Creek should be mapped and rated according to their potential sediment yields, and control measures should be taken.

- 4) Inventory and map sources of stream bank erosion and prioritize them according to present and potential sediment yield. Identified sites should then be treated to reduce the amount of fine sediments entering the stream.

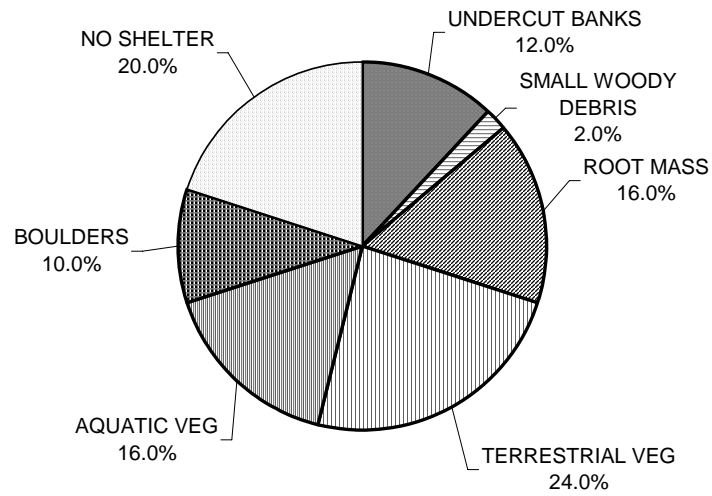
GRAPH 7

Table 5 summarizes mean percent cover by habitat type. Terrestrial Vegetation is the dominant cover types in Washington Creek. Graph 7 describes the pool cover in Washington Creek. Terrestrial Vegetation is the dominant pool cover type followed by no shelter.

The mean shelter rating for pools was 10. The shelter rating in the flatwater habitats was 4. A pool shelter rating of approximately 100 is desirable. The amount of cover that now exists is being provided primarily by Terrestrial Vegetation in Washington Creek. Terrestrial Vegetation is the dominant cover type in pools followed by aquatic vegetation. Log and root wad cover structures in the pool and flatwater habitats would enhance both summer and winter salmonid habitat. Log cover structure provides rearing fry with protection from predation, rest from water velocity, and also divides territorial units to reduce density related competition.

- 5) Increase woody cover in the pools and flatwater habitat units. Most of the existing cover in the pools is from Terrestrial Vegetation. Adding high quality complexity with woody cover in the pools is desirable.

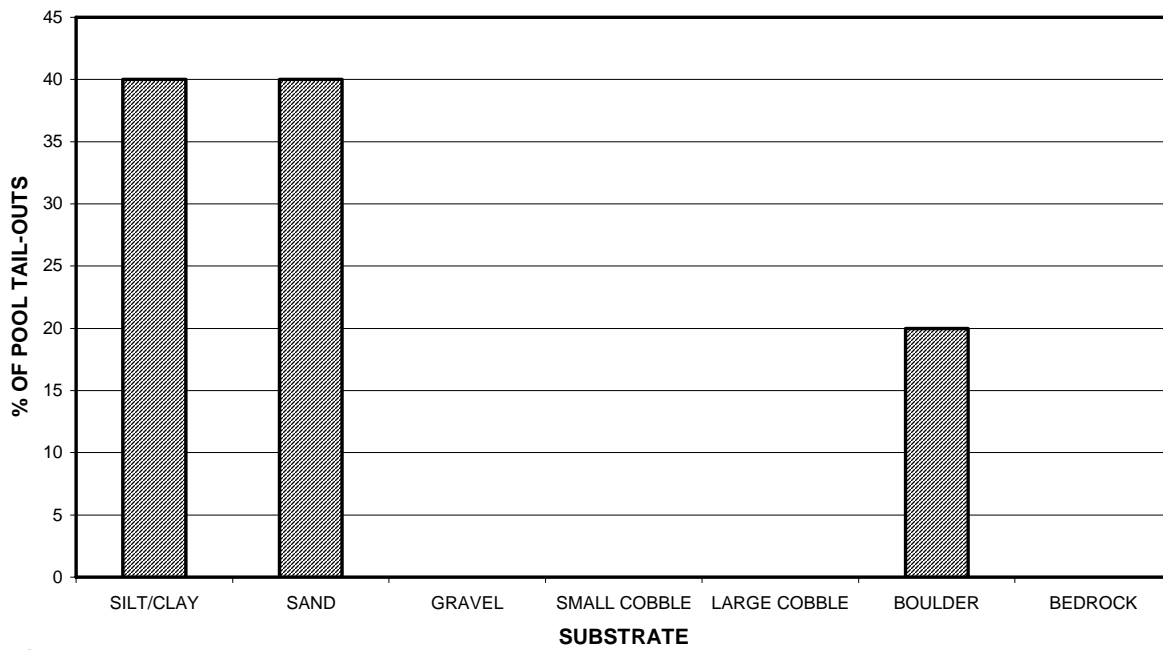
GRAPH 8

Table 6 summarizes the dominant substrate by habitat type. Graph 8 depicts the dominant substrate observed in pool tail-outs. A silt/clay substrate type was observed in 40% of pool tail-outs and sand was observed in 40% of pool tail-outs.

Five of the 5 pool tail-outs had silt, sand, large cobble, boulders or bedrock as the dominant substrate. This is generally considered unsuitable for spawning salmonids.

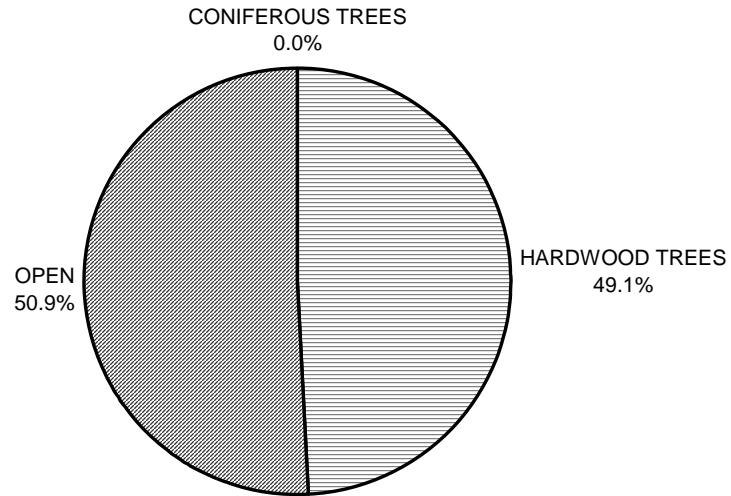
GRAPH 9

The mean percent canopy density for the surveyed length of Washington Creek was 49%. The mean percentages of hardwood and coniferous trees were 100% and 0%, respectively. Fifty-one percent of the canopy was open. Graph 9 describes the mean percent canopy in Washington Creek.

The mean percent canopy density for the stream was 49%. Reach 1 had a canopy density of 33%, Reach 2 had a canopy density of 40%, Reach 3 had a canopy density of 61% and Reach 4 had a canopy density of 64%. In general, revegetation projects are considered when canopy density is less than 80%.

- 3) Increase the canopy on Washington Creek by planting appropriate native vegetation like willow, alder, redwood, and Douglas fir along the stream where shade canopy is not at acceptable levels. The reaches above this survey section should be inventoried and treated as well, since the water flowing here is affected from upstream. In many cases, planting will need to be coordinated to follow bank stabilization or upslope erosion control projects.

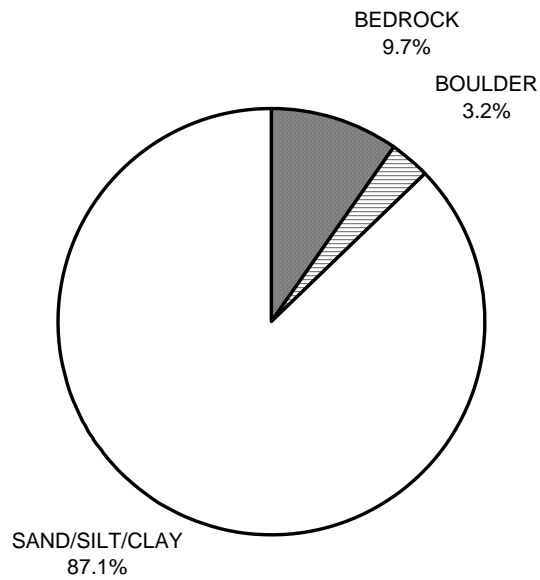
GRAPH 10

For the stream reach surveyed, the mean percent right bank vegetated was 52%. The mean percent left bank vegetated was 54%. The dominant elements composing the structure of the stream banks consisted of 10% bedrock, 3% boulder and 87% sand/silt/clay (Graph 10). Grass

The percentage of right and left bank covered with vegetation was moderate at 52% and 54%, respectively. In areas of stream bank erosion or where bank vegetation is sparse, planting endemic species of coniferous and hardwood trees, in conjunction with bank stabilization, is recommended.

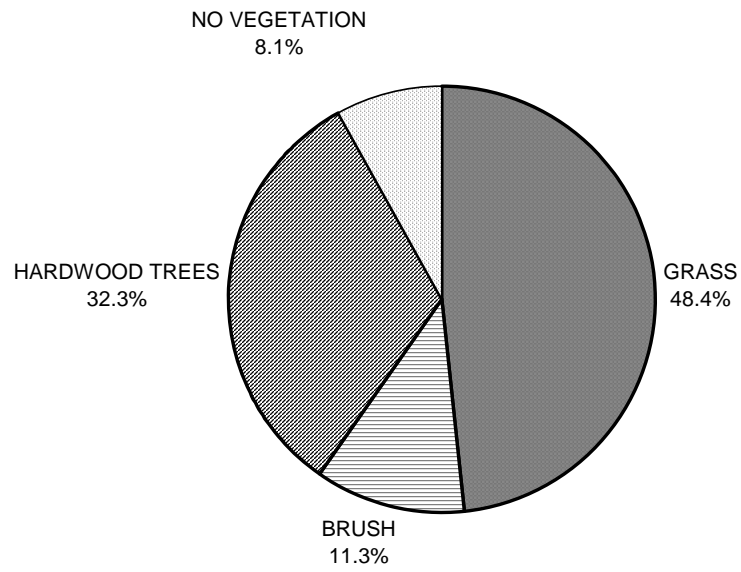
GRAPH 11

was the dominant vegetation type observed in 48% of the units surveyed. Additionally, 32% of the units surveyed had deciduous trees as the dominant vegetation type, and 11% had brush as the dominant vegetation (Graph 11).
