California Department of Fish and Game
Petaluma River Watershed
Stream Habitat Assessment Reports
Willow Brook
Surveyed 2007

STREAM INVENTORY REPORT

Willow Brook

Surveyed: Summer 2007

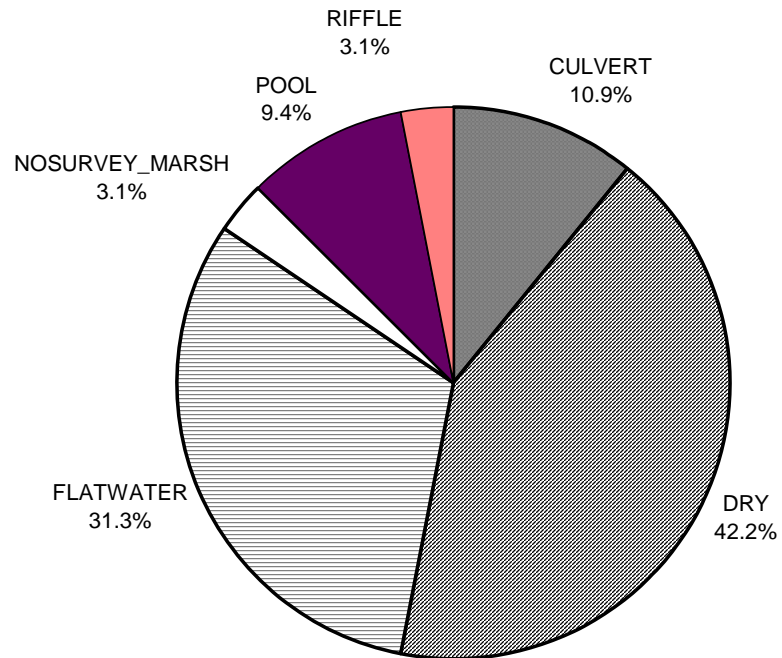
GRAPH 1

Table 1 summarizes the Level II riffle, flatwater, and pool habitat types. Based on frequency of occurrence there were 11% culvert units, 42% dry units, 3% nosurvey_marsh units, 31% flatwater units, 9% pool units, and 3% riffle units (Graph 1). Based on total length of Level II habitat types there were 73% dry units, 5% nosurvey_marsh units, 21% flatwater units, and 1% riffle units (Graph 2).

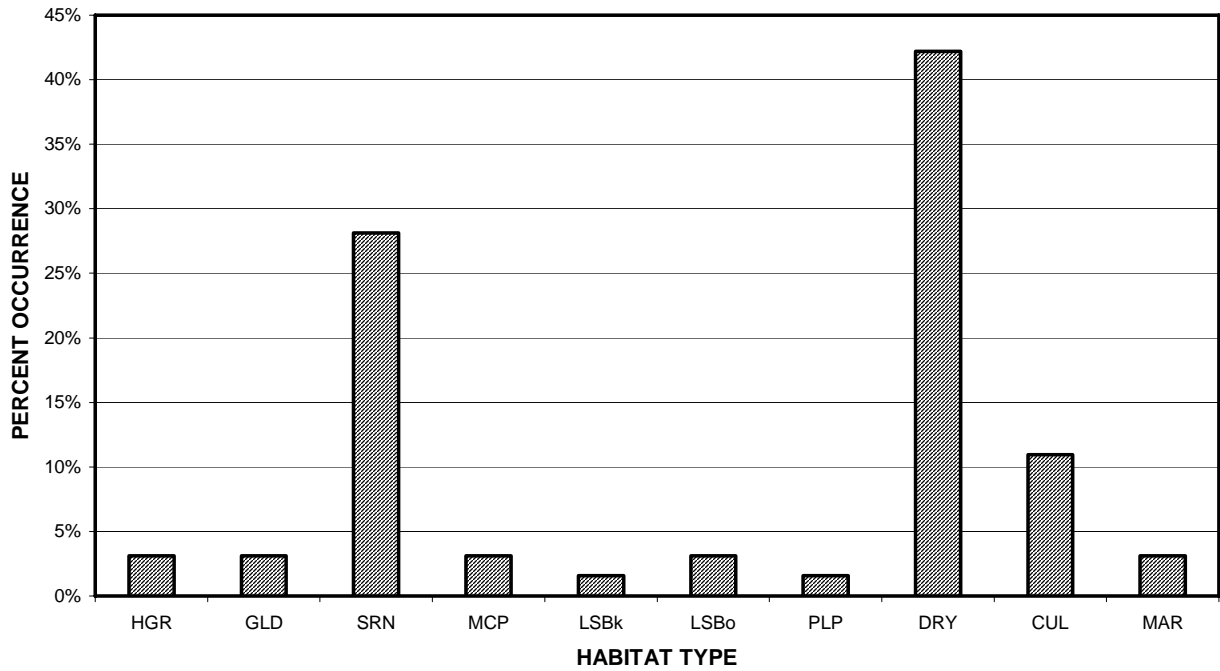
GRAPH 3

Eight Level IV habitat types were identified (Table 2). The most frequent habitat types by percent occurrence were 11% Culvert units, 42% Dry units, and 28% Step Run units (Graph 3). Based on percent total length, 73% Dry units, 16% Step Run units, and 5% Not Surveyed due to a marsh units.

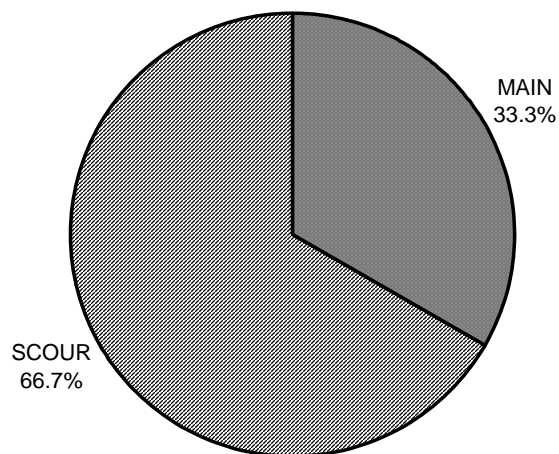
GRAPH 4

A total of 6 pools were identified (Table 3). Scour pools were the most frequently encountered, at 67%, and comprised 38% of the total length of all pools (Graph 4).

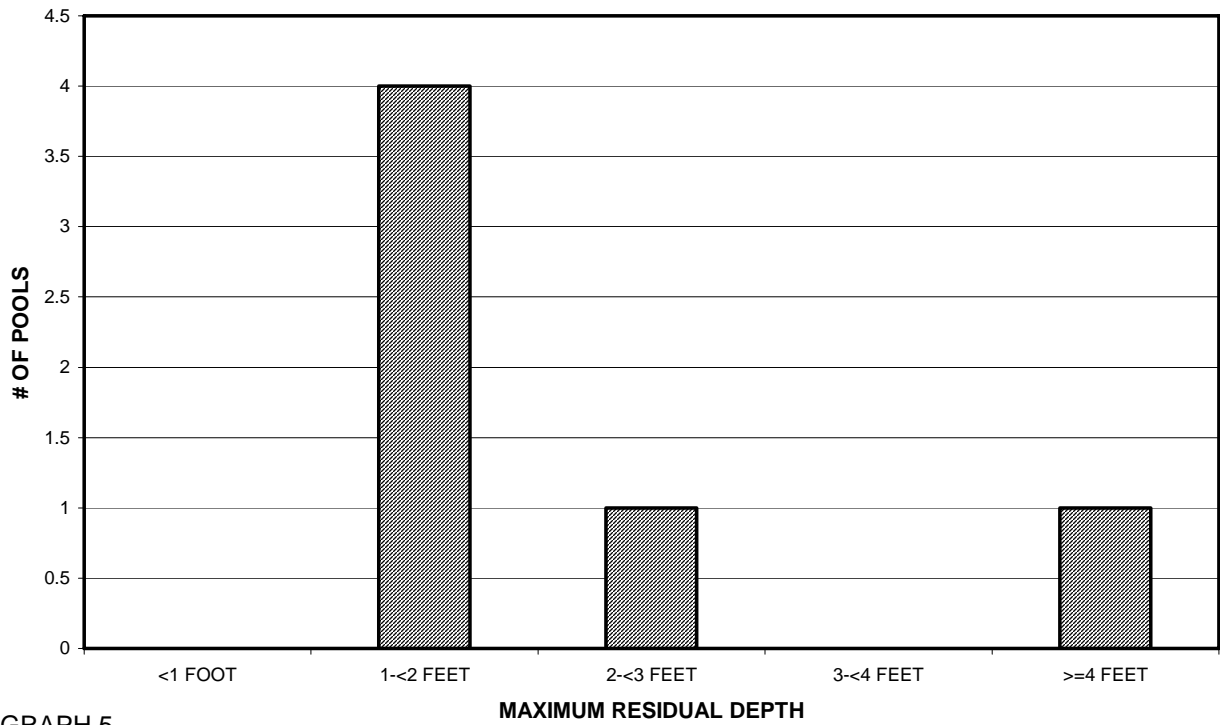
GRAPH 5

Table 4 is a summary of maximum residual pool depths by pool habitat types. Pool quality for salmonids increases with depth. Two of the 6 pools (33%) had a residual depth of two feet or greater (Graph 5).

Flatwater habitat types comprised 21% of the total length of this survey, riffles 1%, and pools 0.3%. The pools are relatively shallow, with only 2 of the 6 (33%) pools having a maximum residual depth greater than 2 feet. In general, pool enhancement projects are considered when primary pools comprise less than 40% of the length of total stream habitat. In first and second order streams, a primary pool is defined to have a maximum residual depth of at least two feet, occupy at least half the width of the low flow channel, and be as long as the low flow channel width. Installing structures that will increase or deepen pool habitat is recommended for locations where their installation will not be threatened by high stream energy, or where their installation will not conflict with the modification of the numerous log debris accumulations (LDA's) in the stream.

- 8) Where feasible, design and engineer pool enhancement structures to increase the number of pools. This must be done where the banks are stable or in conjunction with stream bank armor to prevent erosion.

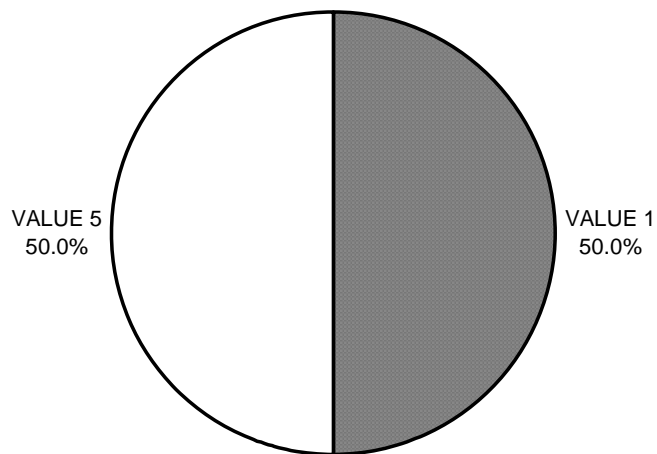
GRAPH 6

The depth of cobble embeddedness was estimated at pool tail-outs. Of the 6 pool tail-outs measured, 3 had a value of 1 (50%) and 3 had a value of 5 (50%) (Graph 6). On this scale, a value of 1 indicates the best spawning conditions and a value of 4 the worst. Additionally, a value of 5 was assigned to tail-outs deemed unsuited for spawning due to inappropriate substrate such as bedrock, log sills, boulders, or other considerations.

Three of the 6 pool tail-outs measured had embeddedness ratings of 1 or 2. None of the pool tail-outs had embeddedness ratings of 3 or 4. Three of the pool tail-outs had a rating of 5, which is considered unsuitable for spawning. Cobble embeddedness measured to be 25% or less, a rating of 1, is considered to indicate good quality spawning substrate for salmon and steelhead. Sediment sources in Willow Brook should be mapped and rated according to their potential

- 5) Inventory and map sources of stream bank erosion and prioritize them according to present and potential sediment yield. Identified sites should then be treated to reduce the amount of fine sediments entering the stream.

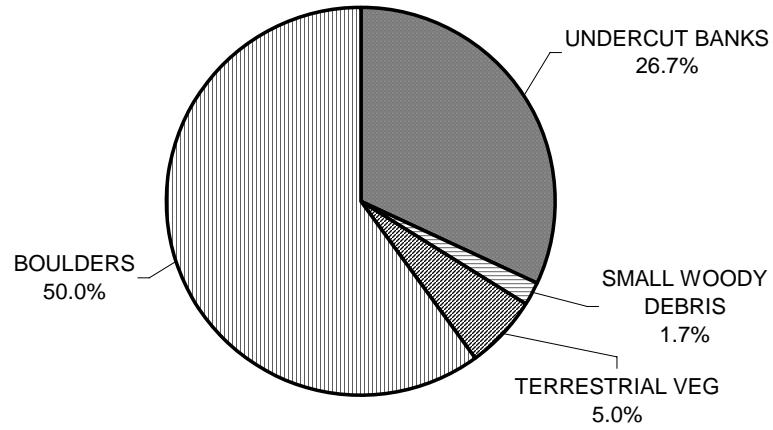
GRAPH 7

Table 5 summarizes mean percent cover by habitat type. Boulders are the dominant cover types in Willow Brook. Graph 7 describes the pool cover in Willow Brook. Boulders are the dominant pool cover type followed by undercut banks.

The mean shelter rating for pools was 12. The shelter rating in the flatwater habitats was 6. A pool shelter rating of approximately 100 is desirable. The amount of cover that now exists is being provided primarily by Boulders in Willow Brook. Boulders are the dominant cover type in pools followed by Terrestrial vegetation. Log and root wad cover structures in the pool and flatwater habitats would enhance both summer and winter salmonid habitat. Log cover structure provides rearing fry with protection from predation, rest from water velocity, and also divides territorial units to reduce density related competition.

- 9) Increase woody cover in the pools and flatwater habitat units. Most of the existing cover in the pools is from Boulders. Adding high quality complexity with woody cover in the pools is desirable.

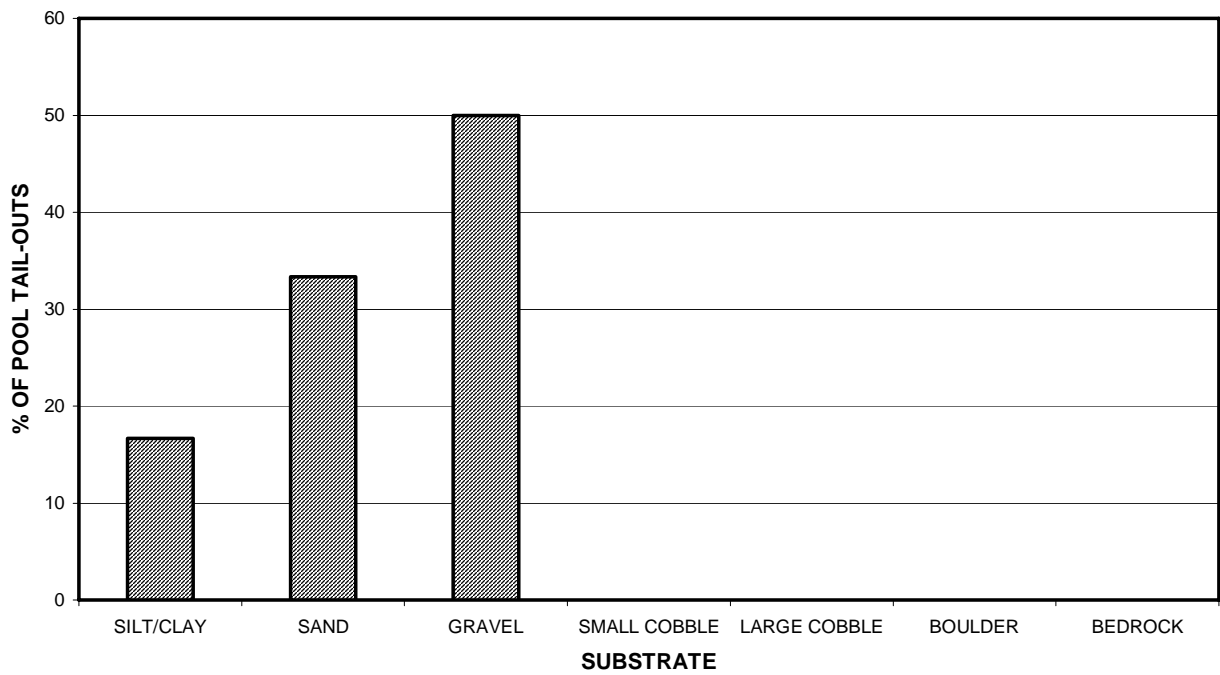
GRAPH 8

Table 6 summarizes the dominant substrate by habitat type. Graph 8 depicts the dominant substrate observed in pool tail-outs. Sand was observed in 33% of pool tail-outs and gravel observed in 50% of pool tail-outs.

Three of the 6 pool tail-outs measured had gravel or small cobble as the dominant substrate. This is generally considered good for spawning salmonids.

- 11) Suitable size spawning substrate on Willow Brook is limited to relatively few reaches. Projects should be designed at suitable sites to trap and sort spawning gravel.

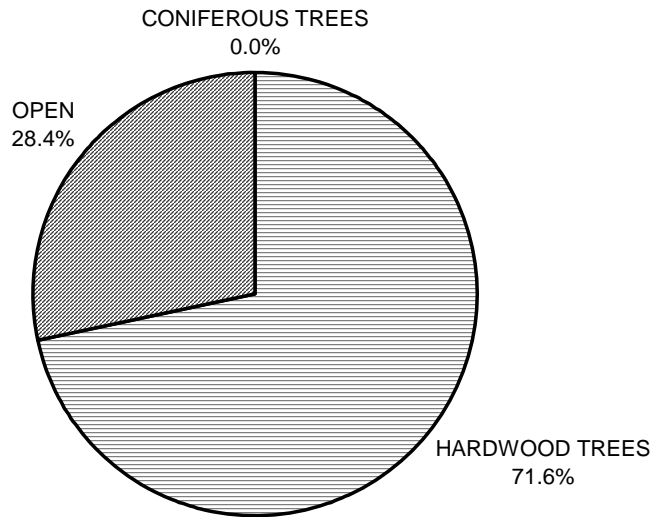
GRAPH 9

The mean percent canopy density for the surveyed length of Willow Brook was 72%. The mean percentages of hardwood and coniferous trees were 100% and 0%, respectively. Twenty eight percent of the canopy was open. Graph 9 describes the mean percent canopy in Willow Brook.

The mean percent canopy density for the stream was 72%. Reach 1 had a canopy density of 39%, Reach 2 had a canopy density of 61%, Reach 3 had a canopy density of 0%, and Reach 4 had a canopy density of 83%. In general, revegetation projects are considered when canopy density is less than 80%.

- 4) Increase the canopy on Willow Brook by planting appropriate native vegetation like willow, alder, redwood, and Douglas fir along the stream where shade canopy is not at acceptable levels. The reaches above this survey section should be inventoried and treated as well, since the water flowing here is affected from upstream. In many cases, planting will need to be coordinated to follow bank stabilization or upslope erosion control projects.

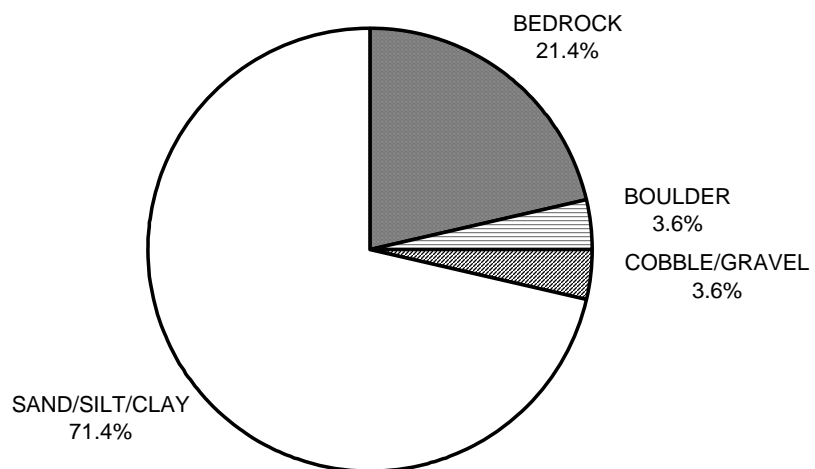
GRAPH 10

For the stream reach surveyed, the mean percent right bank vegetated was 28% and mean percent left bank vegetated was 33%. The dominant elements composing the structure of the stream banks consisted of 21% bedrock, 4% boulder, 4% cobble/gravel and 71% sand/silt/clay (Graph 10). Deciduous trees were the dominant vegetation type observed in 46% of the units surveyed.

The percentage of right and left bank covered with vegetation was LOW at 28% and 33%, respectively. In areas of stream bank erosion or where bank vegetation is sparse, planting endemic species of coniferous and hardwood trees, in conjunction with bank stabilization, is recommended.

- 7) Willow Brook Creek would benefit from utilizing bio-technical vegetative techniques for bank stabilization and to re-establish floodplain benches and a defined low flow channel. This would discourage lateral migration of the base flow channel and decrease bank erosion.

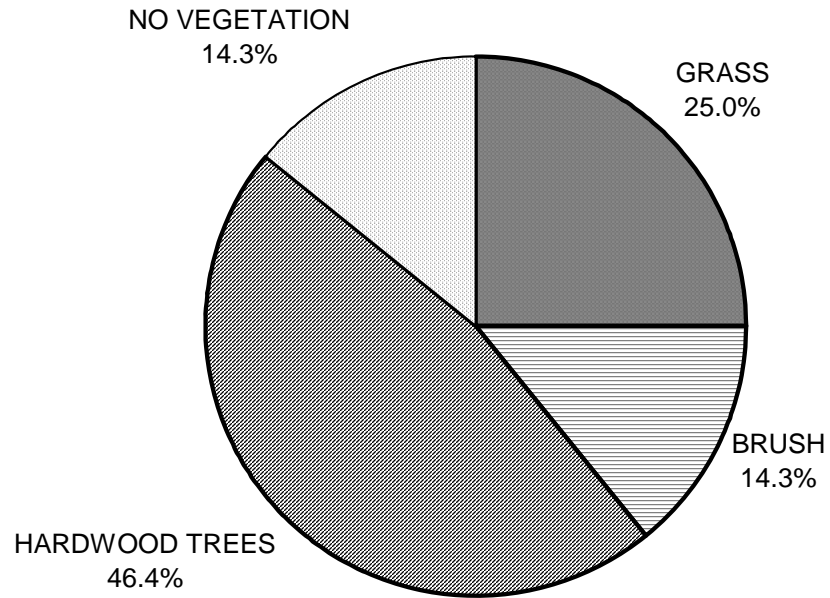
GRAPH 11

Additionally, 25% of the units surveyed had grass as the dominant vegetation type, and 14% had brush as the dominant vegetation (Graph 11).
