California Department of Fish and Wildlife
San Mateo County
San Mateo Coastal Watersheds
Stream Habitat Assessment Reports

Apanolio Creek

Surveyed 2011

STREAM INVENTORY REPORT

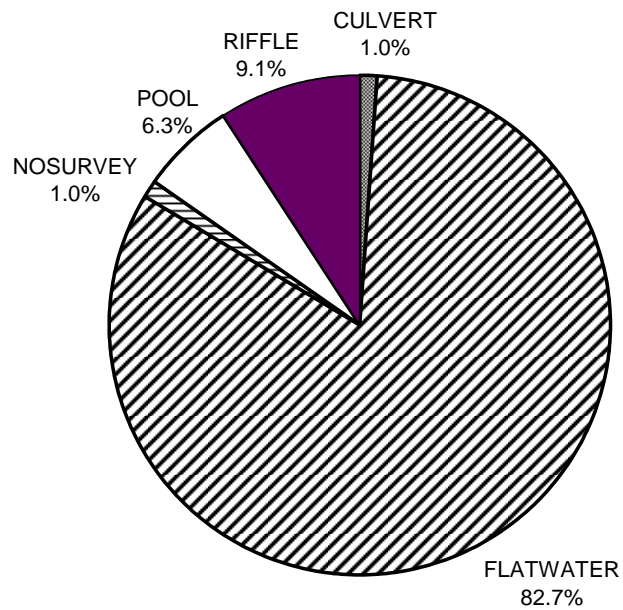
GRAPH 2

Table 1 summarizes the Level II riffle, flatwater, and pool habitat types. Based on frequency of occurrence there were 50% flatwater units, 30% pool units, 18% riffle units, 2% culvert units, 0% not surveyed units (Graph 1). Based on total length of Level II habitat types, there were 83% flatwater units, 9% riffle units, 6% pool units, 1% not surveyed units, 1% culvert units (Graph 2).

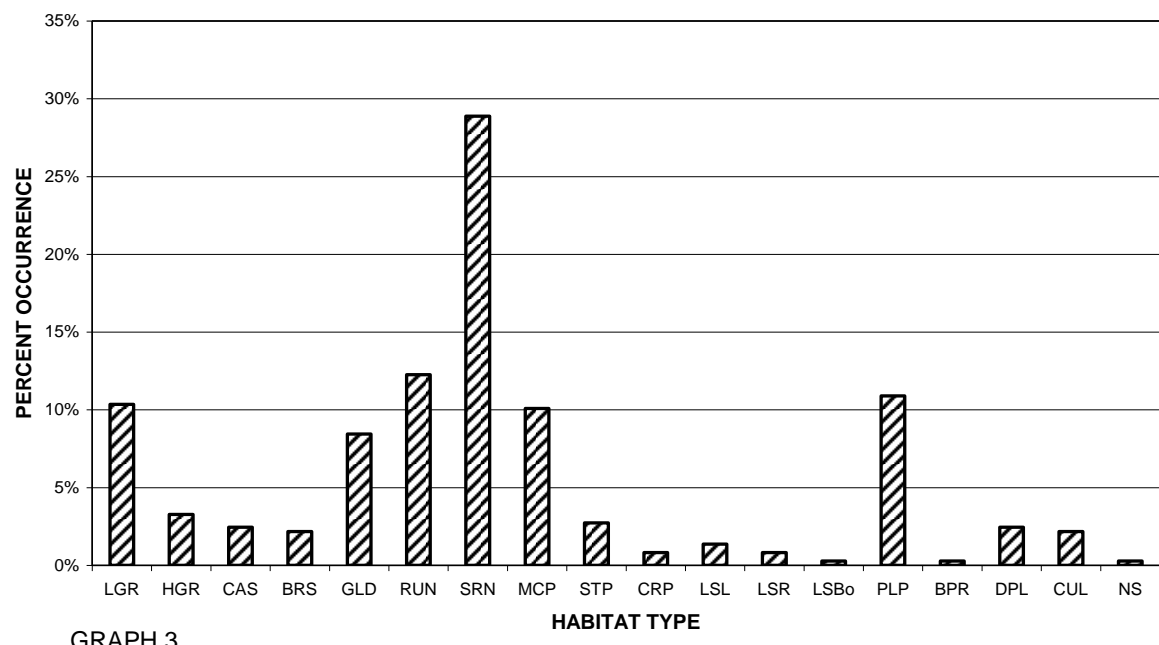
GRAPH 3

percent occurrence were 29% step run units, 12% run units, 11% plunge pool units (Graph 3). Based on percent total length, 64% step run units, 12% run units and 8% glide units.

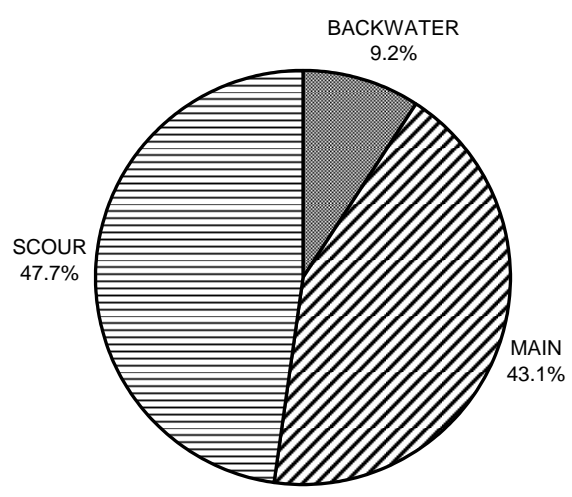
GRAPH 4

A total of 109 pools were identified (Table 3). Scour pools were the most frequently encountered at 48% (Graph 4), and comprised 40% of the total length of all pools (Table 3).

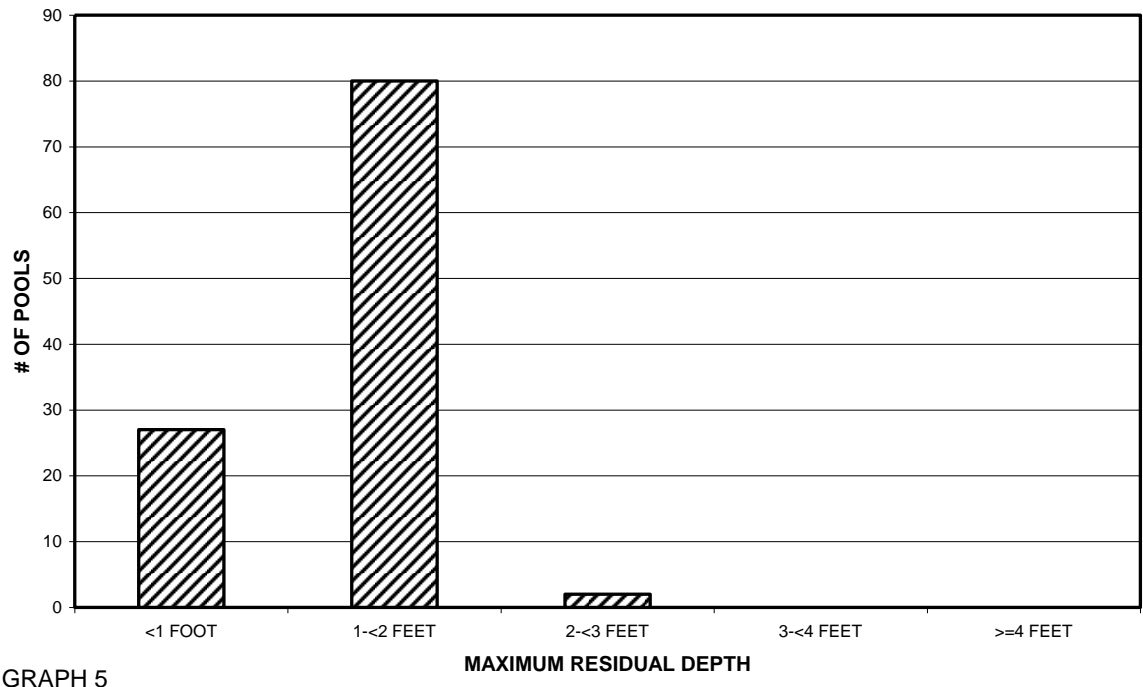
GRAPH 5

Table 4 is a summary of maximum residual pool depths by pool habitat types. Pool quality for salmonids increases with depth. One of the 109 pools (1%) had a residual depth of two feet or greater (Graph 5).

Flatwater habitat types comprised 83% of the total length of this survey, riffles 9%, and pools 6%. The pools are relatively shallow, with 1 of the 109 (1%) pools having a maximum residual depth greater than two feet. In general, pool enhancement projects are considered when primary pools comprise less than 40% of the length of total stream habitat. In first and second order streams, a primary pool is defined to have a maximum residual depth of at least two feet, occupy at least half the width of the low flow channel, and be as long as the low flow channel width. Installing structures that will increase or deepen pool habitat is recommended for locations where their installation will not be threatened by high stream energy, or where their installation will not conflict with the modification of the numerous log debris accumulations (LDA's) in the stream.

- 3) Where feasible, design and engineer pool enhancement structures to increase the number of pools. This must be done where the banks are stable or in conjunction with stream bank armor to prevent erosion.

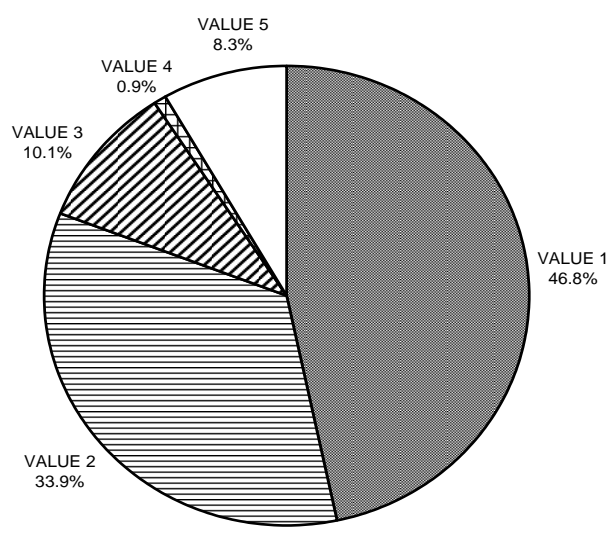
GRAPH 6

The depth of cobble embeddedness was estimated at pool tail-outs. Of the 109 pool tail-outs measured, 51 had a value of 1 (47%), 37 had a value of 2 (34%), 11 had a value of 3 (10%), 1 had a value of 4 (1%), 9 had a value of 5 (8%) (Graph 6). On this scale, a value of 1 indicates the best spawning conditions and a value of 4 the worst. Additionally, a value of 5 was assigned to tail-outs deemed unsuited for spawning due to inappropriate substrate such as bedrock, log sills, boulders, or other considerations.

Eighty-eight of the 109 pool tail-outs measured had embeddedness ratings of 1 or 2. Twelve of the pool tail-outs had embeddedness ratings of 3 or 4. Nine of the pool tail-outs had a rating of 5, which is considered unsuitable for spawning. Cobble embeddedness measured to be 25% or less, a rating of 1, is considered to indicate good quality spawning substrate for salmon and steelhead. Sediment sources in Apanolio Creek should be mapped and rated according to their potential sediment yields, and control measures should be taken.

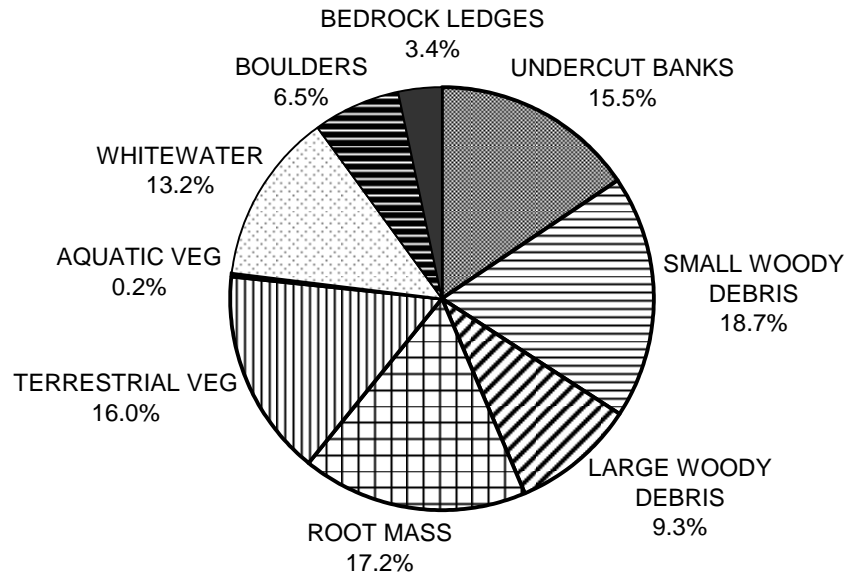
GRAPH 7

Table 5 summarizes mean percent cover by habitat type. Terrestrial vegetation is the dominant cover type in Apanolio Creek. Graph 7 describes the pool cover in Apanolio Creek. Small woody debris is the dominant pool cover type, followed by root masses.

The mean shelter rating for pools is 40. The shelter rating in the flatwater habitats is 30. A pool shelter rating of approximately 100 is desirable. The amount of cover that now exists is being provided primarily by terrestrial vegetation in Apanolio Creek. Small woody debris is the dominant cover type in pools, followed by root masses. Log and root wad cover structures in the pool and flatwater habitats would enhance both summer and winter salmonid habitat. Log cover structure provides rearing fry with protection from predation, rest from water velocity, and also divides territorial units to reduce density related competition.

- 1) Increase woody cover in the pools and flatwater habitat units. Most of the existing cover in the pools is from Terrestrial Vegetation. Adding high quality complexity with woody cover in the pools is desirable.

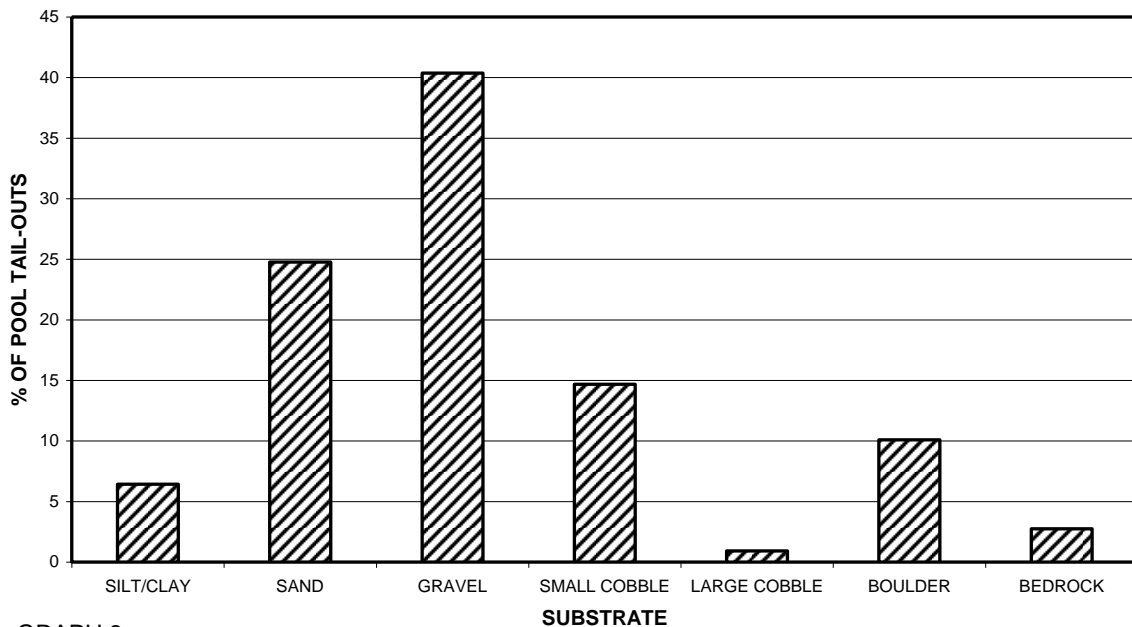
GRAPH 8

Table 6 summarizes the dominant substrate by habitat type. Graph 8 depicts the dominant substrate observed in pool tail-outs. Gravel substrate was observed in 40% of pool tail-outs; and sand substrate was observed in 25% of pool tail-outs.

Sixty of the 109 pool tail-outs measured had gravel and small cobble as the dominant substrate. This is generally considered good for spawning salmonids.

- 2) Suitable size spawning substrate on Apanolio Creek is limited to relatively few reaches. Projects should be designed at suitable sites to trap and sort spawning gravel.

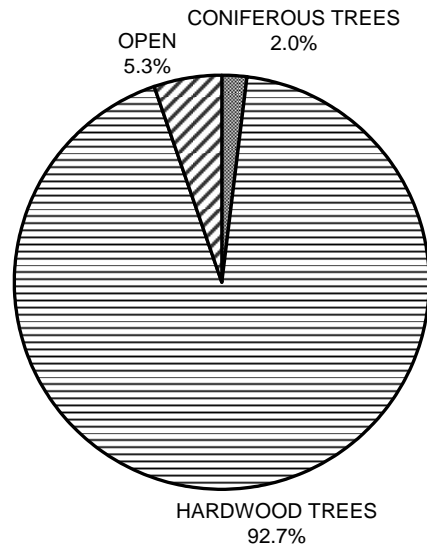
GRAPH 9

The mean percent canopy density for the surveyed length of Apanolio Creek was 95%. Of the canopy present, the mean percentages of hardwood and coniferous trees were 98% and 2%, respectively. Five percent of the canopy was open. Graph 9 describes the mean percent canopy in Apanolio Creek.

The mean percent canopy density for the stream was 95%. Reach 1 had a canopy density of 92.6%, Reach 2 had a canopy density of N/A, Reach 3 had a canopy density of 96.7%, Reach 4 had a canopy density of 95.5%, and Reach 5 had a canopy density of 96.4%. In general, revegetation projects are considered when canopy density is less than 80%.

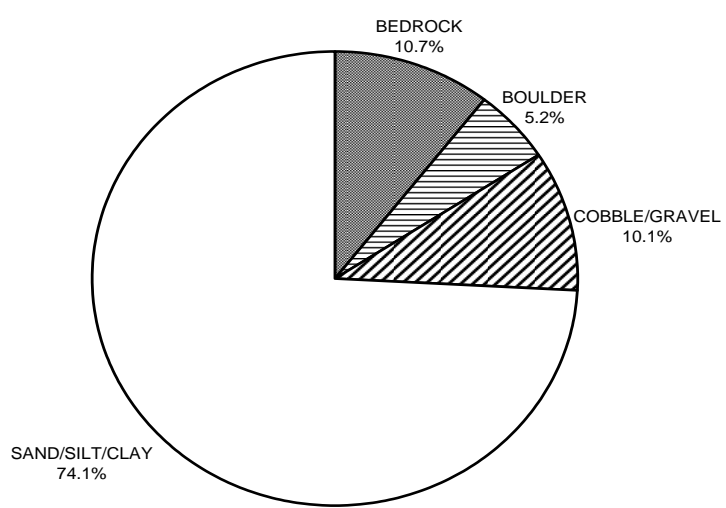
GRAPH 10

For the stream reach surveyed, the mean percent right bank vegetated was 92%. The mean percent left bank vegetated was 93% (Table 7). The dominant elements composing the structure of the stream banks consisted of 74% sand/silt/clay, 11% bedrock, 10% cobble/gravel and 5% boulder (Graph 10). Brush was the dominant vegetation type observed in 49% of the units surveyed. Additionally, 49% of the units surveyed had deciduous trees as the dominant vegetation type, and 2% had grass as the dominant vegetation type (Graph 11).

The percentage of right and left bank covered with vegetation was 92% and 93%, respectively. In areas of stream bank erosion or where bank vegetation is sparse, planting endemic species of coniferous and hardwood trees, in conjunction with bank stabilization, is recommended.
