**California Department of Fish and Wildlife
San Mateo County
San Mateo Coastal Watersheds
Stream Habitat Assessment Reports**

Arroyo Leon Creek

Surveyed 2011

STREAM INVENTORY REPORT

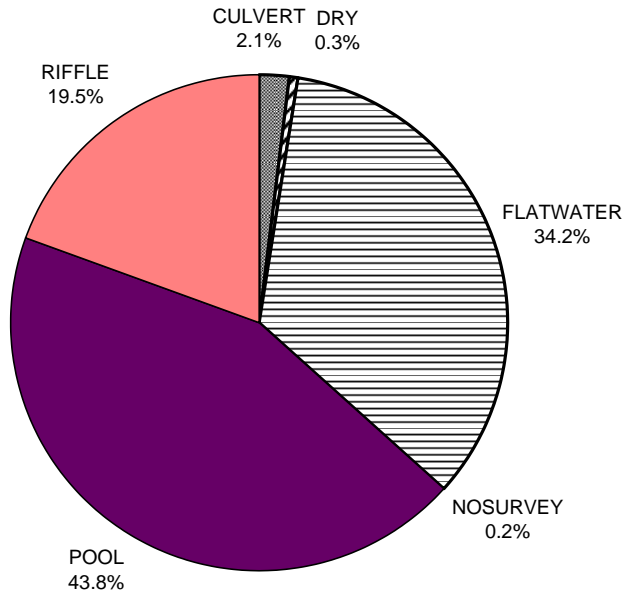
GRAPH 1

Table 1 summarizes the Level II riffle, flatwater, and pool habitat types. Based on frequency of occurrence there were 44% pool units, 34% flatwater units, 19% riffle units, 2% culvert units, 0% dry units, and 0% not surveyed units (Graph 1). Based on total length of Level II habitat types, there were 52% flatwater units, 26% pool units, 14% riffle units, 8% not surveyed units, 1% culvert units, and 0% dry units (Graph 2).

**LEON, ARROYO 2011
HABITAT TYPES BY PERCENT OCCURRENCE**

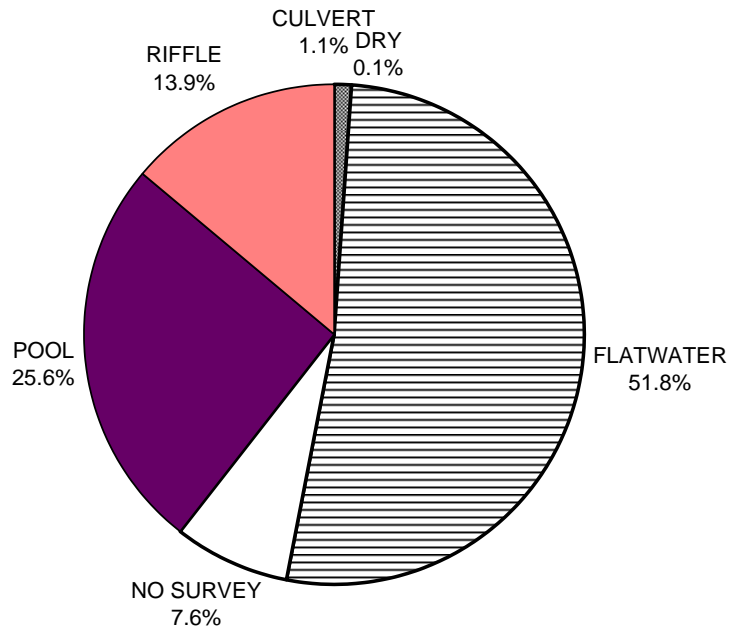
GRAPH 2

**LEON, ARROYO 2011
HABITAT TYPES BY PERCENT TOTAL LENGTH**

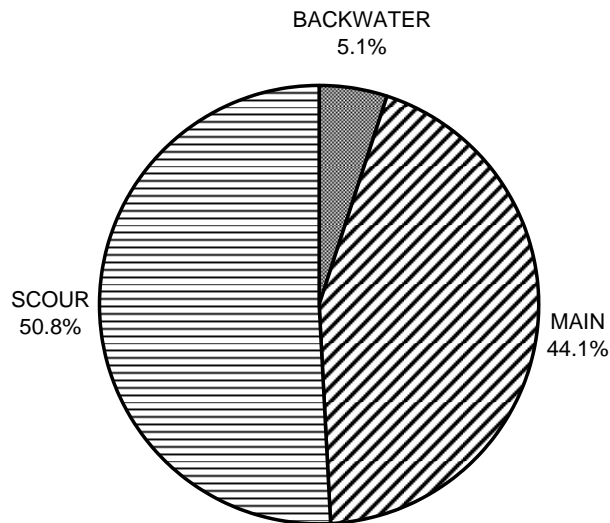
GRAPH 4

A total of 256 pools were identified (Table 3). Scour pools were the most frequently encountered at 51% (Graph 4), and comprised 37% of the total length of all pools (Table 3).

**LEON, ARROYO 2011
POOL TYPES BY PERCENT OCCURRENCE**

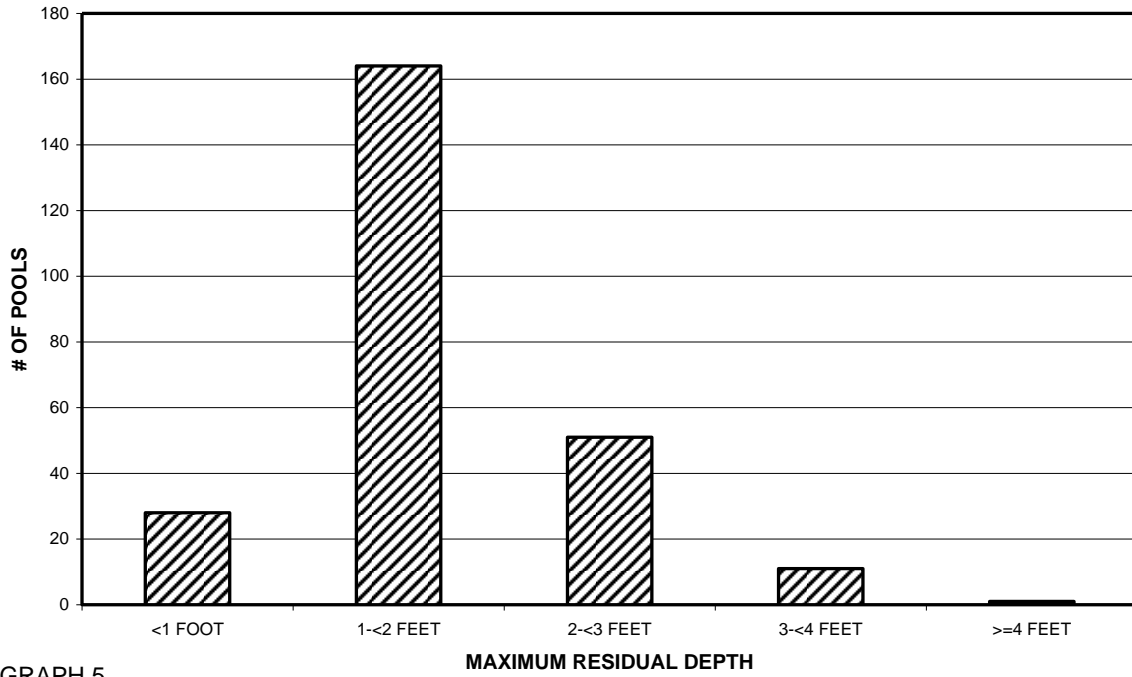
GRAPH 5

Table 4 is a summary of maximum residual pool depths by pool habitat types. Pool quality for salmonids increases with depth. Twelve of the 256 pools (5%) had a residual depth of three feet or greater (Graph 5).

LEON, ARROYO 2011
MAXIMUM DEPTH IN POOLS

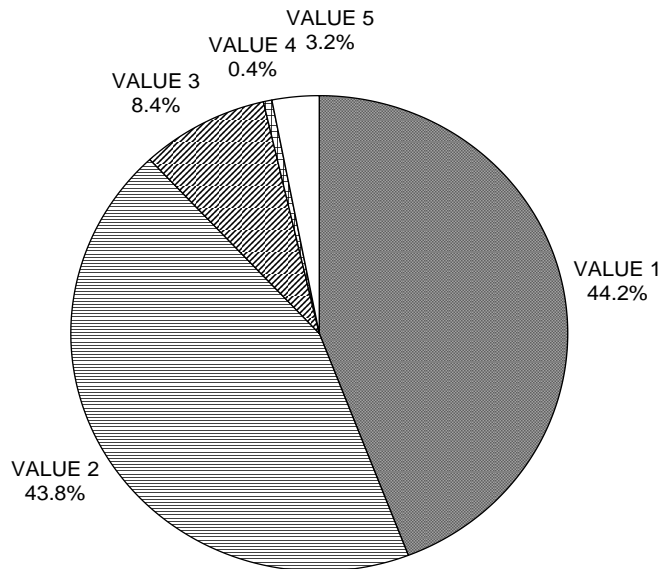
GRAPH 6

The depth of cobble embeddedness was estimated at pool tail-outs. Of the 256 pool tail-outs measured, 111 had a value of 1 (43%), 110 had a value of 2 (43%), 21 had a value of 3 (8%), 1 had a value of 4 (0%), 8 had a value of 5 (3%) (Graph 6). On this scale, a value of 1 indicates the best spawning conditions and a value of 4 the worst. Additionally, a value of 5 was assigned to tail-outs deemed unsuited for spawning due to inappropriate substrate such as bedrock, log sills, boulders, or other considerations.

Two hundred twenty-one of the 256 pool tail-outs measured had embeddedness ratings of 1 or 2. Twenty-two of the pool tail-outs had embeddedness ratings of 3 or 4. Eight of the pool tail-outs had a rating of 5, which is considered unsuitable for spawning. Cobble embeddedness measured to be 25% or less, a rating of 1, is considered to indicate good quality spawning substrate for salmon and steelhead. Sediment sources in Arroyo Leon should be mapped and rated according to their potential sediment yields, and control measures should be taken.

LEON, ARROYO 2011
PERCENT EMBEDDEDNESS

- 3) Inventory and map sources of stream bank erosion and prioritize them according to present and potential sediment yield. Identified sites should then be treated to reduce the amount of fine sediments entering the stream. Active and potential sediment sources related to the road system need to be identified, mapped, and treated according to their potential for sediment yield to the stream and its tributaries.

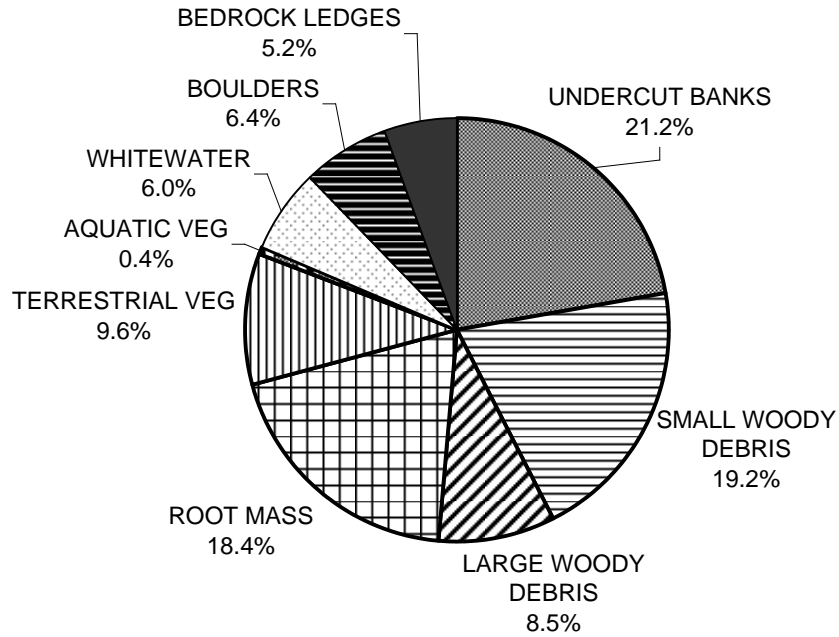
GRAPH 7

Table 5 summarizes mean percent cover by habitat type. Undercut banks is the dominant cover type in Arroyo Leon. Graph 7 describes the pool cover in Arroyo Leon. Undercut banks is the dominant pool cover type, followed by small woody debris.

The mean shelter rating for pools is 47. The shelter rating in the flatwater habitats is 25. A pool shelter rating of approximately 100 is desirable. The amount of cover that now exists is being provided primarily by undercut banks in Arroyo Leon. Undercut banks is the dominant cover type in pools, followed by small woody debris. Log and root wad cover structures in the pool and flatwater habitats would enhance both summer and winter salmonid habitat. Log cover structure provides rearing fry with protection from predation, rest from water velocity, and also divides territorial units to reduce density related competition.

**LEON, ARROYO 2011
MEAN PERCENT COVER TYPES IN POOLS**

- 2) Increase woody cover in the pools and flatwater habitat units. Most of the existing cover in the pools is from Undercut Banks. Adding high quality complexity with woody cover in the pools is desirable.

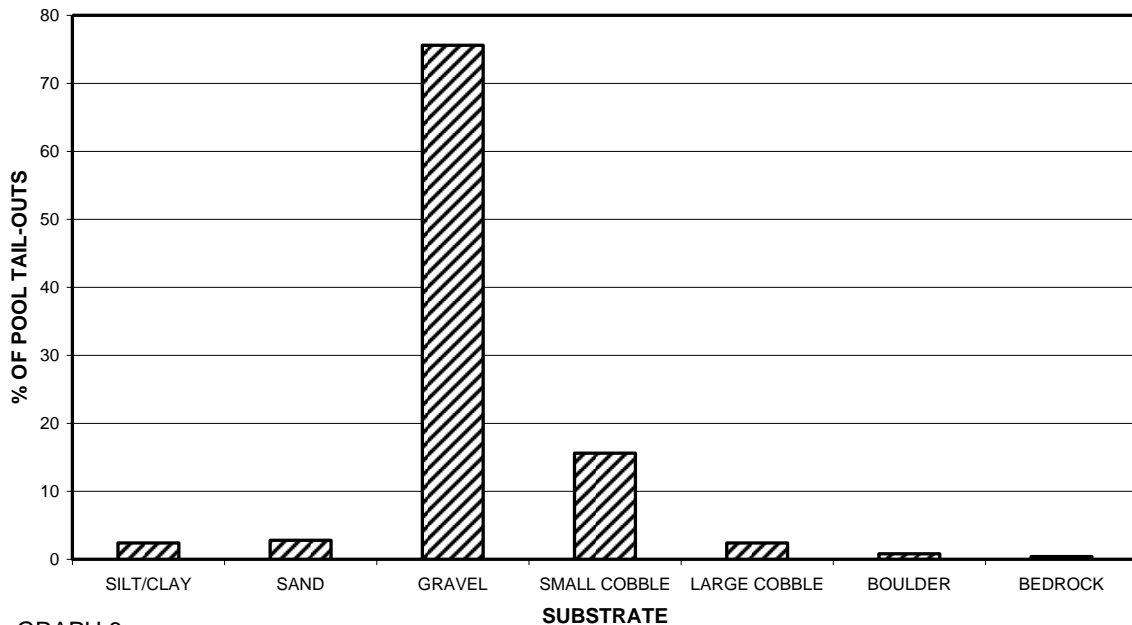
GRAPH 8

Table 6 summarizes the dominant substrate by habitat type. Graph 8 depicts the dominant substrate observed in pool tail-outs. Gravel substrate was observed in 76% of pool tail-outs; and small cobble substrate was observed in 16% of pool tail-outs.

Two hundred twenty-nine of the 256 pool tail-outs measured had gravel and small cobble as the dominant substrate. This is generally considered good for spawning salmonids.

**LEON, ARROYO 2011
SUBSTRATE COMPOSITION IN POOL TAIL-OUTS**

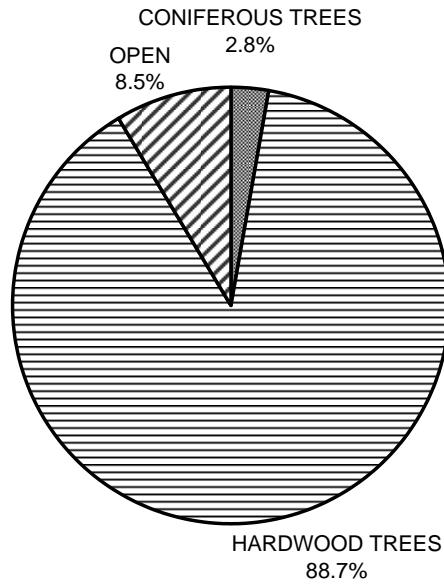
GRAPH 9

The mean percent canopy density for the surveyed length of Arroyo Leon was 91%. Of the canopy present, the mean percentages of hardwood and coniferous trees were 97% and 3%, respectively. Nine percent of the canopy was open. Graph 9 describes the mean percent canopy in Arroyo Leon.

The mean percent canopy density for the stream was 91%. Reach 1 had a canopy density of 85.9%, Reach 2 had a canopy density of 95.9%, Reach 3 had a canopy density of 89.8%, Reach 4 had a canopy density of N/A. Reach 5 had a canopy density of 96.1%, Reach 6 had a canopy density of 95.5%, Reach 7 had a canopy density of 91.6%, Reach 8 had a canopy density of 95.4%, Reach 9 had a canopy density of 91.1%, Reach 10 had a canopy density of 96.5%, Reach 11 had a canopy density of 92.7%, Reach 12 had a canopy density of 90.8%, and Reach 13 had a canopy density of 92%. In general, revegetation projects are considered when canopy density is less than 80%.

**LEON, ARROYO 2011
MEAN PERCENT CANOPY**

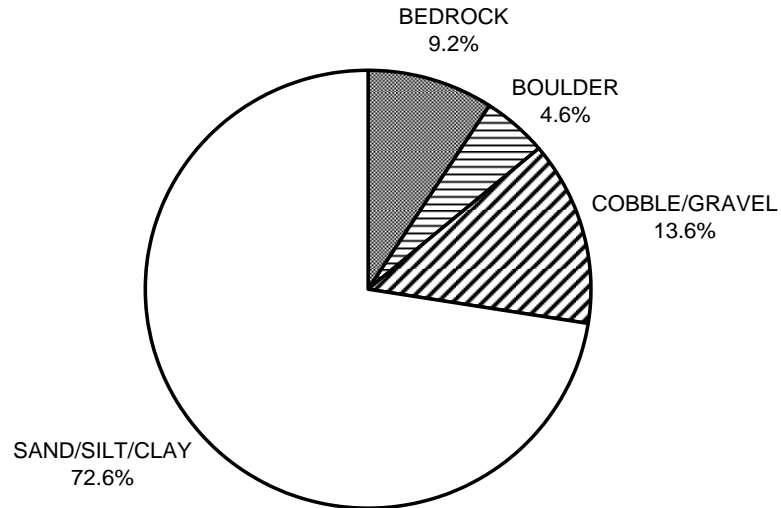
GRAPH 10

For the stream reach surveyed, the mean percent right bank vegetated was 85%. The mean percent left bank vegetated was 84% (Table 7). The dominant elements composing the structure of the stream banks consisted of 73% sand/silt/clay, 14% cobble/gravel, 9% bedrock, and 5% boulder (Graph 10). Brush was the dominant vegetation type observed in 62% of the units surveyed. Additionally, 36% of the units surveyed had deciduous trees as the dominant vegetation type, and 1% had coniferous trees as the dominant vegetation type (Graph 11).

**LEON, ARROYO 2011
DOMINANT BANK COMPOSITION IN SURVEY REACH**

The percentage of right and left bank covered with vegetation was 85% and 84%, respectively. In areas of stream bank erosion or where bank vegetation is sparse, planting endemic species of coniferous and hardwood trees, in conjunction with bank stabilization, is recommended.

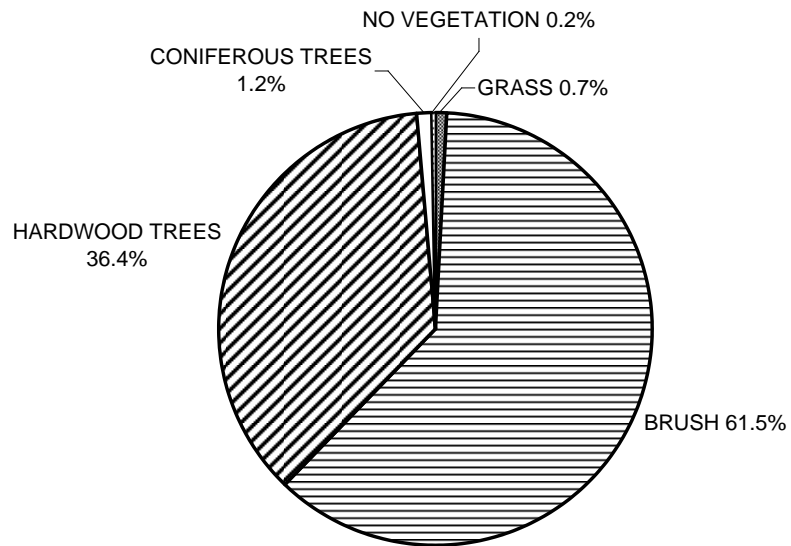
GRAPH 11

**LEON, ARROYO 2011
DOMINANT BANK VEGETATION IN SURVEY REACH**
